## HISTORIC AND DESIGN REVIEW COMMISSION

**HDRC CASE NO:** 2019-223  
**ADDRESS:** 517 E HOUSTON ST  
**LEGAL DESCRIPTION:** NCB 422 BLK 26 W 26 FT OF 5 ARB A2  
**ZONING:** D, H, HS  
**CITY COUNCIL DIST.:** 1  
**DISTRICT:** Alamo Plaza Historic District  
**LANDMARK:** Rosenberg, Frank Building  
**APPLICANT:** Michael Litofsky  
**OWNER:** Michael Litofsky  
**TYPE OF WORK:** Front Facade Reconstruction, including removal of ClearBoarding for compliance  
**APPLICATION RECEIVED:** April 17, 2019  
**60-DAY REVIEW:** June 16, 2019  
**CASE MANAGER:** Huy Pham  
**REQUEST:**

The applicant is requesting a Certificate of Appropriateness for approval to construct the storefront at 517 E Houston in accordance with plans approved by the HDRC on May 20, 2015 and a timeline of compliance. This request is a result of a municipal court case filed for the installation of ClearBoarding prior to approval.

# 517 BUILDING SHELL IMPROVEMENTS

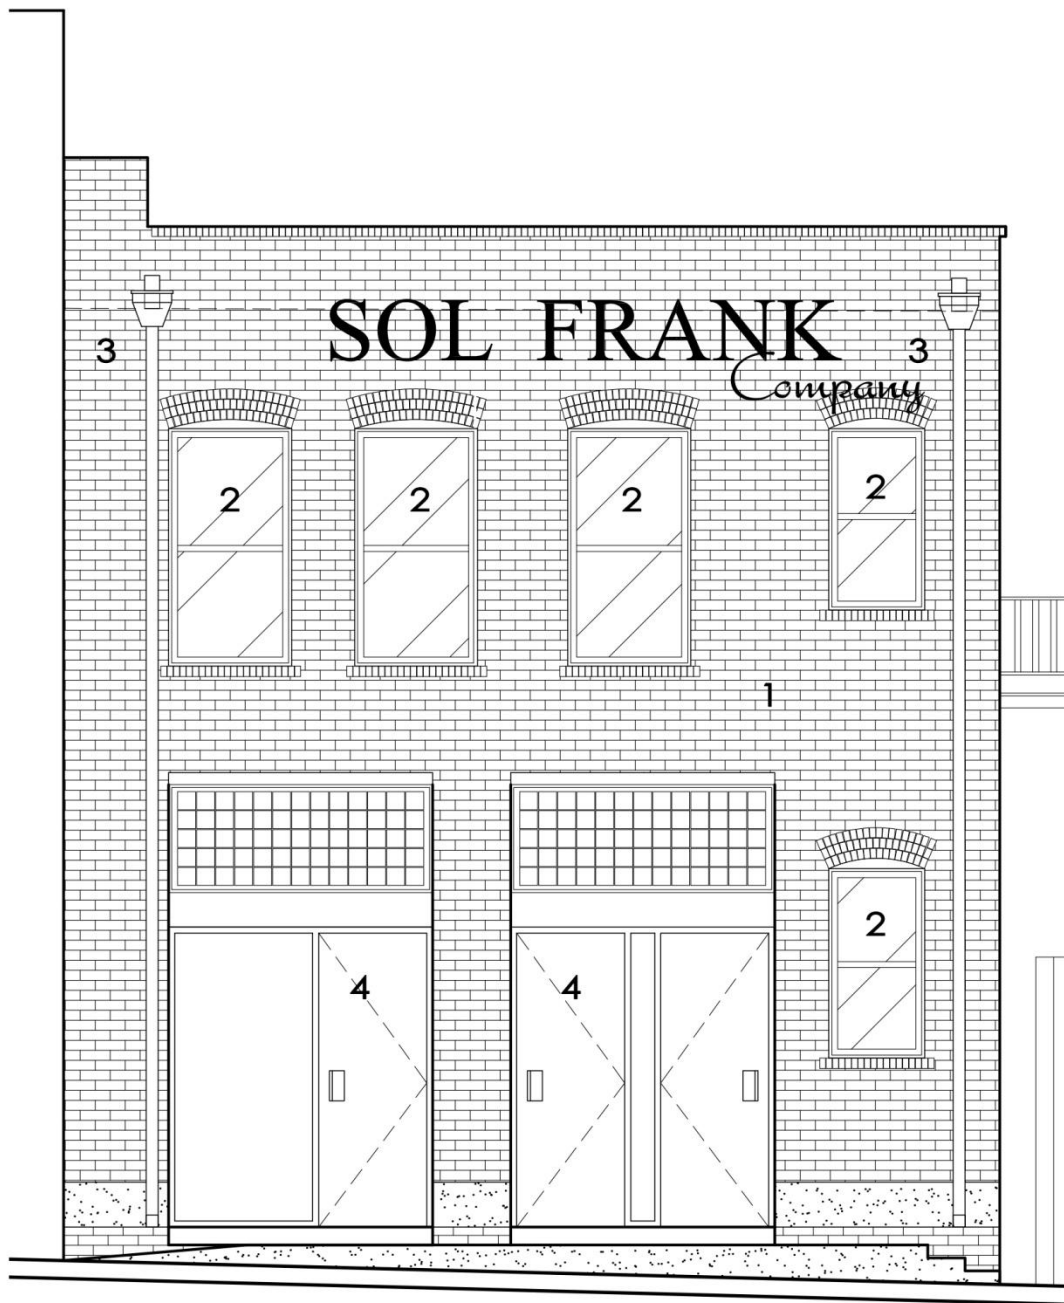
- 1 CLEAN AND RESTORE EXISTING BRICK
- 2 REPLACE WINDOWS
- 3 RESTORE SCUPPER, DOWNSPOUT AND DOWN LEADER
- 4 NEW DOORS

- i. **GUTTER SYSTEM** - The applicant has proposed to restore the scuppers, downspouts and down leaders of the existing gutter system. While those that are currently on the façade are not historic, their repair is consistent with the Guidelines for Exterior Maintenance and Alterations 4.A.

- m. **NEW WINDOWS** - According to the Guidelines for Exterior Maintenance and Alterations, new windows that match the historic windows of a structure should be installed when the existing windows are missing or deteriorated beyond repair. The applicant has proposed to install new one over one wood windows on the Peacock Alley (rear) façade of the structure. This is consistent with the Guidelines for Exterior Maintenance and Alterations 6.B.iv.

- n. **NEW DOORS** - The applicant has proposed to install two (2) new doors on the Peacock Alley façade. While this is the rear of the building, in this instance the rear is proposed to be treated as the front also. The Guidelines for Exterior Maintenance and Alterations 6.A.i. does not recommend that new entrances be created where visible from the public right of way. This proposal is not consistent with the Guidelines. Staff recommends that the applicant keep the existing door openings and widths.
