# HISTORIC AND DESIGN REVIEW COMMISSION

**HDRC CASE NO:** 2019-414  
**ADDRESS:** 367 QUENTIN DR  
**LEGAL DESCRIPTION:** NCB 8411 BLK 6 LOT E 25 FT OF 6 & W 35 FT OF 7  
**ZONING:** R-6,H  
**CITY COUNCIL DIST.:** 7  
**DISTRICT:** Monticello Park Historic District  
**APPLICANT:** JEFF CHOI/WINDOW EXPO  
**OWNER:** ROBERTO FLORES/VELASQUEZ LISA MARIE  
**TYPE OF WORK:** Window and door replacement  
**APPLICATION RECEIVED:** July 16, 2019  
**60-DAY REVIEW:** September 14, 2019  
**CASE MANAGER:** Adam Rajper  
**REQUEST:**

The applicant is requesting a Certificate of Appropriateness for approval to:

1. Replace thirteen (13) windows
2. Replace two doors (front and rear)

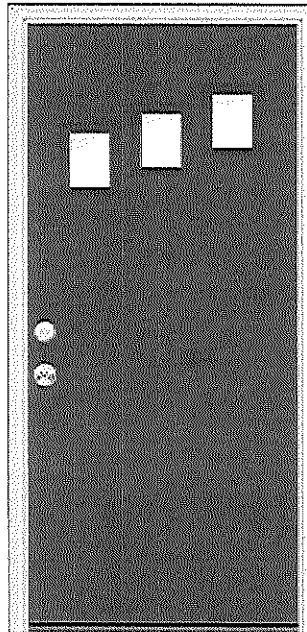
Outside Looking In  
 Due to variances in color and manufacturing  
 process, image shown may vary from final  
 product.

- c. **DOOR REPLACEMENTS** – The applicant has proposed to replace two doors (front and rear). According to the Historic Design Guidelines for Exterior Maintenance and Alterations, replacement doors should be appropriate for the style of the home. Staff finds that the proposed doors are appropriate for the Mid-Century Modern style of the home.
