HISTORIC AND DESIGN REVIEW COMMISSION

HDRC CASE NO: 2017-478
ADDRESS: 205 OSTROM
LEGAL DESCRIPTION: NCB 6938 BLK LOT 1&2
ZONING: R-4 CD, H, RIO-1
CITY COUNCIL DIST.: 1
DISTRICT: River Road Historic District
APPLICANT: Tobias Stapleton
OWNER: Tobias Stapleton
TYPE OF WORK: Demolition with new construction of two residential structures and two accessory structures

1. Demolish the historic structure located at 205 Ostrom.
2. Construct a two story, primary residential structure on the east end of the lot.
3. Construct a two story, primary residential structure on the west end of the lot.
4. Construct two, two story, rear accessory structures at the rear of each two story structure.
5. Install two driveways/parking locations on the site.

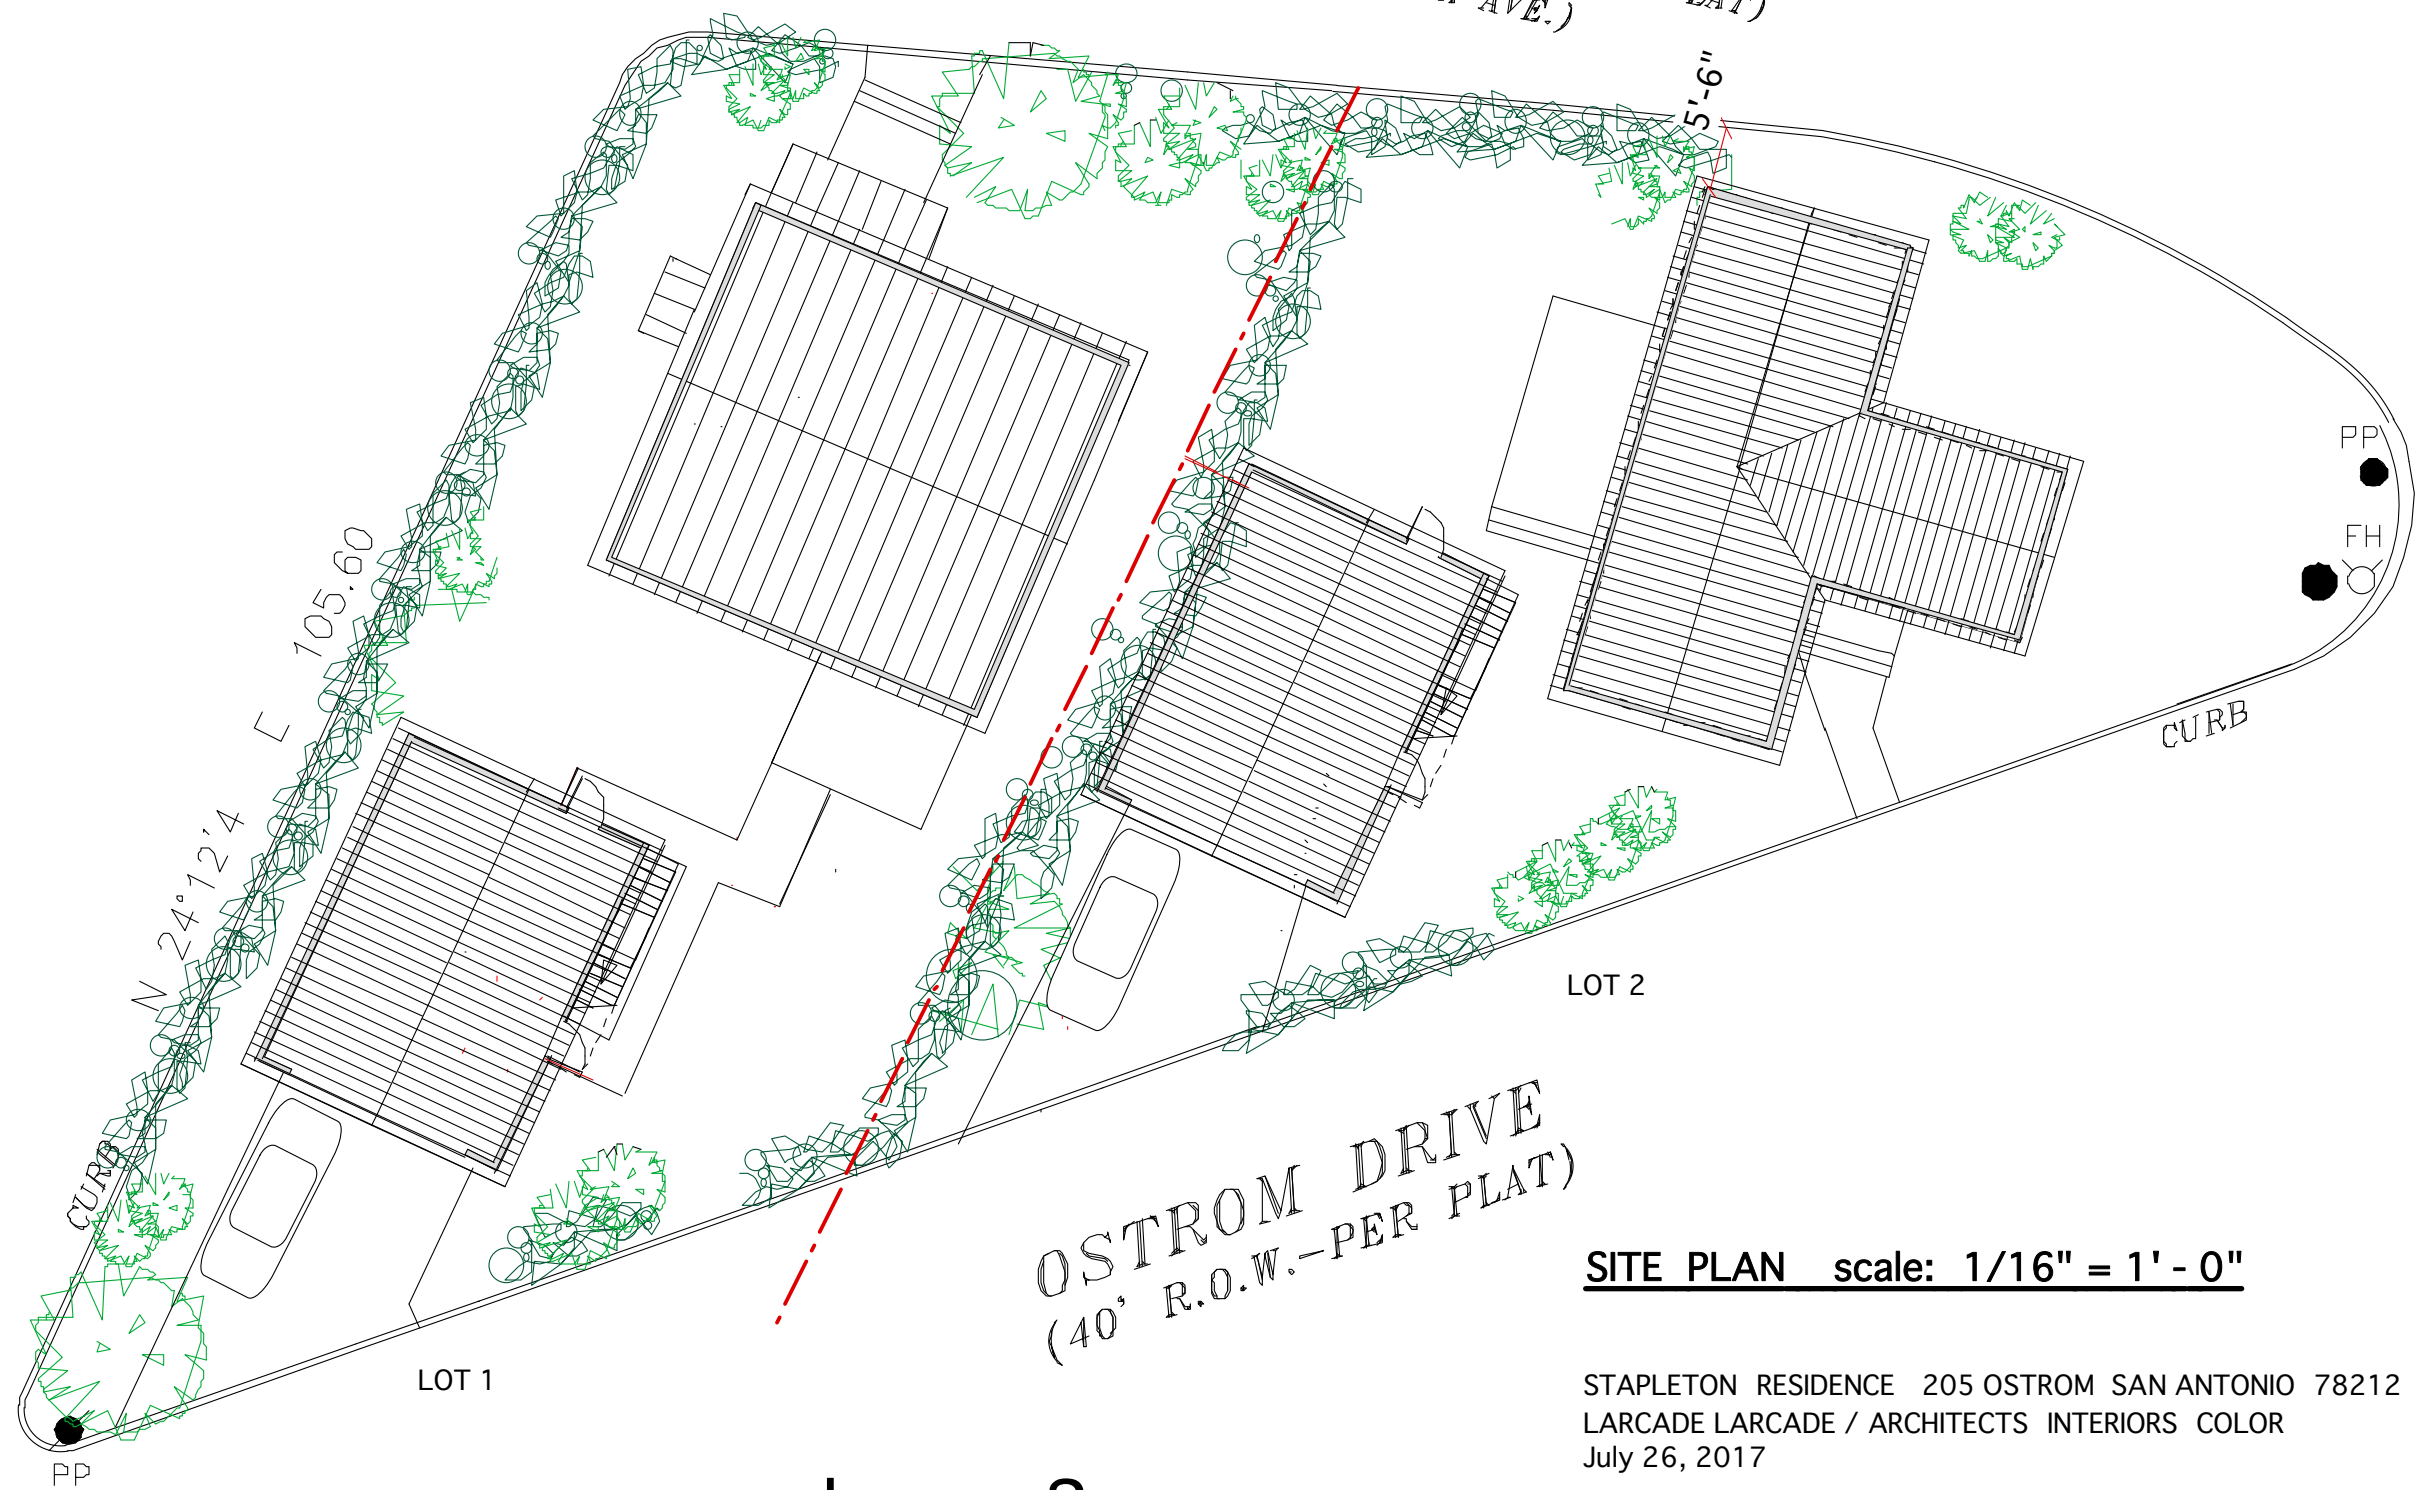
SITE PLAN scale: 1/16" = 1' - 0"

OSTROM DRIVE
(40' R.O.W.-PER PLAT)

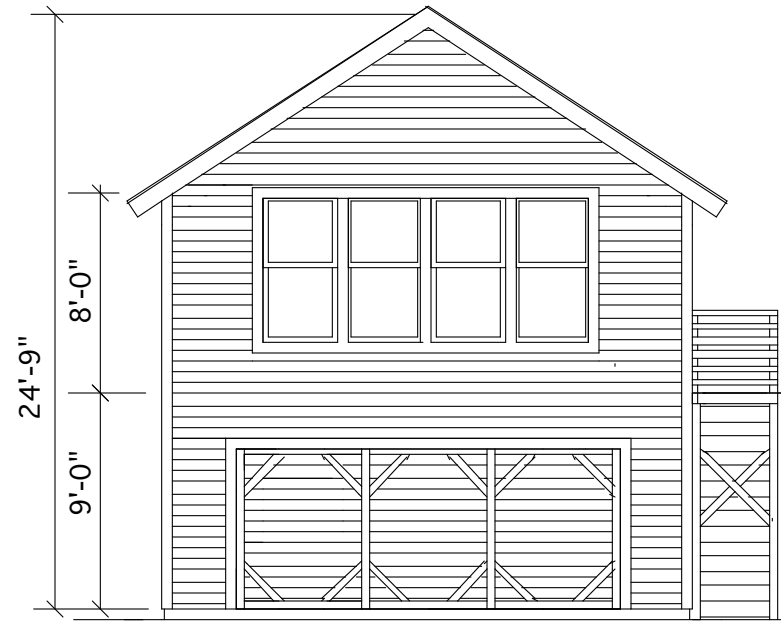
Front Elevation scale: 1/8" = 1' - 0"

**Accessory Buildings
Identical one on each Lot
Qty 2**

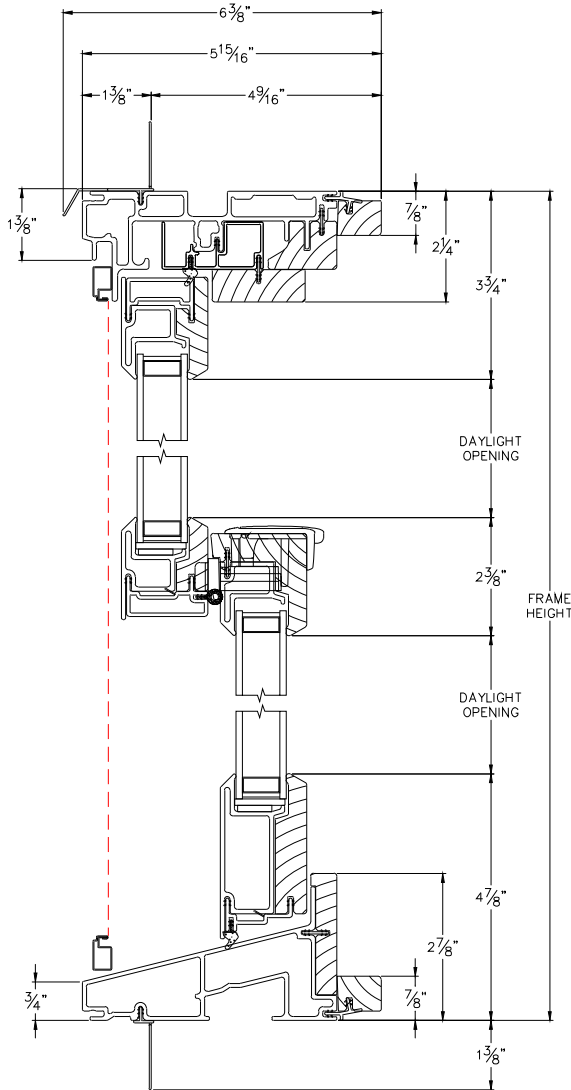
HEAD & SILL

DOUBLE HUNG SERIES 9200

**We are proposing this style windows that are inline with the HDRC window guidelines for new construction, These windows have been used in the following locations within Historic Districts with no objection.
Howl & Moon on the River Walk
111 W Crockett St, San Antonio, Tx 78205**

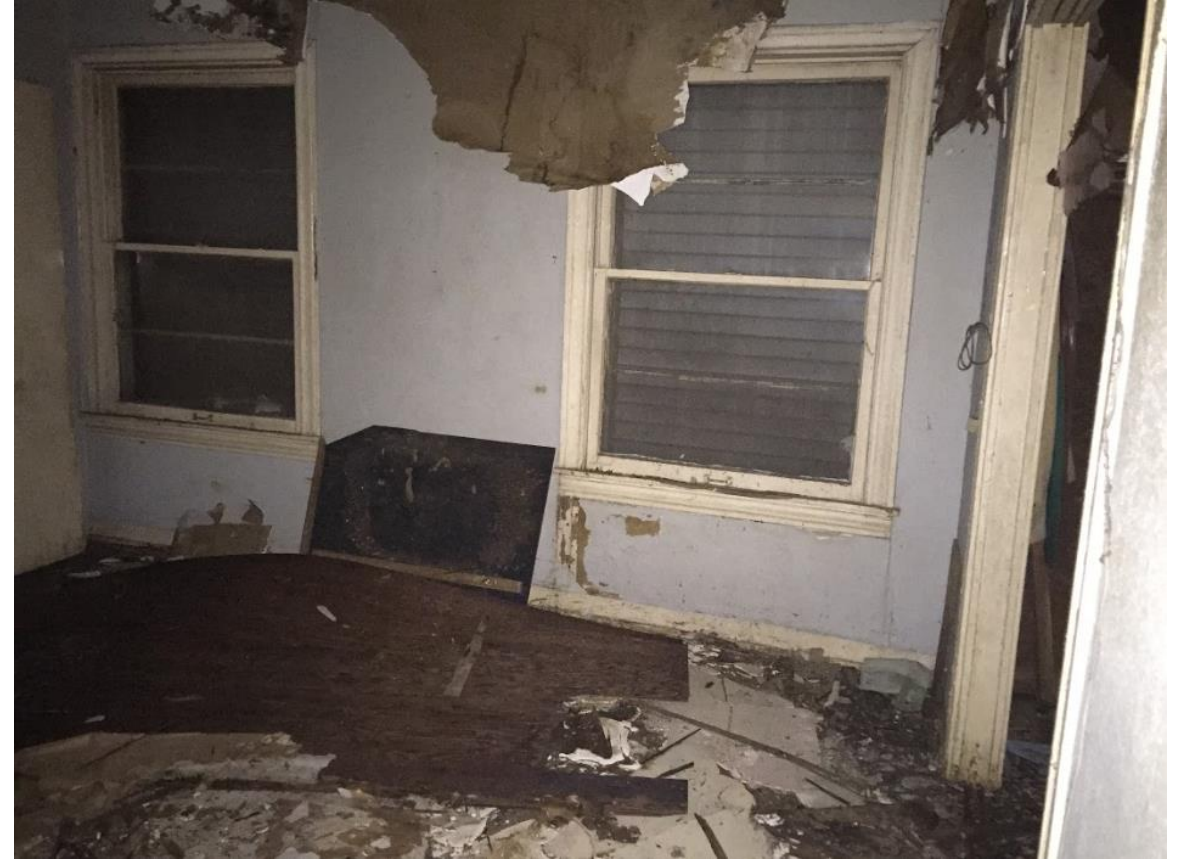
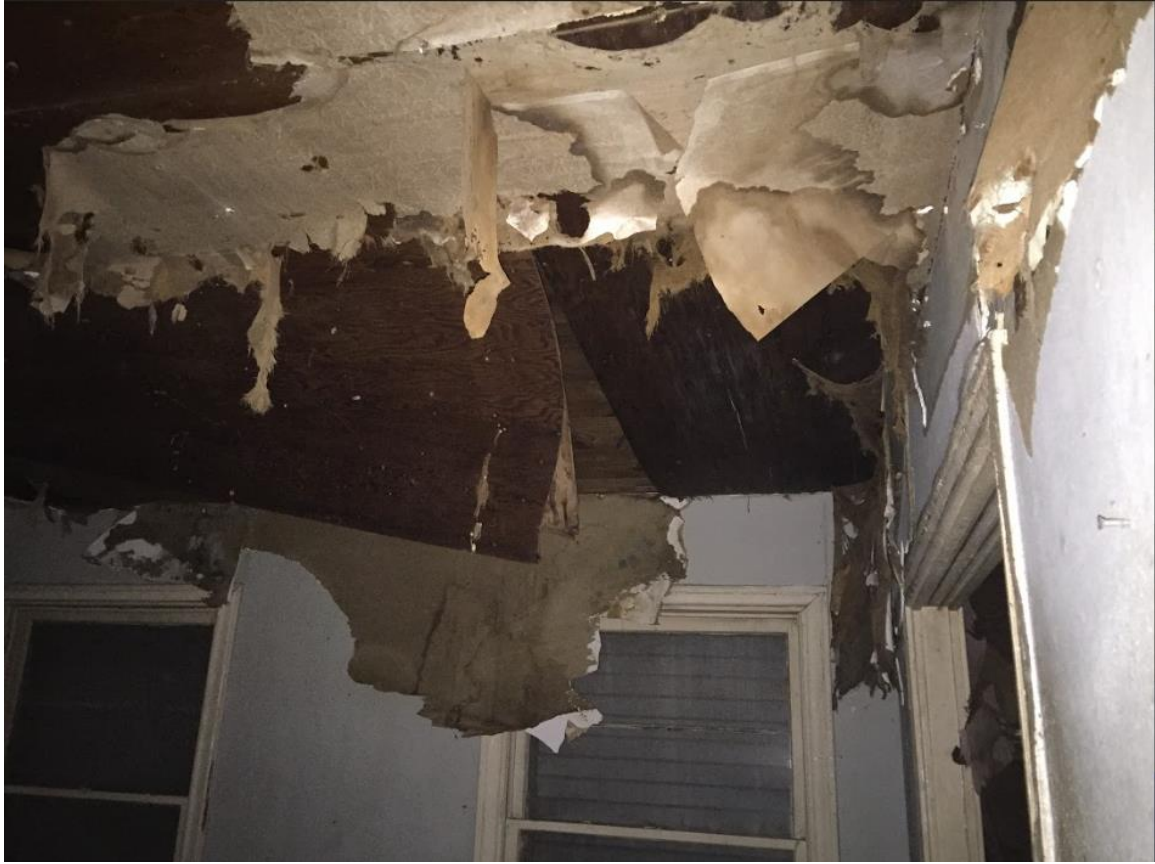
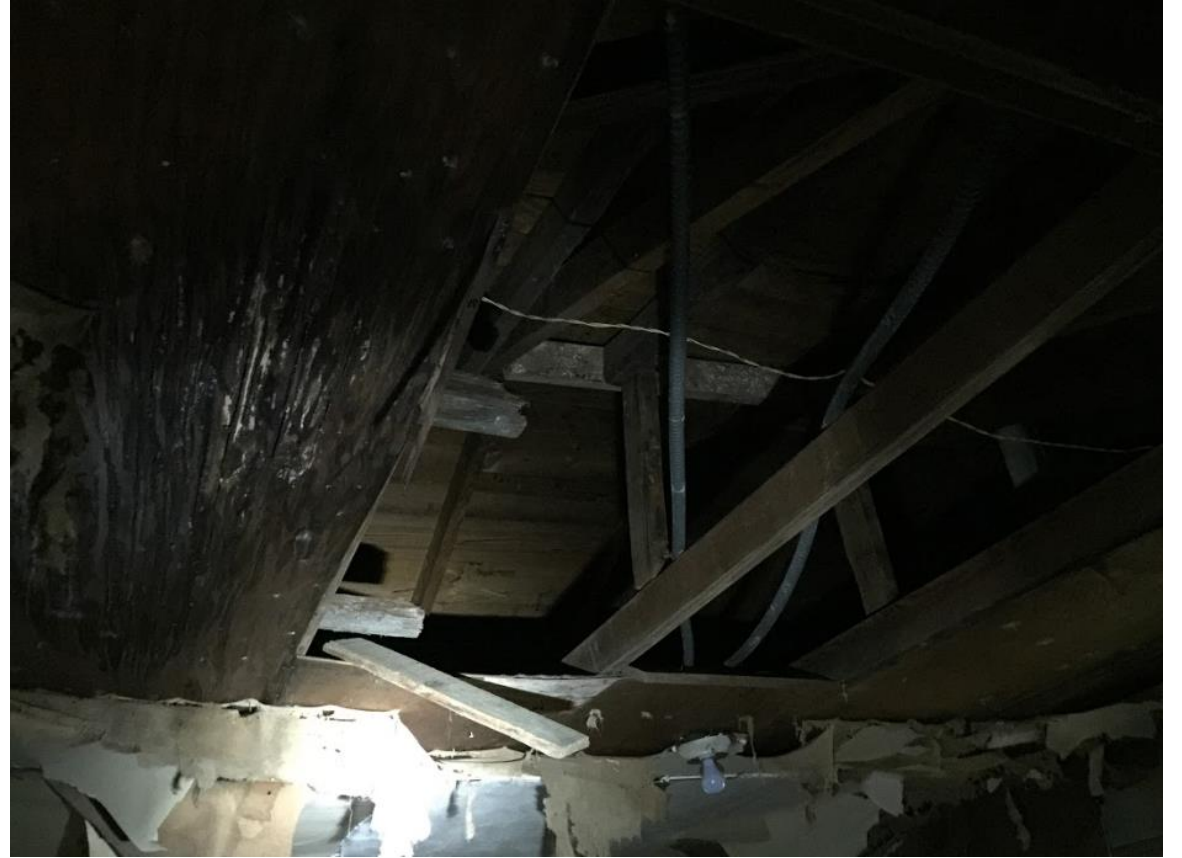
205 Ostrom Drive
Interior Photo's
23 Years Abandoned

Due to age and apparent lack of maintenance for many years, the house is severely deteriorated. It is our understanding that the house has been abandoned for the past 23 years and the lack of any maintenance or climate control over a long period of time has contributed to the deterioration of the house. Wood decomposition was evident all over the interior and exterior house. Signs of dry rot, fungus, and wood worm or termite infestation could be seen in the wood framing throughout the house. This deterioration is widespread and has reduced the structural integrity of the

wooden members. Section loss could be seen in the wood framing. Floors were collapsed in some areas. Wall sheathing had cracks between sheathing panels and large sections were deteriorated or missing. In addition, parts of the ceiling and roof were collapsed at various locations. Daylight could be seen coming through holes in the roof. Some areas of the roof were sagging from what appeared to be buildup of material on the roof, like tree branches, or from the deterioration of the wooden framing below due to rot, fungus, etc. Most of the house has been subjected to water intrusion due to the deterioration and collapse of portions of the roof. It also appeared that both types of foundations present at the house were adversely affected by shrink/swell movement of the underlying soil. The cracking in the concrete portion of the foundation was caused by expansive clay soils, where the soil becomes saturated and expands, then subsequently dries out and shrinks with seasonal moisture changes. The movement caused by the expansive soil conditions is also evident in the wood portion of the foundation, demonstrated by various wooden piers that extend at an angle from the ground as well as cracking and separation in the concrete foundation. Also, floor beams were found to be shifted away from their wooden pier foundation supports. The movement in the foundation also caused cracks in the wall framing and sheathing. There are many deficiencies in the structural integrity of the foundations, walls, and roof elements.
