HISTORIC AND DESIGN REVIEW COMMISSION

HDRC CASE NO: 2015-370
ADDRESS: 418 E MYRTLE
LEGAL DESCRIPTION: NCB 1752 BLK 5 LOT 14
ZONING: R6 H
CITY COUNCIL DIST.: 1
DISTRICT: Tobin Hill Historic District
APPLICANT: Gabriel Sanchez
OWNER: Gabriel Sanchez
TYPE OF WORK: Final approval of rehabilitation and construction of an accessory structure
REQUEST:

Proposed Work at 418 E. Myrtle

DETAILS:
INTERIOR RENOVATION OF
EXISTING SINGLE FAMILY
RESIDENCE & CONSTRUCTION
OF NEW 500 S.F. GUEST HOUSE

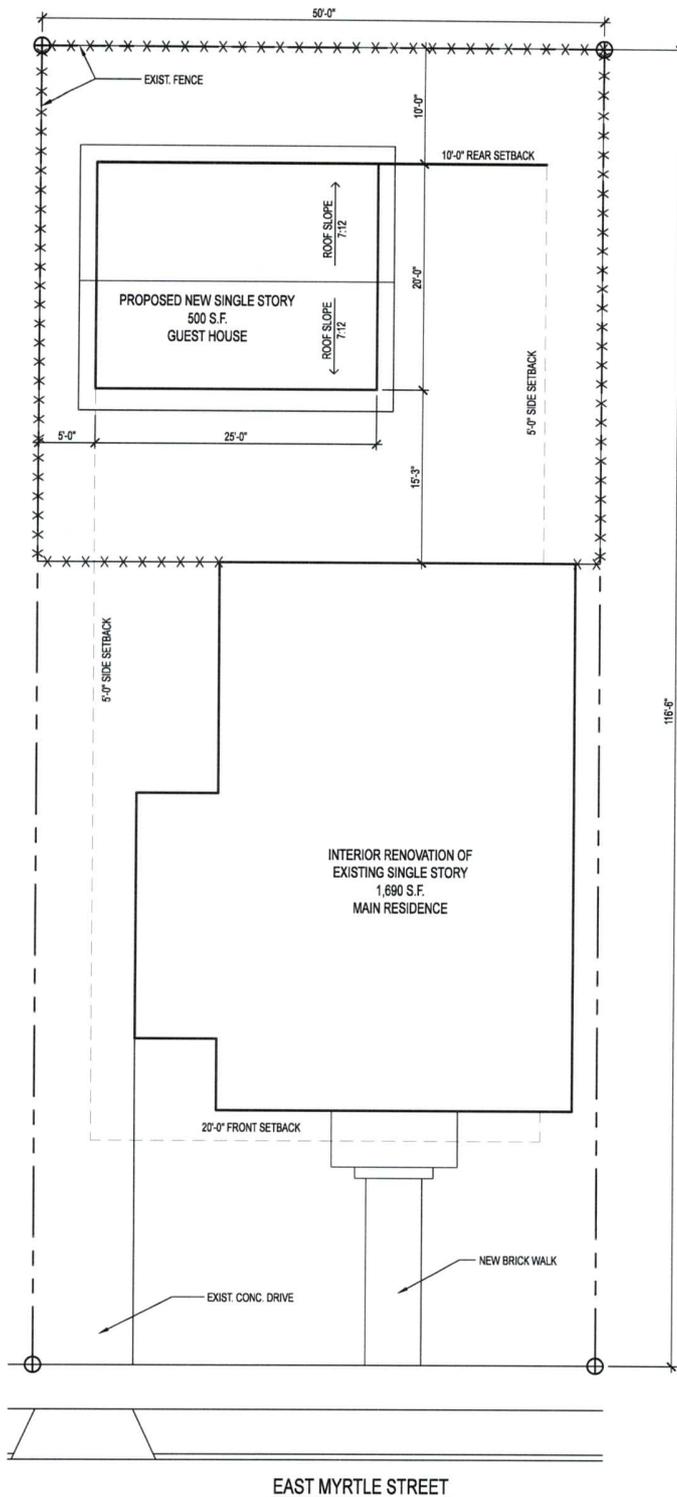
1 SITE PLAN
SCALE: 1" = 10'-0"

The guest house is proposed to be 25 x 20 feet, or 500 square feet – about the size of a two-car garage. The guest house will be built on a pier and beam foundation, as is the main house, and will have appropriate set-back from the property lines. Exterior construction materials will consist of asphalt shingles for the roof, Hardie trim, and Hardie siding.
