HISTORIC AND DESIGN REVIEW COMMISSION

HDRC CASE NO: 2018-004
ADDRESS: 102 ALDER
LEGAL DESCRIPTION: NCB 1300 BLK 1 LOT 14
ZONING: R-5, H
CITY COUNCIL DIST.: 2
DISTRICT: Dignowity Hill Historic District
APPLICANT: Robert Richmond
OWNER: Meek Corp
TYPE OF WORK: Construction of a rear addition, porch modifications, window replacement, install fence
APPLICATION RECEIVED: December 21, 2017
60-DAY REVIEW: February 20, 2018
REQUEST:

The applicant is requesting a Certificate of Appropriateness for approval to:

1. Construct a rear addition to feature approximately 380 square feet.
2. Modify the existing front porch to include new columns, railings and a standing seam metal roof.
3. Remove non-original aluminum windows and replace with new wood windows.
4. Remove non-historic elements including vinyl siding and skirting, and install stucco skirting.

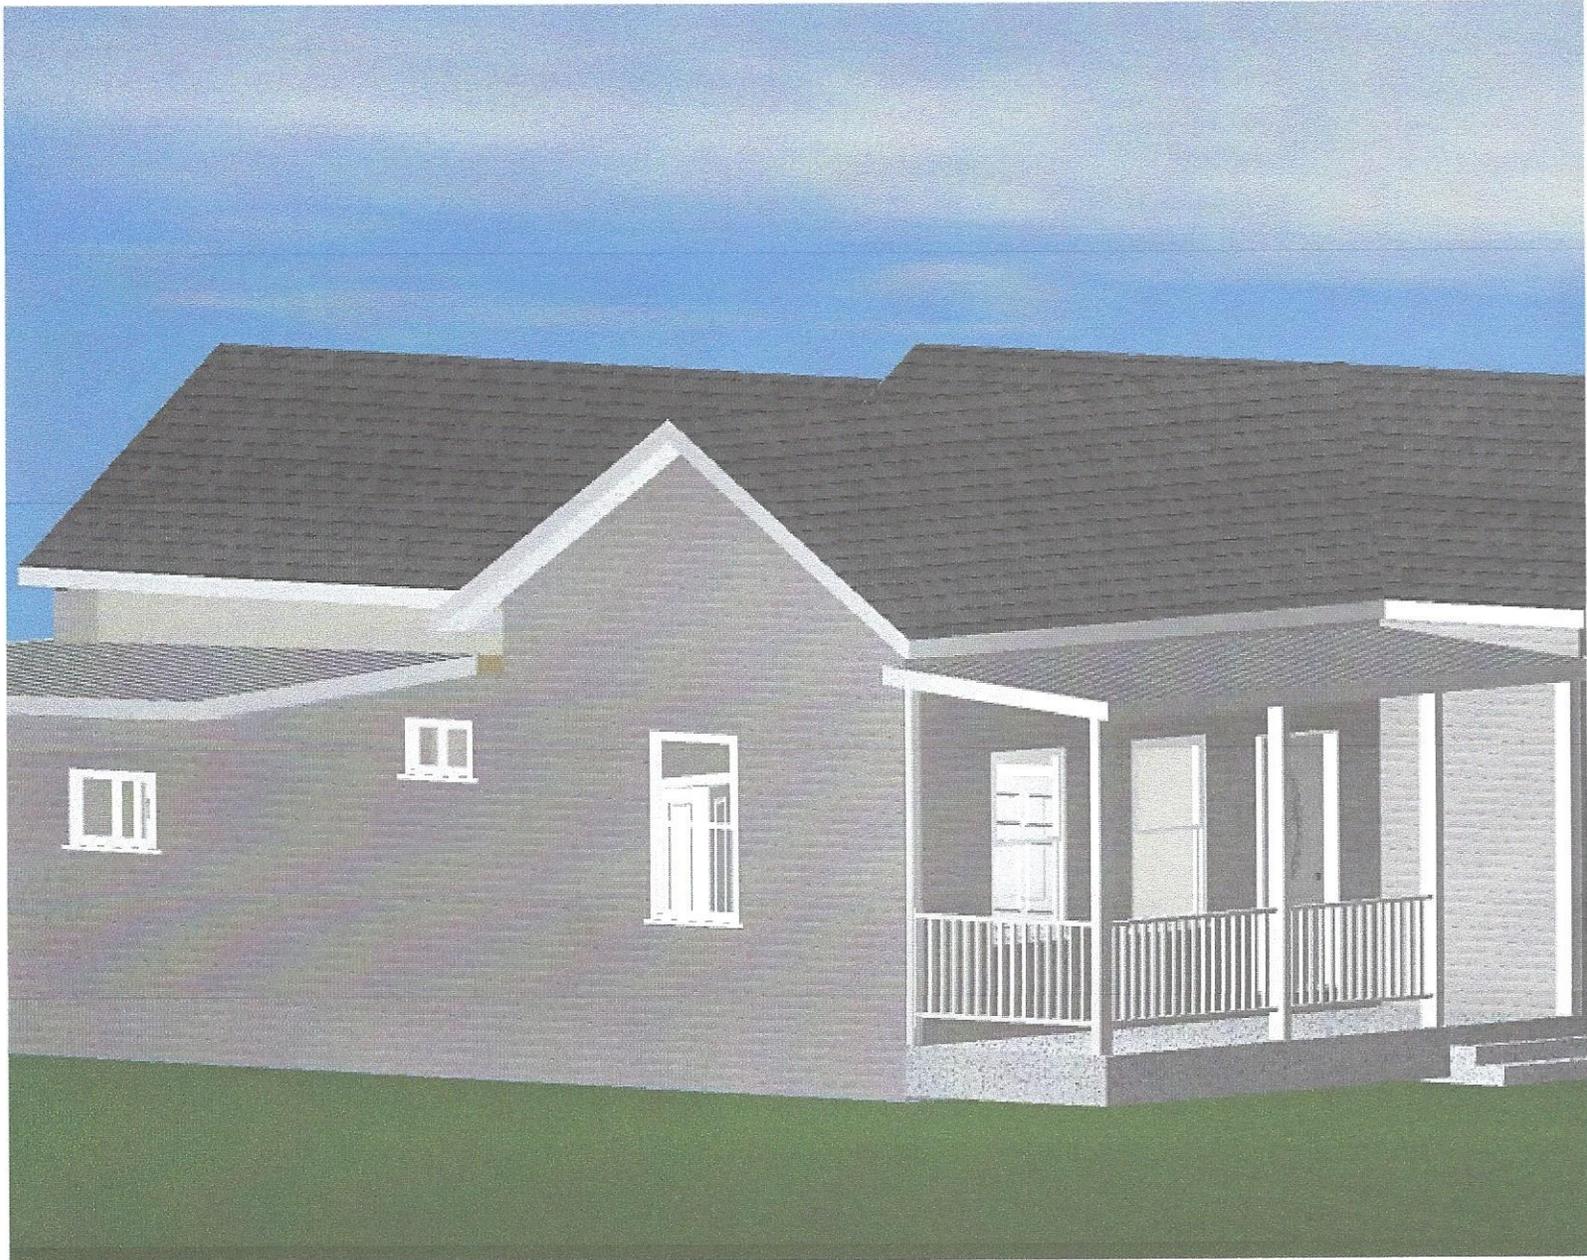
DILEMMA, EXISTING ROOF RAFTERS ARE CONSTRUCTED WITH 2X6'S
2X6 RAFTERS WOULD AESTHETICALLY MATCH, BUT WOOD NOT ALLOW
FOR MINIMUM R-30 ROOF INSULATION. (WALL FRAME WOULD BE 2X4)
THE REST OF THE HOUSE DOES NOT MEET THE REQUIREMENTS

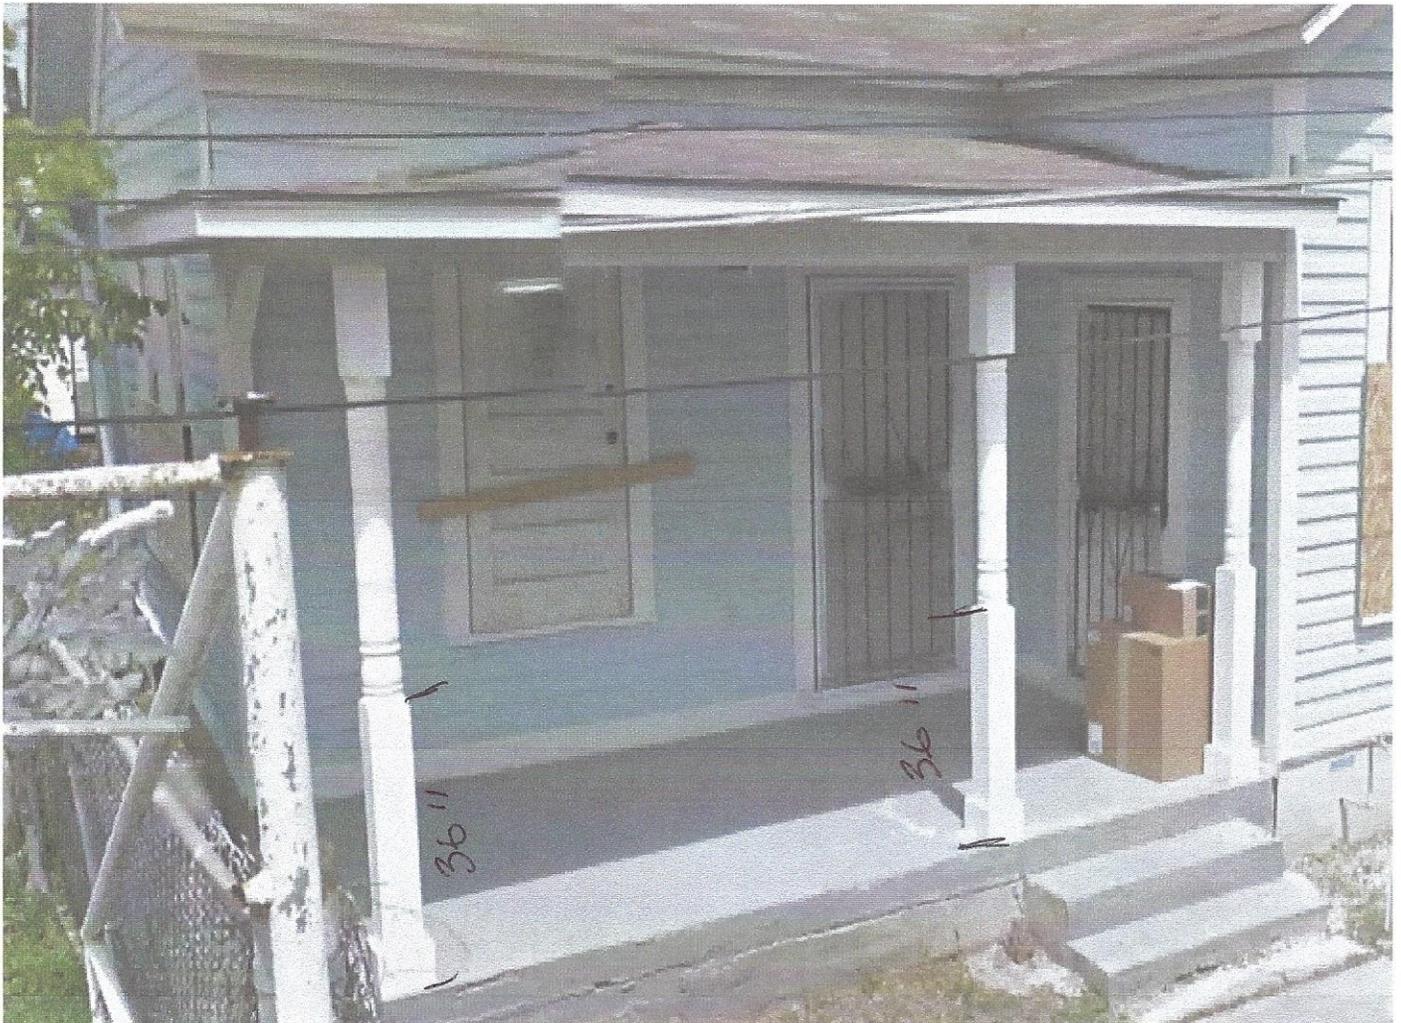
EXAMPLE A

BASE WRAPPED IN 1x4 FOR TOTAL 5" x 5" AT BASE

(RAIL WILL CONNECT ABOVE 1x4 BASE)

If the plan is approved I will replace all aluminum windows with wood windows. I will remove all vinyl siding, and all antennas and wires from the front of the house. I will rebuild front porch with wood, and use post pictures in example A. I will leave the existing pitched roof with 3 tab composition. I will match the existing flat roof with metal roof. (not visible from ground level), since the pitch is too slight to use 3 tab composition, and will cover the front porch with the same metal roof (also not visible from ground level) The handrail will be made of wood spindles like those pictured in example B.

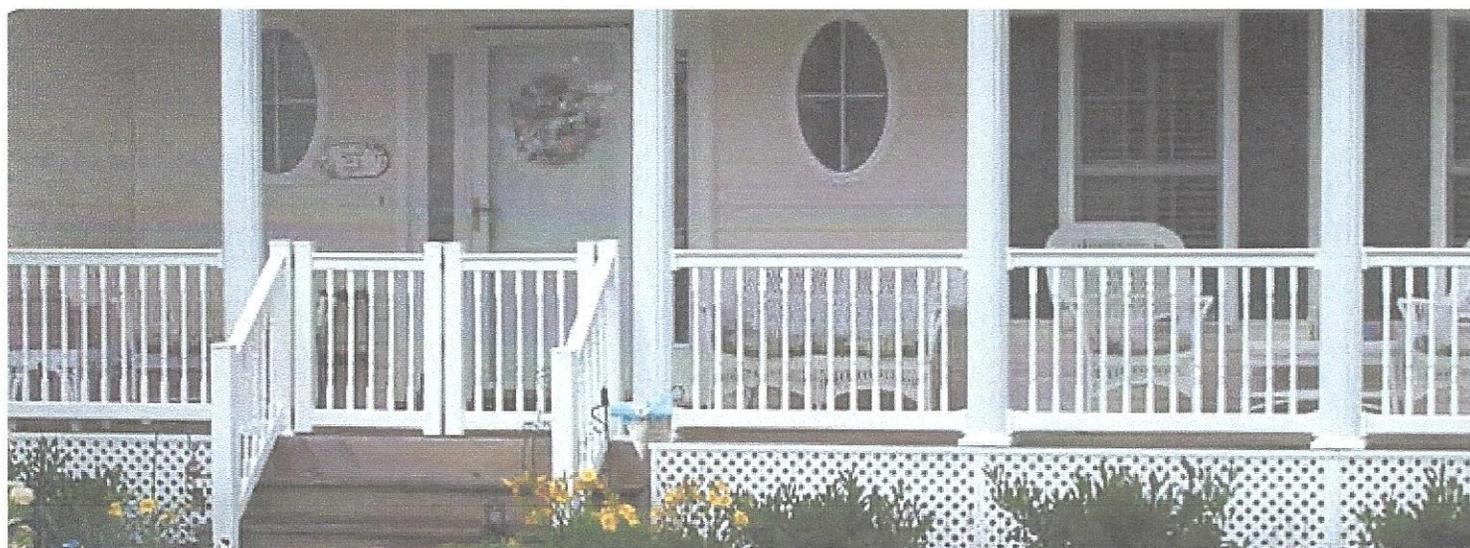
EXAMPLE B

HAND RAIL + DECORATIVE PICKETS
WILL BE COMPOSED OF WOOD
