# HISTORIC AND DESIGN REVIEW COMMISSION

**HDRC CASE NO:** 2017-486  
**ADDRESS:** 310 TRAIL  
**LEGAL DESCRIPTION:** NCB 6391 BLK LOT 12 & NE PT OF 9  
**ZONING:** MF-33 H  
**CITY COUNCIL DIST.:** 1  
**DISTRICT:** River Road Historic District  
**APPLICANT:** Gaspar Rivera/Poma Properties  
**OWNER:** Poma Properties  
**TYPE OF WORK:** Window replacement, fenestration modifications, porch modifications

# 310 Trail San Antonio, TX. 78212

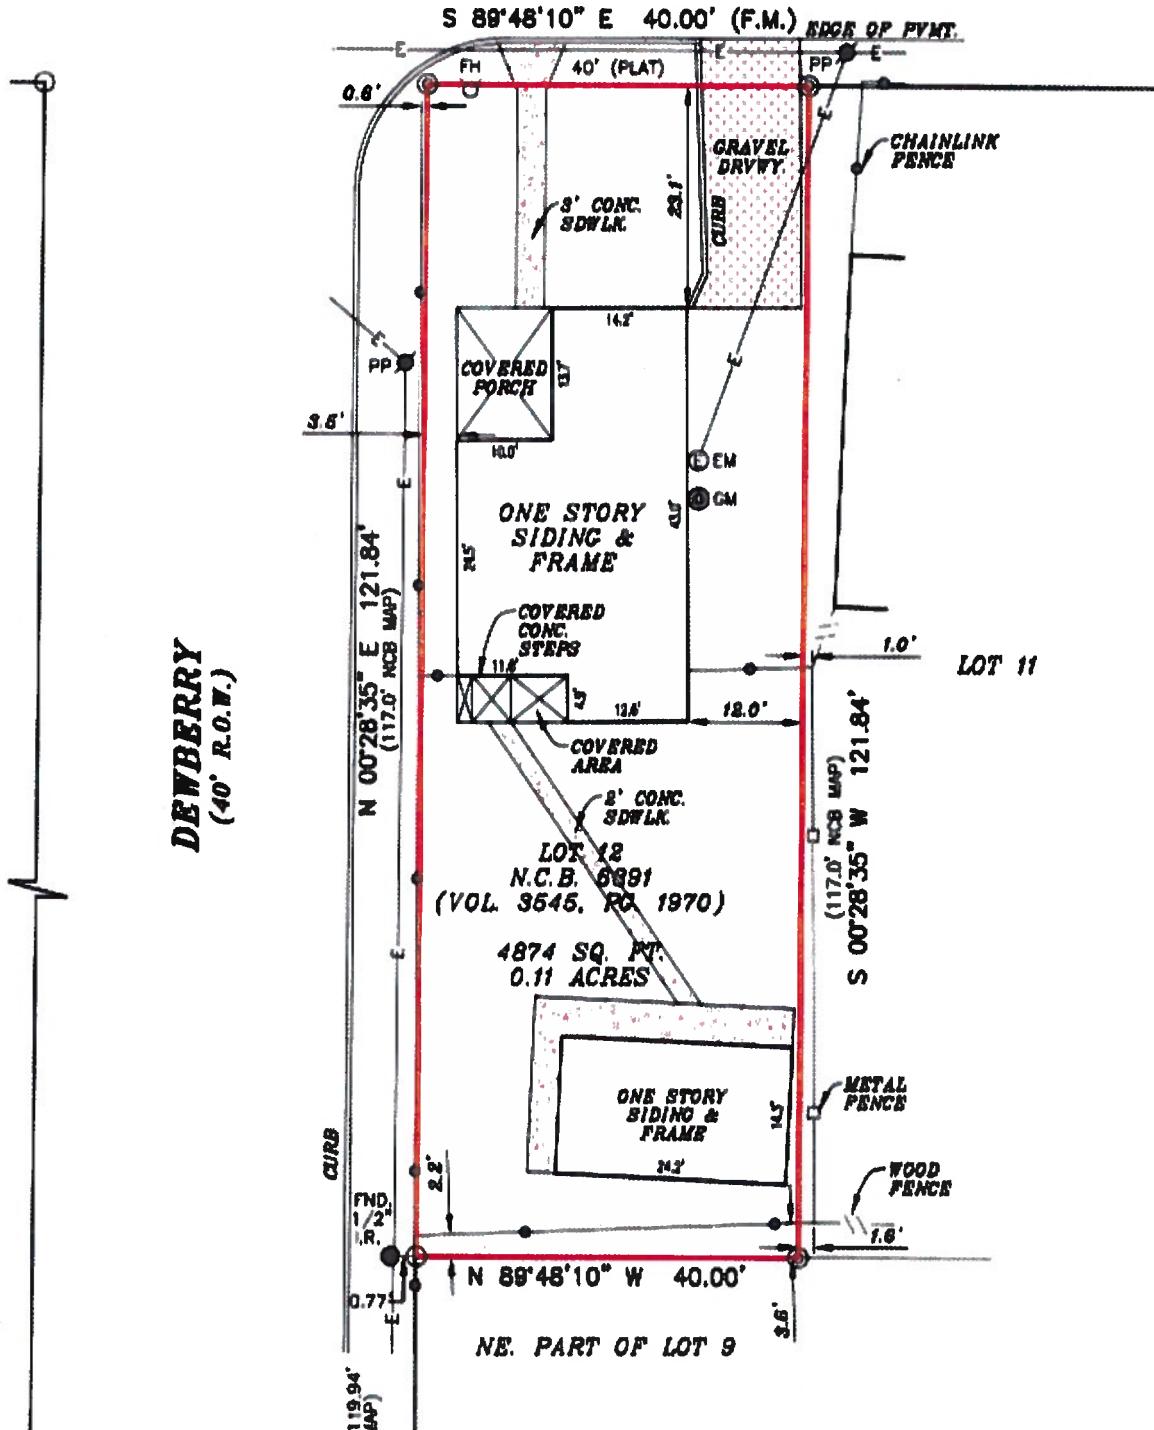
**TRAIL ST.**

(PER PLAT FITZHUGH ST.-50' R.O.W.)
