### HISTORIC AND DESIGN REVIEW COMMISSION

HDRC CASE NO: 2015-273

**ADDRESS:** 151 GRAMERCY PL E

**TYPE OF WORK:** Conceptual approval of front yard fence, roof modification, gutter installation, and

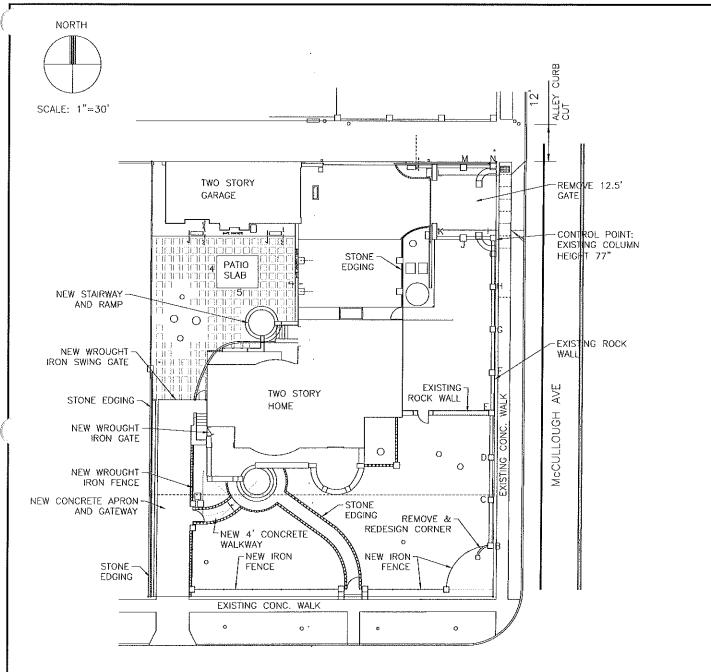
Proposed Site Plan

151 East Gramercy Turner Residence Site Plan REV. NO.

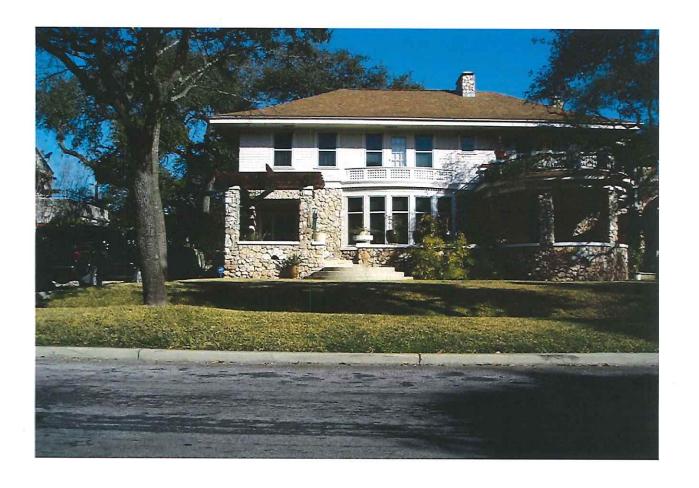
Existing South Elevation

151 East Gramercy Turner Residence Photo Elevation

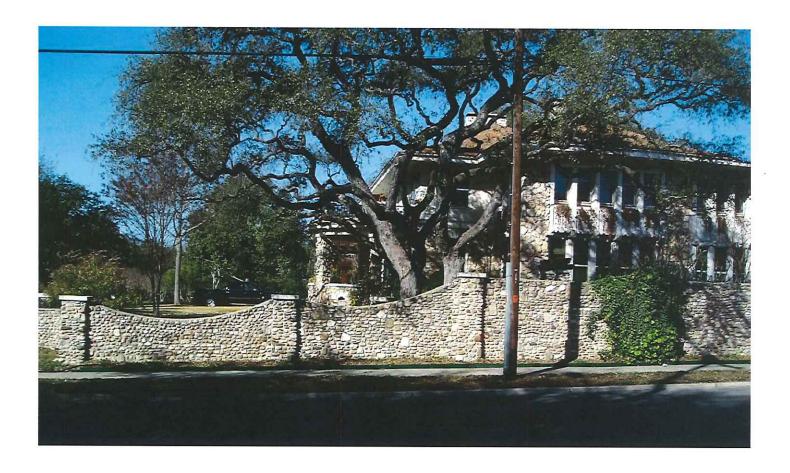
Existing East Elevation

151 East Gramercy Turner Residence Photo Elevation

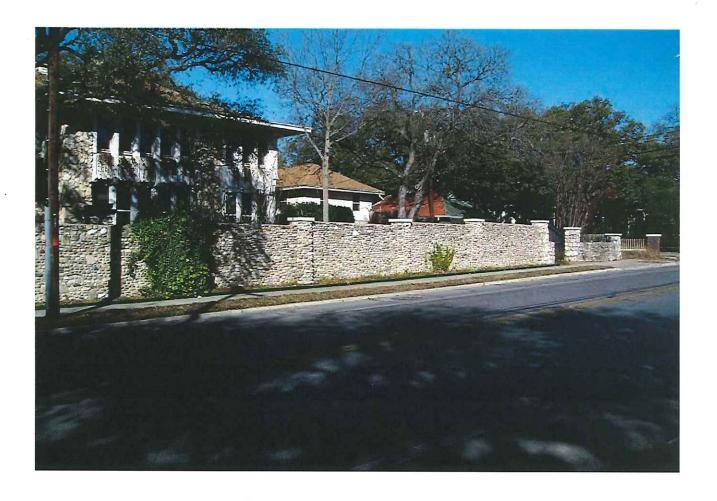
Existing East Elevation

151 East Gramercy Turner Residence

Photo Elevation

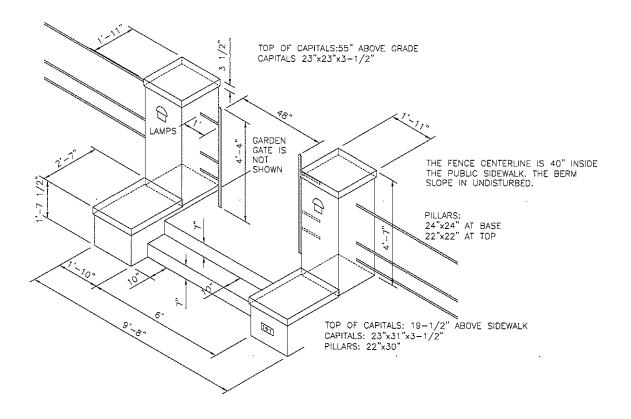
Proposed Front Gate

151 East Gramercy Turner Residence !sometric

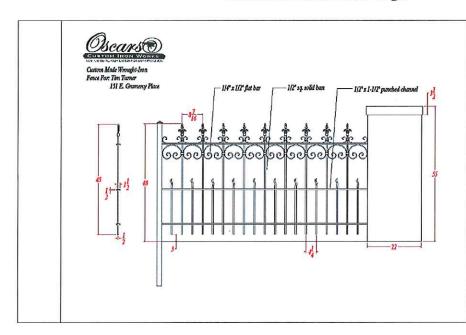
Oscar's Custom Iron Work (Oscar Hernández, Jr.) has prepared a basic design of the fence, based on information provided by the owner.

The gates would be based on this style.

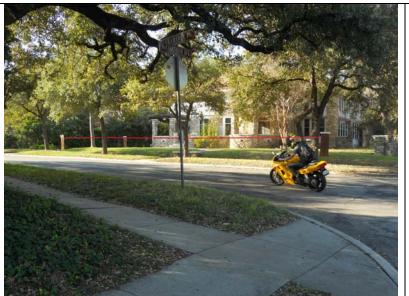
151 E Gramercy Pl, looking northwest

The red line connects the proposed pillars (H 55") situated on the respective corners. The location of these proposed pillars are constants in the sense that one on the east cannot be moved further east and the one the west cannot be moved further west.

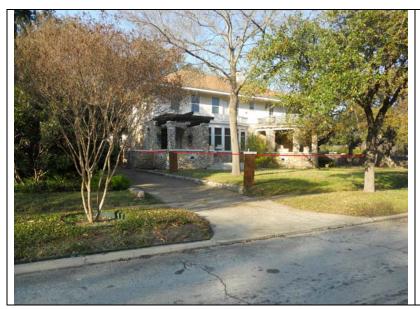
151 E Gramercy Pl, looking northwest

The red line represents the height of the finials (48") in the proposed fence.

The faux pillar in the foreground is on a corner. The red line on its left represents the proposed fence along the driveway, and the red line on its right represents the proposed fence along the public sidewalk.

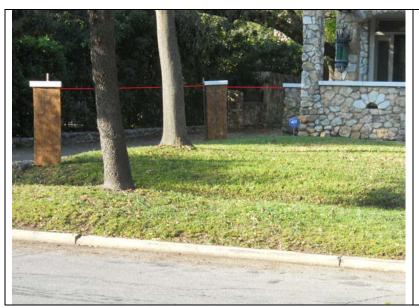
151 E Gramercy Pl, looking north

The faux pillar in the center of the photograph represents the approximate location of the proposed garden gate between the driveway and the circular stairway.

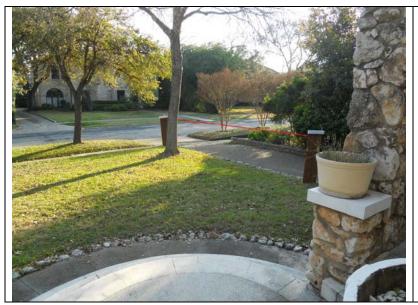
151 E Gramercy Pl, looking south

The red line represents the height of the finials in the proposed ornamental iron fence. The faux pillar on the right represents the location of the proposed garden gate.

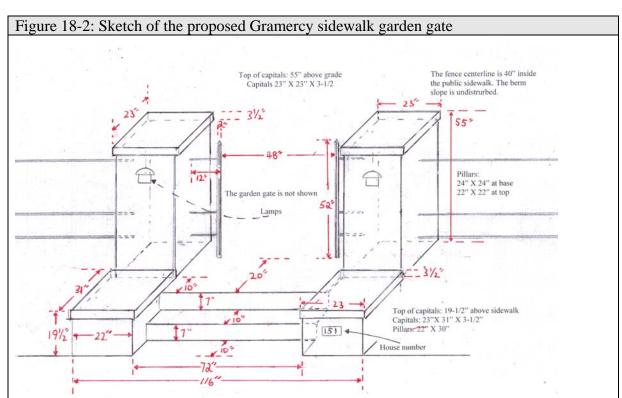
The above graphic represents the dimensions of the proposed garden gateway on the E Gramercy Pl public sidewalk. The lamps would be in the craftsman style. The house number plaque currently on pilaster A would be relocated as shown. See also item 31 on page 341.

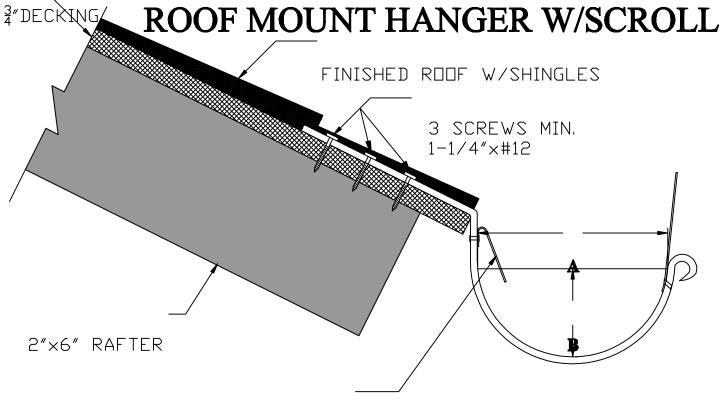
MAKE SURE CLIP IS NOT FOLDED LOWER THAN BACK OF GUTTER

HANGERS MAXIMUM 3' ON CENTER

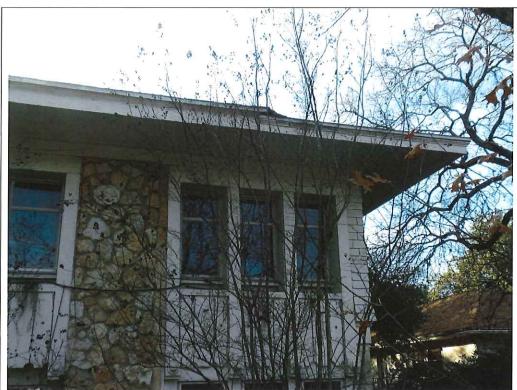
The purpose of the 1957 addition was to provide a downstairs bathroom, which was a good idea. But the profile of the bellcast hip roof was not extended over the addition, leaving a low ceiling in the addition's second floor room and a misalignment of fascia boards as seen in this photograph.

The reasonable purpose of the 1957 addition by James A. and Clara M. Morrison (parents of Marcia Alice Morrison Patton) was to provide one downstairs bathroom. In my opinion, however, the addition was done improperly. The bellcast hip roof should have been maintained over the addition. Instead, Mr. Morrison accepted a flat roof over the addition, the misalignment of the fascia, and the substandard ceiling height in the room in the upper northeast corner.

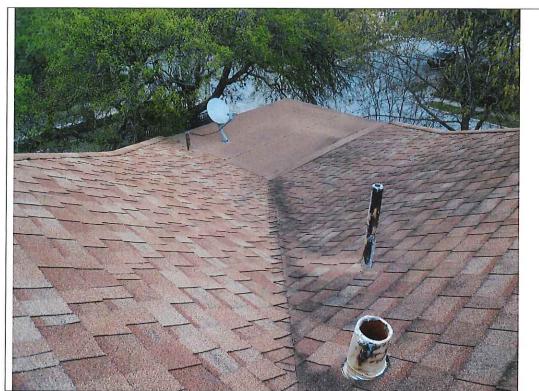
Looking northeast down Valley B. See item 39 in chapter 14

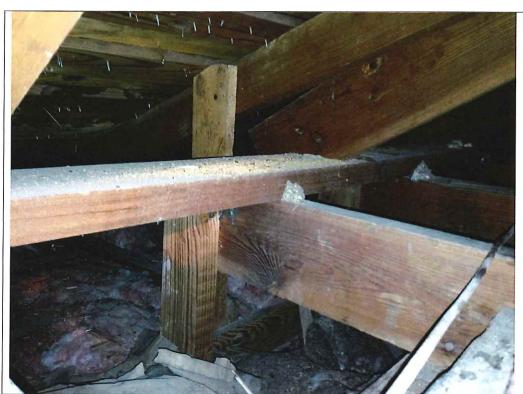
2" X 6" ceiling joists and 2" X 6" top plates were not used over the 1957 addition. The original cornice boxes were left in place, making the height of the ceiling in the second floor room equal to the height of the soffits. The photograph shows the top plate along the original north wall of what was the east end sleeping porch. Looking north past the top plate is the original cornice box which was, in essence, roofed over.

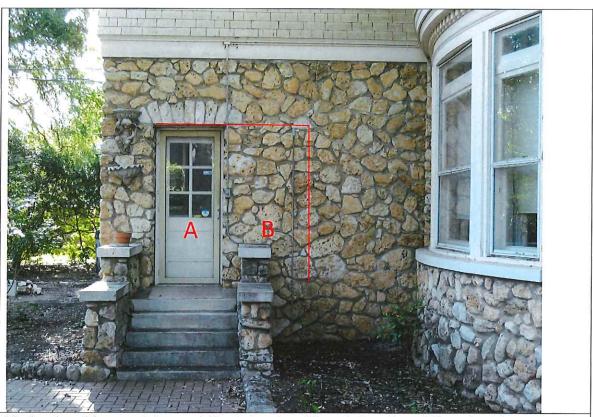
The location of the current door would be the location of Door A. Door B would be to the right.

These four items will require a structural analysis of the wall and the design of necessary structural supports. A similar opening of an original wall was made at 106 E Lullwood Ave (pictured below). A similar opening was part of a new construction design at 215 W Mulberry Ave (pictured below).

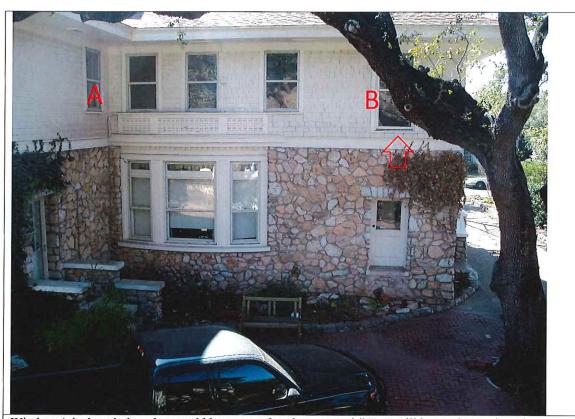
Window A is the window that would be removed under proposal #43. It will be used to replace the oversized Window B, which was installed by Weldon Carter in the mid-1980s. The framing for B will have to be adjusted to accommodate the small window and its companion storm window.

51. Remove (for donation) the oversize second story window (B) on the northwest corner and reframe opening for the window units removed under proposal #43. Install same.

In the early-1980s, Mr. Weldon Carter installed the subject window (B). While it provides needed light for the stairway its dimensions are inconsistent with the other windows and its style is not appropriate.

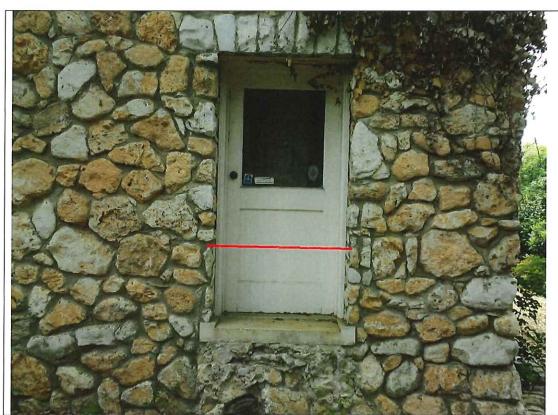
Mrs. Mame Adams converted this window to a "renter's door." Her renters were not to enter and exit the house through the front door or the kitchen door. Mr. Weldon Carter removed the concrete steps that had been affixed to the stonework. Repairing the related is part of the proposal. The red line in the photograph below indicates approximate level of the top of the repositioned sill.

Originally, this opening was a window but was later converted to a "renter's doorway." Inside is a cubbyhole beneath the main stairway. OHP Planner Hudson and Ludueña proposed converting this second-class entry into an ADA-entry, which would necessitate the elimination of the main stairway. During their September 17, 2012 site visit, they entered the house, saw the main stairway and became fully aware of the implications of their absurd proposal.
