HISTORIC AND DESIGN REVIEW COMMISSION

HDRC CASE NO: 2016-197
ADDRESS: 2042 W GRAMERCY PLACE
LEGAL DESCRIPTION: NCB 1933 BLK 31 LOT 18
ZONING: R6 H
CITY COUNCIL DIST.: 7
DISTRICT: Monticello Park Historic District
APPLICANT: Thomas Bergo
OWNER: Thomas Bergo
TYPE OF WORK: Addition, Window replacement, window trim
REQUEST:

2042 W. Gramercy Place – Addition Request

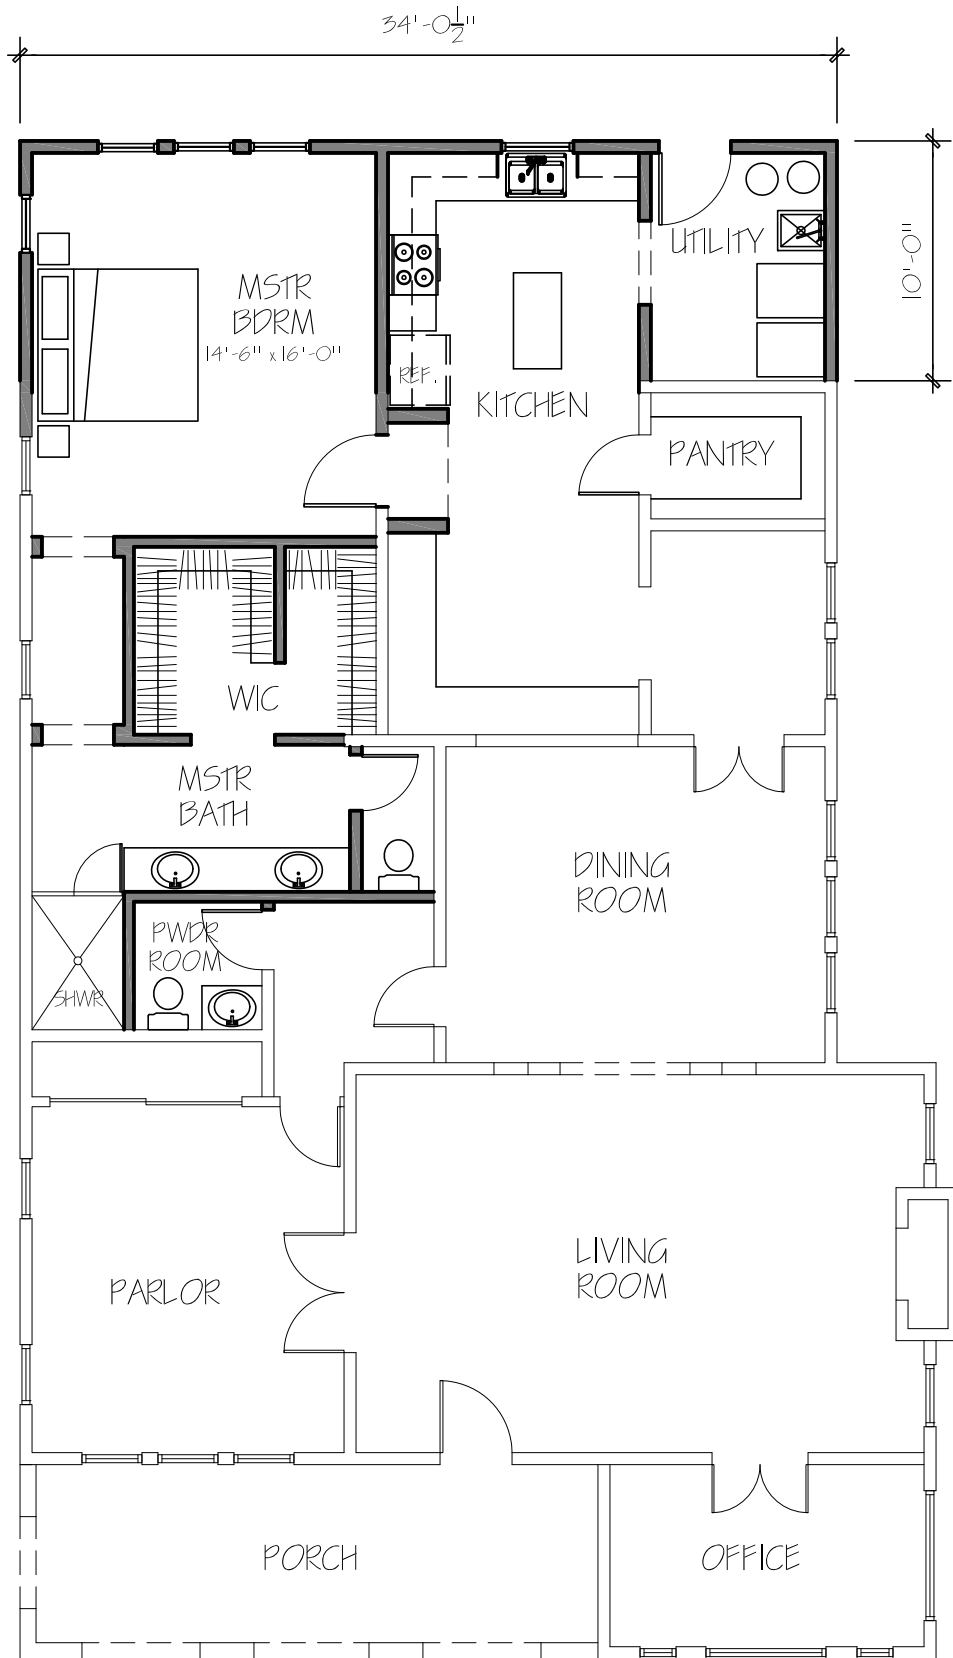
FLOOR PLAN

SCALE: 1/8"=1'-0"

Window	Current	Status
1	3 Window Existing Wood	This set of windows has the original trim and I will try to repair the sashes. Will be replaced with in kind wood window if beyond repair.
2	Single Existing Wood	Wood window with original trim. Will be replaced with in kind wood window if beyond repair.
3	Single Existing Wood	Wood window with original trim. Will be replaced with in kind wood window if beyond repair.
4	Single Alum. Comb.	This small bathroom window will be replaced with a wood window. I don't know what the original window looked like as I have no early pictures of that side of the house but will try to make it match the other windows being repaired or replaced.

5	Single Existing Wood	Wood window with original trim. Will be replaced with in kind wood window if beyond repair.
6	New Window	New window. Will be wood to match other windows.
7	3 Window Alum. Comb.	This set of windows was modified when aluminum combinations were installed. The addition will have the same window placement but will be wooden to match original trim and configuration of that window.
8	Currently Back Door	The addition will place a small wooden window above the sink as shown in the early photos submitted with original request.
9	2 Window Existing Wood	Wood window with original trim. Will be replaced with in kind wood window if beyond repair.
10	3 Window Existing Wood	Wood window with original trim. Will be replaced with in kind wood window if beyond repair.
11	Single Alum. Comb.	Window trim modified when aluminum combination was installed. This will be replaced by wooden window and trim restored to match historical trim.
