HISTORIC AND DESIGN REVIEW COMMISSION

HDRC CASE NO: 2016-228

ADDRESS: 924 DAWSON ST

TYPE OF WORK: Reconstruction of front porch

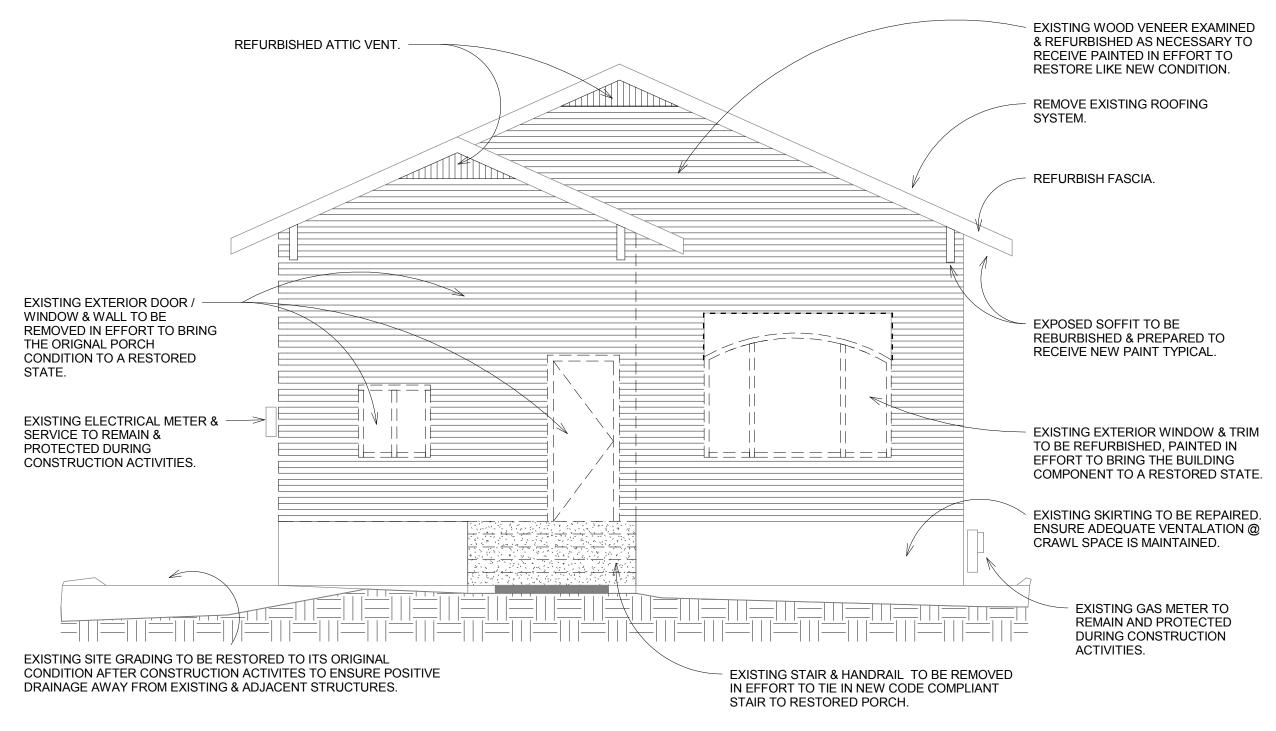
NORTH ELEVATION DEMO

North Elevation - Demolition

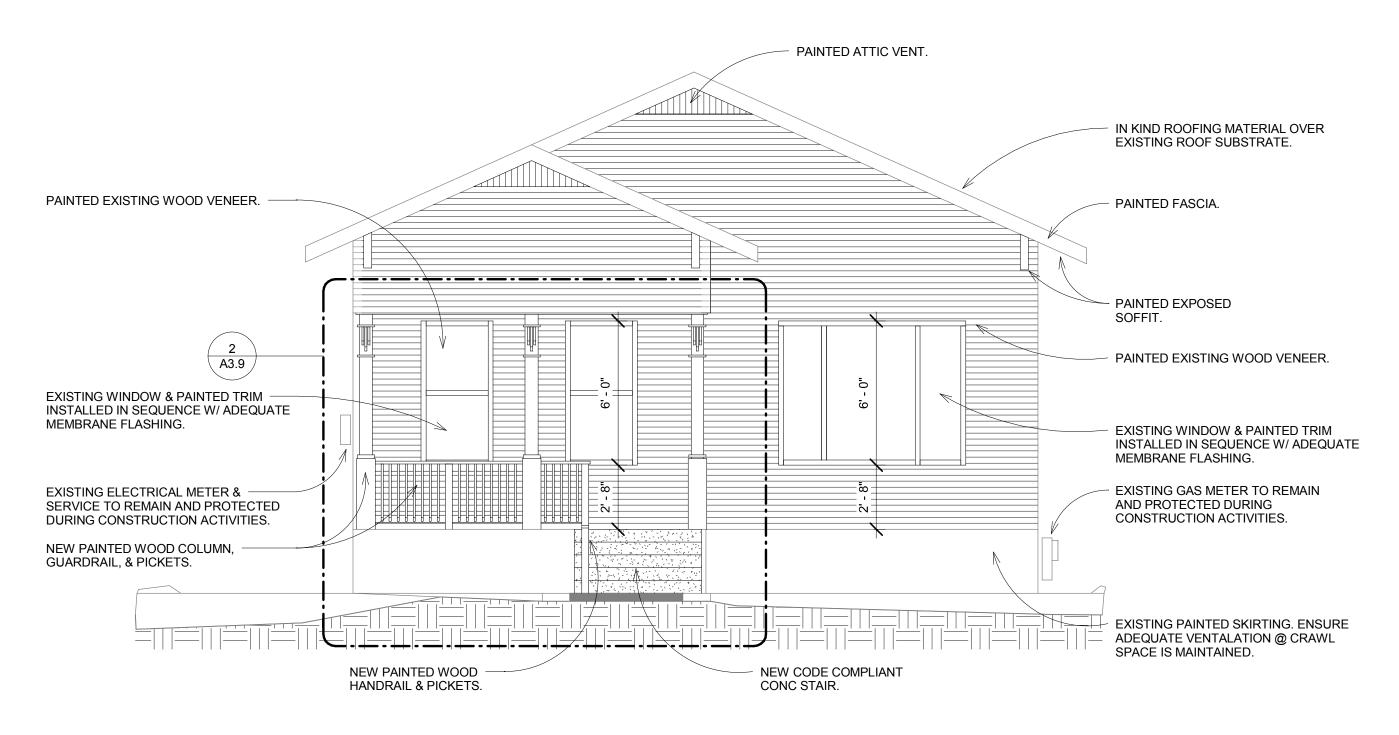
NORTH ELEVATION NEW

North E	levation Ne	W
Project number	101	
Date	June 30, 2016	A3.2
Drawn by	Author	7 (012
Checked by	Chacker	Scale 1/4" = 1'-0"

- f. Historic houses in San Antonio often feature a vernacular entrance and ventilation system comprised of two front doors; one facing the street and one facing the side yard. The applicant has proposed to reintroduce the front porch door facing the side yard, but no the door facing the street. Staff finds this inappropriate and recommends the applicant install both doors. The door which faces the street should be reinstalled at its original location, centered on the front porch steps.

- g. The applicant has proposed to install two windows beneath the front porch overhang. One window spaced evenly between the end of the porch and the street facing front door, which is to be centered on the front porch steps, is appropriate. Staff recommends the applicant install the window in this manner. This window should be inset within the wall at least two (2) inches or at a depth that is consistent with all other windows.

- i. That the applicant eliminate the craftsman ornamentation from the porch columns and eliminate the proposed middle column as noted in finding e.
- ii. That the applicant reintroduce the street facing front door that is to be centered on the front porch steps as noted in finding f.
- iii. That the applicant reintroduce a front window that is appropriately spaced between the end of the porch and the reintroduced street facing front door as noted in finding g.
- iv. That the applicant pour new front porch steps that maintain the width of the original front porch steps as noted in finding h.

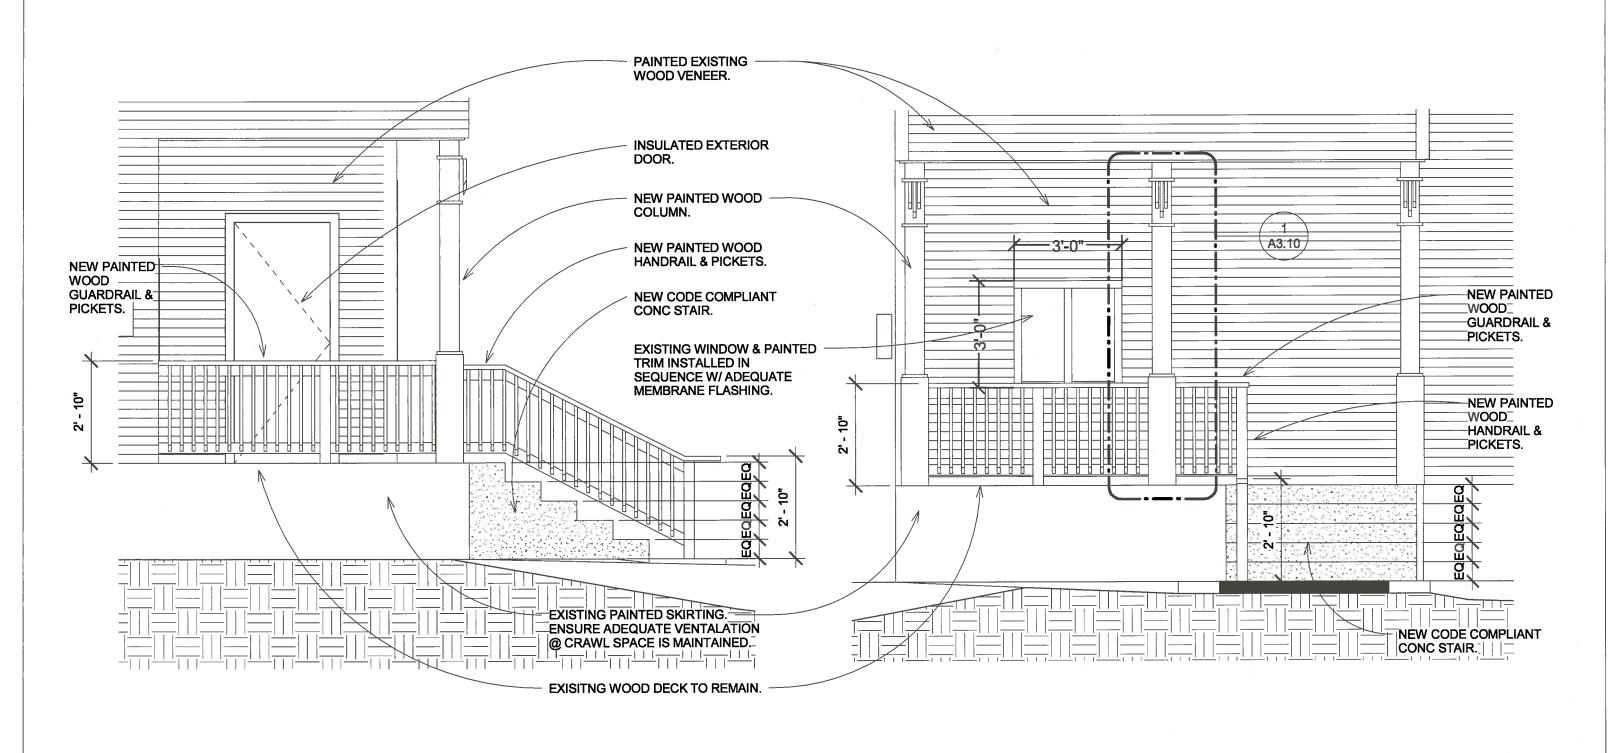
4 ENLARGED EAST ELEVATION

2 ENLARGED NORTH ELEVATION

Enlarge	d Elevatio	ons	
Project number	101		
Date	June 7, 2016	A3.9	
Drawn by	Author	7 (0.10	
Checked by	Checker	Scale 3/8" = 1'-0"	Т
