## HISTORIC AND DESIGN REVIEW COMMISSION

**HDRC CASE NO:** 2016-283  
**ADDRESS:** 110 GLORIETTA  
**LEGAL DESCRIPTION:** NCB 576 BLK B E 9.45 FT OF 2 & W 29.55 FT OF 3 ARB A13  
**ZONING:** RM4 H  
**CITY COUNCIL DIST.:** 2  
**DISTRICT:** Dignowity Hill Historic District  
**APPLICANT:** Kyle Zochert  
**OWNER:** Kyle Zochert  
**TYPE OF WORK:** Historic Tax Certification, rehabilitation and a rear addition  
**REQUEST:**

The applicant is requesting a Certificate of Appropriateness for approval to:

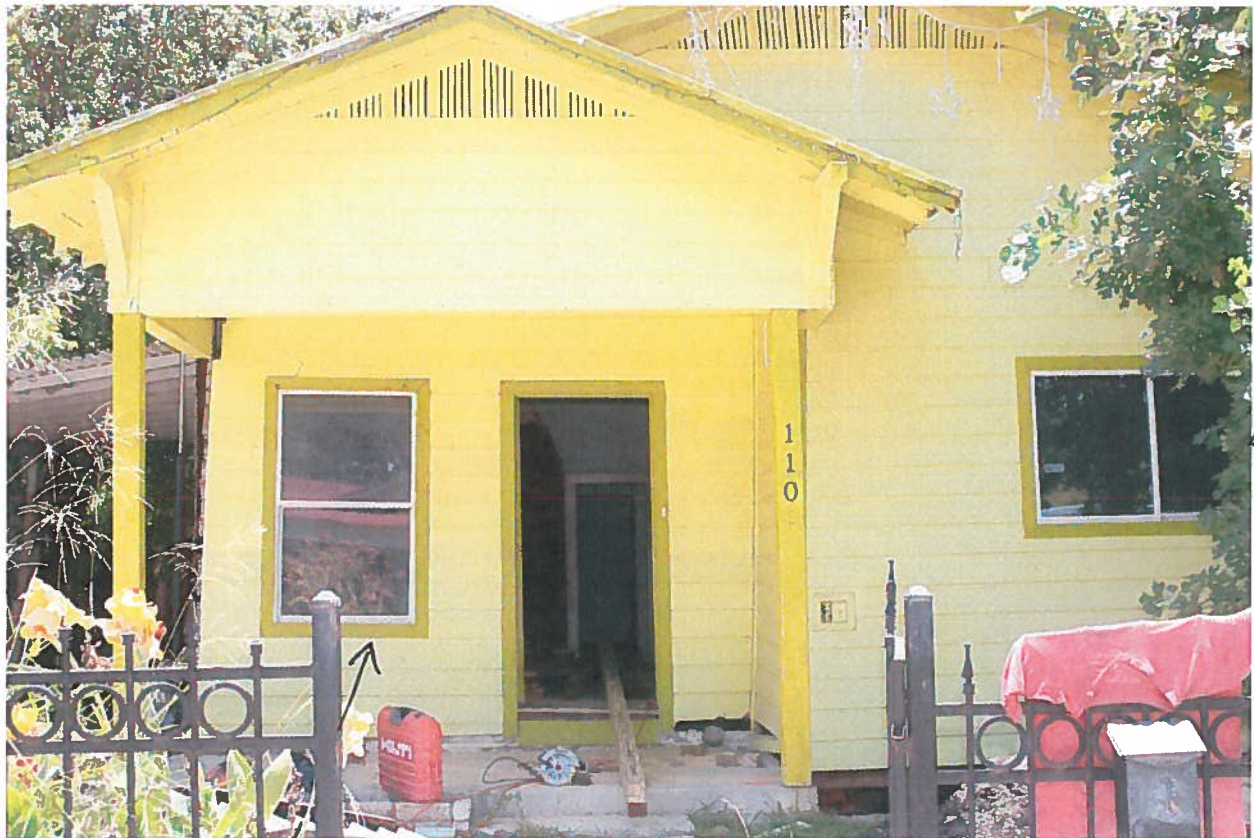
# Front Side

Window 2

Front Entry  
Door

Window 1

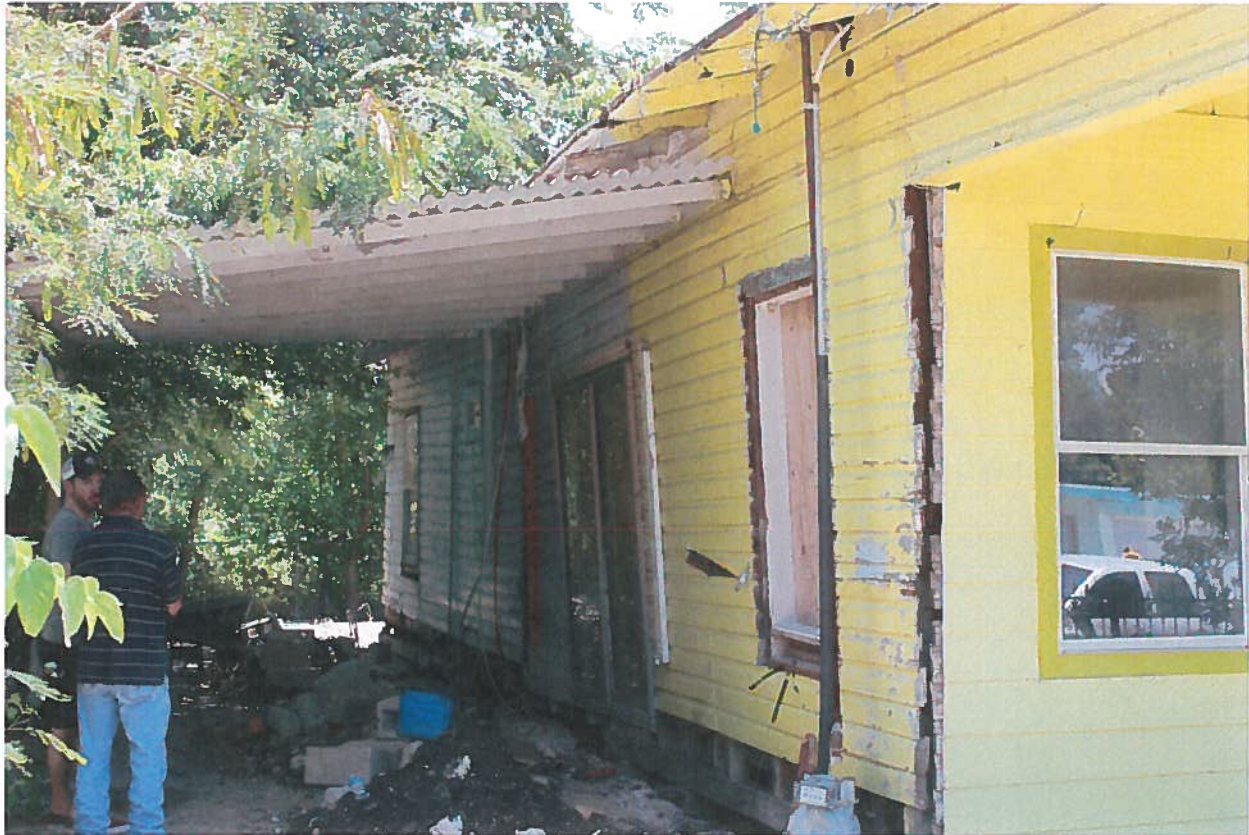
## Left Side

Sliding Door  
(to be replaced)

Window 3  
(to be replaced)

Window 2

- f. The applicant is proposing to remove one metal sliding glass door on the left façade and replace with white steel French doors. According to the Guidelines for Exterior Maintenance and Alterations 6.B., non-historic windows and doors should be replaced with elements that are typical of the architectural style of the building. The corresponding pages from the adopted windows policy document have been added to the exhibits for this request. Staff finds the proposed steel door not consistent with the Guidelines and recommends the applicant install wooden French doors.

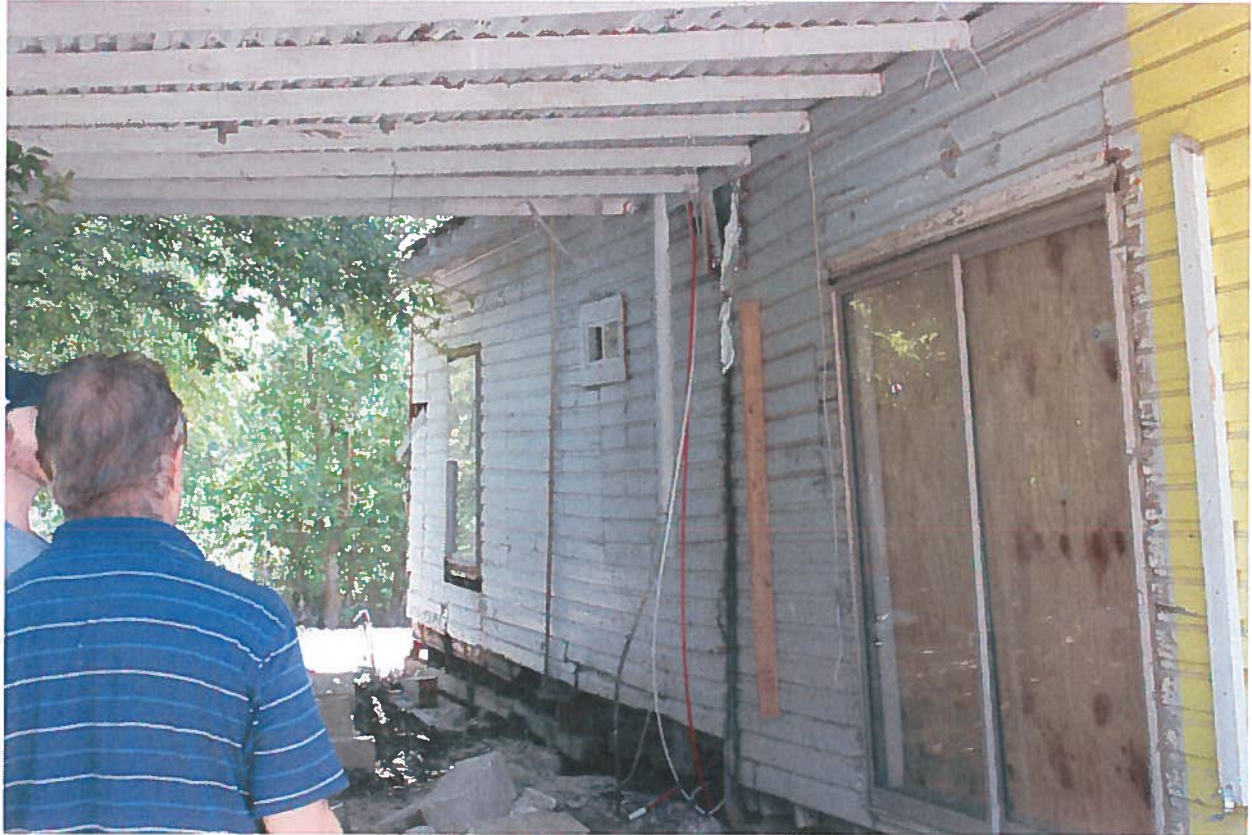
## Left Side

↑  
Sliding Door  
(to be replaced)

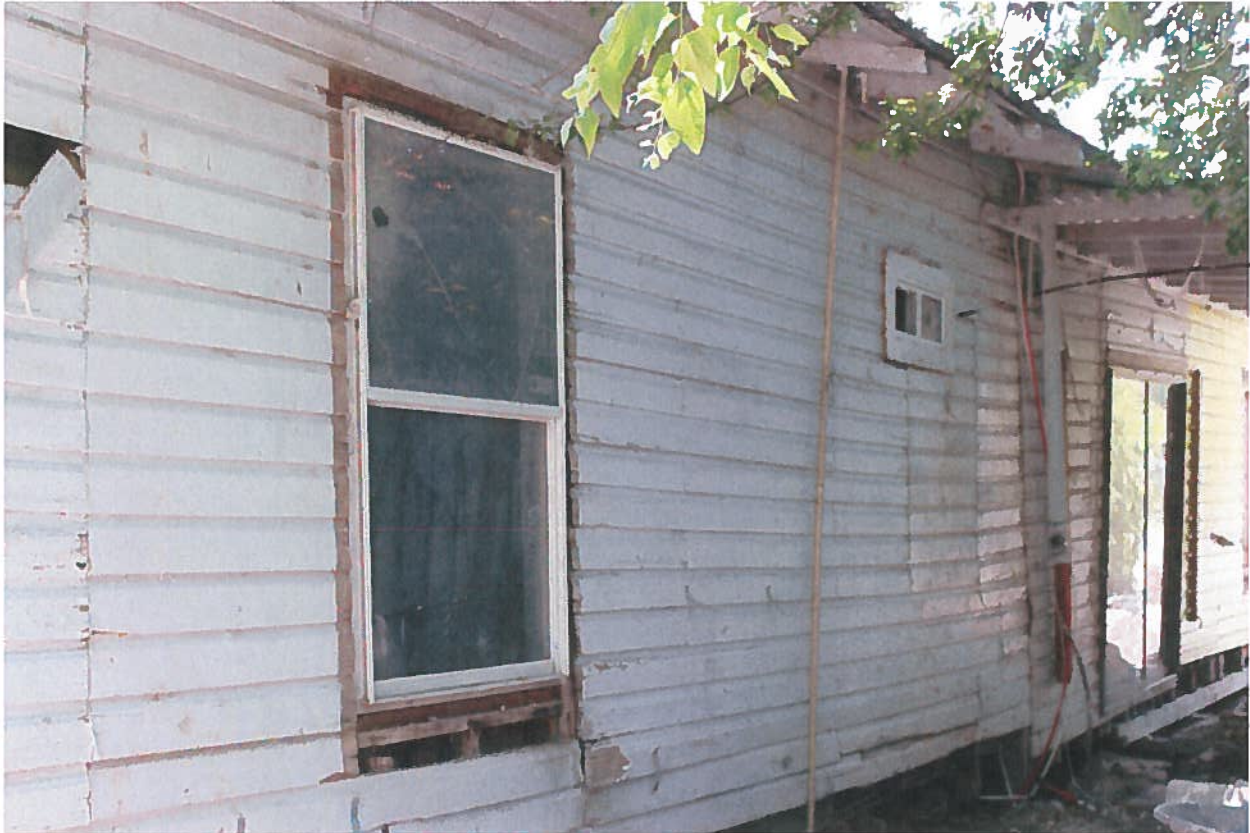
## Left Side

↑  
Window 5  
(to be replaced)

Window 4

- e. The applicant is proposing to remove 3 existing metal windows on the left façade and replace with white single-hung vinyl windows. According to the Guidelines for Exterior Maintenance and Alterations 6.B., non-historic windows and doors should be replaced with elements that are typical of the architectural style of the building. Staff finds the proposed vinyl windows not consistent with the Guidelines and recommends the applicant install wood double-hung windows.

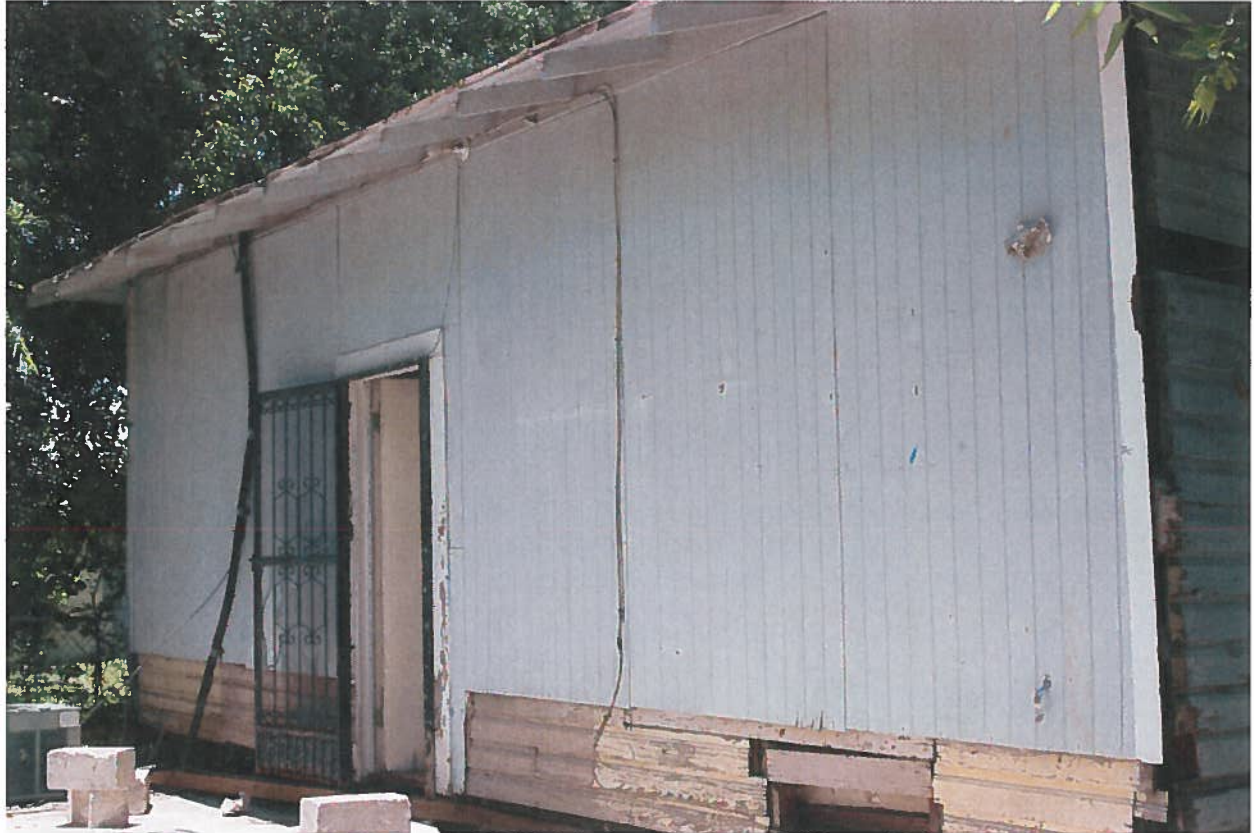
## Back Side

↑  
Back Entry  
Door

- g. There is an existing non-historic wooden door and iron screen door on the rear entrance. The applicant is proposing to remove both doors and install a single steel French door. According to the Guidelines for Exterior Maintenance and Alterations 6.B., non-historic windows and doors should be replaced with elements that are typical of the architectural style of the building. Staff finds the proposed steel door not consistent with the Guidelines and recommends the applicant install a wooden French door.

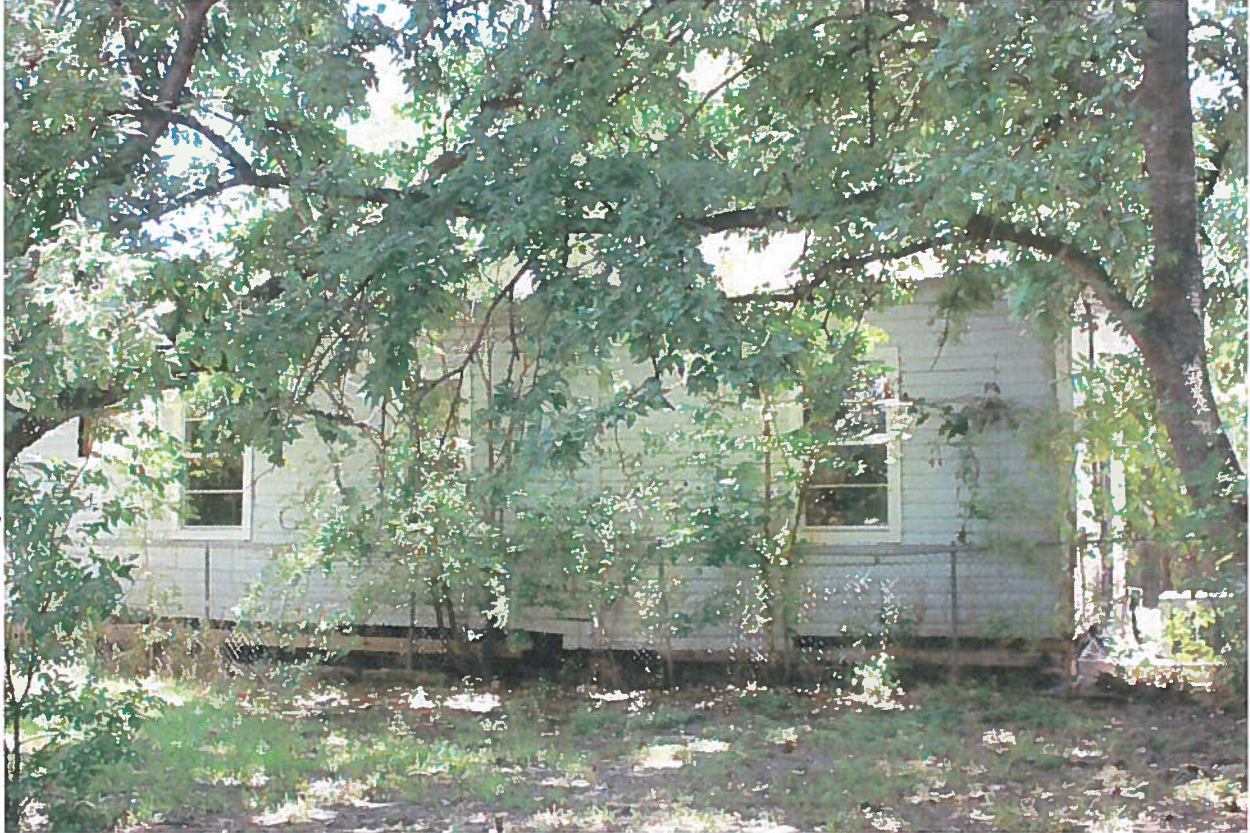
## Right Side

Window 8

Window 7

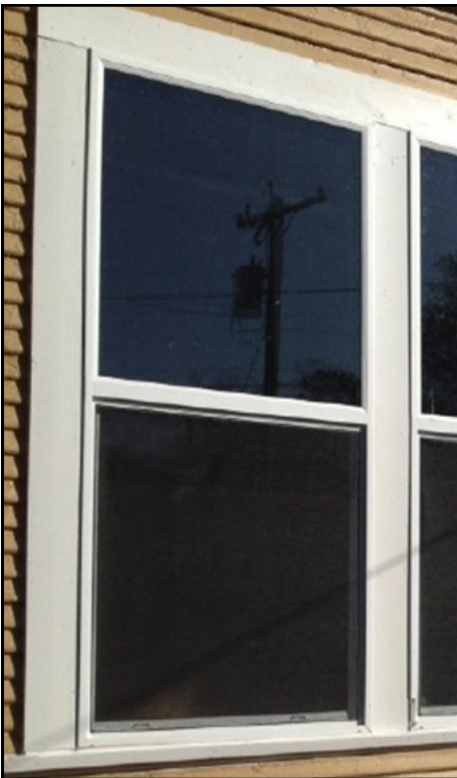
- Vinyl product changes the material
- Window is not recessed within frame
- Sash components do not feature traditional dimensions

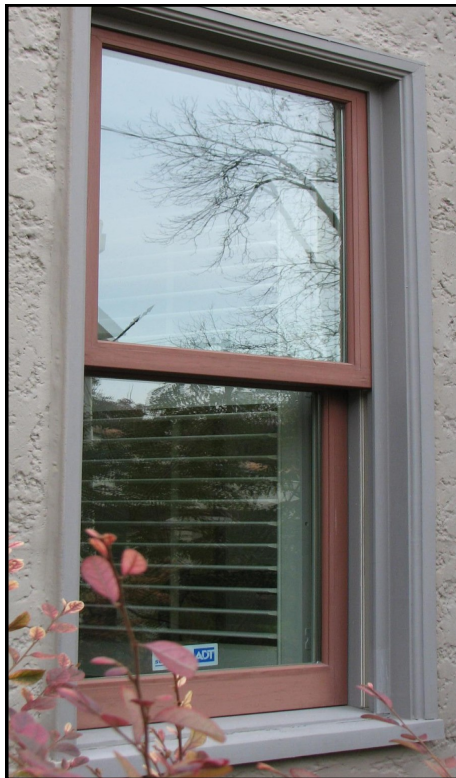
- Track insert alters profile
- Meeting rails thicker than original
- Low-e coating alters hue and reflectivity

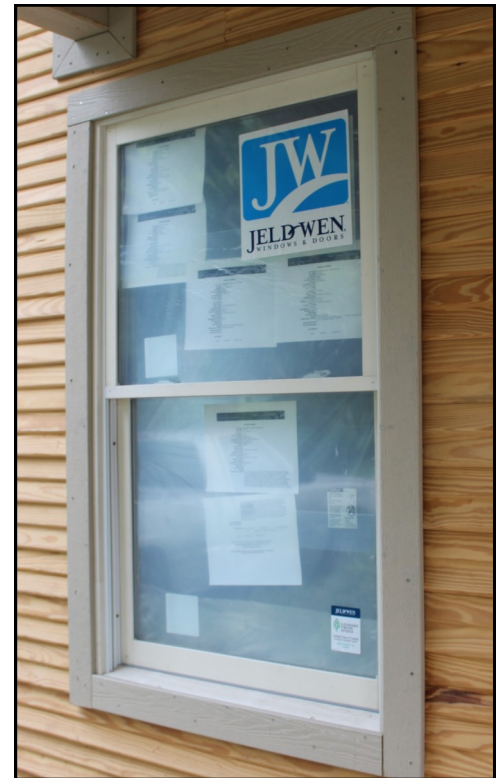
- Window trim and sill detail not consistent with original
