HISTORIC AND DESIGN REVIEW COMMISSION

HDRC CASE NO: 2016-378

ADDRESS: 110 GLORIETTA

TYPE OF WORK: Porch and window fenestration modifications

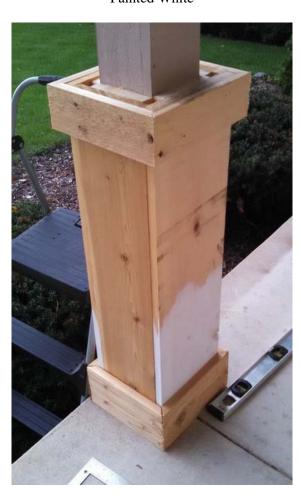
Specifications of Materials to Be Used

Front Porch Columns

Painted White

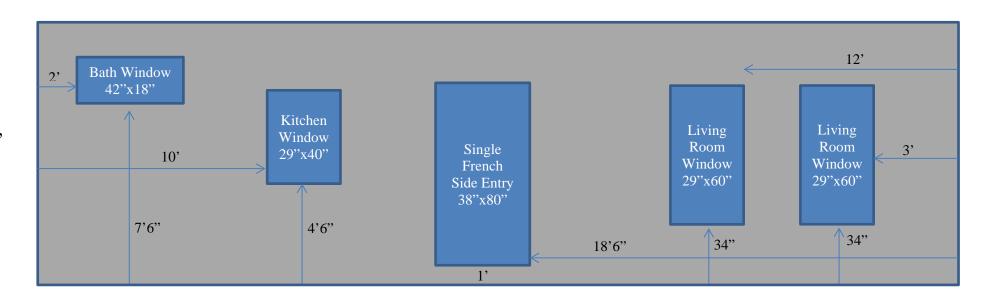
110 Glorietta Left Side Elevation Old Layout

Window hole 29"x60"

11'

- d. ALTER WINDOW OPENING There is an existing aluminum sliding glass door on the left elevation. The applicant is proposing to remove the door and install a wood single French door in its place. According to the Guidelines for Exterior Maintenance and Alterations 6.B.vii., non-historic incompatible windows should be replaced with windows that are typical of the architectural style. Staff finds the proposal consistent with the Guidelines.

- e. ALTER WINDOW OPENING There is an existing aluminum horizontal 24" x 12" window on the left elevation to the left of the existing sliding aluminum door. The applicant is proposing to remove the window and install a wood one over one window in its place. According to the Guidelines for Exterior Maintenance and Alterations 6.B.vii., non-historic incompatible windows should be replaced with windows that are typical of the architectural style. Staff finds the proposal consistent with the Guidelines.

- f. ALTER WINDOW OPENING There is an existing aluminum one over one window on the left elevation toward the rear. The applicant is proposing to remove the window and install a horizontal 42" x 18" wood window. According to the Guidelines for Exterior Maintenance and Alterations 6.B.vii., non-historic incompatible windows should be replaced with windows that are typical of the architectural style, and that window openings should be preserved. Staff finds the proposal to remove the aluminum window and replace with wood appropriate, but finds the proposal to alter the window opening and the proposed proportion not appropriate for the bungalow style home. Staff finds an appropriate window proportion would be vertical one over one.

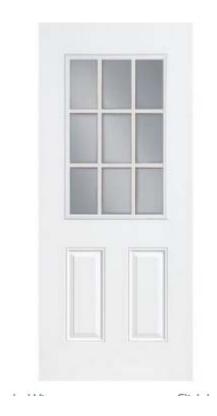
Single French Door

Door for Left Side Entry

38 in. x 80 in. JELD-WEN Single French Premium 9 Lite Wood Door (Below)

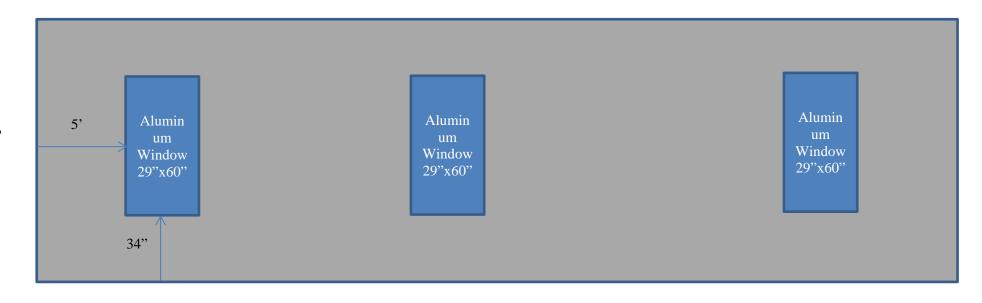
110 Glorietta Right Side Elevation Old Layout

11'

- g. ALTER WINDOW OPENING There is an existing aluminum one over one window on the right elevation toward the rear. The applicant is proposing to remove the window and fill in the opening. According to the Guidelines for Exterior Maintenance and Alterations 6.A.i., original window openings should be preserved. Staff finds the proposal to infill the window not consistent with the Guidelines. Staff recommends the window opening be retained.

- h. ALTER WINDOW OPENING There is an existing aluminum one over one window on the right elevation. The applicant is proposing to shift the opening to the right of the existing, historic opening. According to the Guidelines for Exterior Maintenance and Alterations 6.A.i., original window openings should be preserved. Staff finds the proposal to alter the original opening not consistent with the Guidelines. Staff recommends the opening be retained.

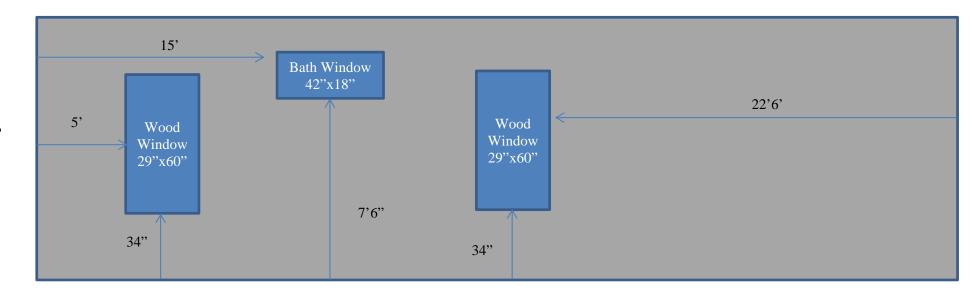
110 Glorietta Right Side Elevation Proposed Layout

11'

- 1. That the new opening installed on the right elevation be a one over one window as noted in finding c.
- 2. That the window to be installed on the left toward the rear be a one over one window as noted in finding f.

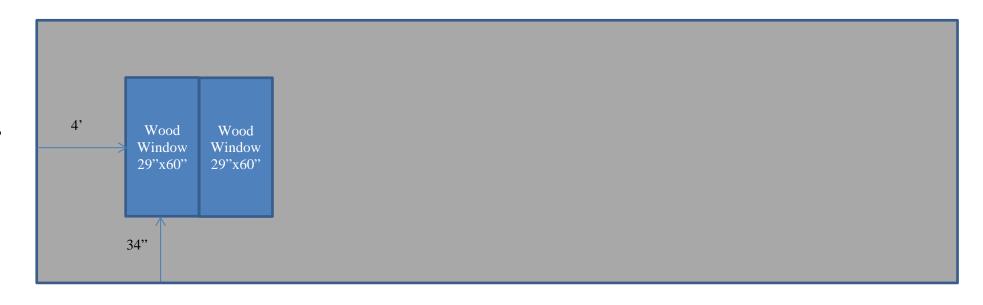
110 Glorietta Back Side Elevation Proposed Layout

Fiber Board
Door
36"x80"
