## HISTORIC AND DESIGN REVIEW COMMISSION

**HDRC CASE NO:** 2016-391  
**ADDRESS:** 315 W LYNWOOD  
**LEGAL DESCRIPTION:** NCB 6386 BLK 6 LOT 13 THRU 22  
**ZONING:** R-5 H  
**CITY COUNCIL DIST.:** 1  
**DISTRICT:** Monte Vista Historic District  
**APPLICANT:** Lauren Diliberto/Don McDonald  
**OWNER:** Denis Karbach, Robert Kevin Brown  
**TYPE OF WORK:** Modifications to existing accessory structure  
**REQUEST:**

The applicant is requesting a Certificate of Appropriateness for approval to fill in three existing garage door bays, create 3 loggia door openings on the front façade, and alter two existing window openings on the left and front facades.

315 W. Lynwood Ave. Restoration  
San Antonio, TX 78212

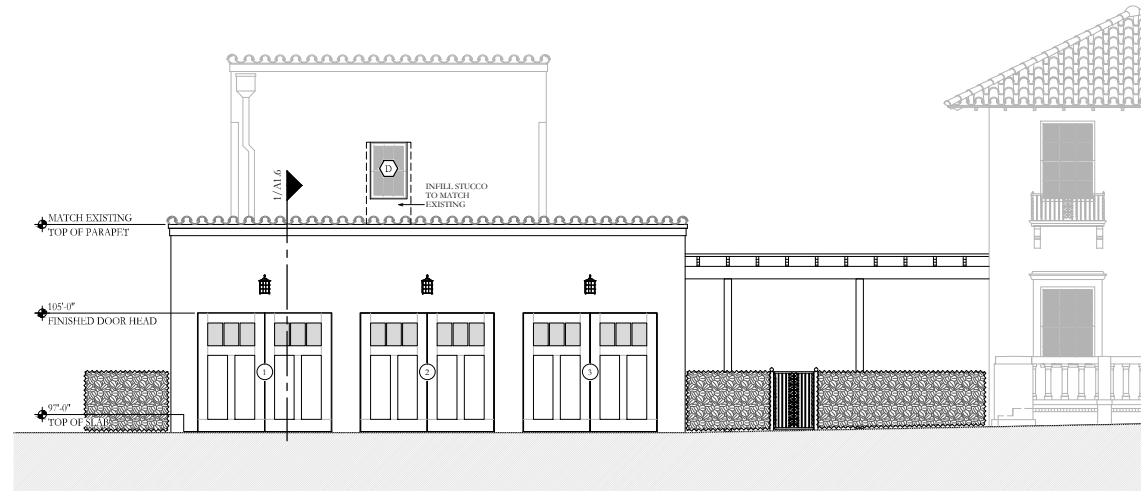
1 SOUTH ELEVATION @ GARAGE

SCALE: 1/4"=1'-0"

Existing Garage to be repurposed into pool cabana. Structure to be restored to original condition, including replacement of second floor middle window and stucco color. Replacement of contemporary garage doors are to be French doors with openings that relate to the openings at the East Loggia. The current structure sits at the North West corner of the property and the current drive is to become a lawn with in ground pool. A hedge fence will enclose the new lawn making the structure not visible to the street and public right of way.

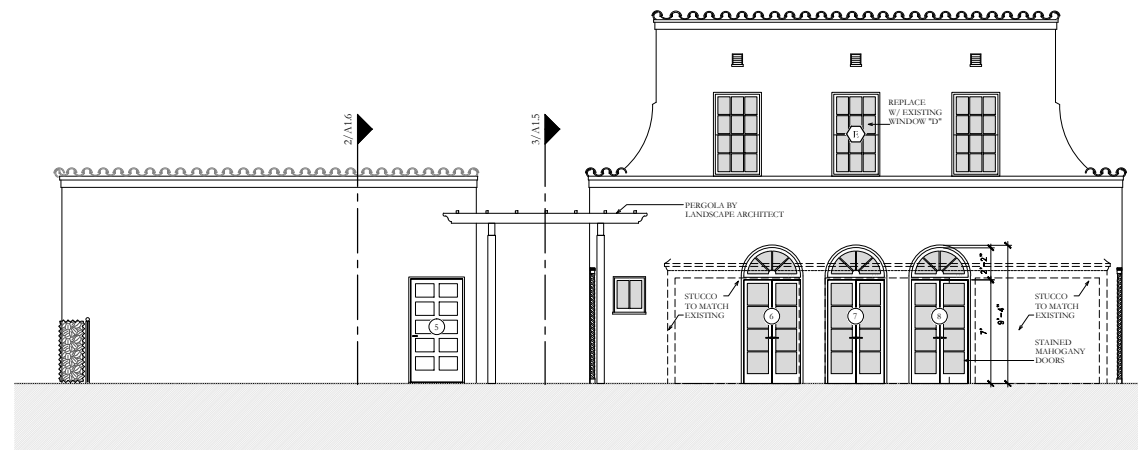
2 EAST ELEVATION @ GARAGE

SCALE: 1/4"=1'-0"

The Pool Cabana has been presented to the Monte Vista Historical Association Architectural Review Board and approved with a recommendation that the openings be aligned with the windows above. We believe that the closer placement of the arched openings relates better to the proceeding lawn and to the existing East loggia.

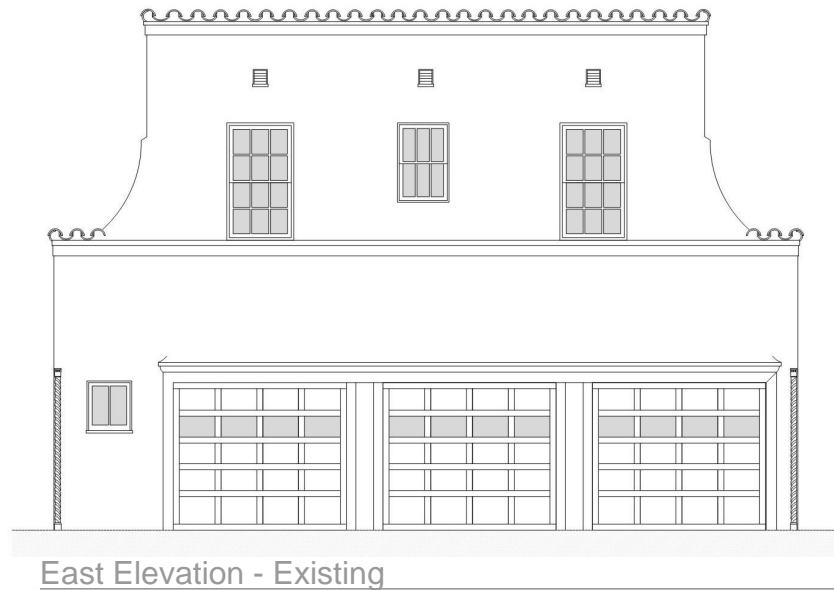
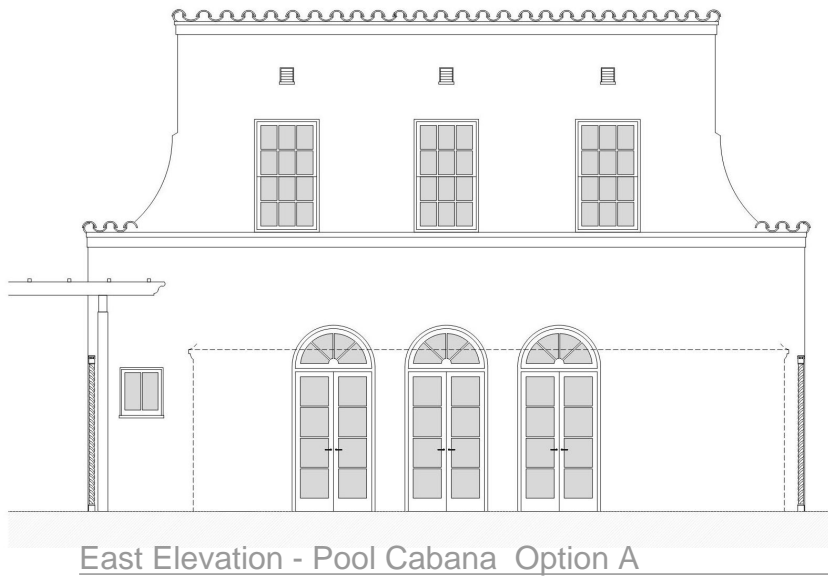
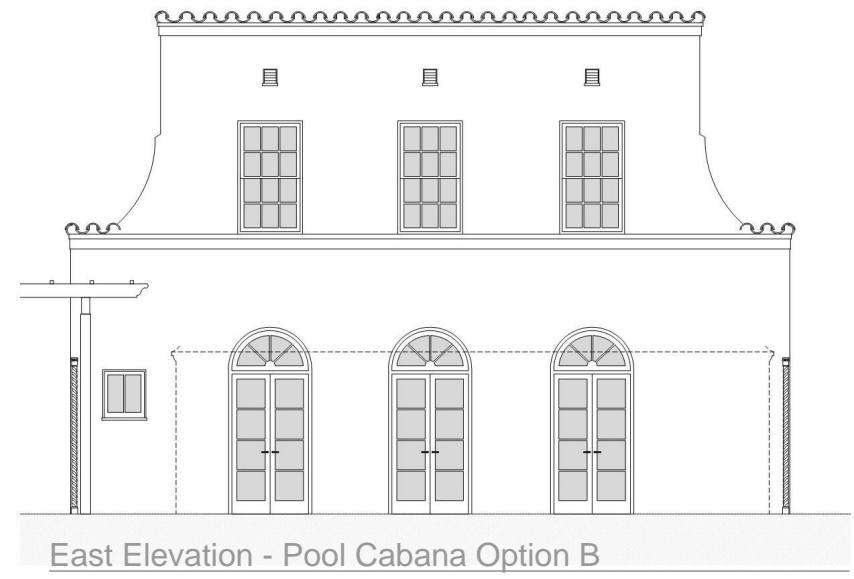
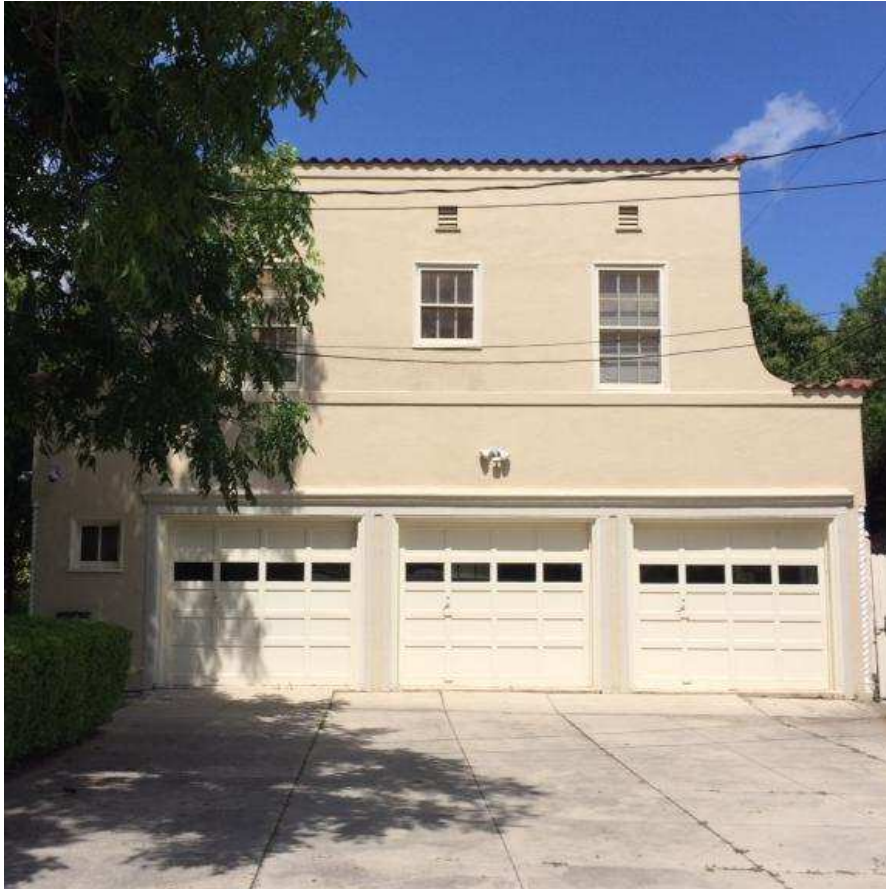
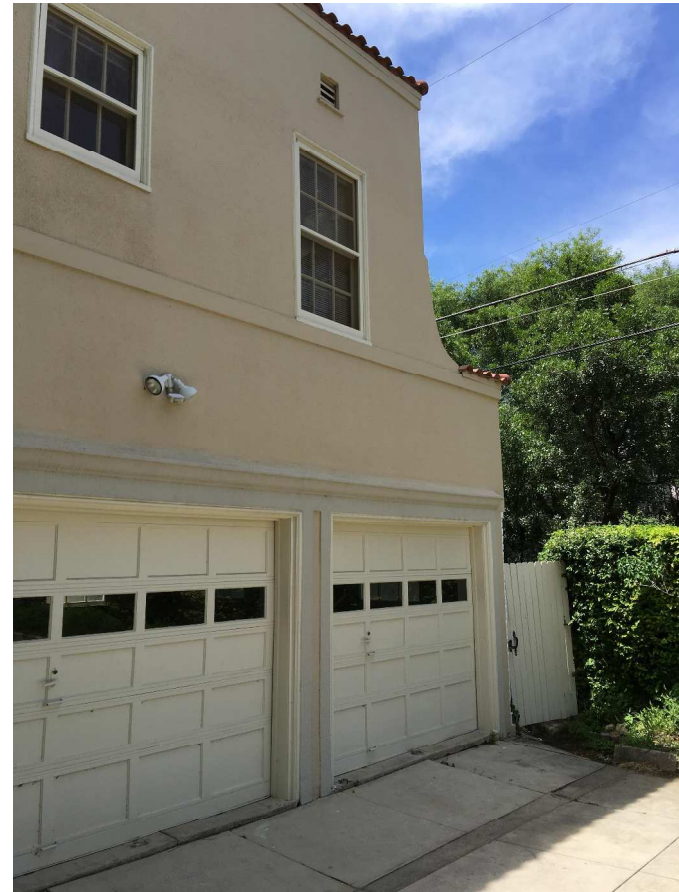
EXISTING EAST ELEVATIONS @ GARAGE  
315 W. LYNWOOD AVE. | MONTE VISTA, SAN ANTONIO  
DON B. MCDONALD, ARCHITECT, LTD.

- f. On front façade of the existing garage there are 3 car bays, two 6 over 6 windows and one 3 over 3 window. On the left façade there is another 6 over 6 wood window. The applicant is proposing to remove the middle 3 over 3 window on the front façade and exchange it with the side 6 over 6 window. According to the Guidelines for Exterior Maintenance and Alterations 6.B.i, window openings should be preserved. Staff visited the site September 26, 2016, and found that the stucco had been patched below center window and is not original to the structure. Also, staff finds the left window is not seen from the public right-of-way. Staff finds the proposal to enlarge the front middle opening, using an existing historic window from the structure, to match the existing flanking windows appropriate.

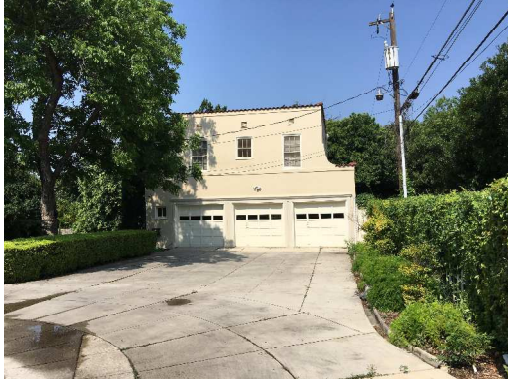
EAST ELEVATION

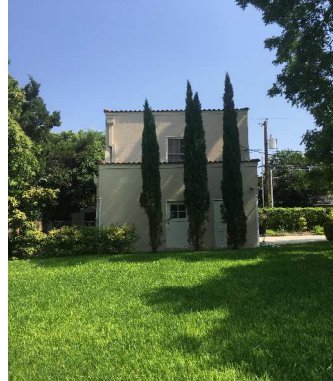
NORTH ELEVATION

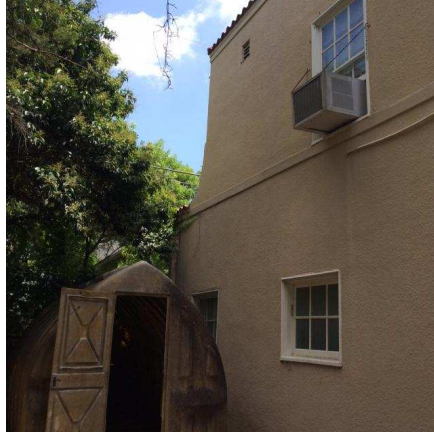
WEST ELEVATION

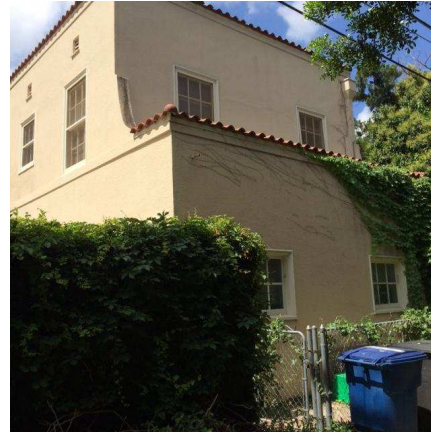
SOUTH ELEVATION

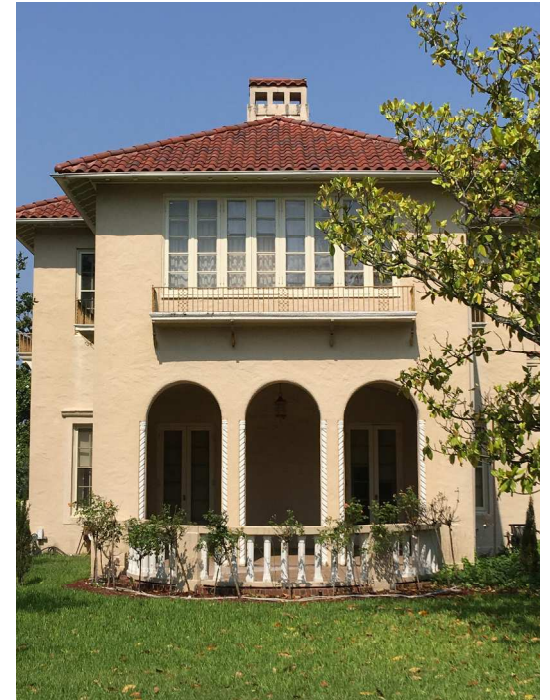
SITE PHOTOS - EXISTING GARAGE & EAST LOGGIA  
315 W. LYNWOOD AVE. | MONTE VISTA, SAN ANTONIO  
DON B. MCDONALD, ARCHITECT, LTD.
