# HISTORIC AND DESIGN REVIEW COMMISSION

**HDRC CASE NO:** 2016-363  
**COMMON NAME:** Malt House  
**ADDRESS:** 115 S ZARZAMORA  
**LEGAL DESCRIPTION:** NCB 2322 BLK 1 LOT 7&8 AND 9  
**ZONING:** C-2 HL  
**CITY COUNCIL DIST.:** 5  
**LANDMARK:** Malt House Restaurant  
**APPLICANT:** 7-Eleven, Inc.  
**OWNER:** Baldemar Gonzalez  
**TYPE OF WORK:** Demolition with New Construction  
**REQUEST:**

1. Demolish the structure at 115 S Zarzamora, including a commercial building and canopies.
2. Construct a commercial structure and canopy.
3. Install signage on the commercial structure and canopy.

**Request to Demolish  
City of San Antonio Designated  
Local Historic Landmark**

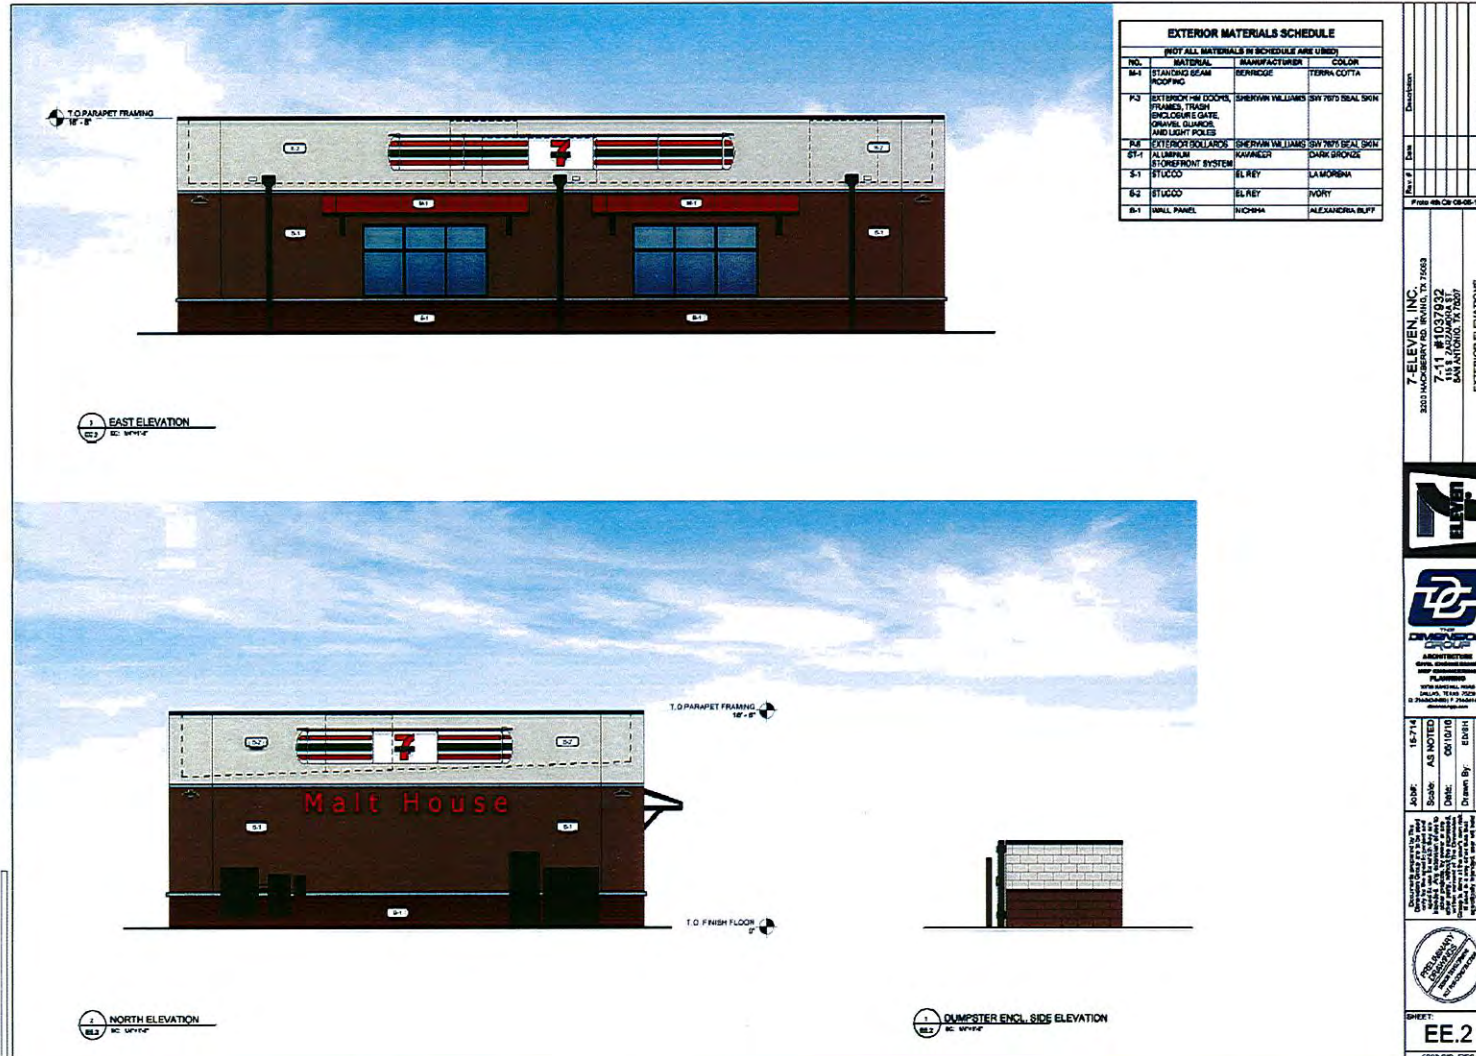
# 115 S. Zarzamora Project Plans

**2 FUELING CANOPY SIDE (EAST/WEST) ELEVATION**  
JUL 2017

7-11 has prepared replacement plans for the Property that are unique for 7-11 and distinctive to this Property. First, the convenience store is proposed to be fronted on the hard corner of Buena Vista and Zarzamora creating an urban, pedestrian friendly experience. After meetings with HDRC members, the proposed building elevations have been updated to better reflect, but not mimic, the Malt House structure. The proposed building will include windows on three (3) sides. The north elevation will not include windows, but will include the iconic Malt House signage. Further, a gathering area will be installed outside of the store. This will include an overhead canopy and a few tables.

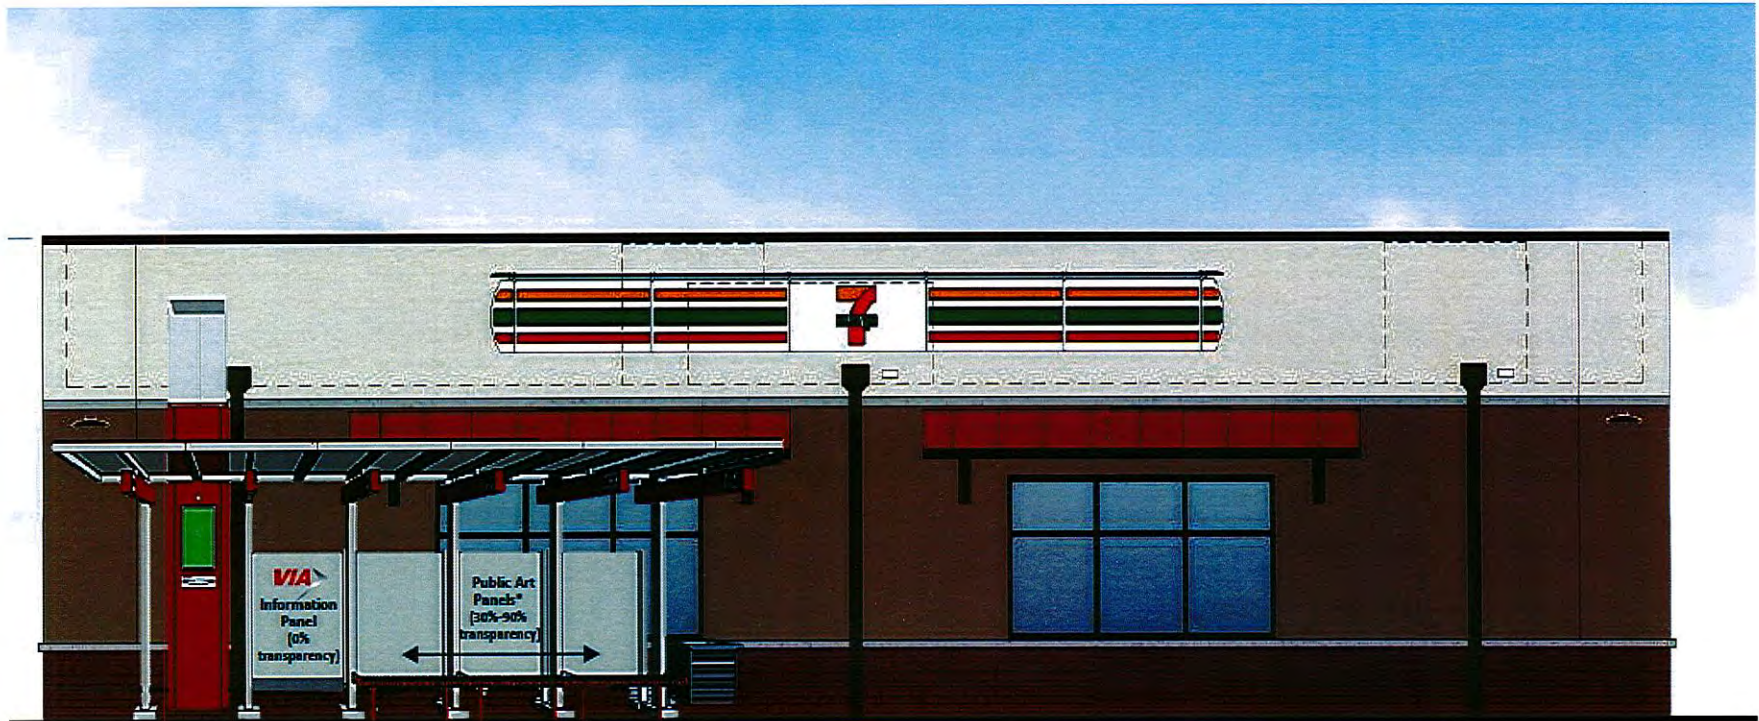
*\* Public Art Panel Design TBD;  
will incorporate homage to  
Historic Landmark Malt House*

**VIA** NextGen+ Shelter w/  
East Elevation of proposed development

- Demolition of the Property will involve coordination with VIA, which has proposed a new Primo Station with Malt House branding.

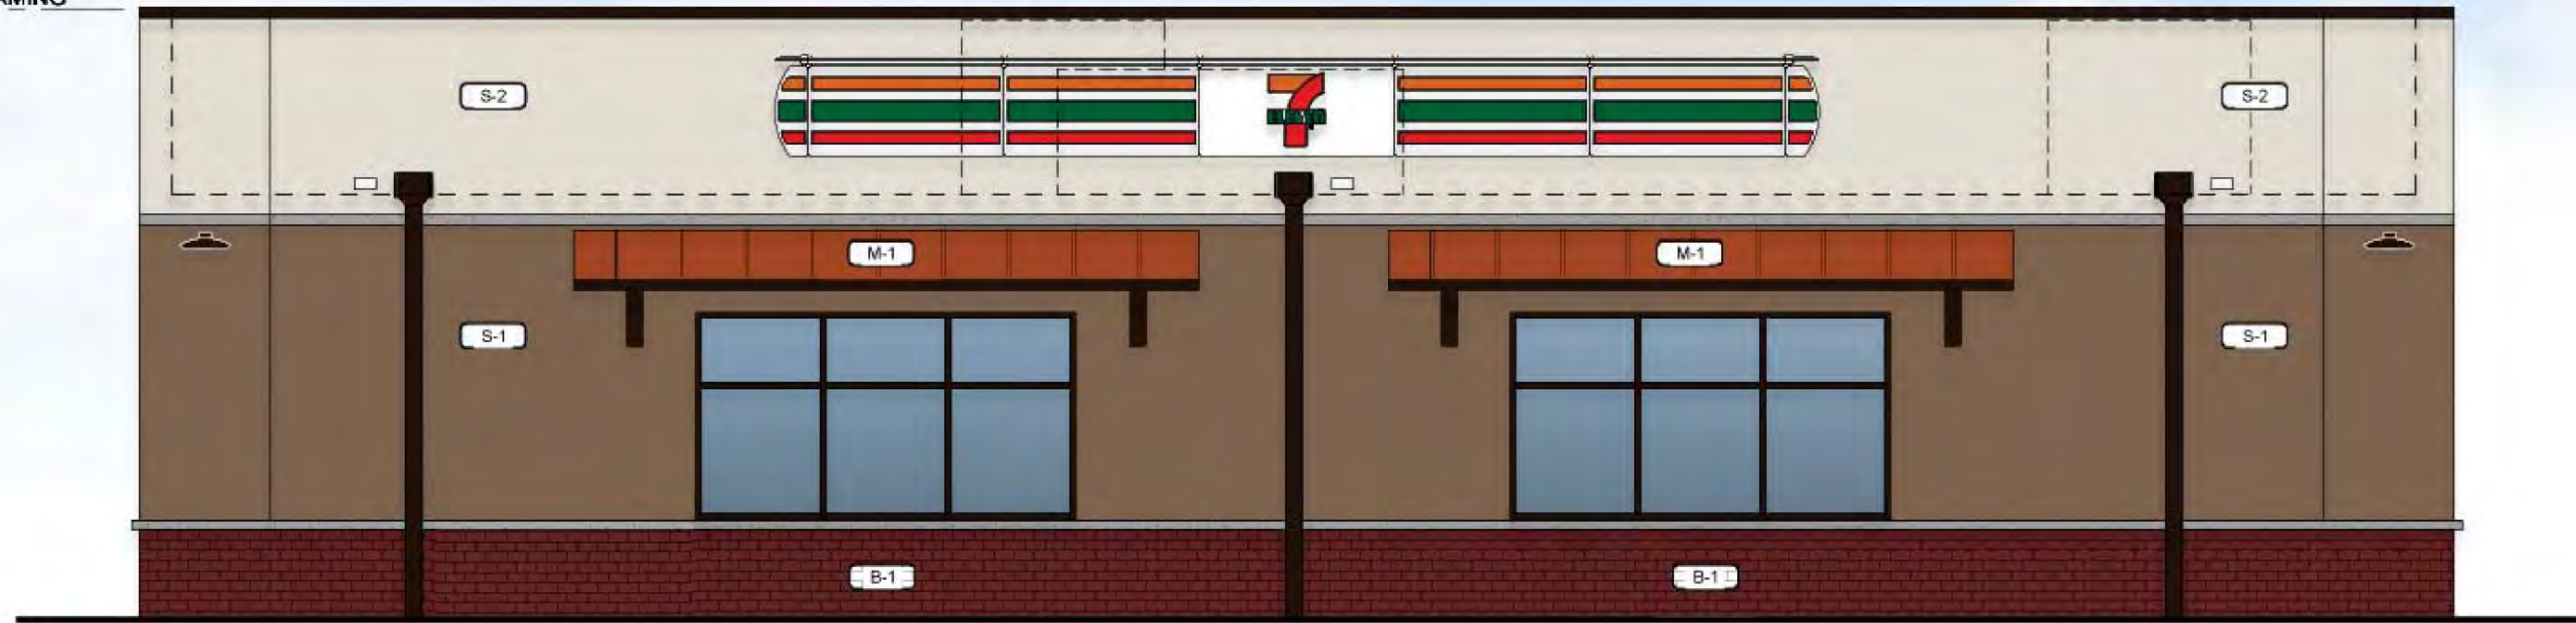
3 EAST ELEVATION  
EE.2 SC: 1/4"=1'-0"

T.O. PARAPET FRAMING  
18' - 8"

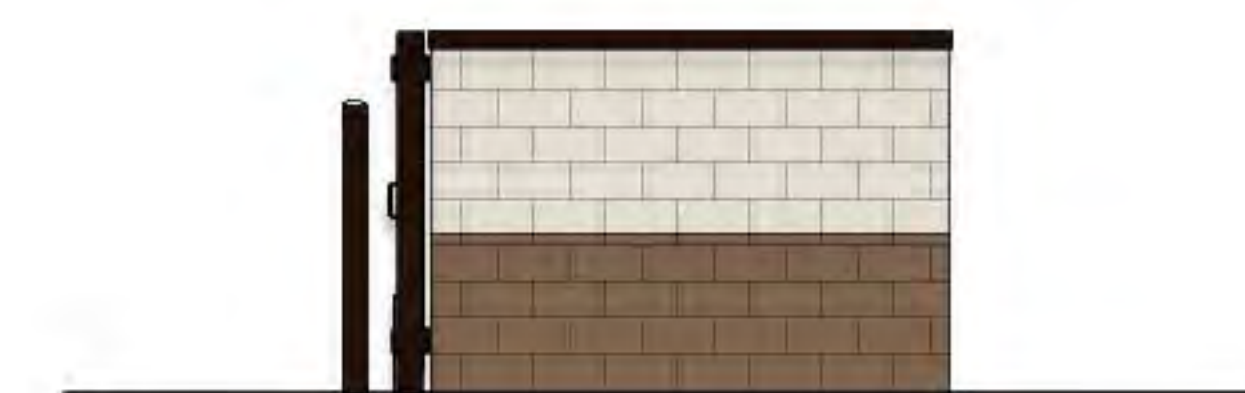
1 DUMPSTER ENCL. SIDE ELEVATION  
EE.2 SC: 1/4"=1'-0"

T.O. PARAPET FRAMING  
18' - 8"

T.O. FINISH FLOOR  
0'
