HISTORIC AND DESIGN REVIEW COMMISSION

HDRC CASE NO: 2017-117
ADDRESS: 421 S ALAMO ST
423 S ALAMO ST
LEGAL DESCRIPTION: NCB 155 BLK 4 LOT 10 & E IRR 240.51 FT OF 4 & 5
ZONING: D,HE
CITY COUNCIL DIST.: 1
DISTRICT: La Villita Historic District
LANDMARK: German-English School
APPLICANT: Guy Chipman III/Guy Chipman Construction, L.P.
OWNER: HH San Antonio LLC c/o Ashford Hospitality
TYPE OF WORK: Door replacement
REQUEST:

The applicant is requesting a Certificate of Appropriateness for approval to replace 4 sets of original wood doors with replica replacement doors to match style, rail, sticking details, and color of existing doors. Replacement doors will have similar hardware to existing sets and identical white laminated glass panels.

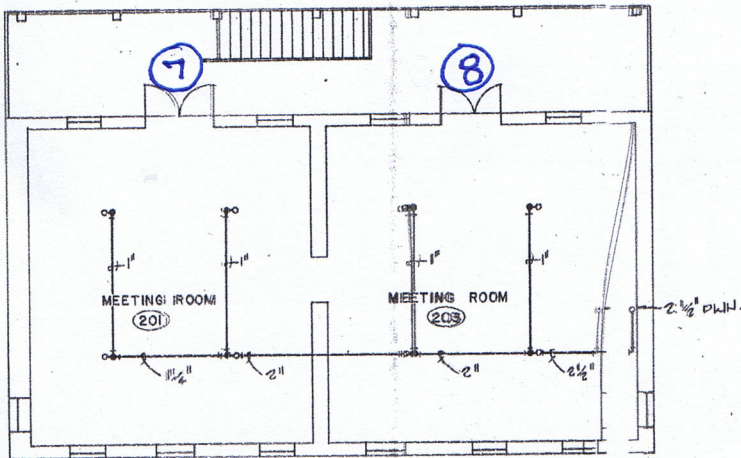
2 SECOND FLOOR PLAN

SOUTH BLDG

SPRINKLER

- 1 3/4" STUB OUT AT WALL ABOVE CEILING LINE FROM SECONDARY CONDENSATE DRAIN. SECONDARY DRAINAGE WILL OCCUR ONLY IF BLOCKAGE OF PRIMARY DRAINAGE SHOULD OCCUR.
- 2 PRIMARY CONDENSATE DRAIN ABOVE CEILING, SLOPE TO DRAIN.
- 3 3/4" CONDENSATE DRAIN TO 2" HUB & TRAP BELOW FLOOR TIE TO 4" WASTE LINE.
- 4 3/4" CONDENSATE DRAIN FROM ROOF SEE 4, ME-1. PER 2 CONTINUATION.
- 5 2 1/2" SPRINKLER PIPE UP TO CEILING JOISTS OF SECOND FLOOR.
- 6 NEW CHILLED & HOT WATER PIPING TO AIR HANDLING UNITS.
- 7 EXISTING CHILLED WATER & HOT WATER PIPING.
- 8 EXISTING ENDSPEC = CHILLED & HOT WATER PIPING AT APPROX. 12" A.B.V. 2ND FLOOR LEVEL.
- 9 CHILLED & HOT WATER PIPING UP THRU ROOF FOR CONTINUATION SEE 4, ME-1.

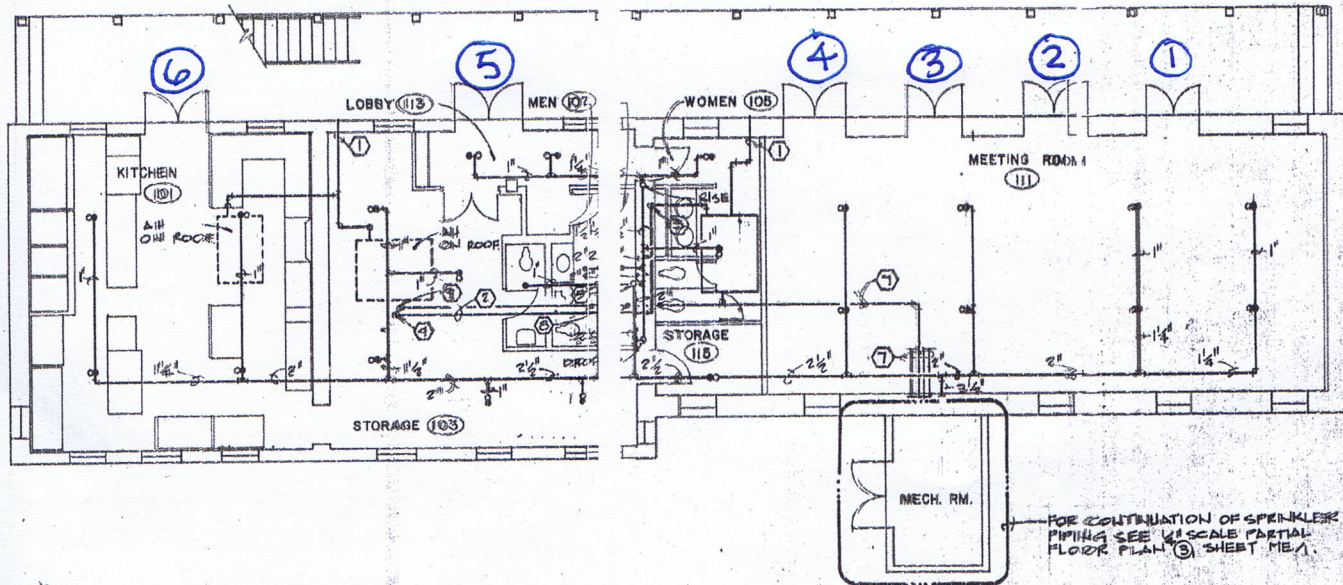
1 FIRST FLOOR PLAN - SOUTH BLDG

SPRINKLER
