HISTORIC AND DESIGN REVIEW COMMISSION

HDRC CASE NO: 2017-245
ADDRESS: 425 N FLORES ST
LEGAL DESCRIPTION: NCB 132 BLK LOT 32 & 32 1/2 ARB A 21 & A 22
ZONING: D,HS, RIO-7
CITY COUNCIL DIST.: 1
LANDMARK: Callaghan, SX Building
APPLICANT: Brian Carney/Weston Urban
OWNER: Weston Urban
TYPE OF WORK: Demolition of the structure at 425 N Flores
REQUEST:

The applicant is requesting a Certificate of Appropriateness for approval to demolish the structure located at 425 N Flores, commonly known as the Callaghan Building and the SX Building.

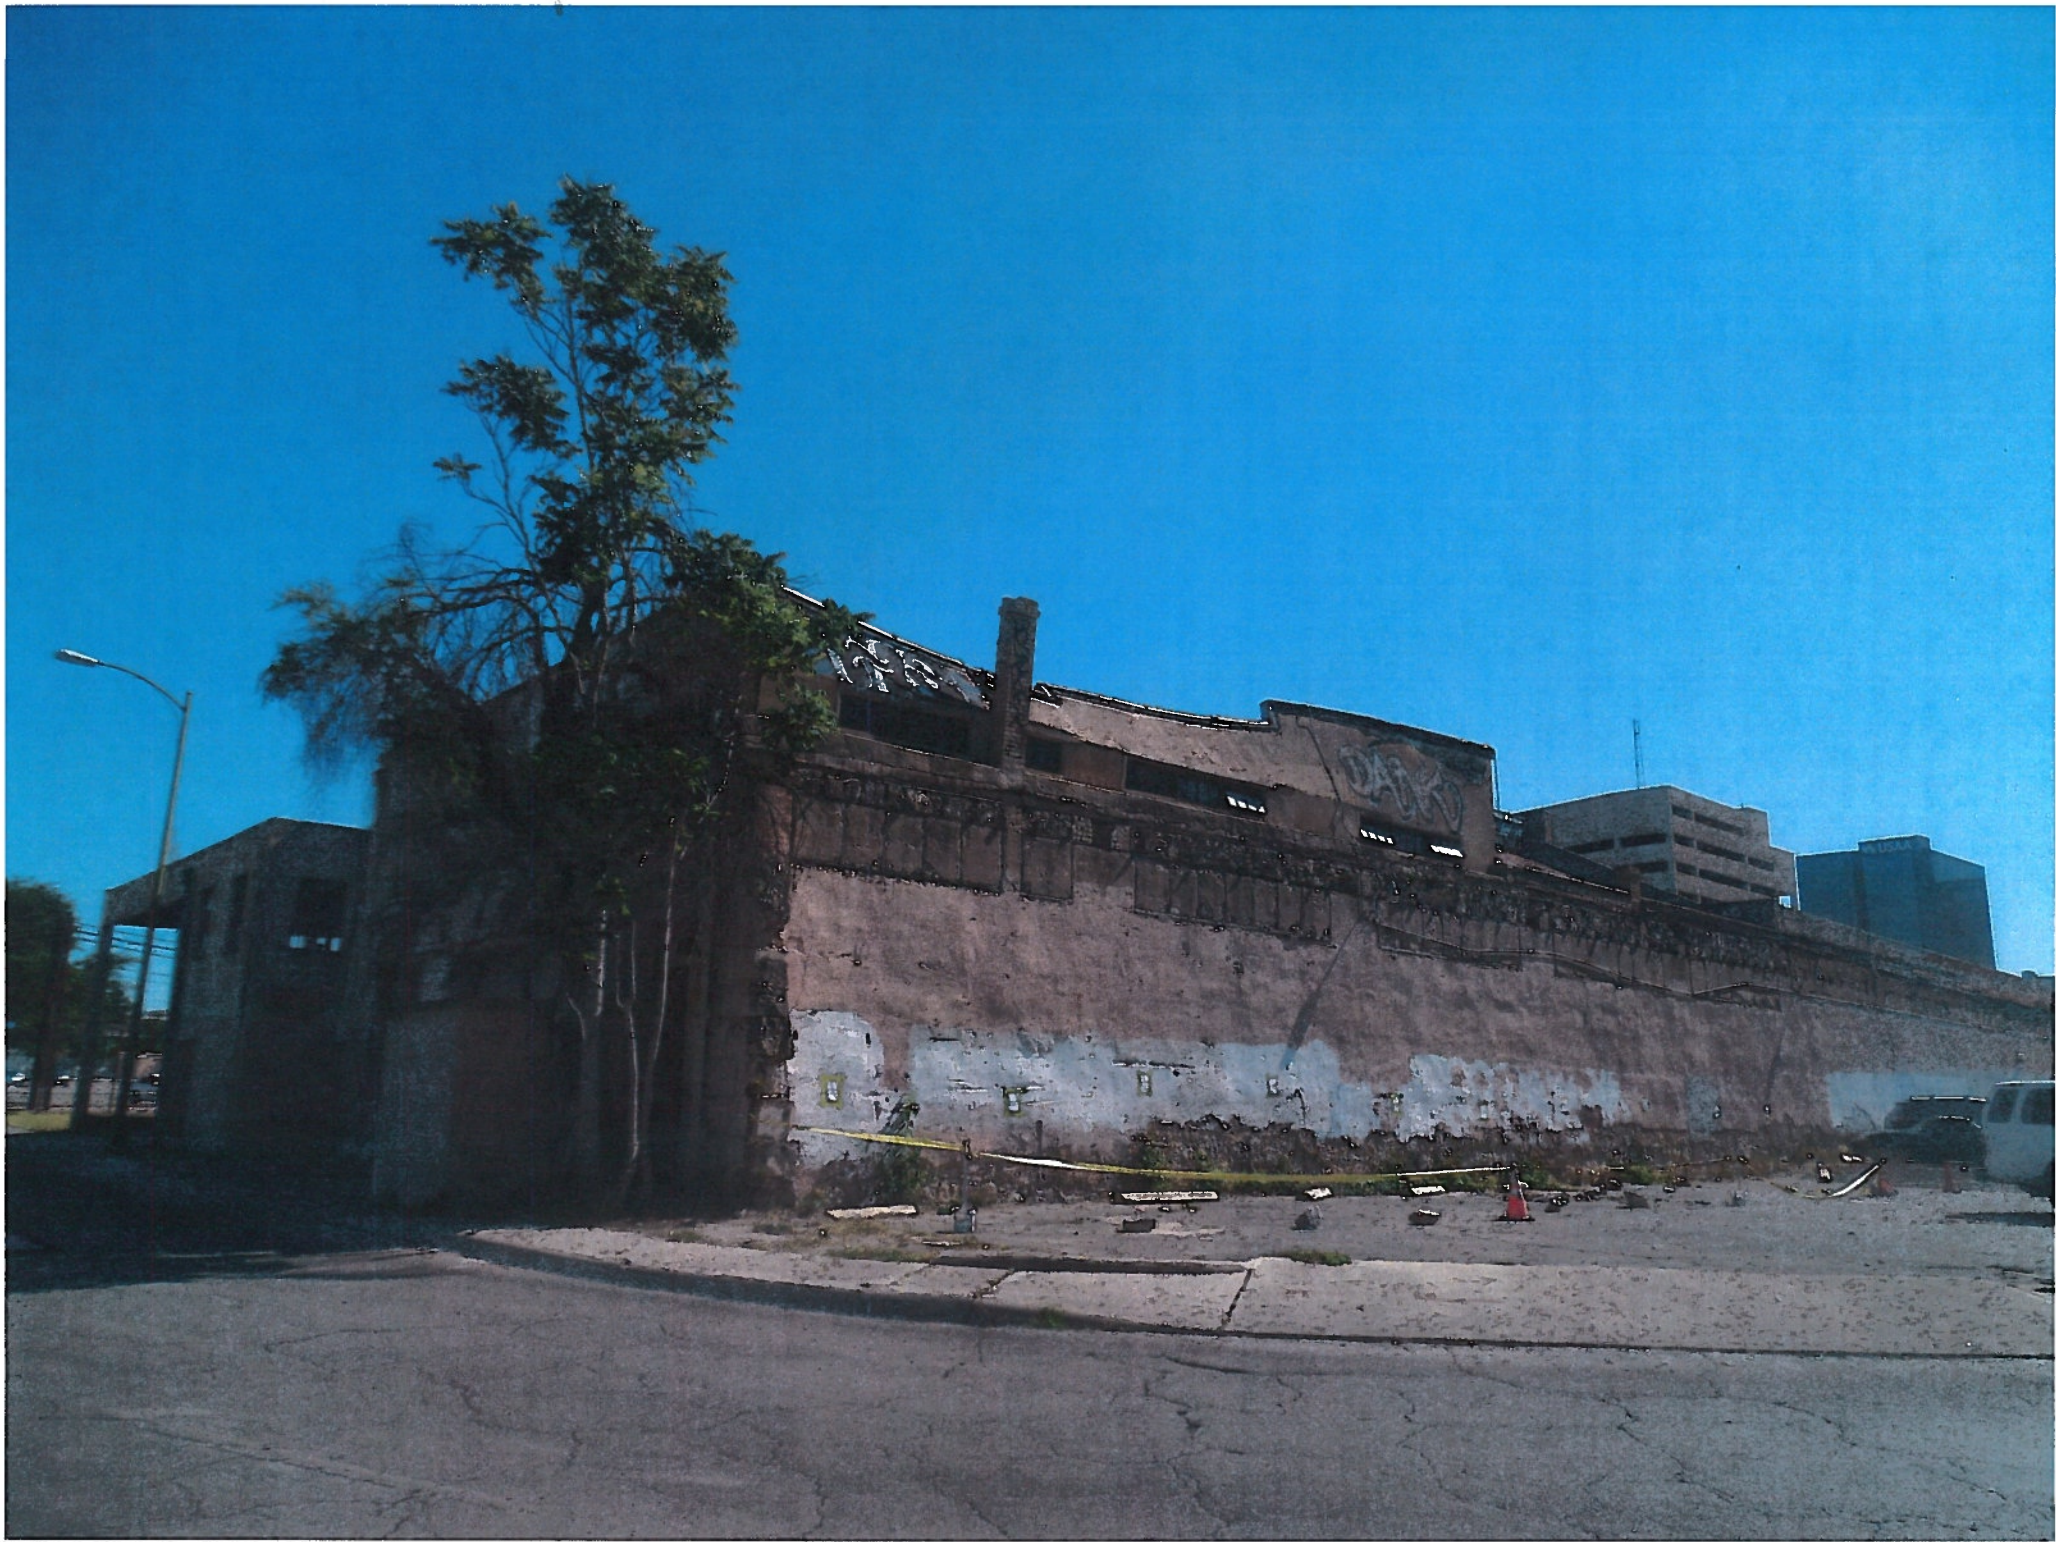
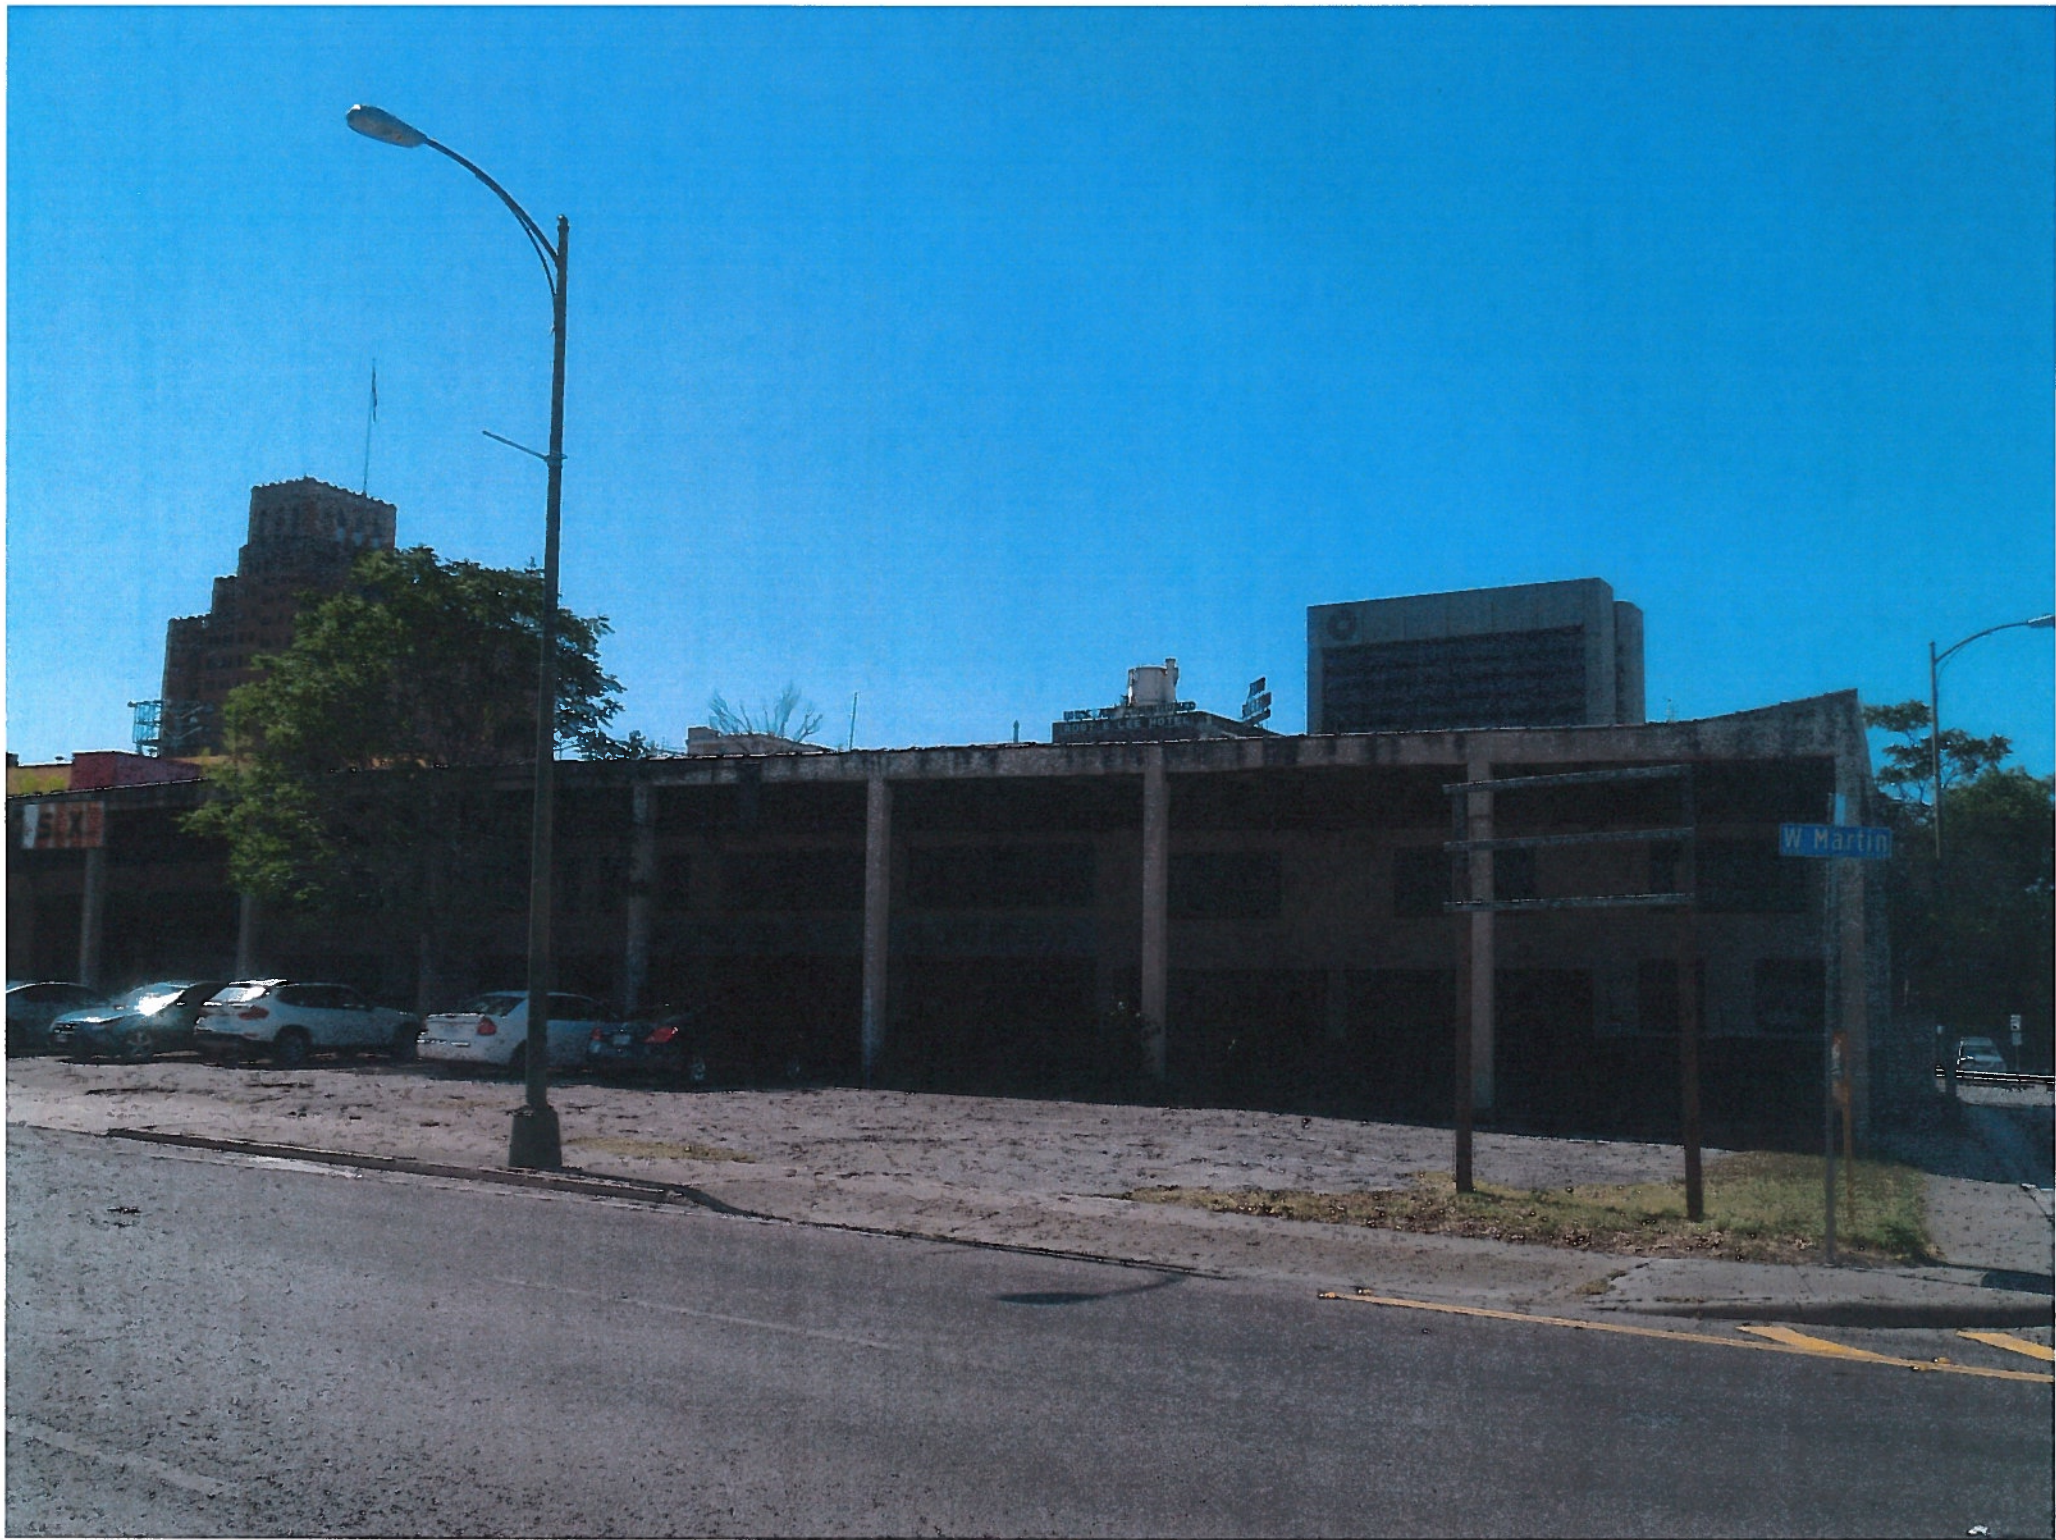
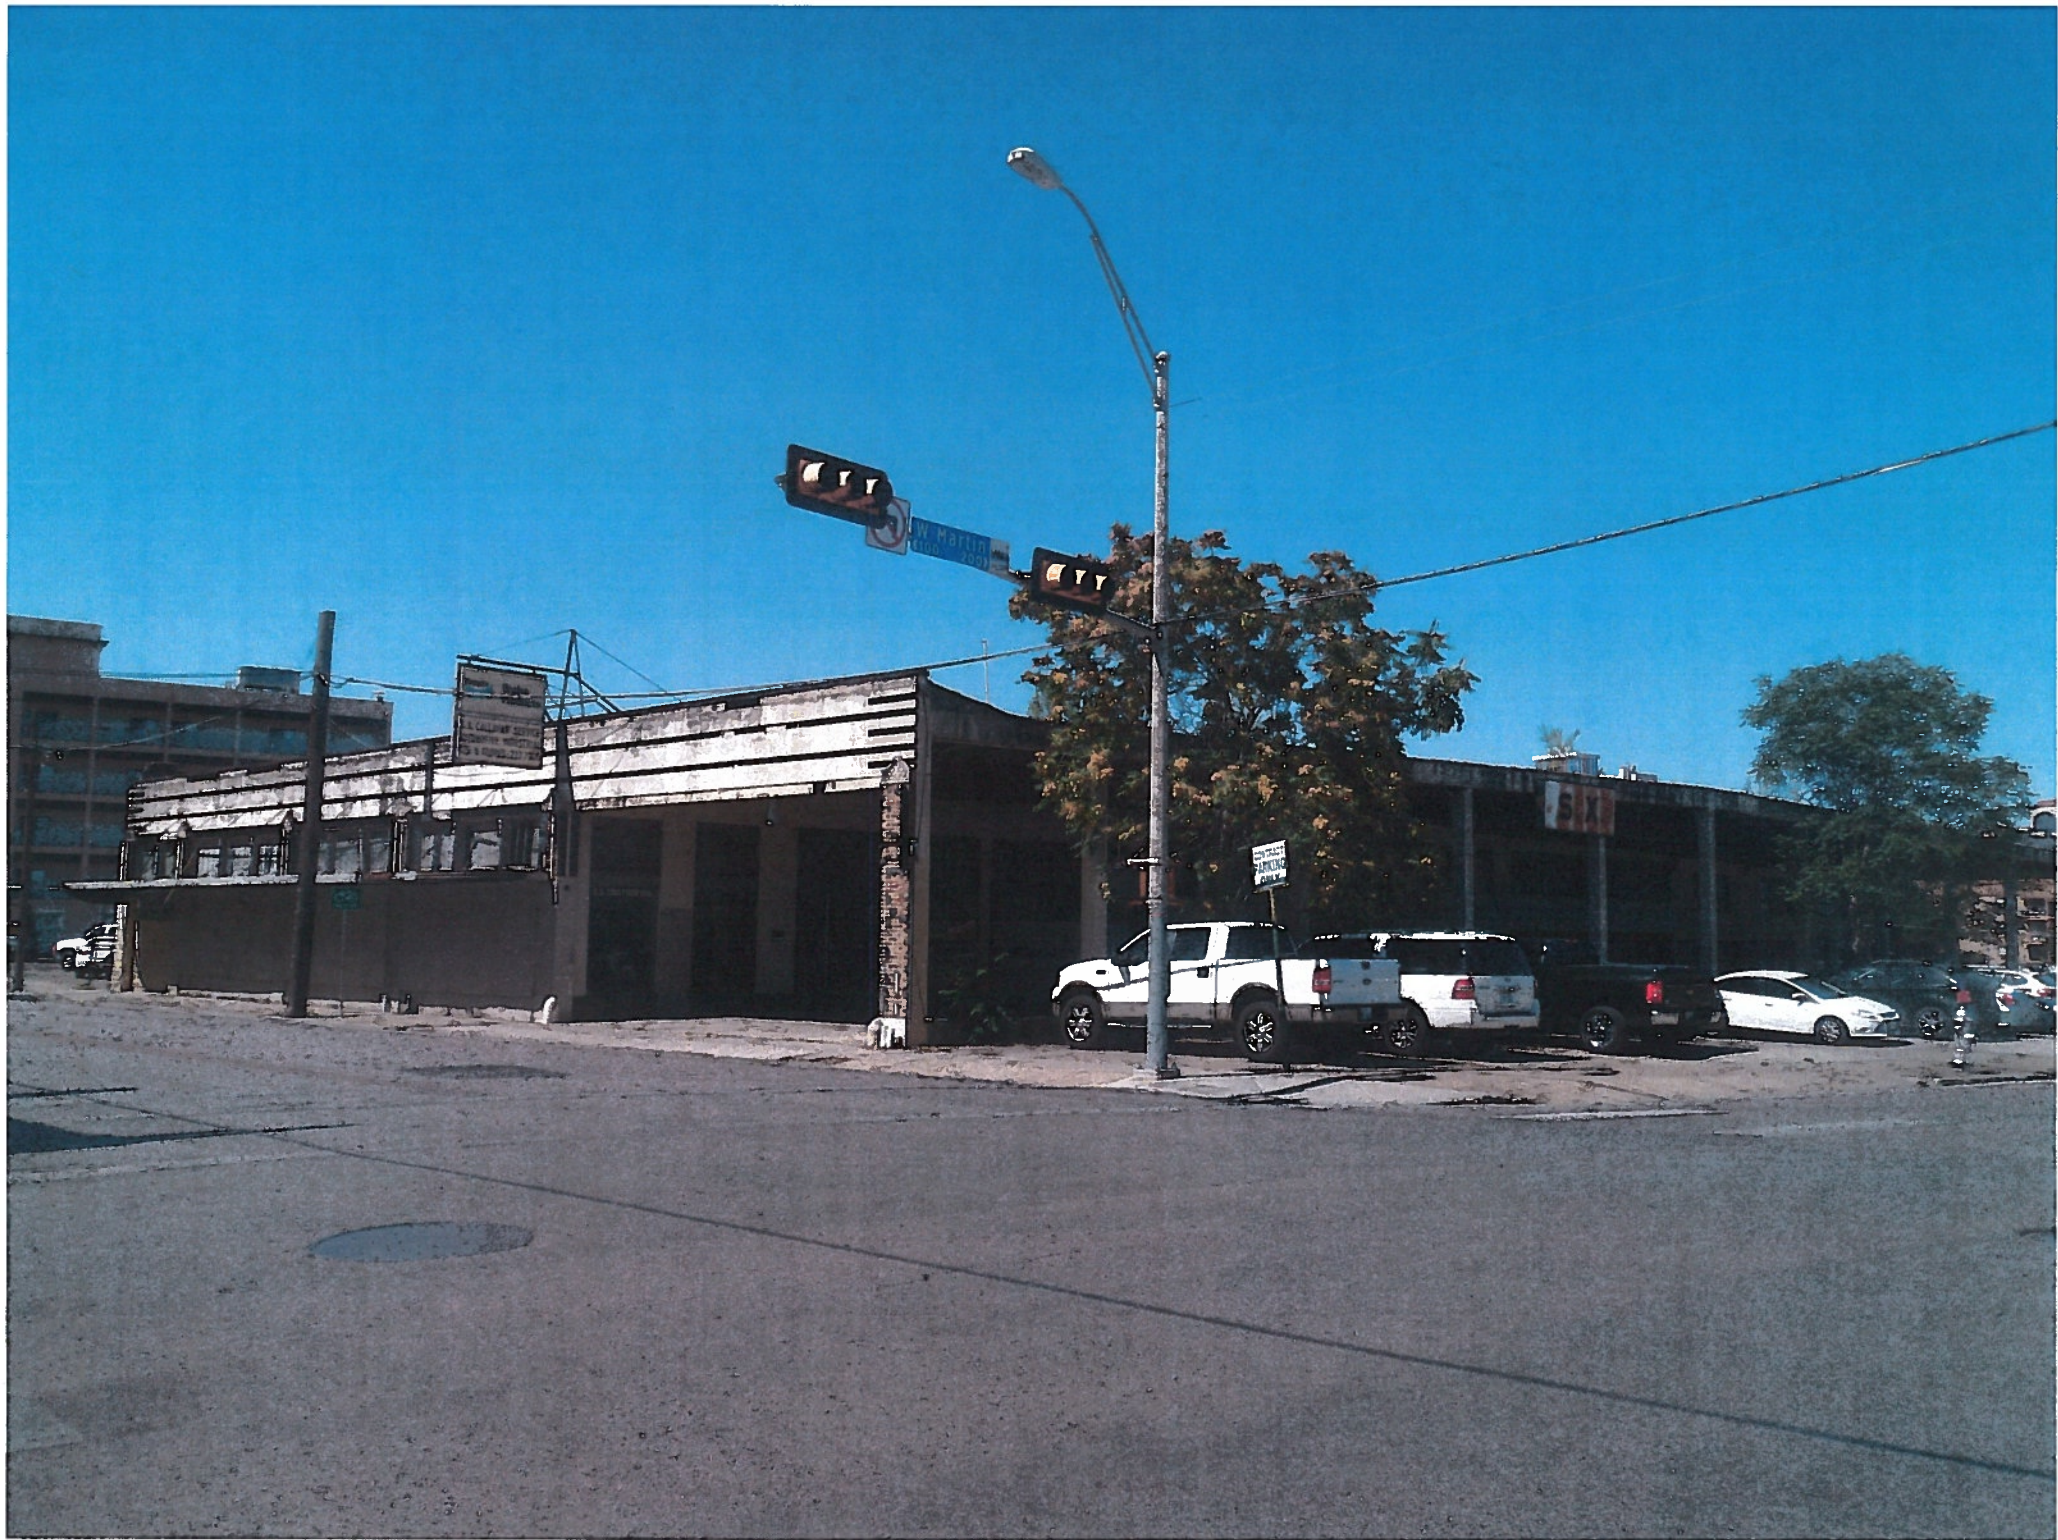
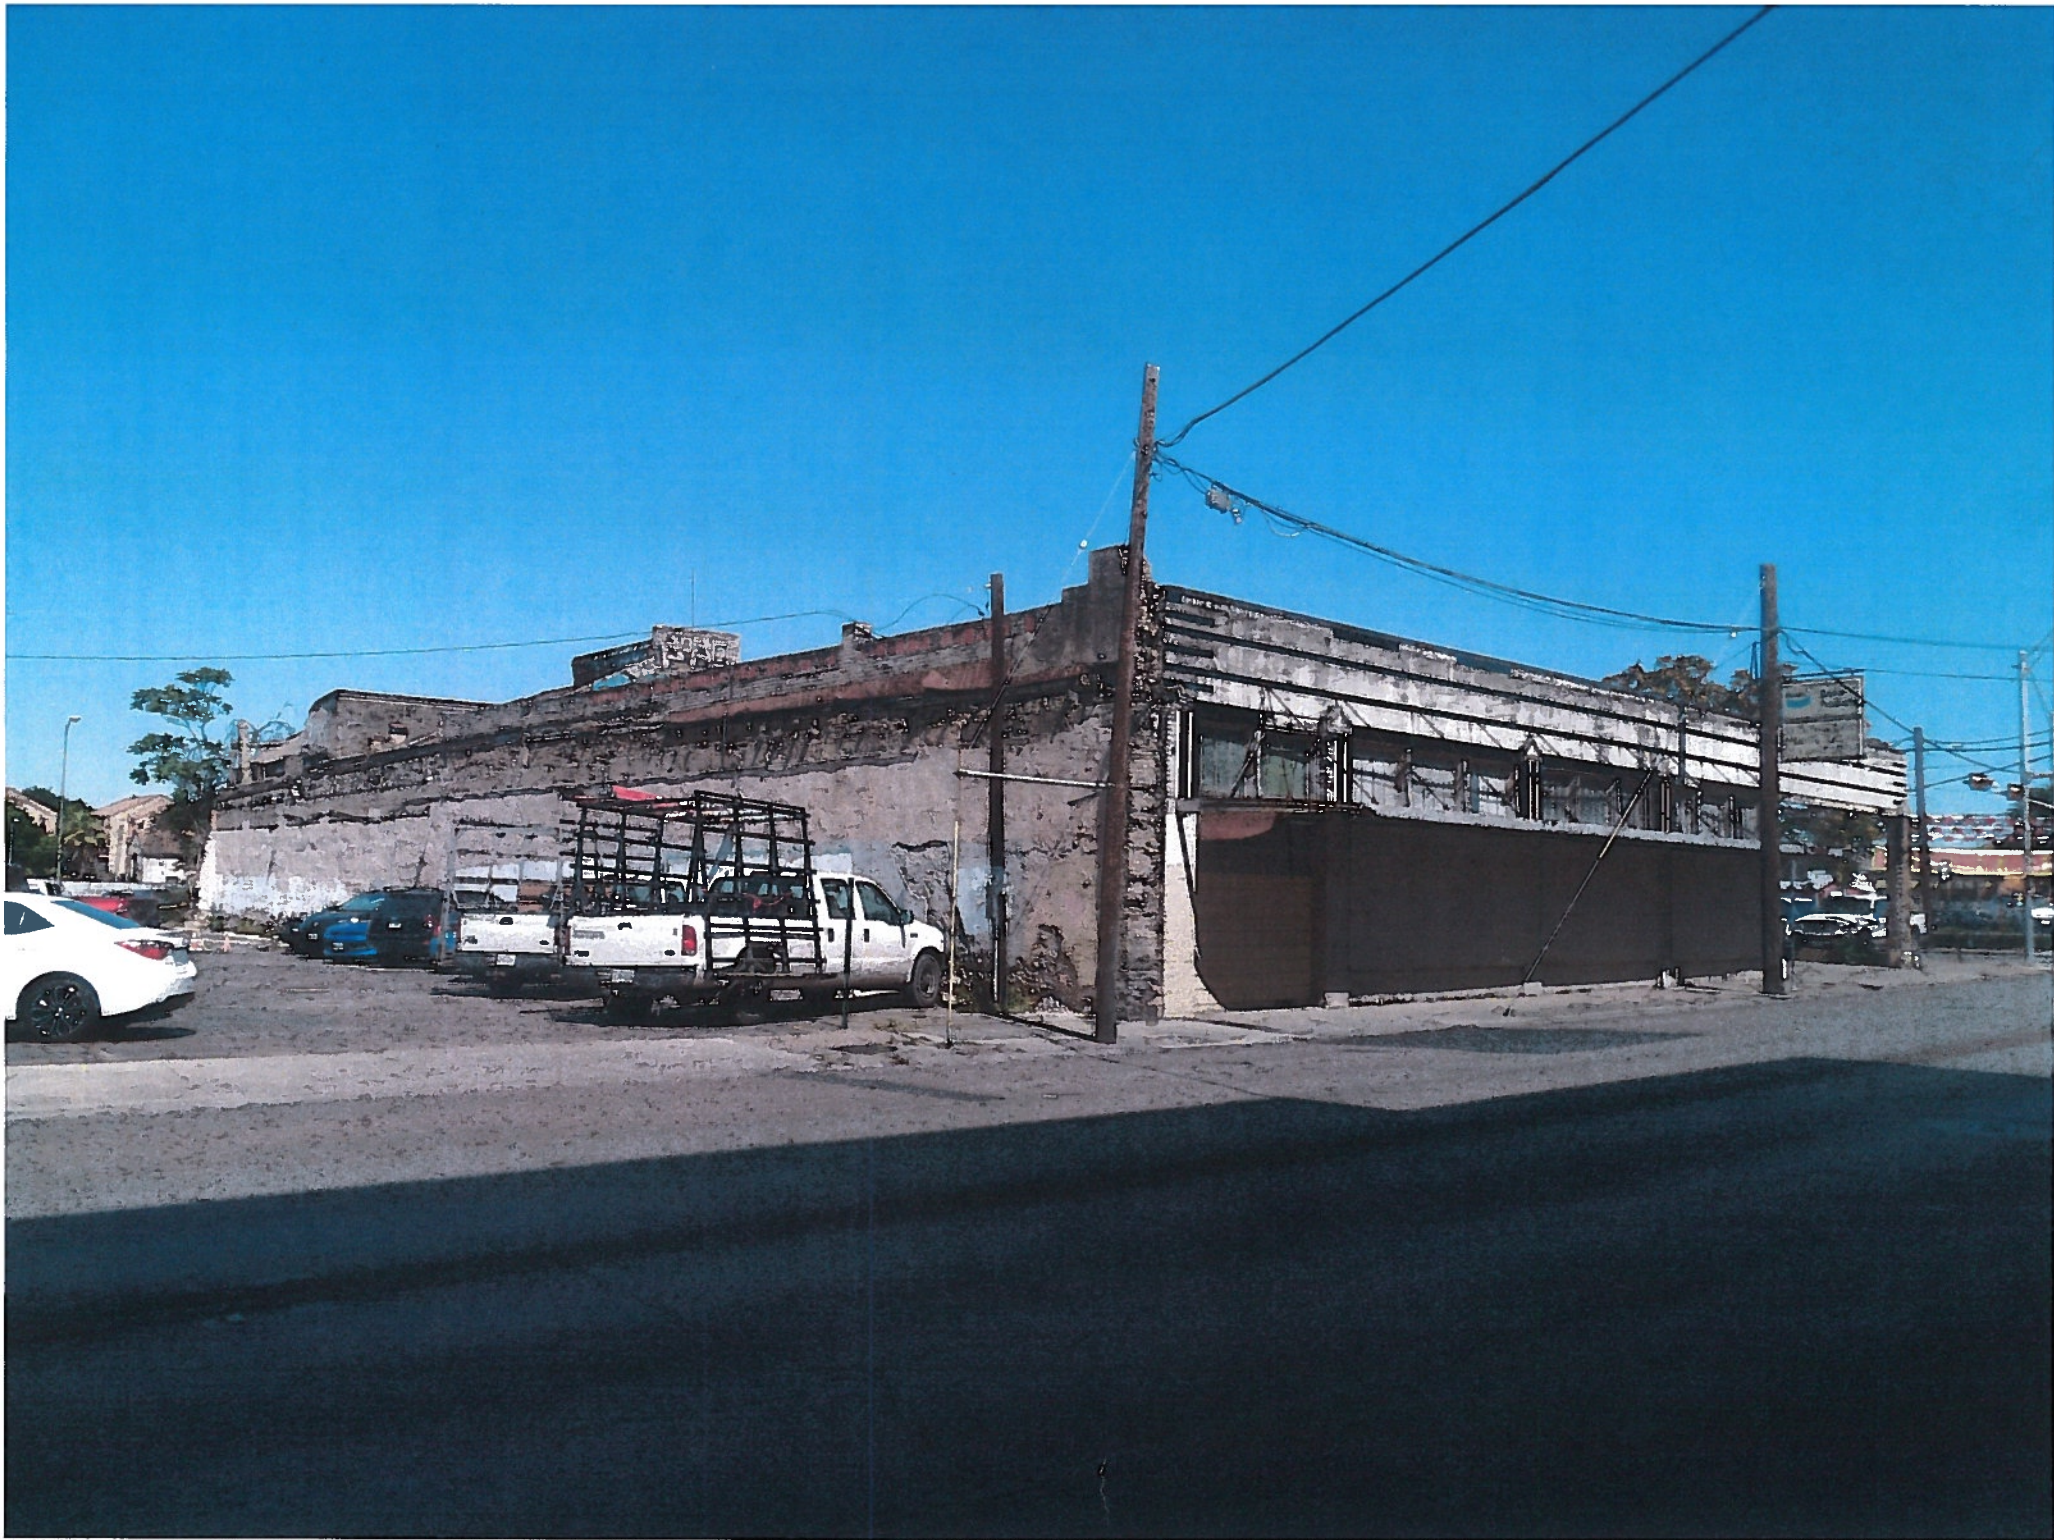
In addition to the observation of the southwest structure Datum observed the northern canopy structure. This structure is showing significant signs of deterioration with: partially collapsed decking,

major concrete spalling and corrosion at the concrete columns and spandrel beams as well as large cracking of the corbels supporting the roof girders. This canopy is not safe in its present condition. We recommend shoring or removal of the canopy structure.

- f. **STRUCTURAL ANALYSIS** – The applicant has provided information from a structural engineering report which notes various structural failures throughout the structure. A significant portion of the roof structure has collapsed and is subsequently pushing the southern exterior wall away from the building mass causing the parapet wall to collapse into the building. Significant fire damage has occurred throughout the structure in addition to weather damage from years of exposure. Other losses of structural integrity are found in the corrosion of the structural concrete columns, the rotting of wood roof decking, the corrosion of spandrel beams and the cracking of the corbels supporting the roof girders. The provided structural report noted that the structure poses a threat to public safety and should be demolished.
