HISTORIC AND DESIGN REVIEW COMMISSION

HDRC CASE NO: 2017-570
ADDRESS: 402 E EVERGREEN
LEGAL DESCRIPTION: NCB 395 BLK 19 LOT N 120.7 FT OF W 53.9 FT OF 1
ZONING: RM-4 H
CITY COUNCIL DIST.: 1
DISTRICT: Tobin Hill Historic District
APPLICANT: Criswell Humphrey/CCH Projects LLC
OWNER: Criswell Humphrey/CCH Projects LLC
TYPE OF WORK: Exterior modifications, entry modifications, demolition of rear accessory structure
APPLICATION RECEIVED: October 23, 2017
60-DAY REVIEW: December 22, 2017

402 E. Evergreen
Residence
402 E. EVERGREEN SAN ANTONIO, TX 78212

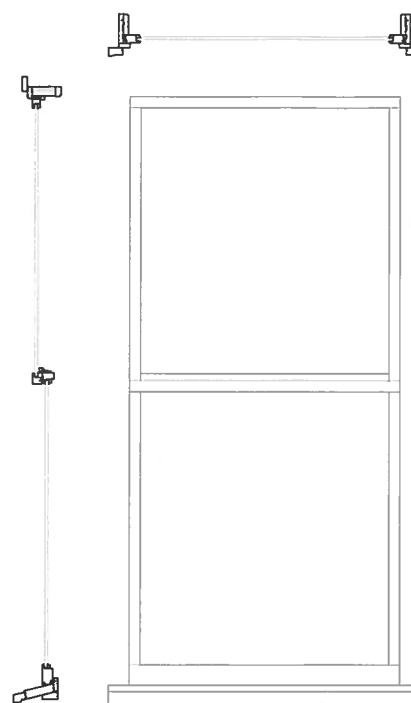
2 Wood Win. Dtl.
SCALE: 1" = 1'-0"

Horizontal Section

*WINDOW PROFILES AND SIZES TO MATCH EXISTING.

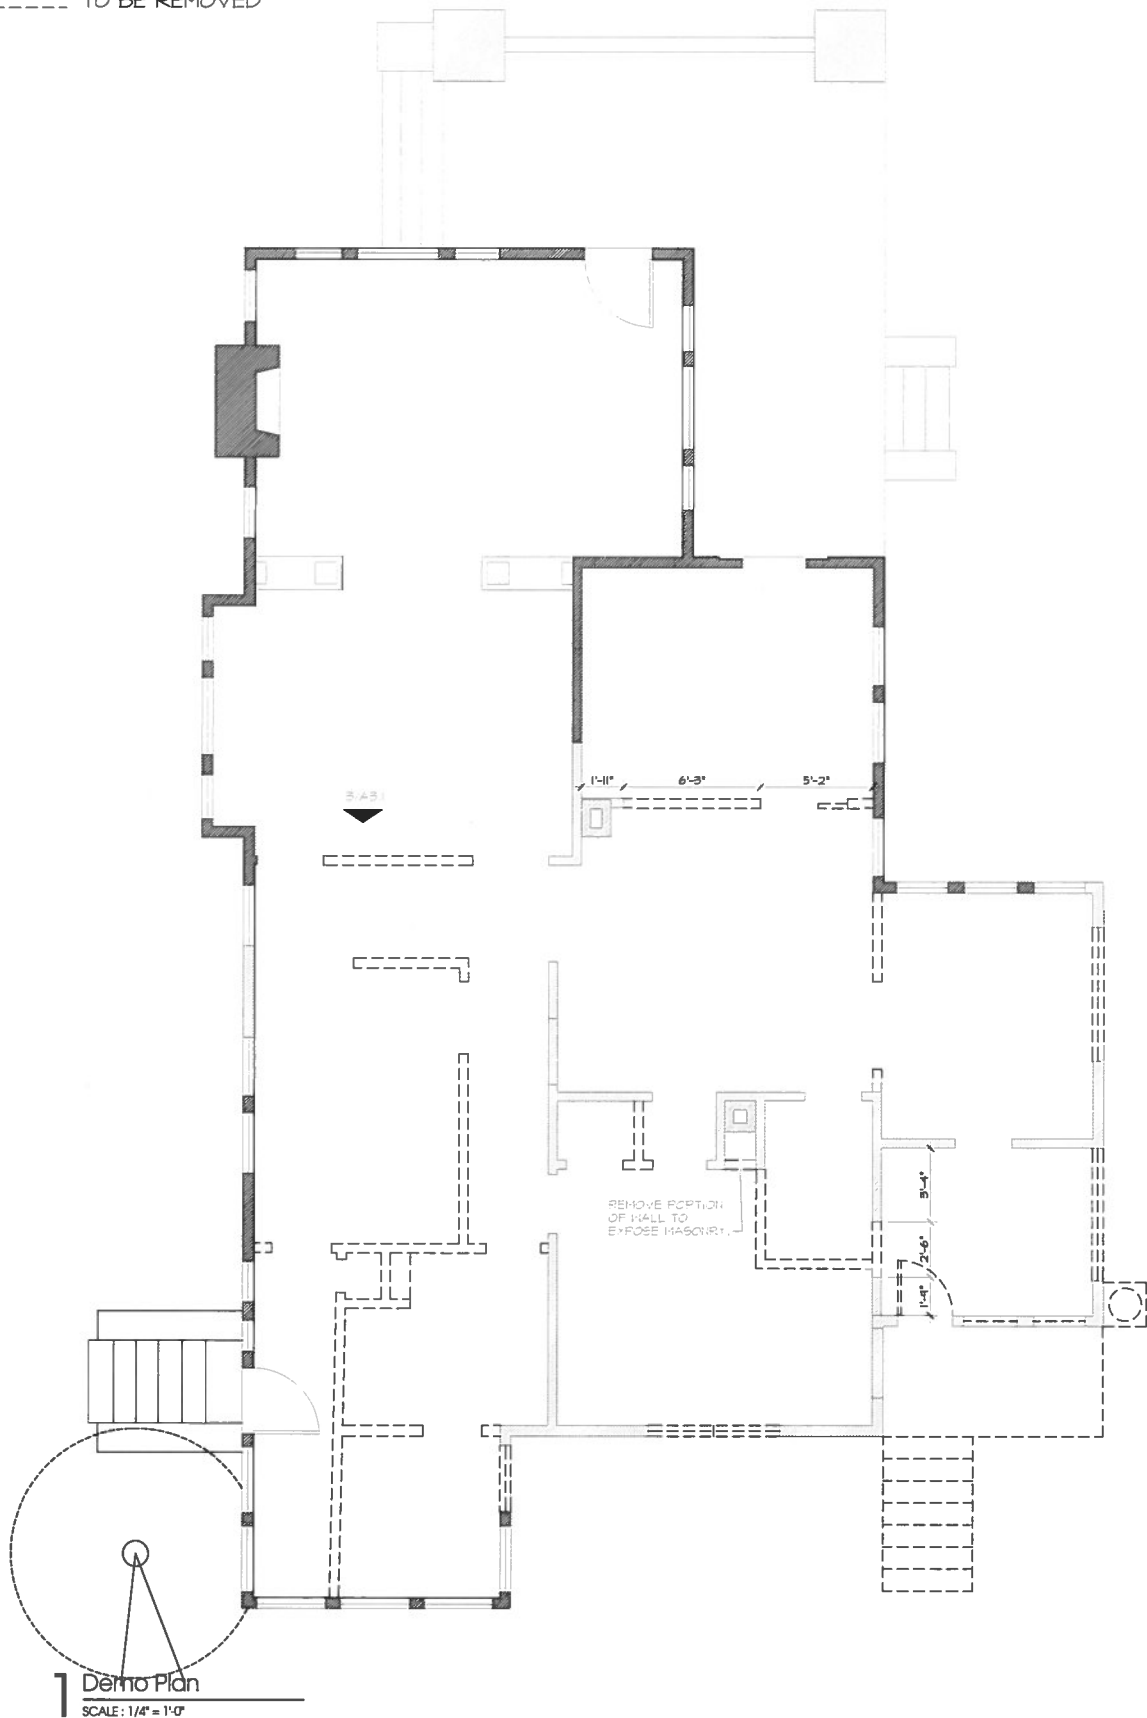
- A. PERMANENTLY CAP/RENDER SAFE ALL PLUMBING LINES AND UTILITIES NOT REUSED.
- B. MAINTAIN OPERATIONAL OF ALL EXISTING UTILITIES TO REMAIN. RELOCATE CONTROLS/SWITCHES AS NECESSARY, AS INDICATED.

----- TO BE REMOVED
