HISTORIC AND DESIGN REVIEW COMMISSION

HDRC CASE NO: 2017-453
ADDRESS: 618 DAWSON ST NCB
LEGAL DESCRIPTION: 569 BLK 17 LOT 5
ZONING: RM-4, H
CITY COUNCIL DIST.: 2
DISTRICT: Dignowity Hill Historic District
APPLICANT: Dustin Brisco
OWNER: Fulco Properties, LLC
TYPE OF WORK: Exterior modifications, rehabilitation
APPLICATION RECEIVED: August 28, 2017
60-DAY REVIEW: October 27, 2017
POSTPONED BY APPLICANT: November 26, 2017

The applicant is requesting a Certificate of Appropriateness for approval to:

- 1) Replace existing windows with wood one-over-one windows.
- 2) Install wood porch deck and rail over concrete porch.

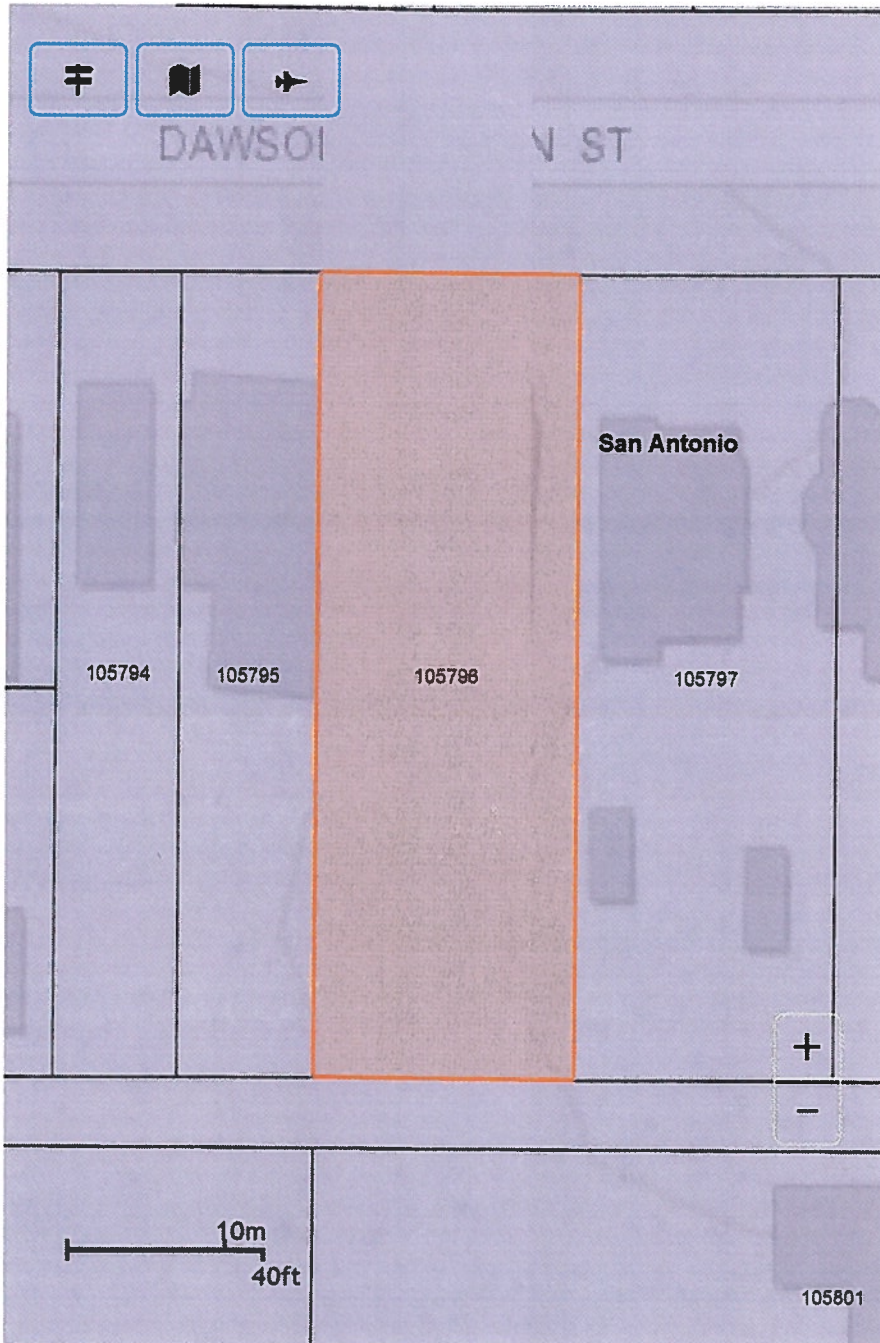
Specs for Proposed Repairs at 618 Dawson St.

Repair patio roof as needed

- Install new metal standing seam roof
- Reinforce and level the roof where it is rotted and sagging down
- Leave existing columns or replace with new columns that have the same dimensions (8 ½ feet tall)

Build New Deck over concrete

- Raise right and left side of deck to a height of 3ft to be level with the middle section in front of the door.
- Go over existing steps with wood steps-yellow pine
- Use 2x6 treated wood to build a new deck that is 3 feet off the ground with stucco skirting (gray-natural) */or use 2x6's to match decking /or siding to match house*
- Stain Wood to keep natural color
- Deck will be 3 feet from the ground and be level with the floor in the house.
- Deck will have 3ft yellow pine wooden balusters
- Dimensions are 2.75 inches x 32.25 inches x 6ft.
- Deck will have 1x3 yellow pine for the top of the railing
- New Porch will be built 2 feet off the ground

Add Transoms around Front Door

- add 12 inch wide, ¼ inch thick glass (non tinted) around the front door
- include 1x4 trim around glass (5 ft x 12 inches-top of door), (7ft x 12 inches-left and right side of door)

Window Trim

- add 1x6 window trim around all windows (yellow pine)

- d. PORCH – The applicant has proposed to install a new wood deck over the existing front porch concrete slabs and steps. The existing concrete porch has begun separating from the concrete foundation of the historic structure and is uneven in respect to the front doorway. The proposed deck would level the front porch to the front door, approximately 3 feet from grade. The deck would be constructed with 2x6 treated and stained lumber and feature 3 feet tall railing, wood steps, and wood skirting. Staff finds the proposed porch modifications consistent with the Guidelines for Exterior Maintenance and Alterations 2.7.B.i through v.
