HISTORIC AND DESIGN REVIEW COMMISSION

HDRC CASE NO: 2017-609
ADDRESS: 130 W WOODLAWN
LEGAL DESCRIPTION: NCB 1860 BLK 1 LOT N 100 FT OF 1 & 2
ZONING: R-4 H
CITY COUNCIL DIST.: 1
DISTRICT: Monte Vista Historic District
APPLICANT: Galvez Works LLC
OWNER: Andres Molina/Galvez Works LLC
TYPE OF WORK: Front porch modifications
APPLICATION RECEIVED: November 22, 2017
60-DAY REVIEW: January 21, 2018
REQUEST:

The applicant is requesting a Certificate of Appropriateness for approval to modify the existing front porch.

A CUSTOM PORCH DESIGN FOR
1300 W. WOODLAWN AVE.
SAN ANTONIO, TEXAS

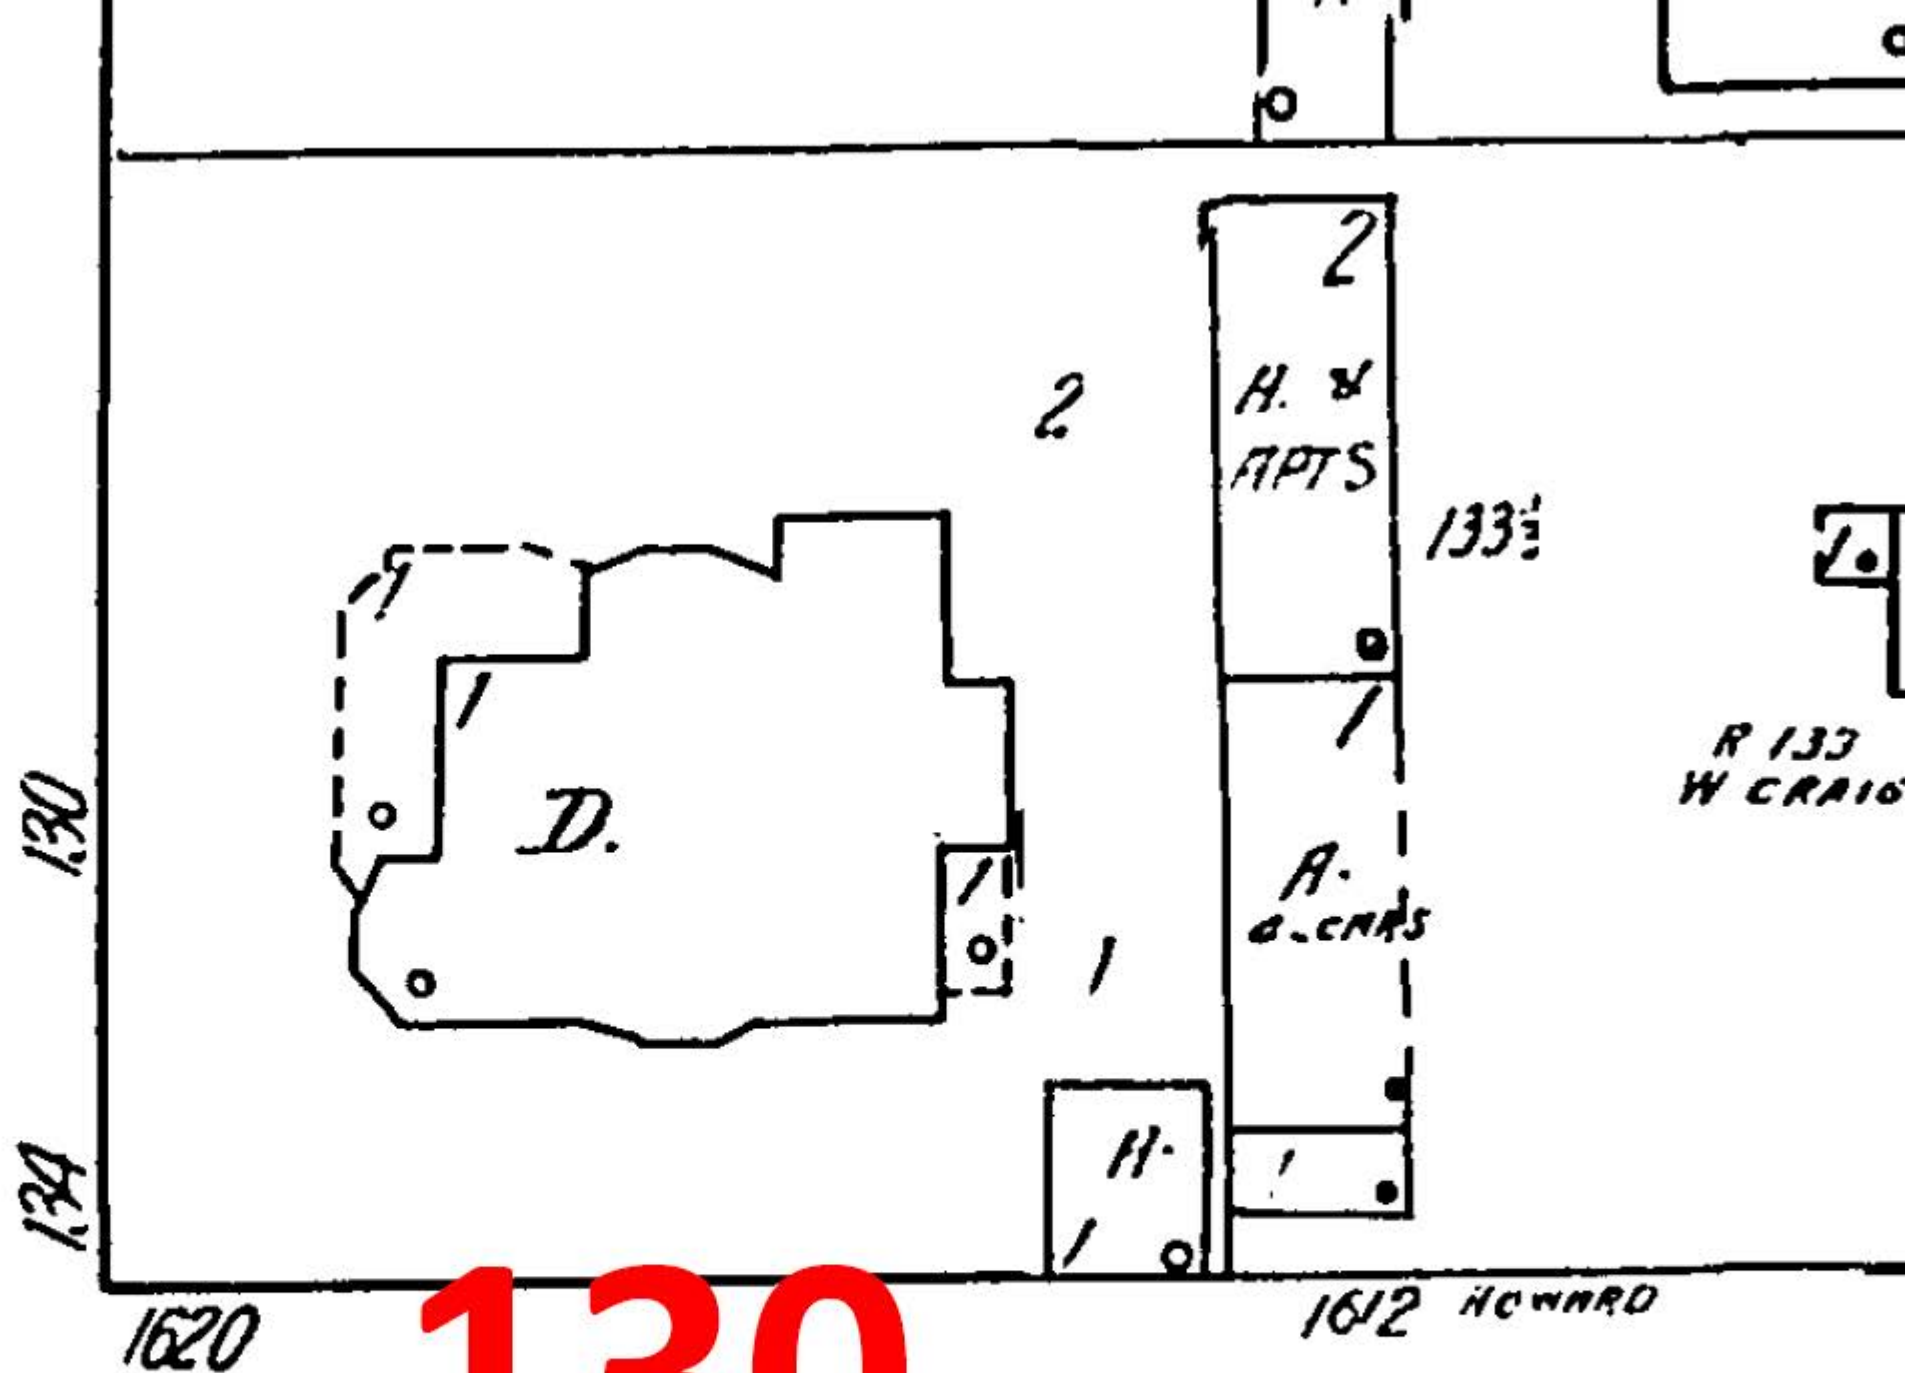
AV. MACADAMIZED.

130

10" W. PIPE

35'

188

Staff does not recommend approval based on finding b. Staff recommends that the applicant proposes a front porch roofline that is more compatible with the style of the structure and is based on historical evidence as seen in the Sanborn Maps.

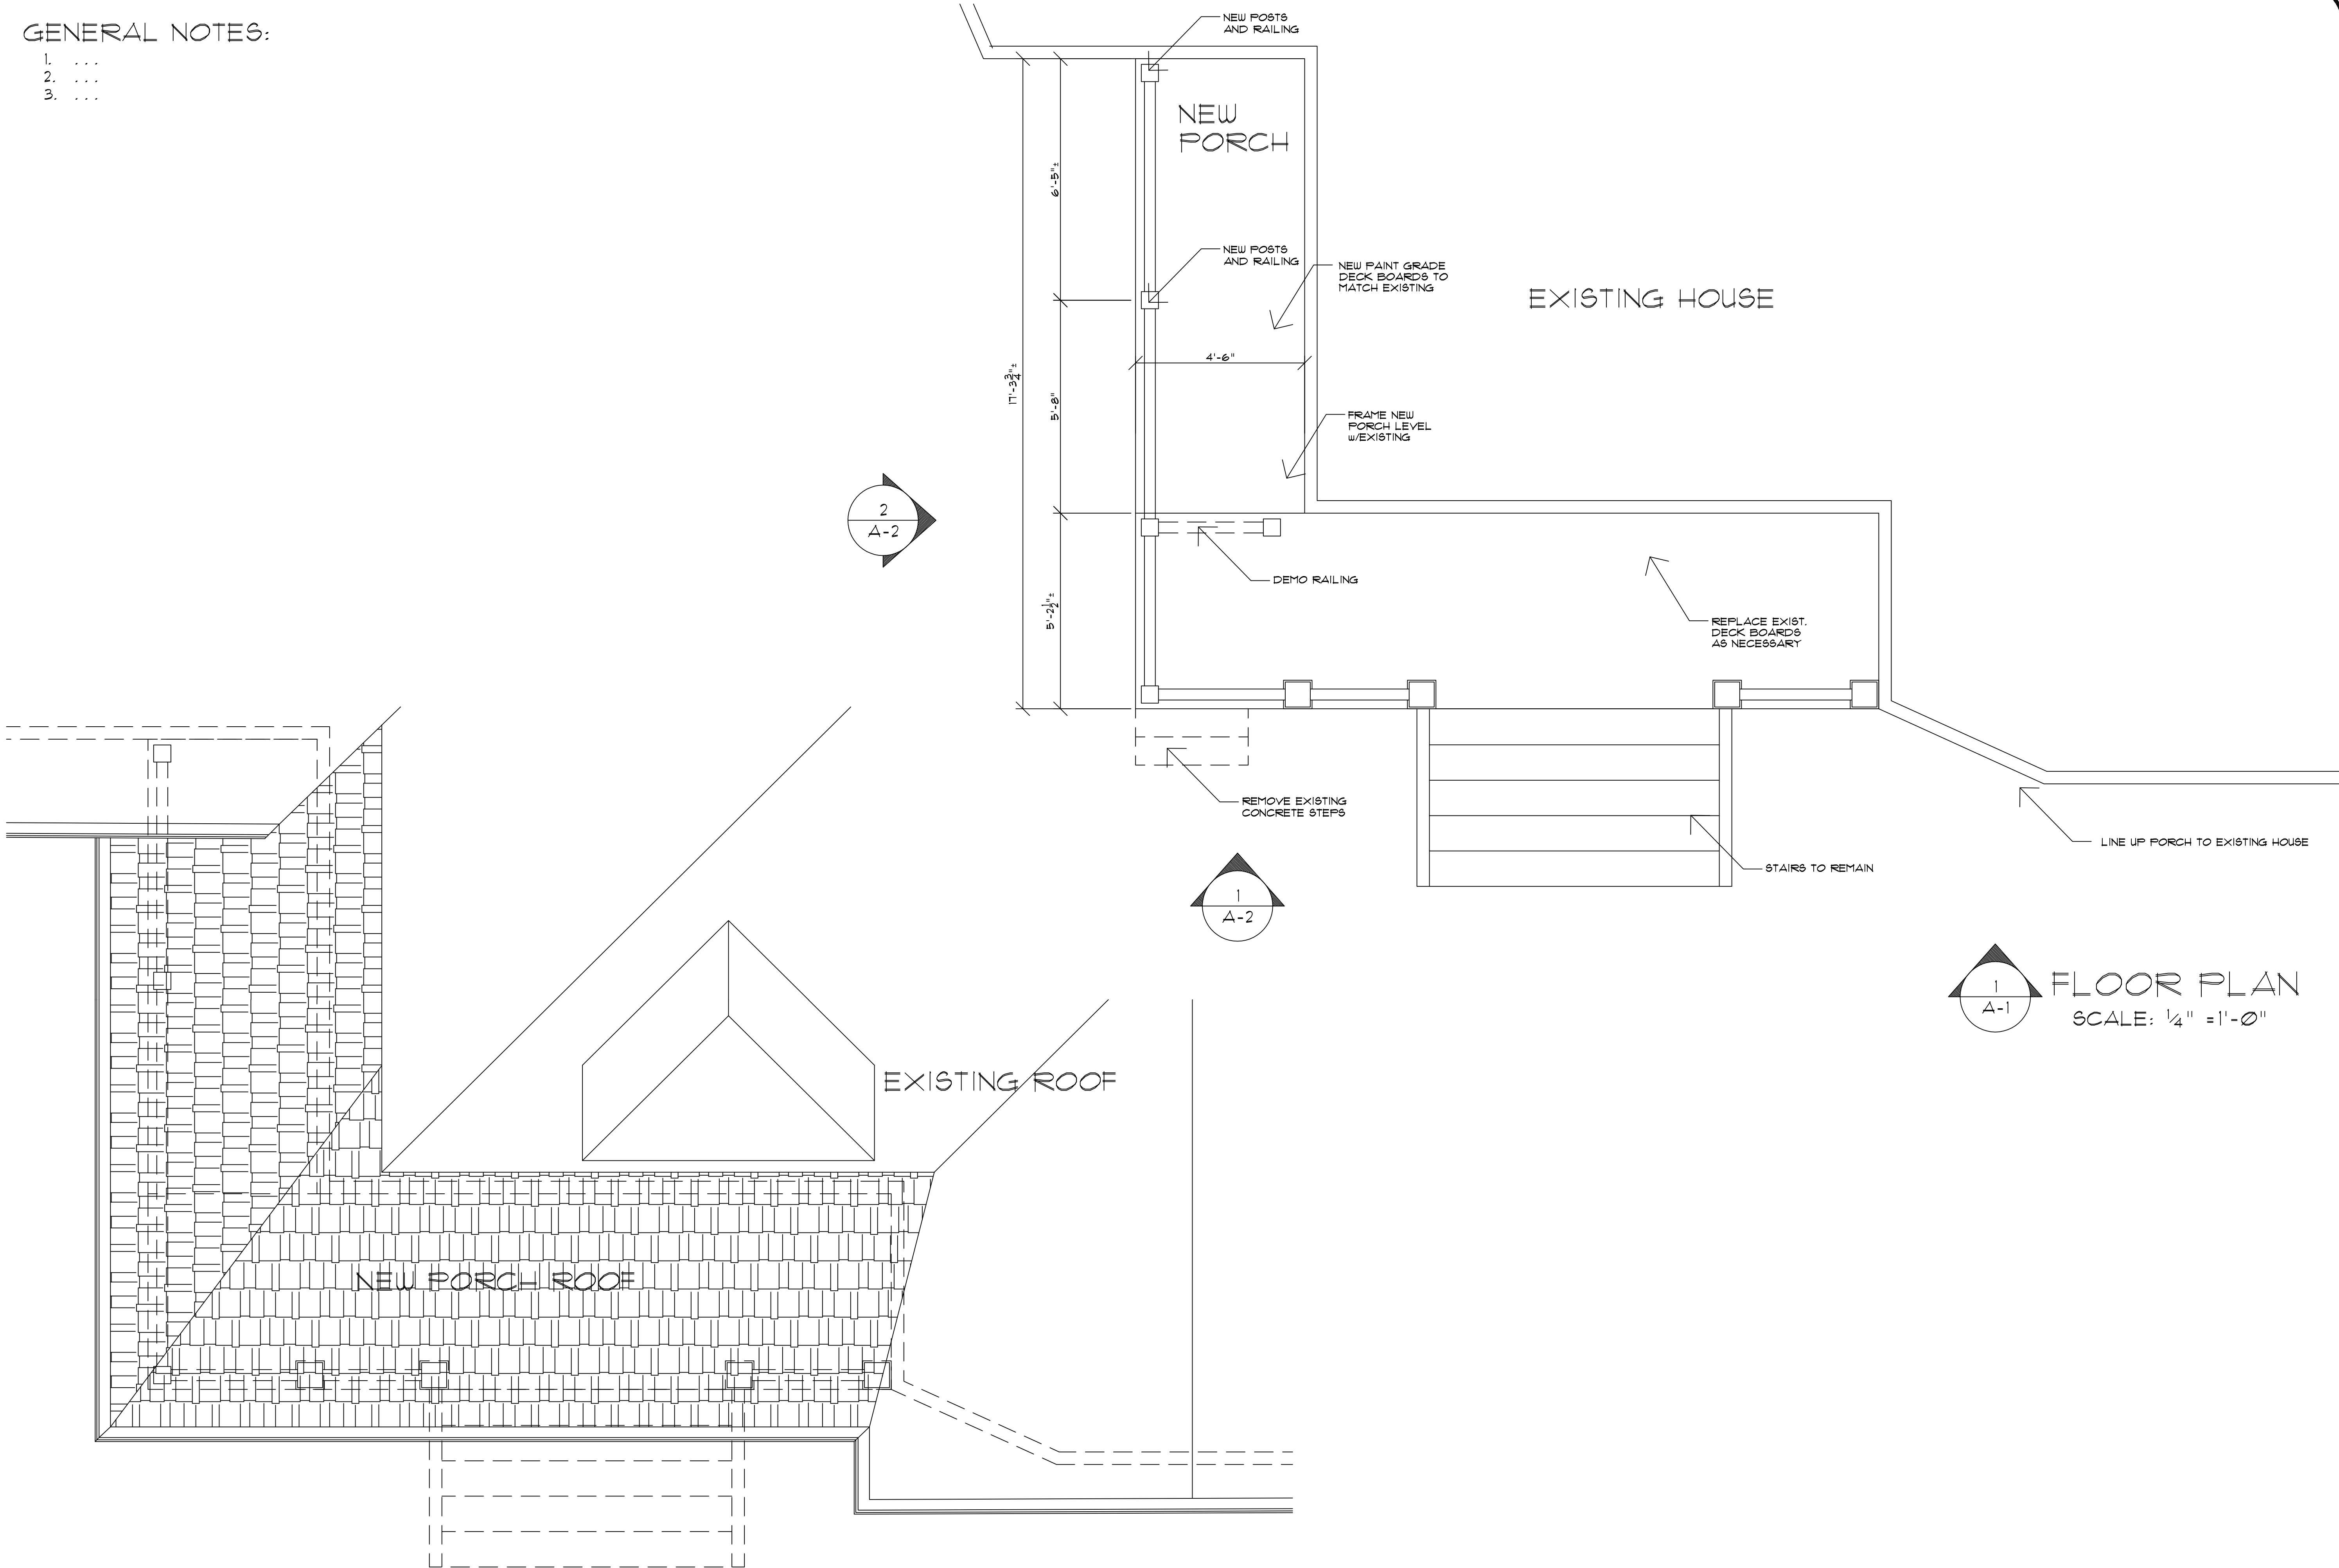
FLOOR PLAN
ROOF PLAN

FLOOR PLAN
SCALE: 1/4" = 1'-0"

ROOF PLAN
SCALE: 1/4" = 1'-0"

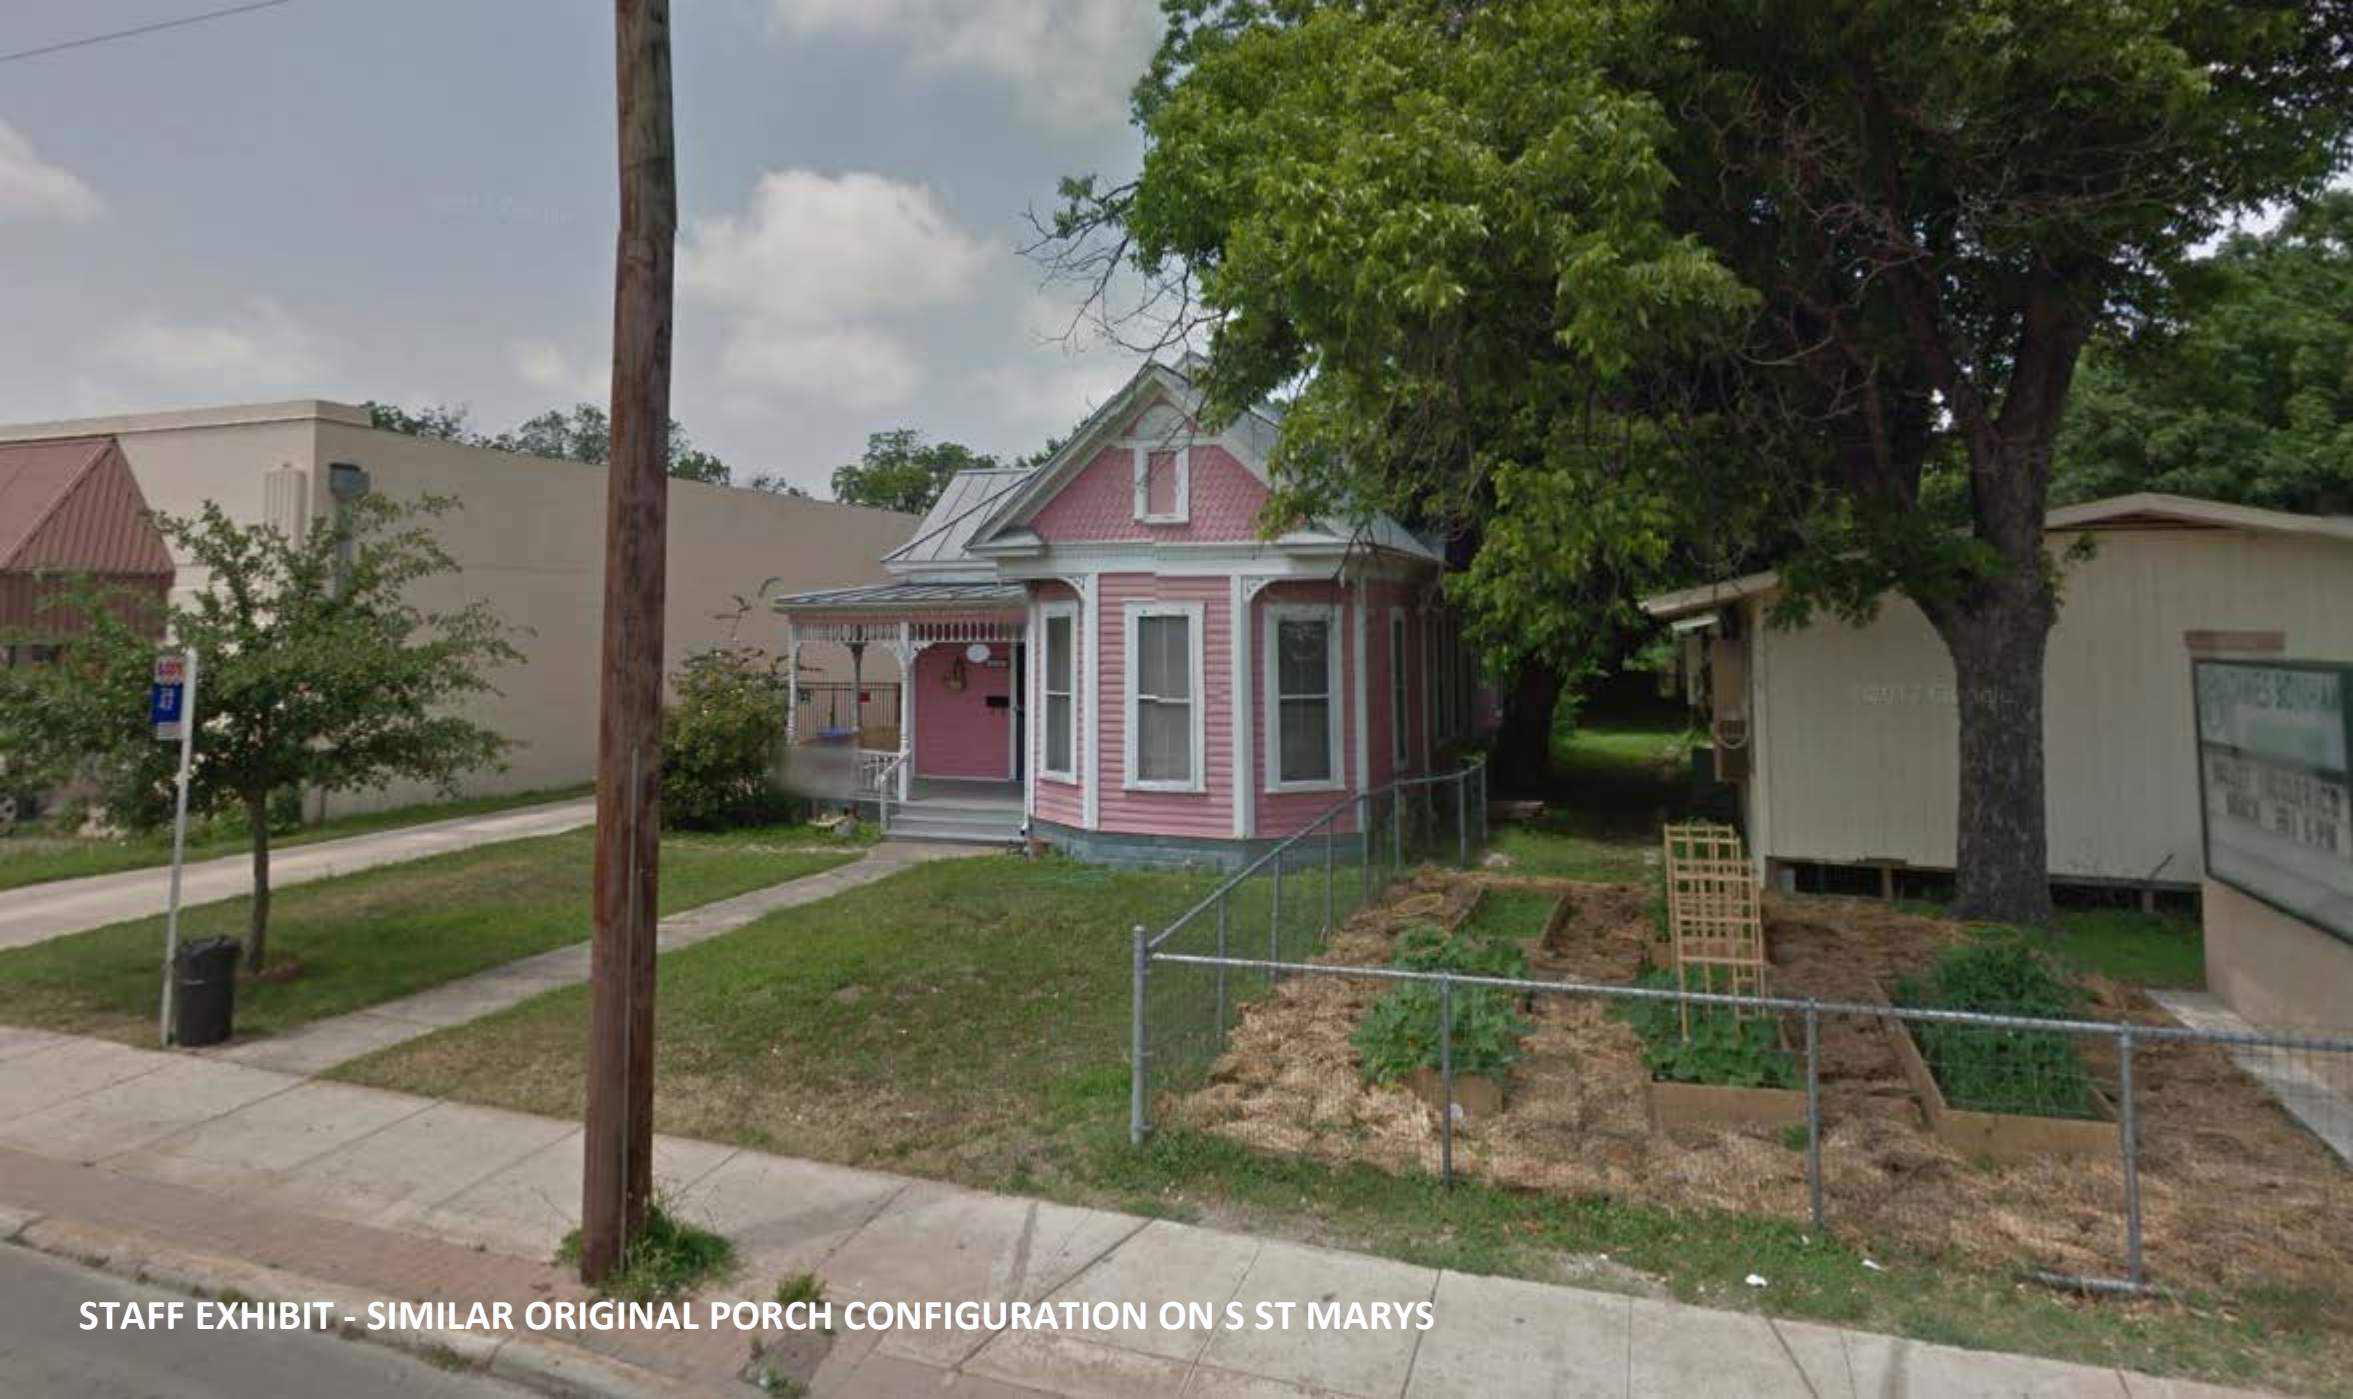
STAFF EXHIBIT - SIMILAR ORIGINAL PORCH CONFIGURATION ON S ST MARYS

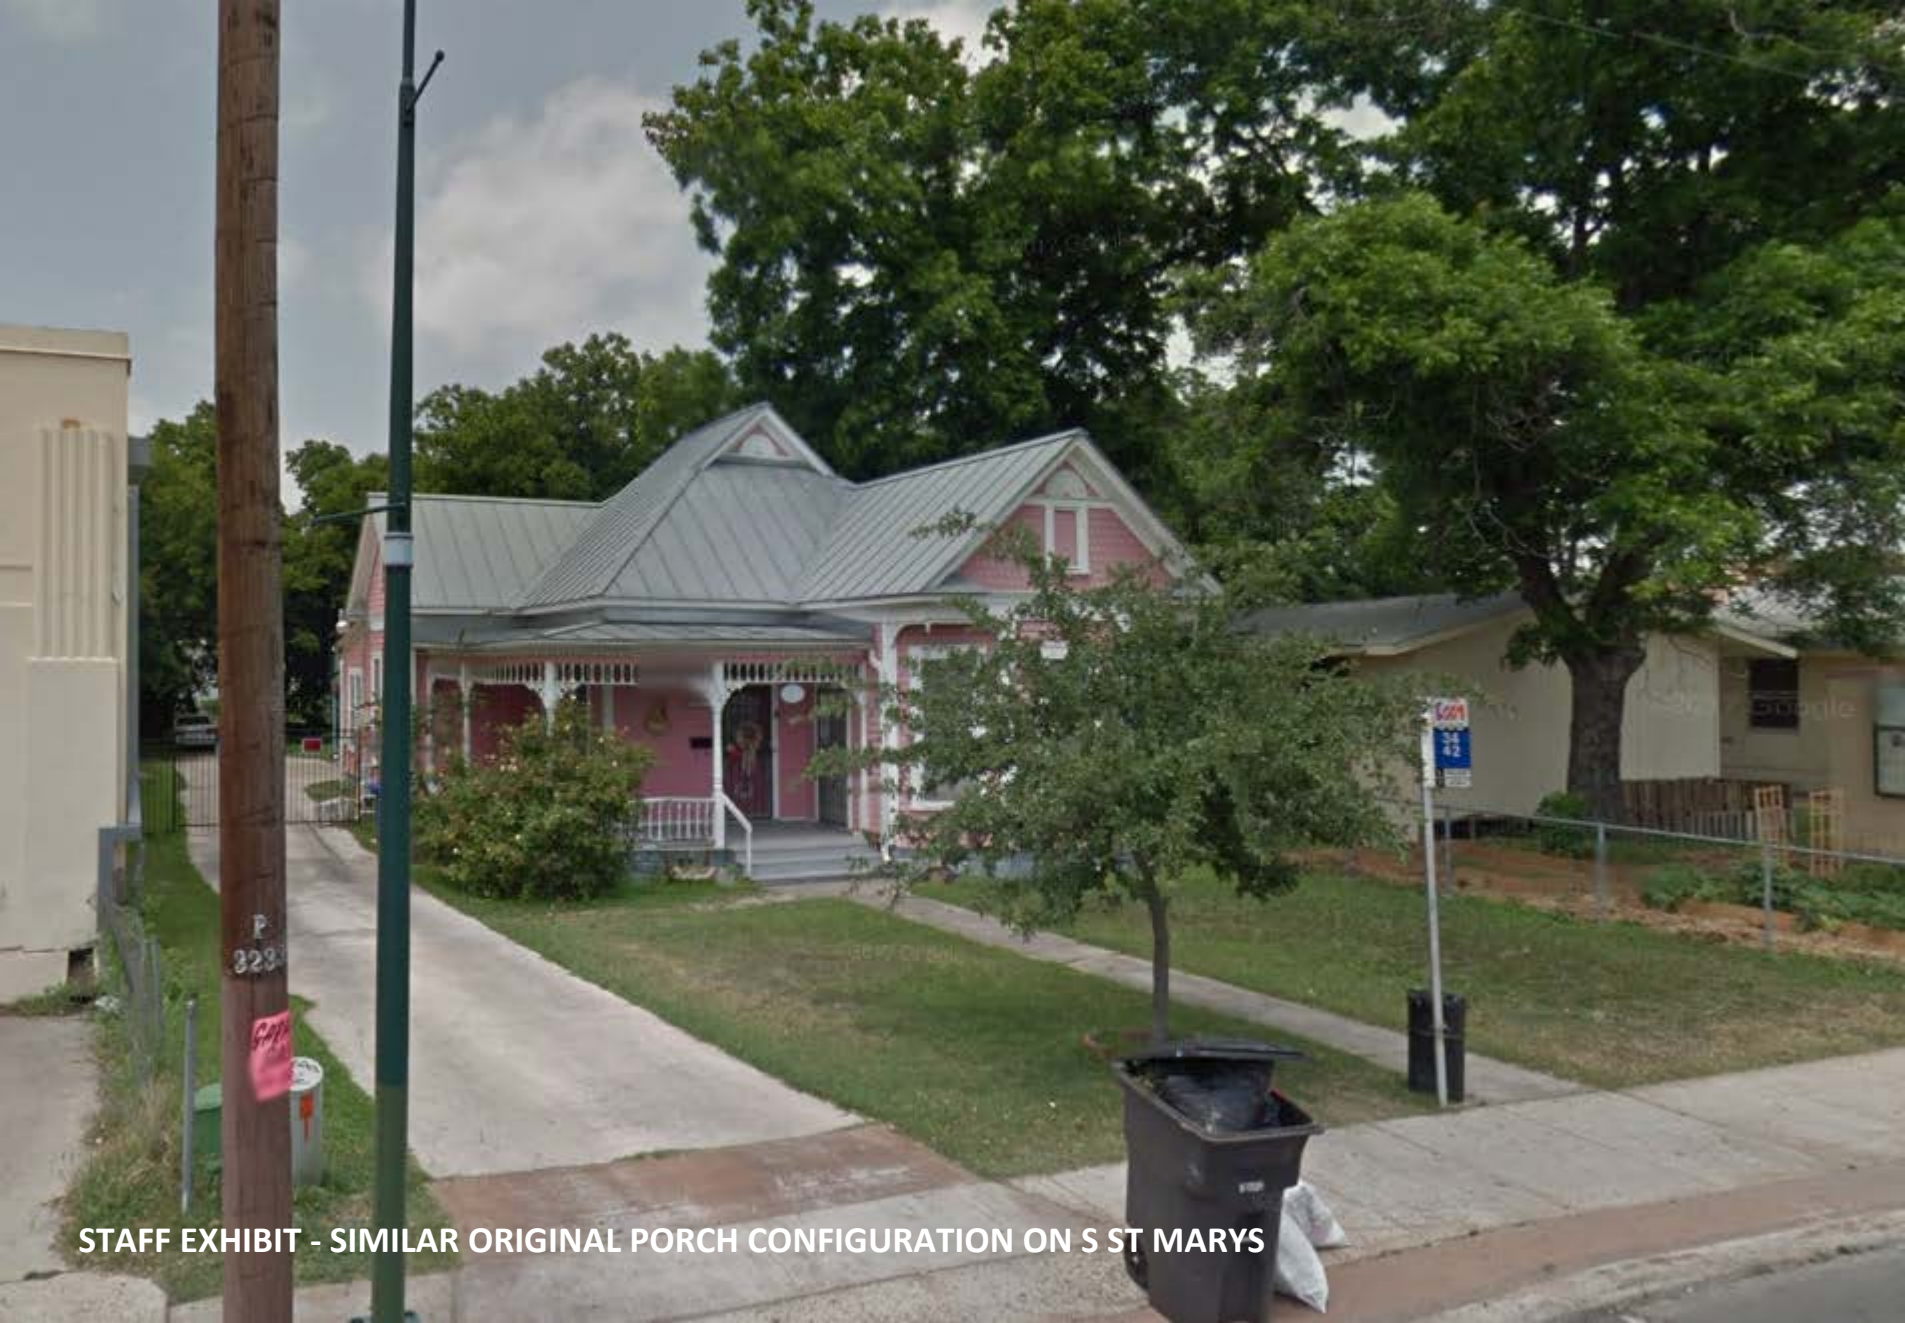
STAFF EXHIBIT - SIMILAR ORIGINAL PORCH CONFIGURATION ON S ST MARYS
