## HISTORIC AND DESIGN REVIEW COMMISSION

February 07, 2018

**HDRC CASE NO:** 2018-034  
**ADDRESS:** 121 BUFORD  
**LEGAL DESCRIPTION:** NCB 1369 BLK 6 LOT S 81.3 FT OF 5  
**ZONING:** R-4, H  
**CITY COUNCIL DIST.:** 2  
**DISTRICT:** Dignowity Hill Historic District  
**APPLICANT:** Ryan McWhirter/LUSH Greenscape Design  
**OWNER:** Chris H. Williams Laura Lopez  
**TYPE OF WORK:** Front yard site elements  
**APPLICATION RECEIVED:** January 17, 2018  
**60-DAY REVIEW:** March 16, 2018  
**REQUEST:**

The applicant is requesting a Certificate of Appropriateness for approval to:

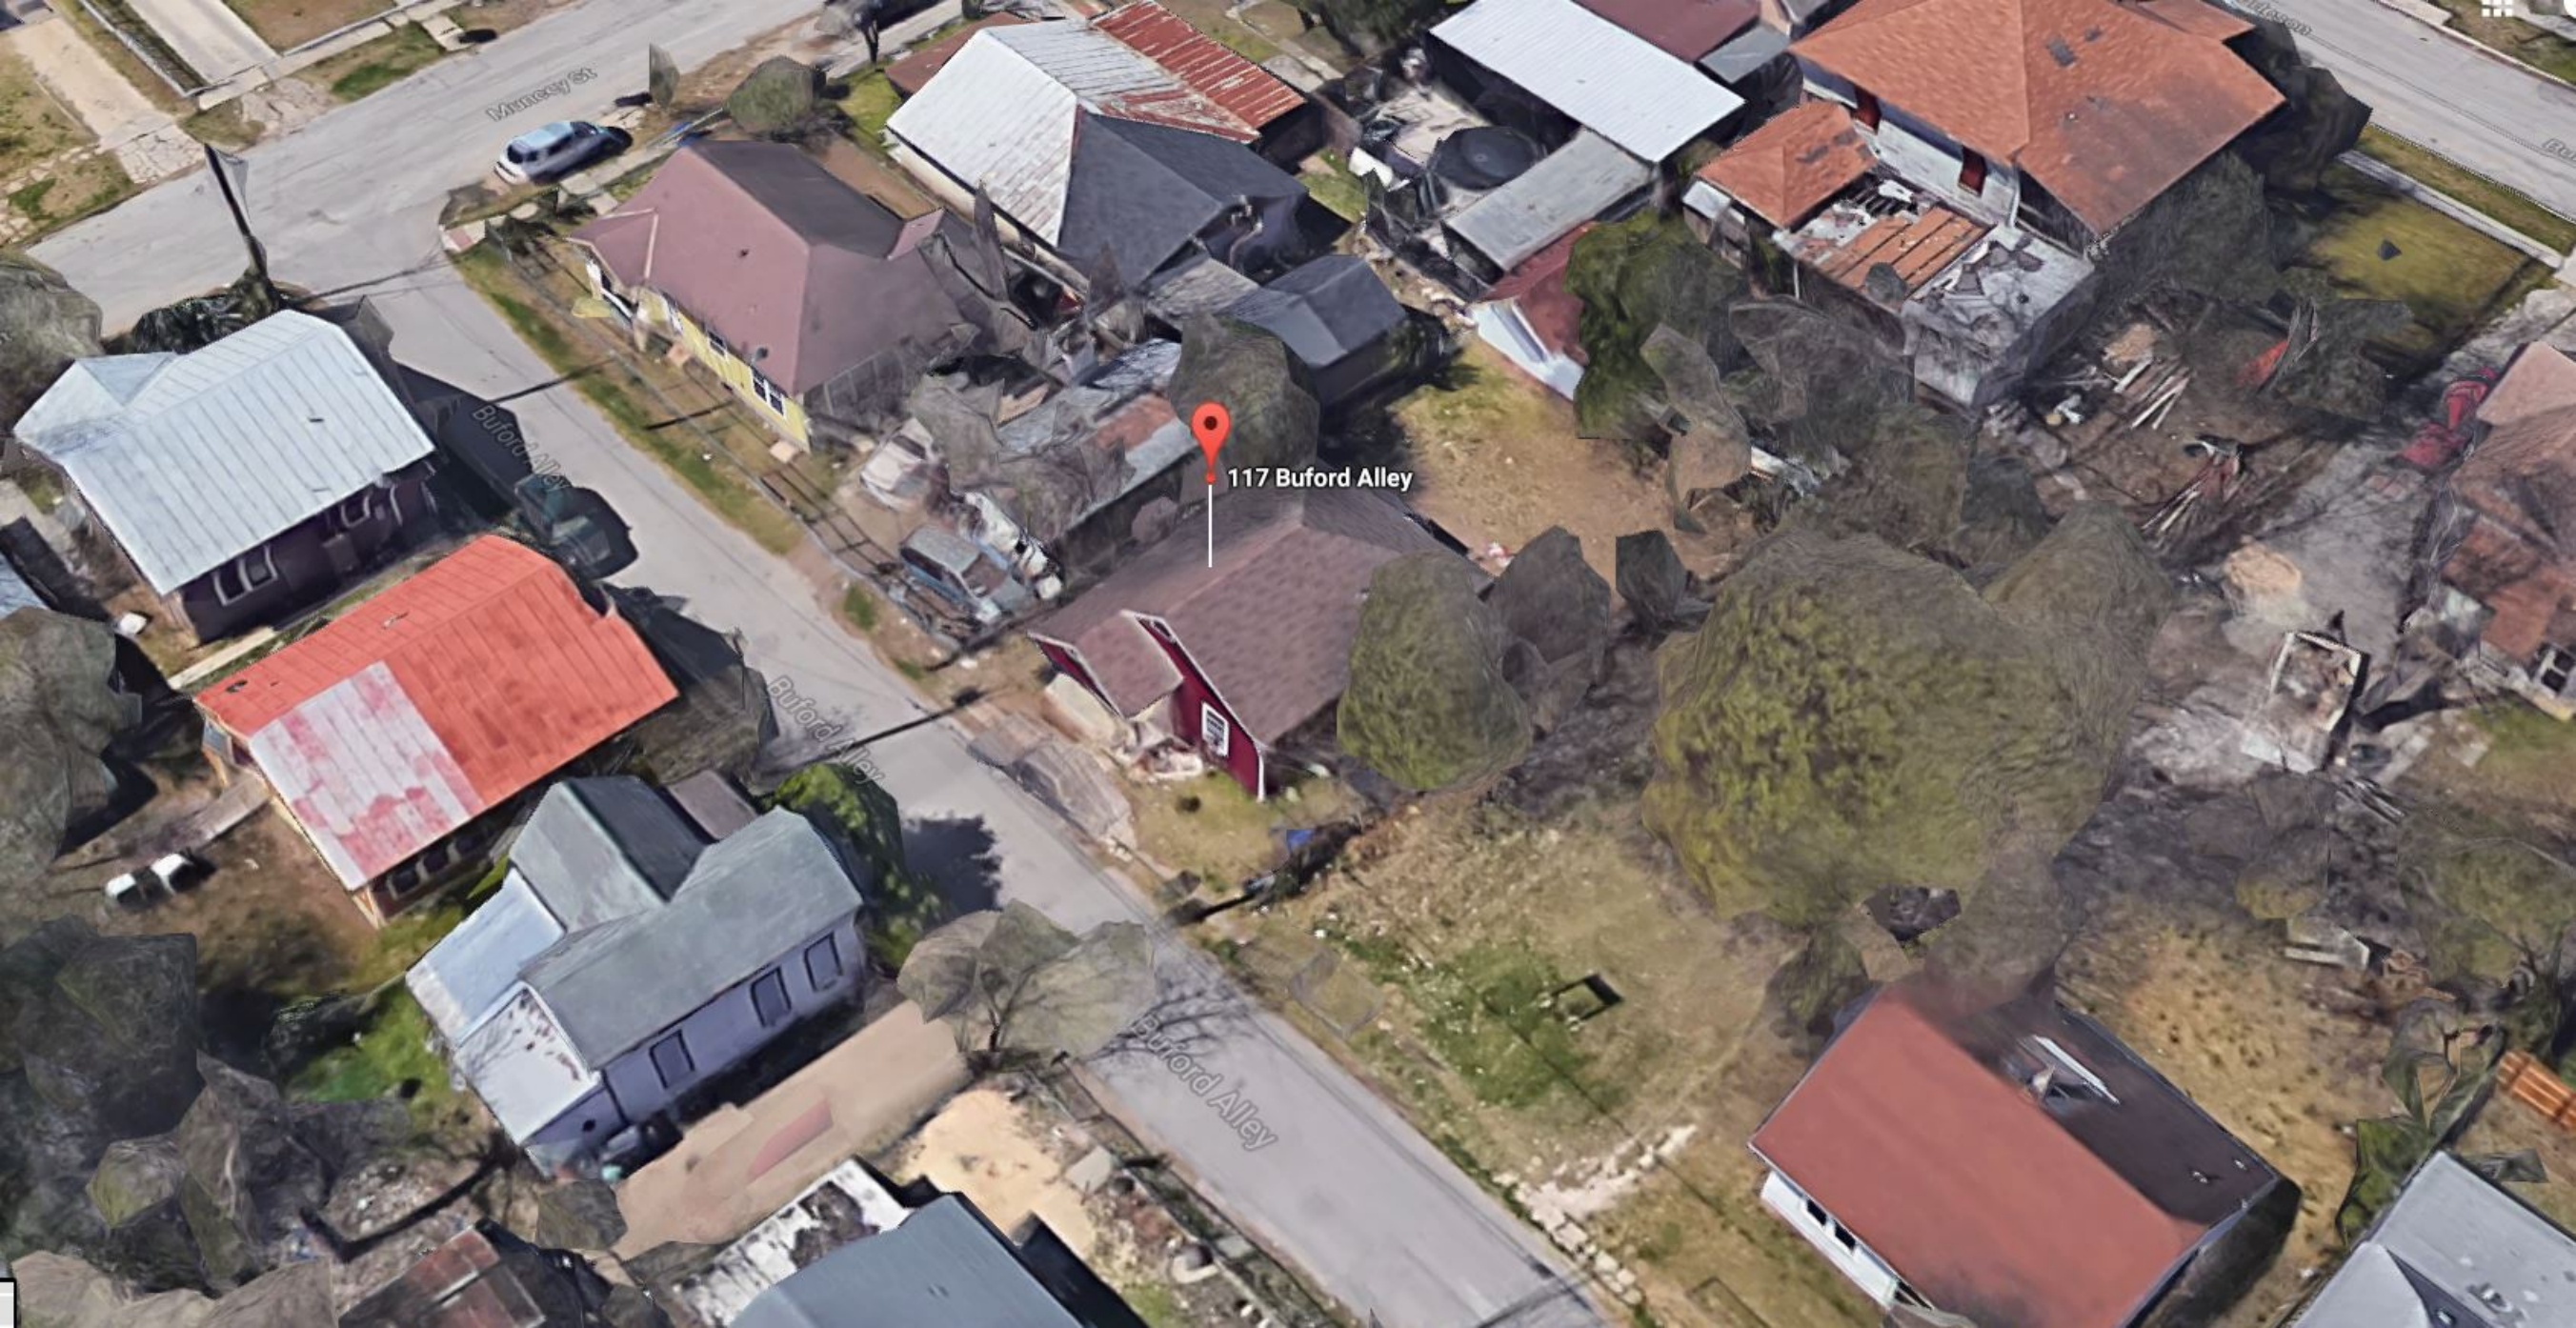
117 Buford Alley

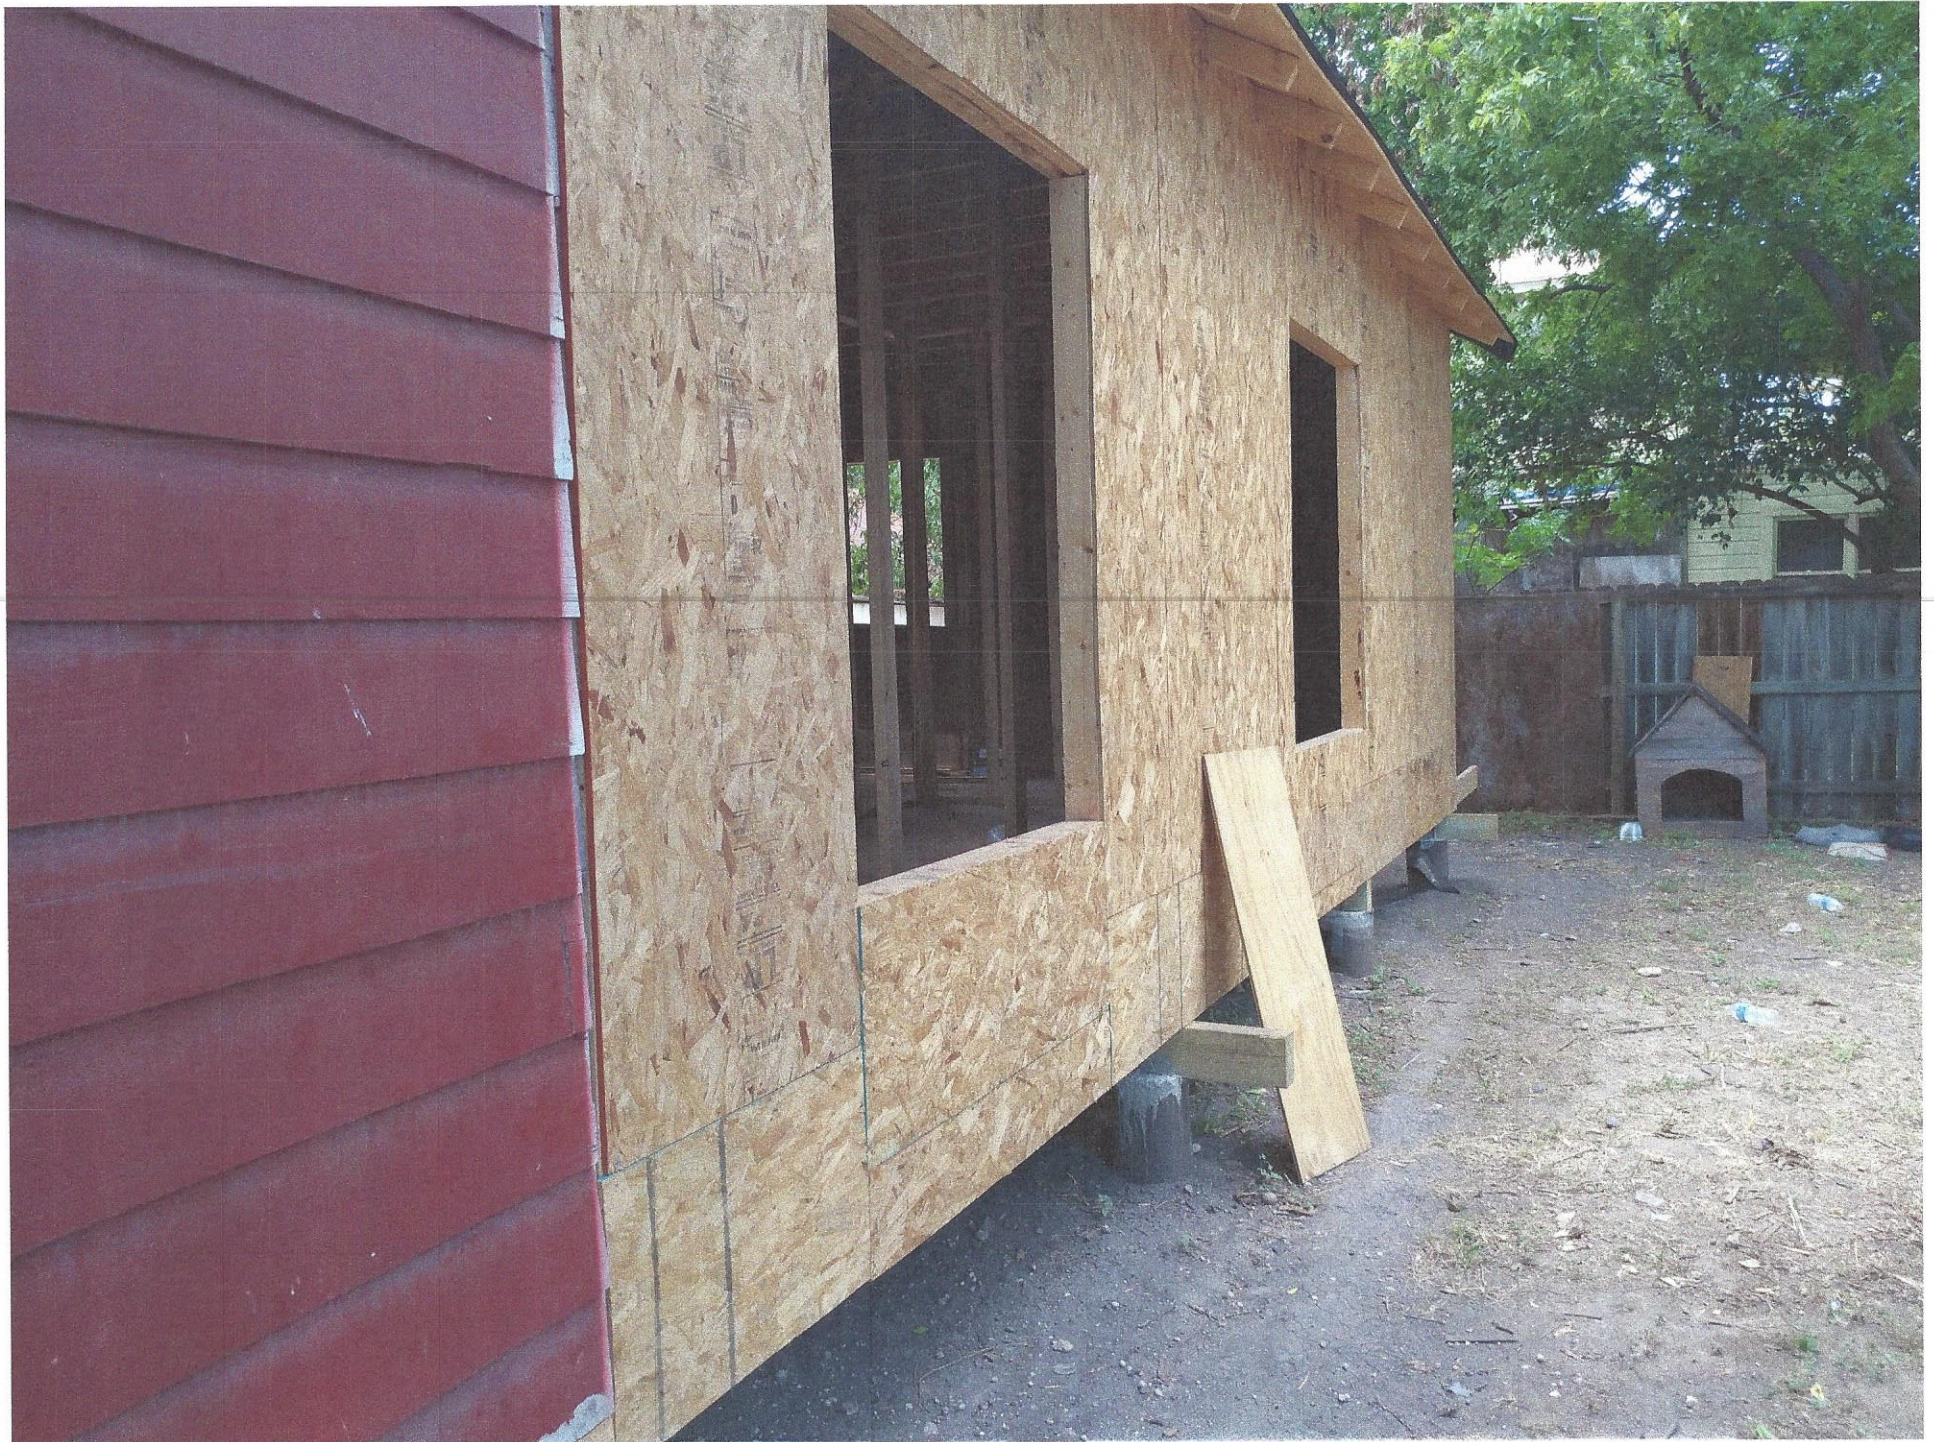
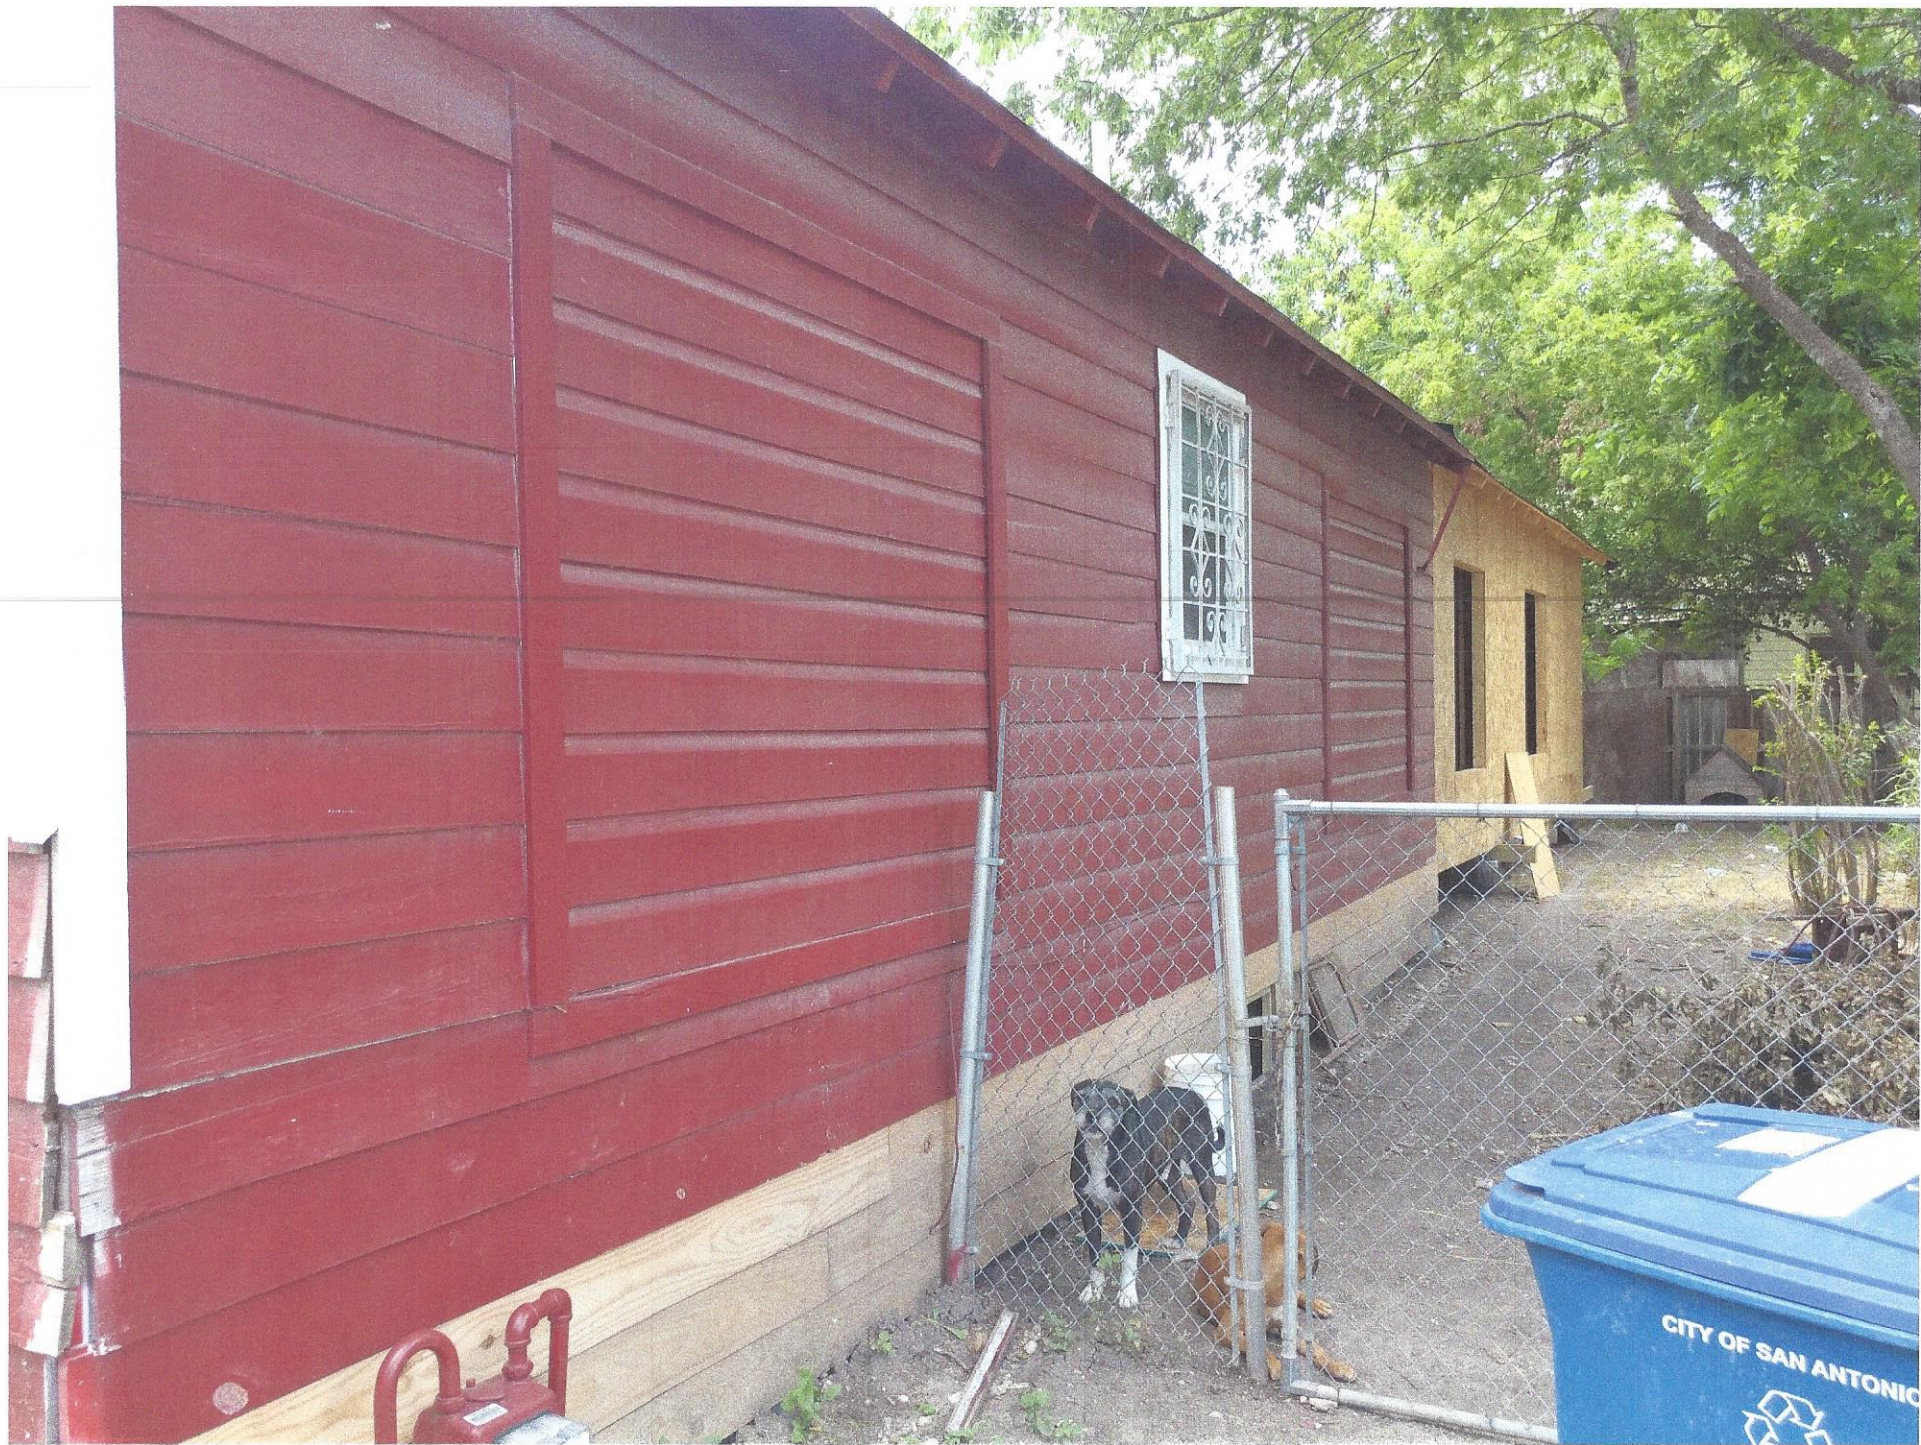
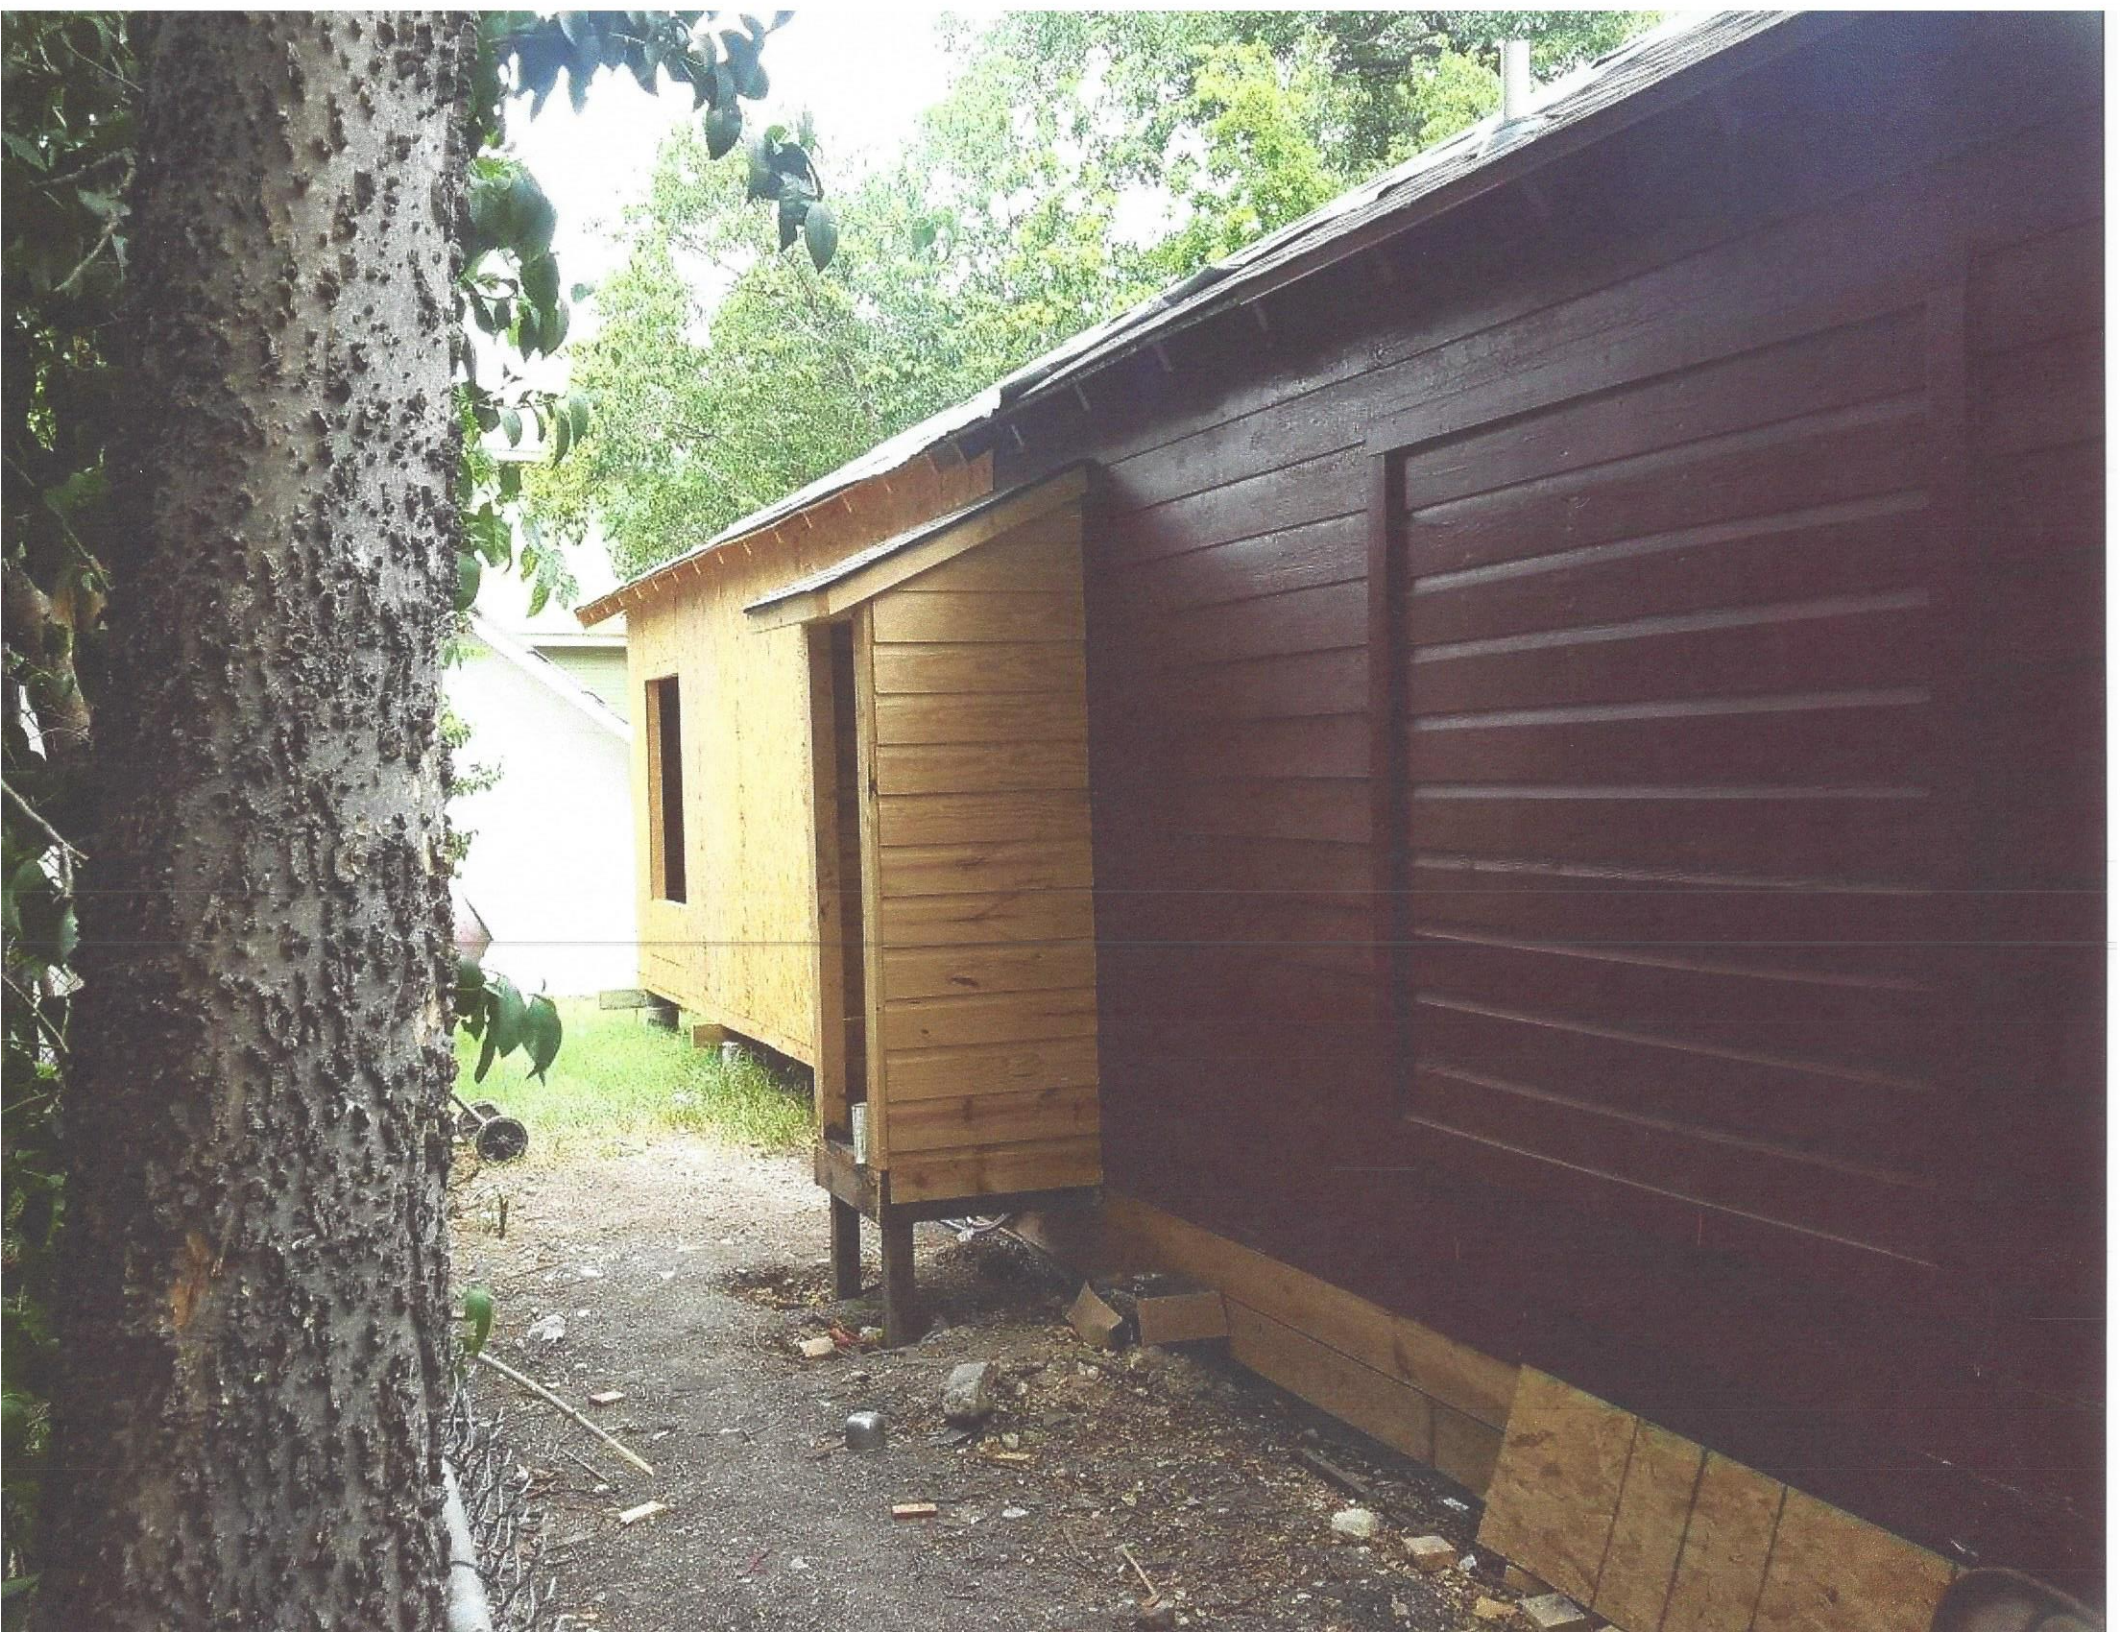
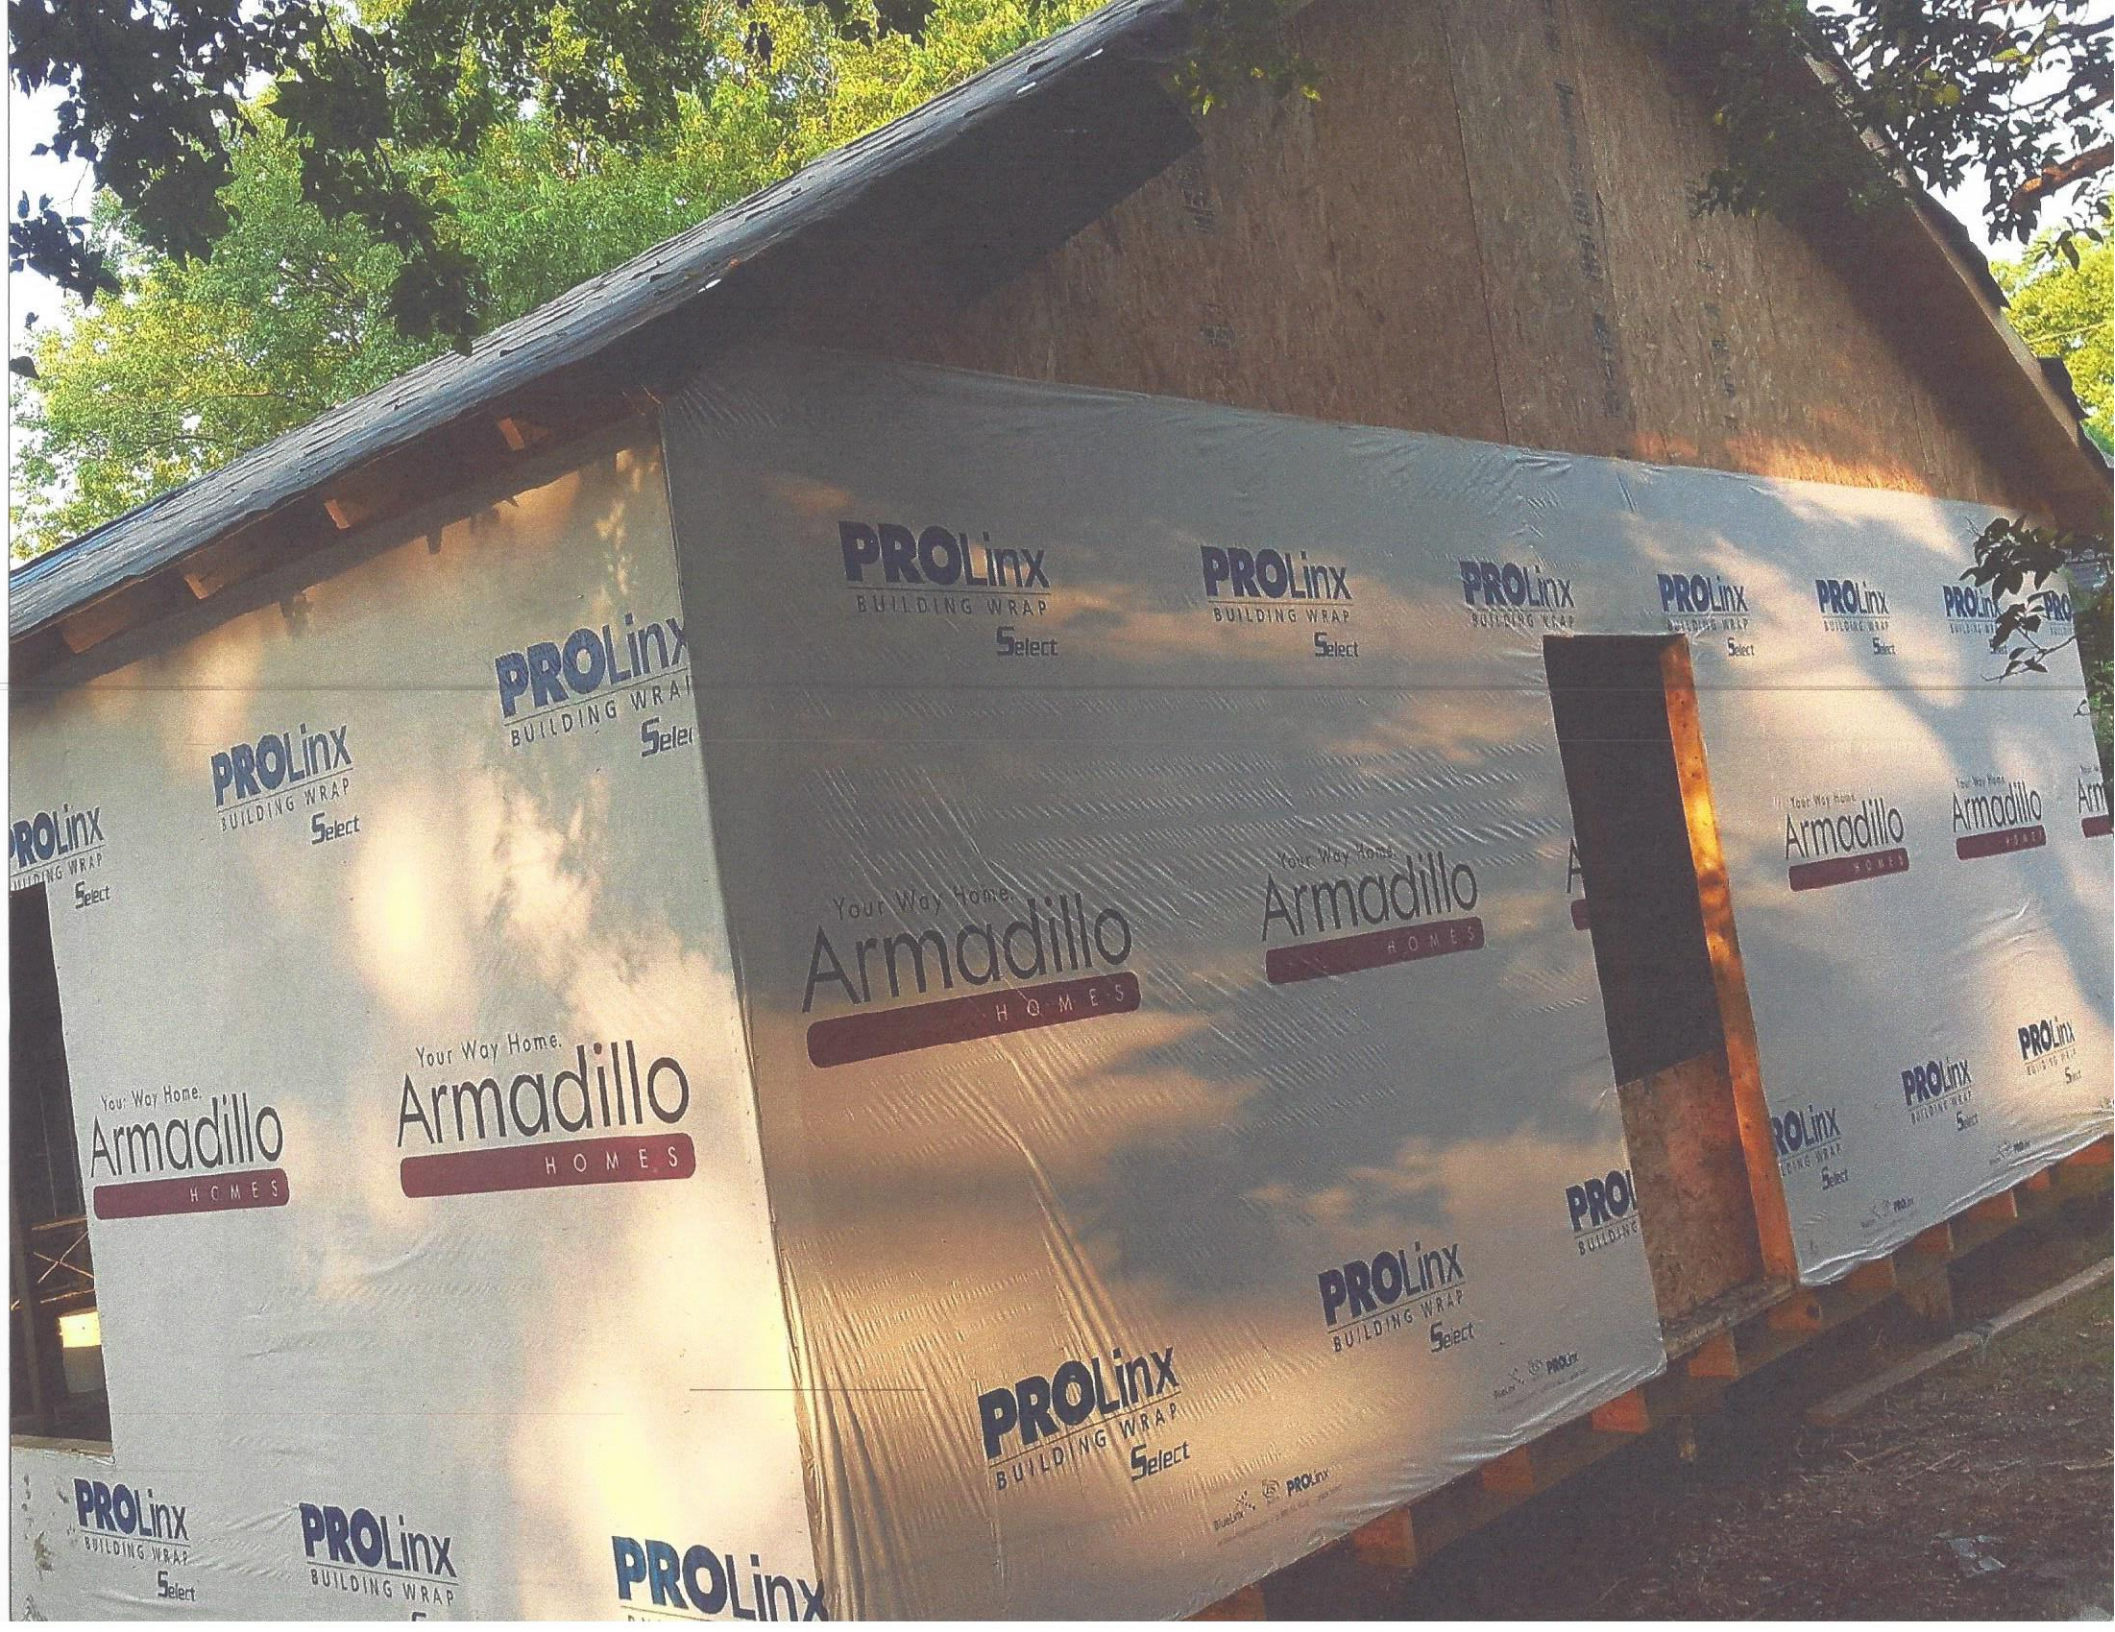
The construction would be of similar material. A pier foundation, plywood flooring, siding, a single tab roof shingle.

Existing house 29 ft

Addition 27 ft
