HISTORIC AND DESIGN REVIEW COMMISSION July 18, 2018

HDRC CASE NO:	2018-333
ADDRESS:	131 ADAMS ST
LEGAL DESCRIPTION:	NCB 931 BLK 1 LOT 15
ZONING:	RM-4, H
CITY COUNCIL DIST.:	1
DISTRICT:	King William Historic District
APPLICANT:	Beverly Bunn/Beaver Meadows II, LLC
OWNER:	Beverly Bunn, Beverly Bunn/Beaver Meadows II, LLC
TYPE OF WORK:	Installation of a mansard roof over an existing porch roof
APPLICATION RECEIVED:	June 25, 2018
APPLICATION RECEIVED:	June 25, 2018
60-DAY REVIEW:	August 24, 2018

The applicant is requesting a Certificate of Appropriateness for approval to remove the existing, front porch balcony railing and install a mansard roof featuring a black standing seam metal roof.

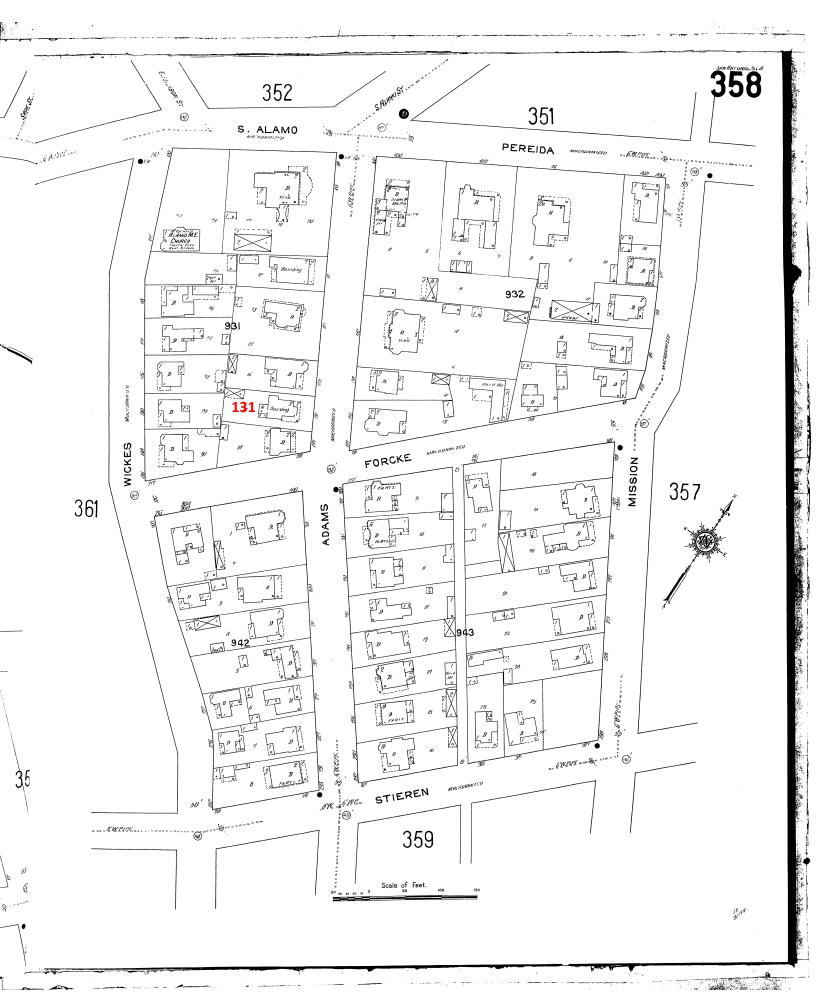
1912 SANBORN MAP NOTING ORIGINAL PORCH DESIGN

- a. The historic structure at 131 Adams was constructed circa 1910 and is found on the 1912 Sanborn Map. The structure originally featured a double height, wrap around front porch. The original design has been modified to its current state which includes a uniform front facade with a centered, entrance porch with balusters above the porch roof. These modifications which exist presently are found on the 1951 Sanborn Map.
