# HISTORIC AND DESIGN REVIEW COMMISSION

**HDRC CASE NO:** 2018-354  
**ADDRESS:** 402 CEDAR ST  
**LEGAL DESCRIPTION:** NCB 2966 BLK 1 LOT 6  
**ZONING:** RM-4, H  
**CITY COUNCIL DIST.:** 1  
**DISTRICT:** King William Historic District  
**APPLICANT:** Mark Hogensen  
**OWNER:** Mark Hogensen  
**TYPE OF WORK:** Exterior modifications, reconstruction of existing additions, replace porch decking, roof replacement  
**APPLICATION RECEIVED:** July 5, 2018  
**60-DAY REVIEW:** September 3, 2018  
**REQUEST:**

The applicant is requesting a Certificate of Appropriateness for approval to:

1. Reconstruct an existing laundry room and hot water heater closet addition on the west (Cedar Street) elevation.
2. Construct a front porch addition to include a new porch roof to match that found on the left side of the west elevation and perform front porch modifications.
3. Replace the existing porch decking with a composite decking material.
4. Replace the existing, asphalt shingle roof with a standing seam metal roof.

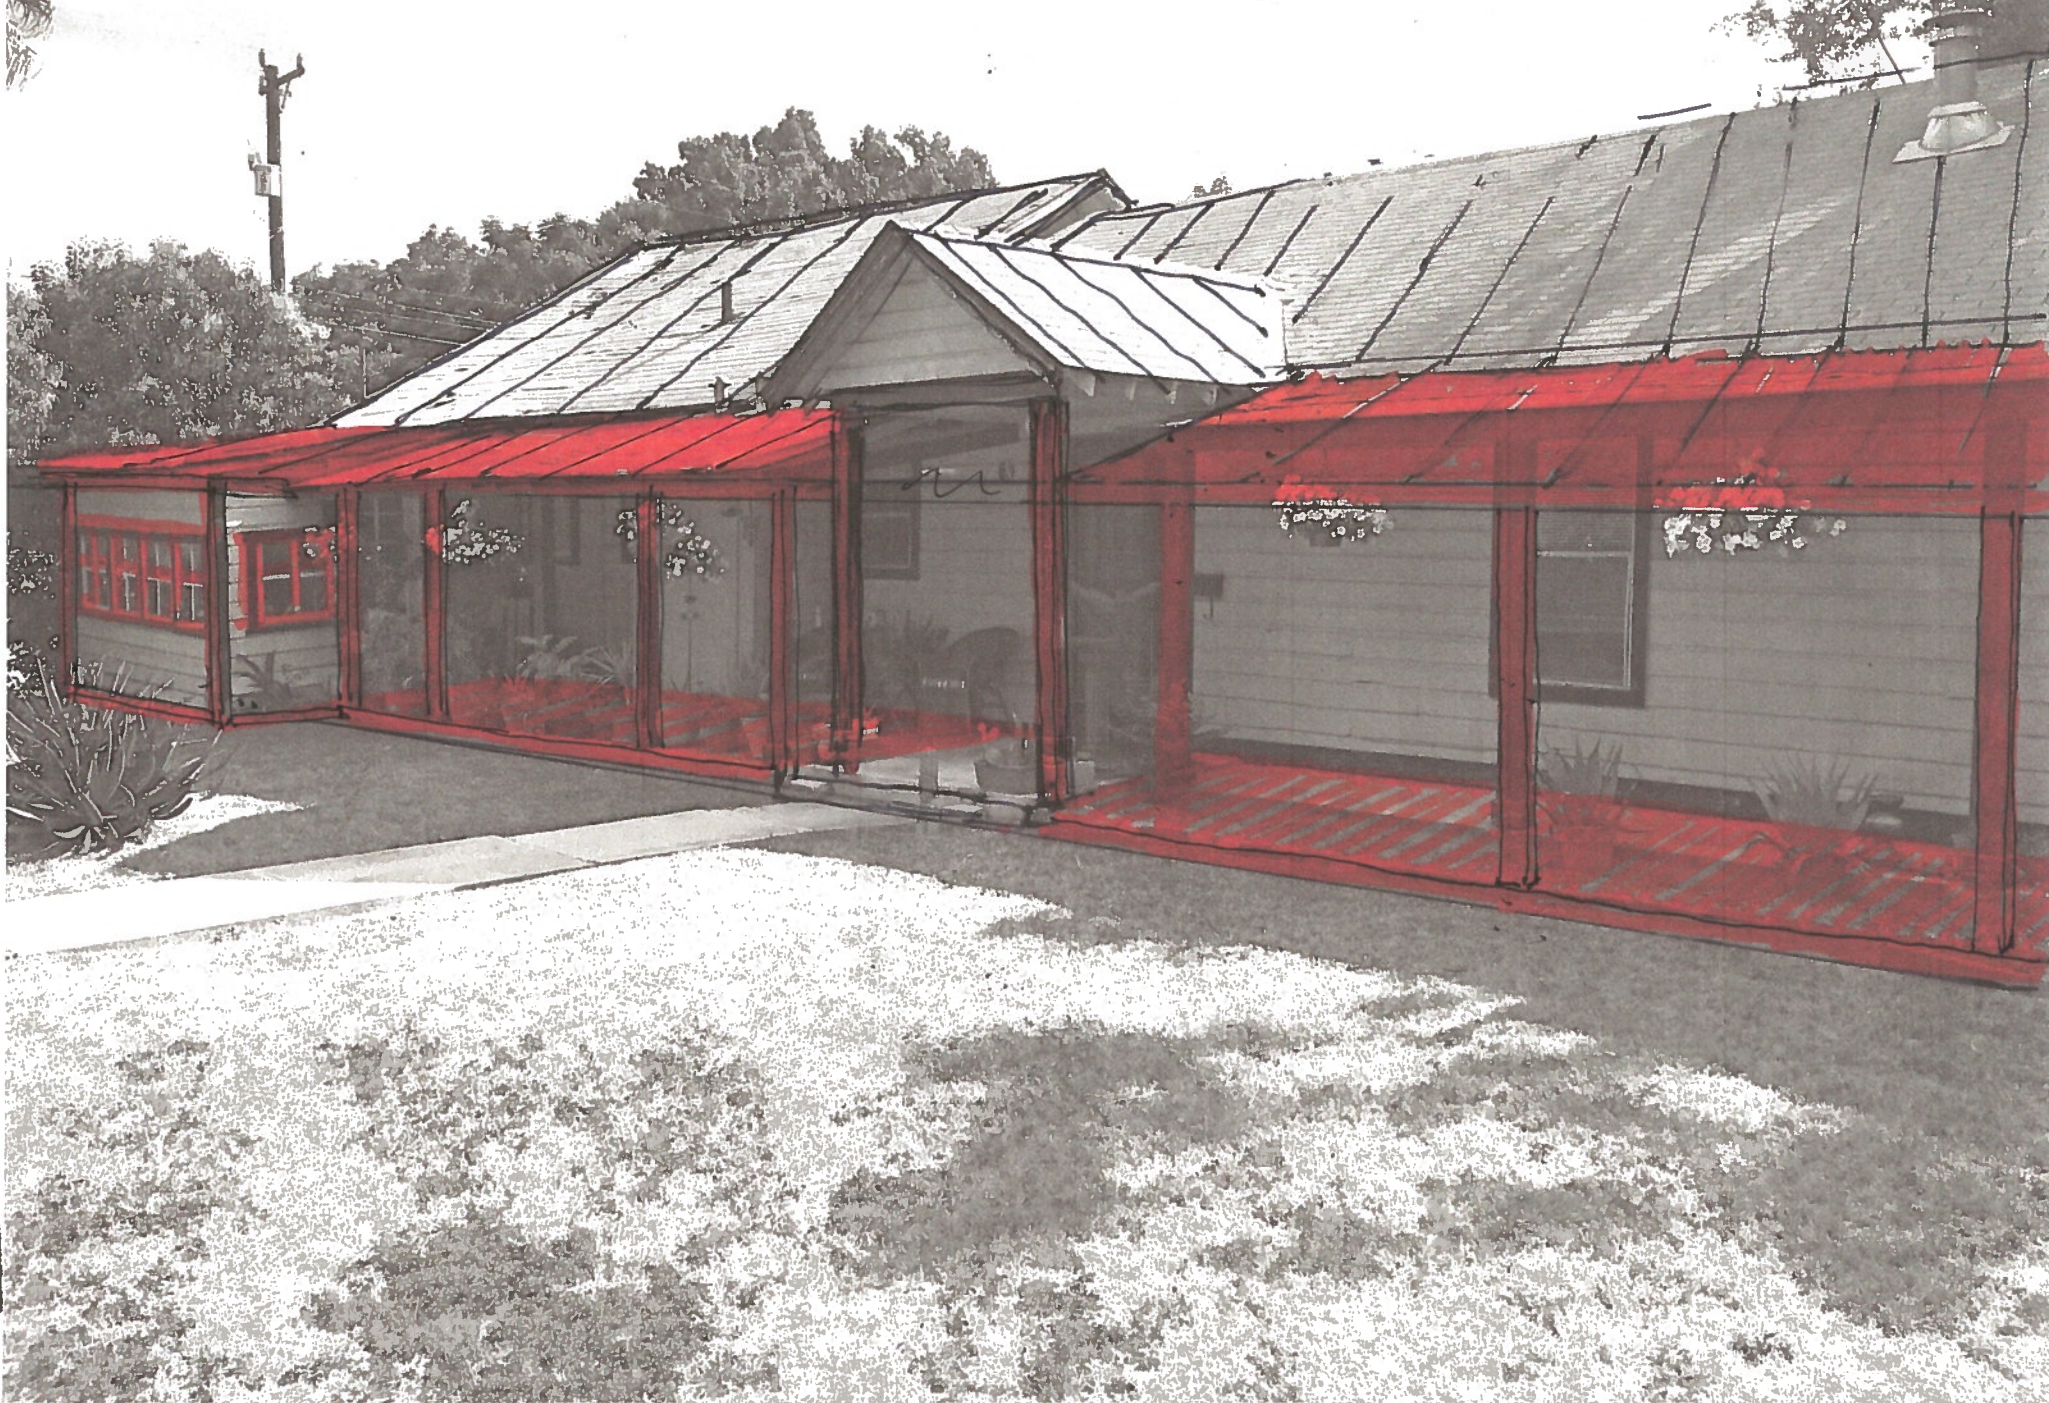
LAUNDRY ROOM  
EXISTING ELEVATIONS

402 CEDAR  
HOGENSEN

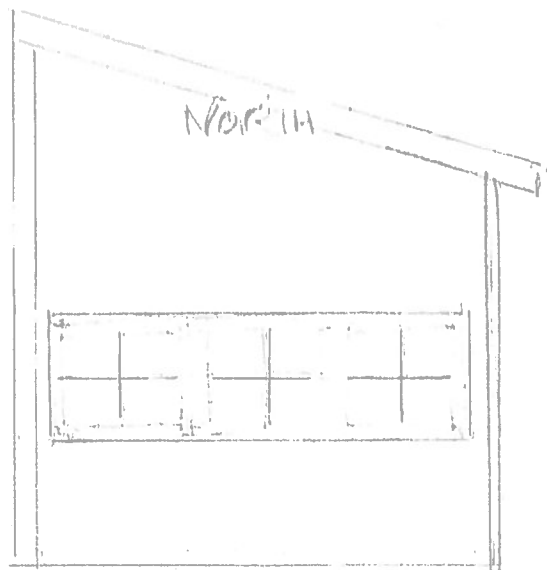
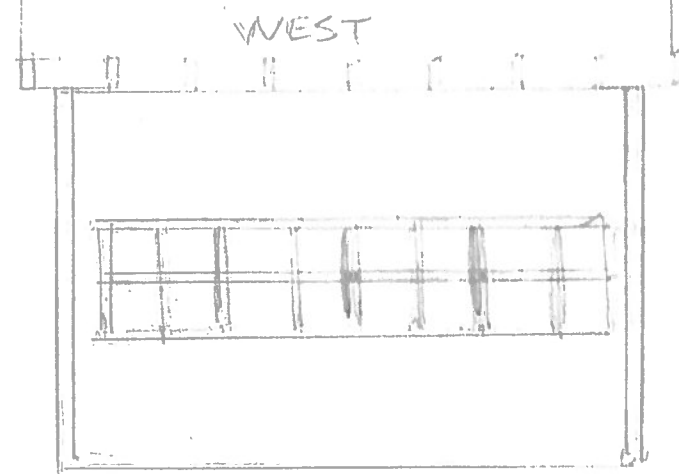
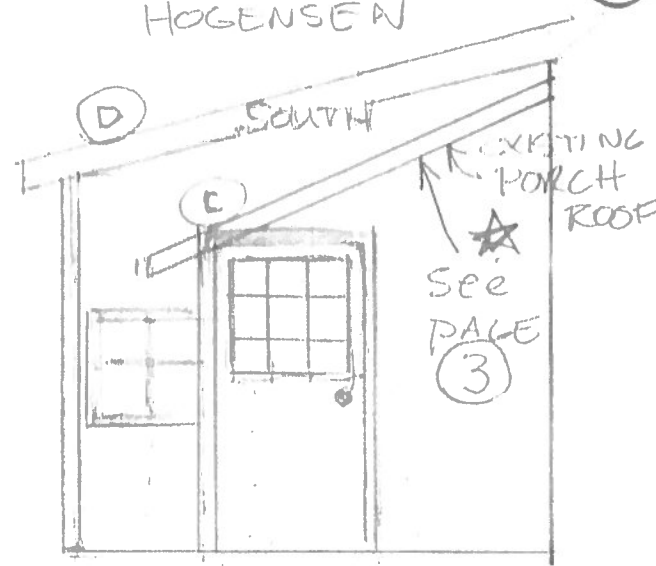
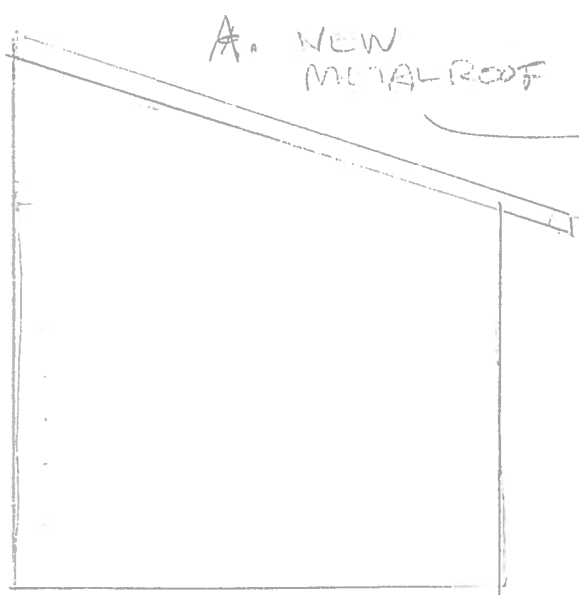
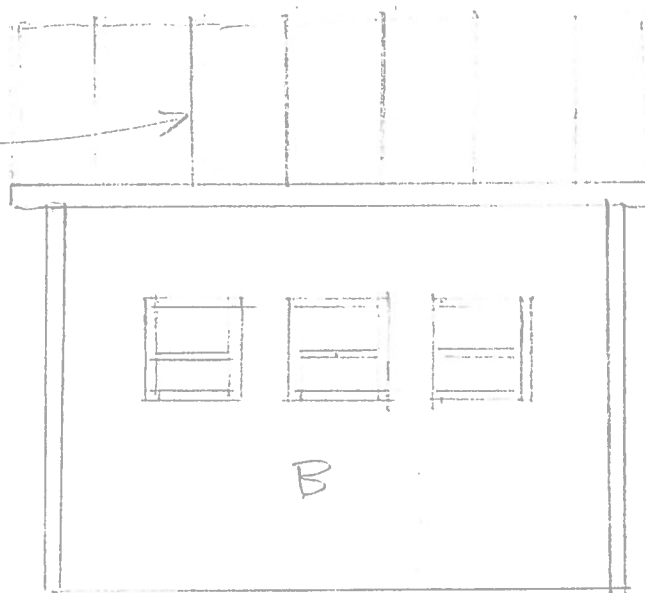
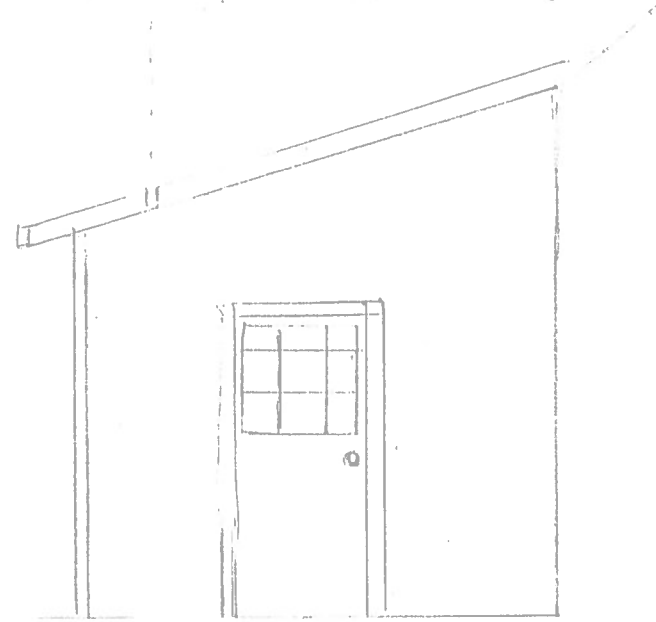
PROPOSED ELEVATIONS

A. NEW  
METAL ROOF

B

A. NEW STANDING SEAM  
METAL ROOF 24ga.  
MARCUS PERPLEK ROOFING  
CONTRACTOR

B. REPLACE WINDOWS  
W WOOD/SINGLE HUNG  
2'x2' (Approx.)

C. REPLACE  
DOOR W/  
9 LITE ENTRY  
TO MATCH  
HOUSE ENTRY

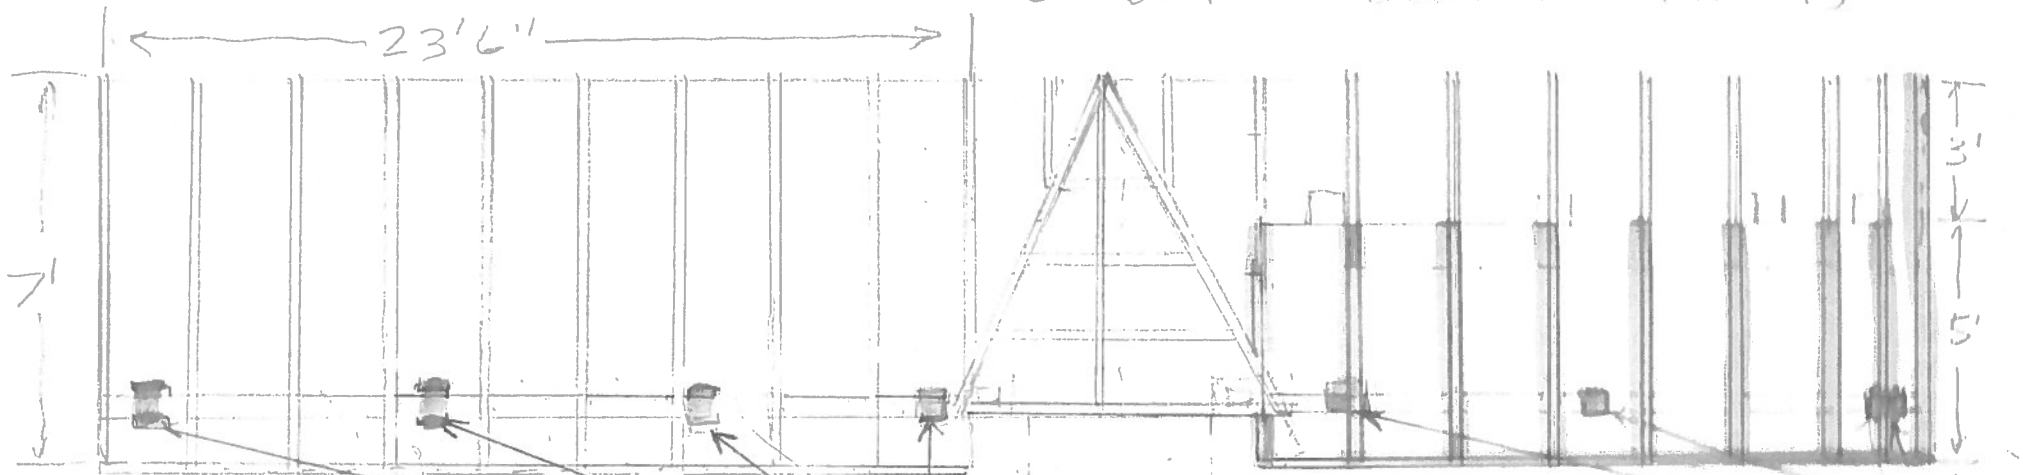
6X6 CEDAR POSTS  
POSTS WILL BE SPACED EVENLY  
4 ON LEFT SIDE  
3 ON RT SIDE

6"x6"  
cedar  
post

UNEVEN CONCRETE PORCH  
REMOVE/REPLACE W/ 2X6 TREX  
MANUFACTURED WOOD - TO EXTEND  
TO EXISTING DIMENSION EVENLY  
ACROSS FRONT OF HOUSE  
1X6 FASCIA

GRAPED AREA SHOWS HOW  
EXTENDING THE PORCH  
LEFT SECTION FOR  
COMPARISON WITH EXISTING  
FRONT OF HOUSE

PORCH FASCIA 1X6  
PROPOSED FOR ELEVATION

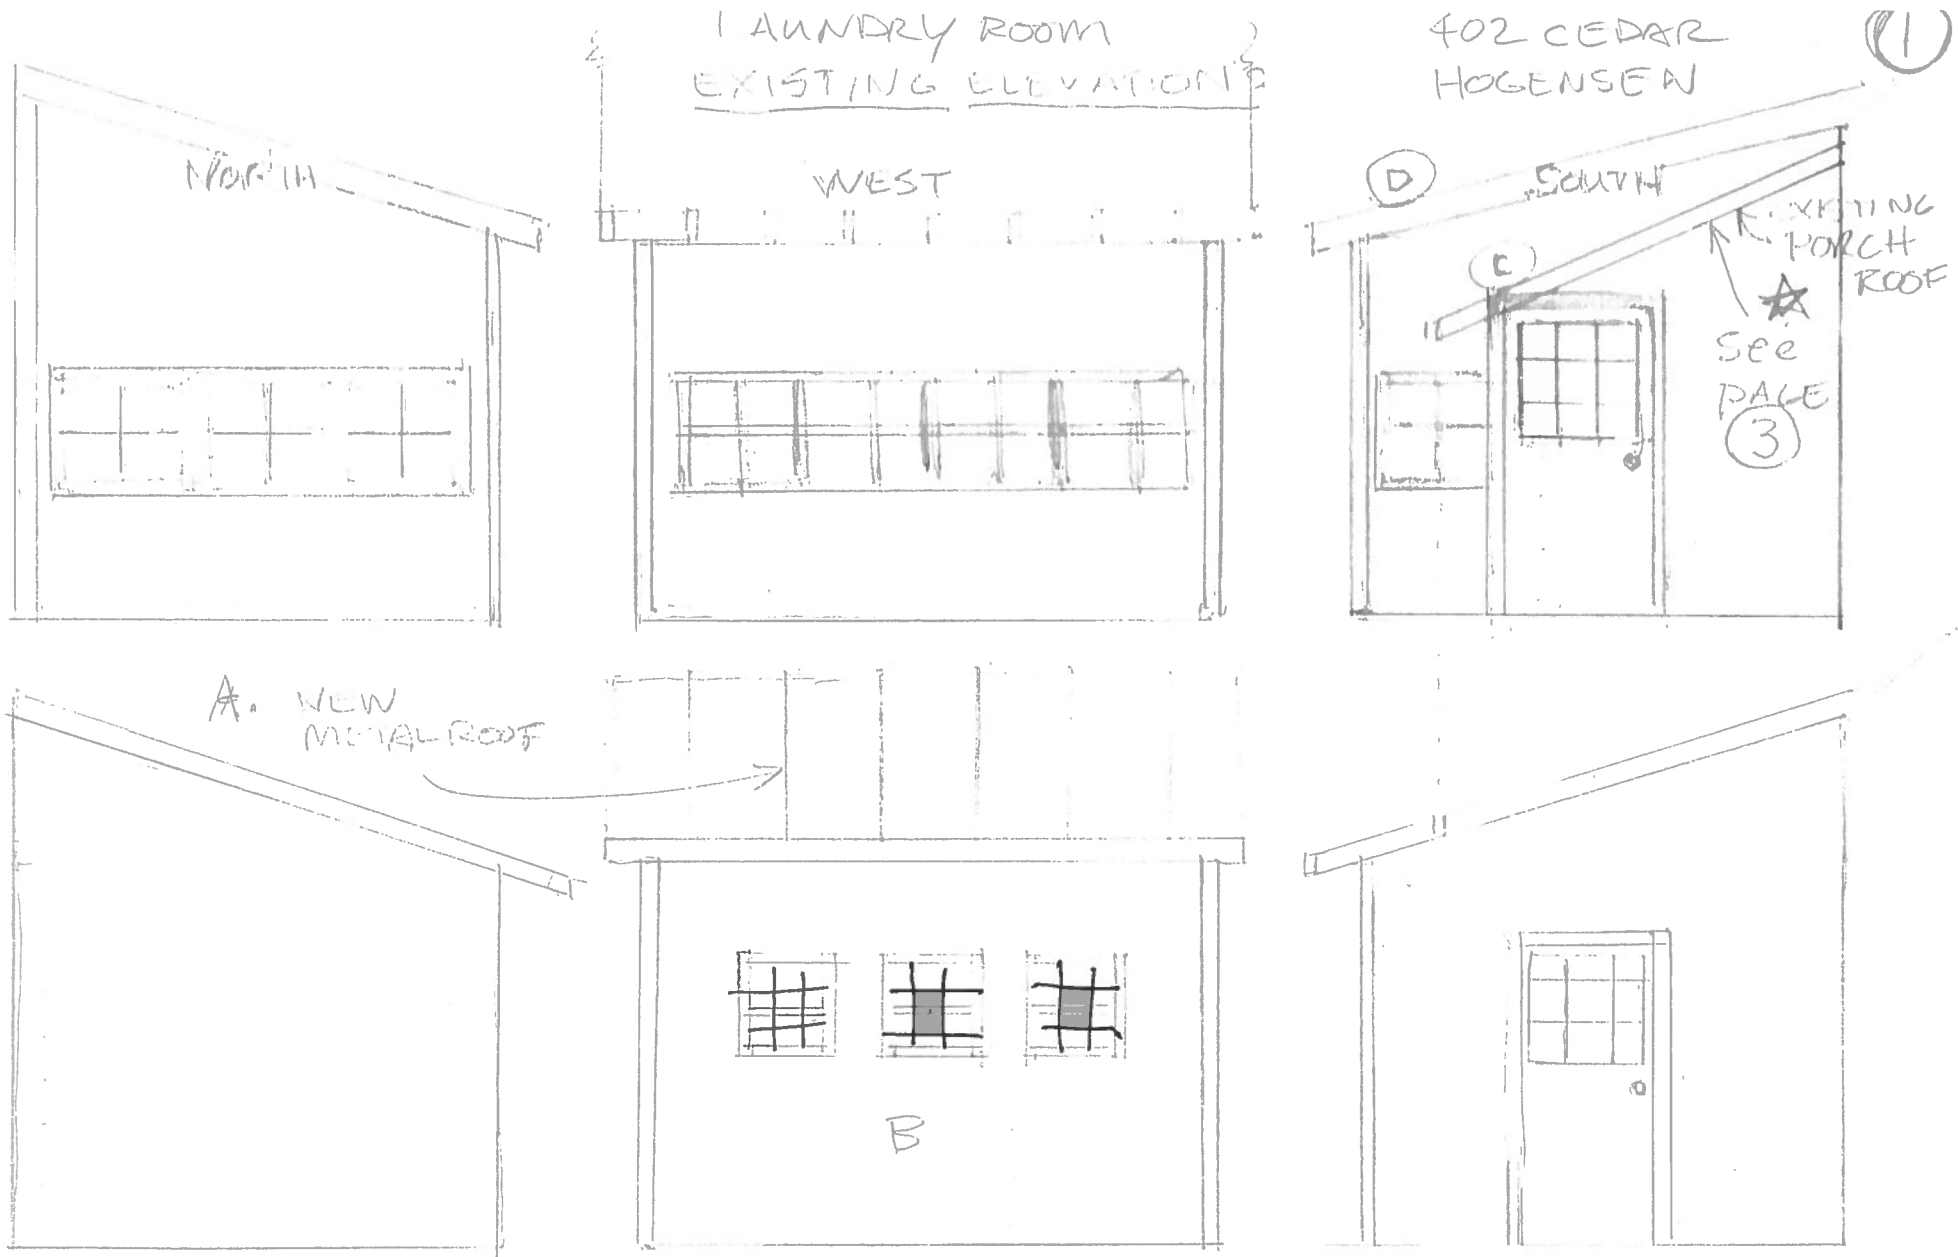
PROPOSED ELEVATIONS  
B. REPLACE WINDOWS  
W WOOD/SINGLE HUNG  
2'x2' (Approx.)

A. NEW STANDING SEAM  
METAL ROOF 24ga.  
MARCUS PEPPELE ROOFING  
CONTRACTOR

C. REPLACE  
DOOR W/  
9 LITE ENTRY  
TO MATCH  
HOUSE ENTRY

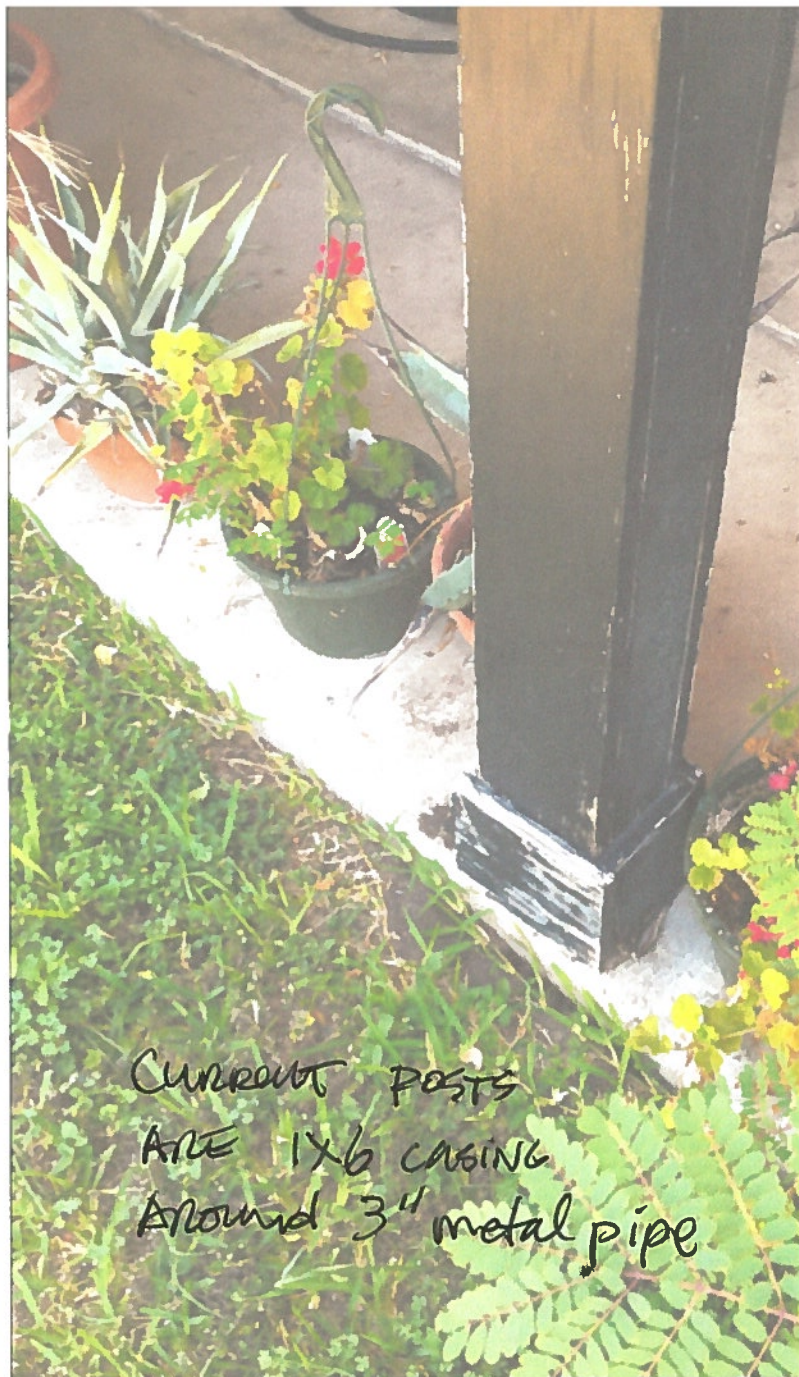
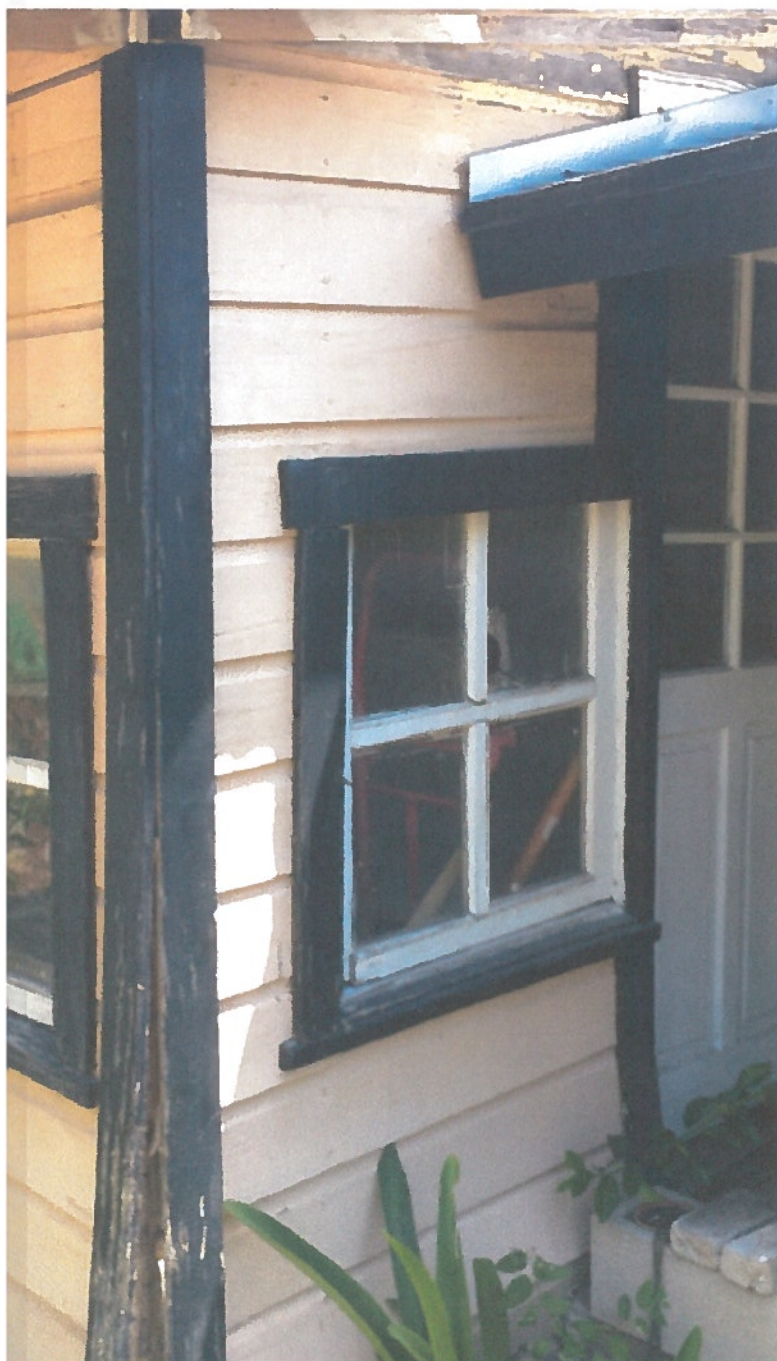
Current posts  
are 1x6 casing  
around 3" metal pipe

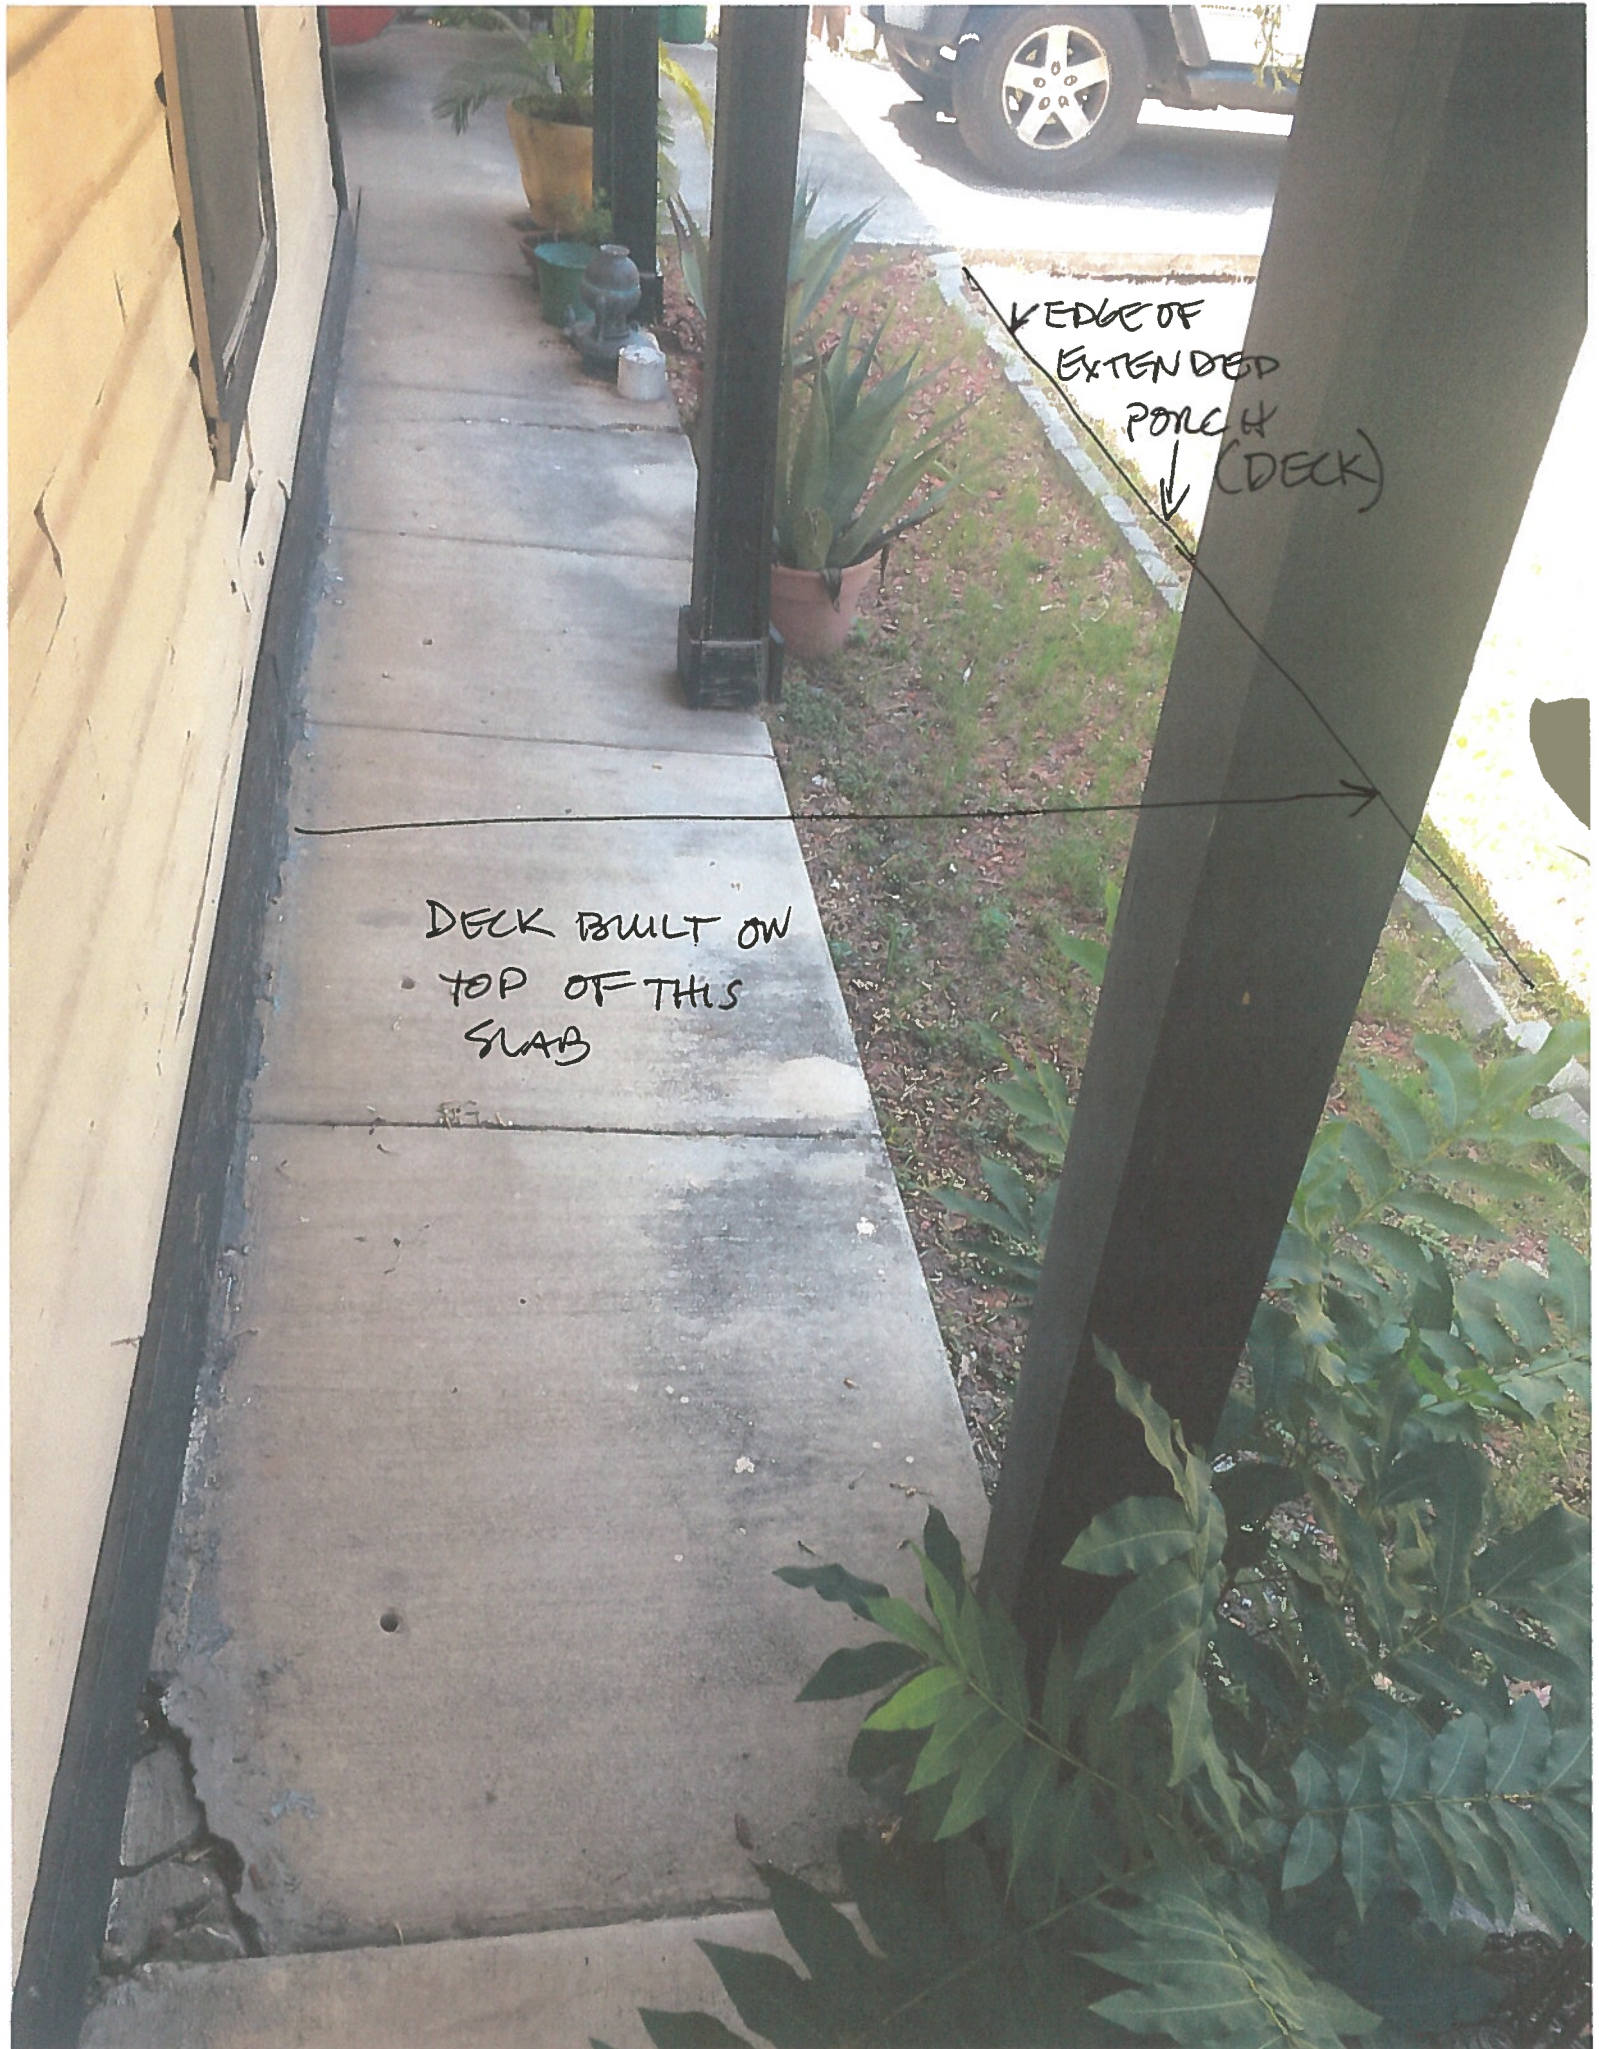
EDGE OF  
EXTENDED  
PORCH  
(DECK)

DECK BUILT ON  
TOP OF THIS  
SLAB

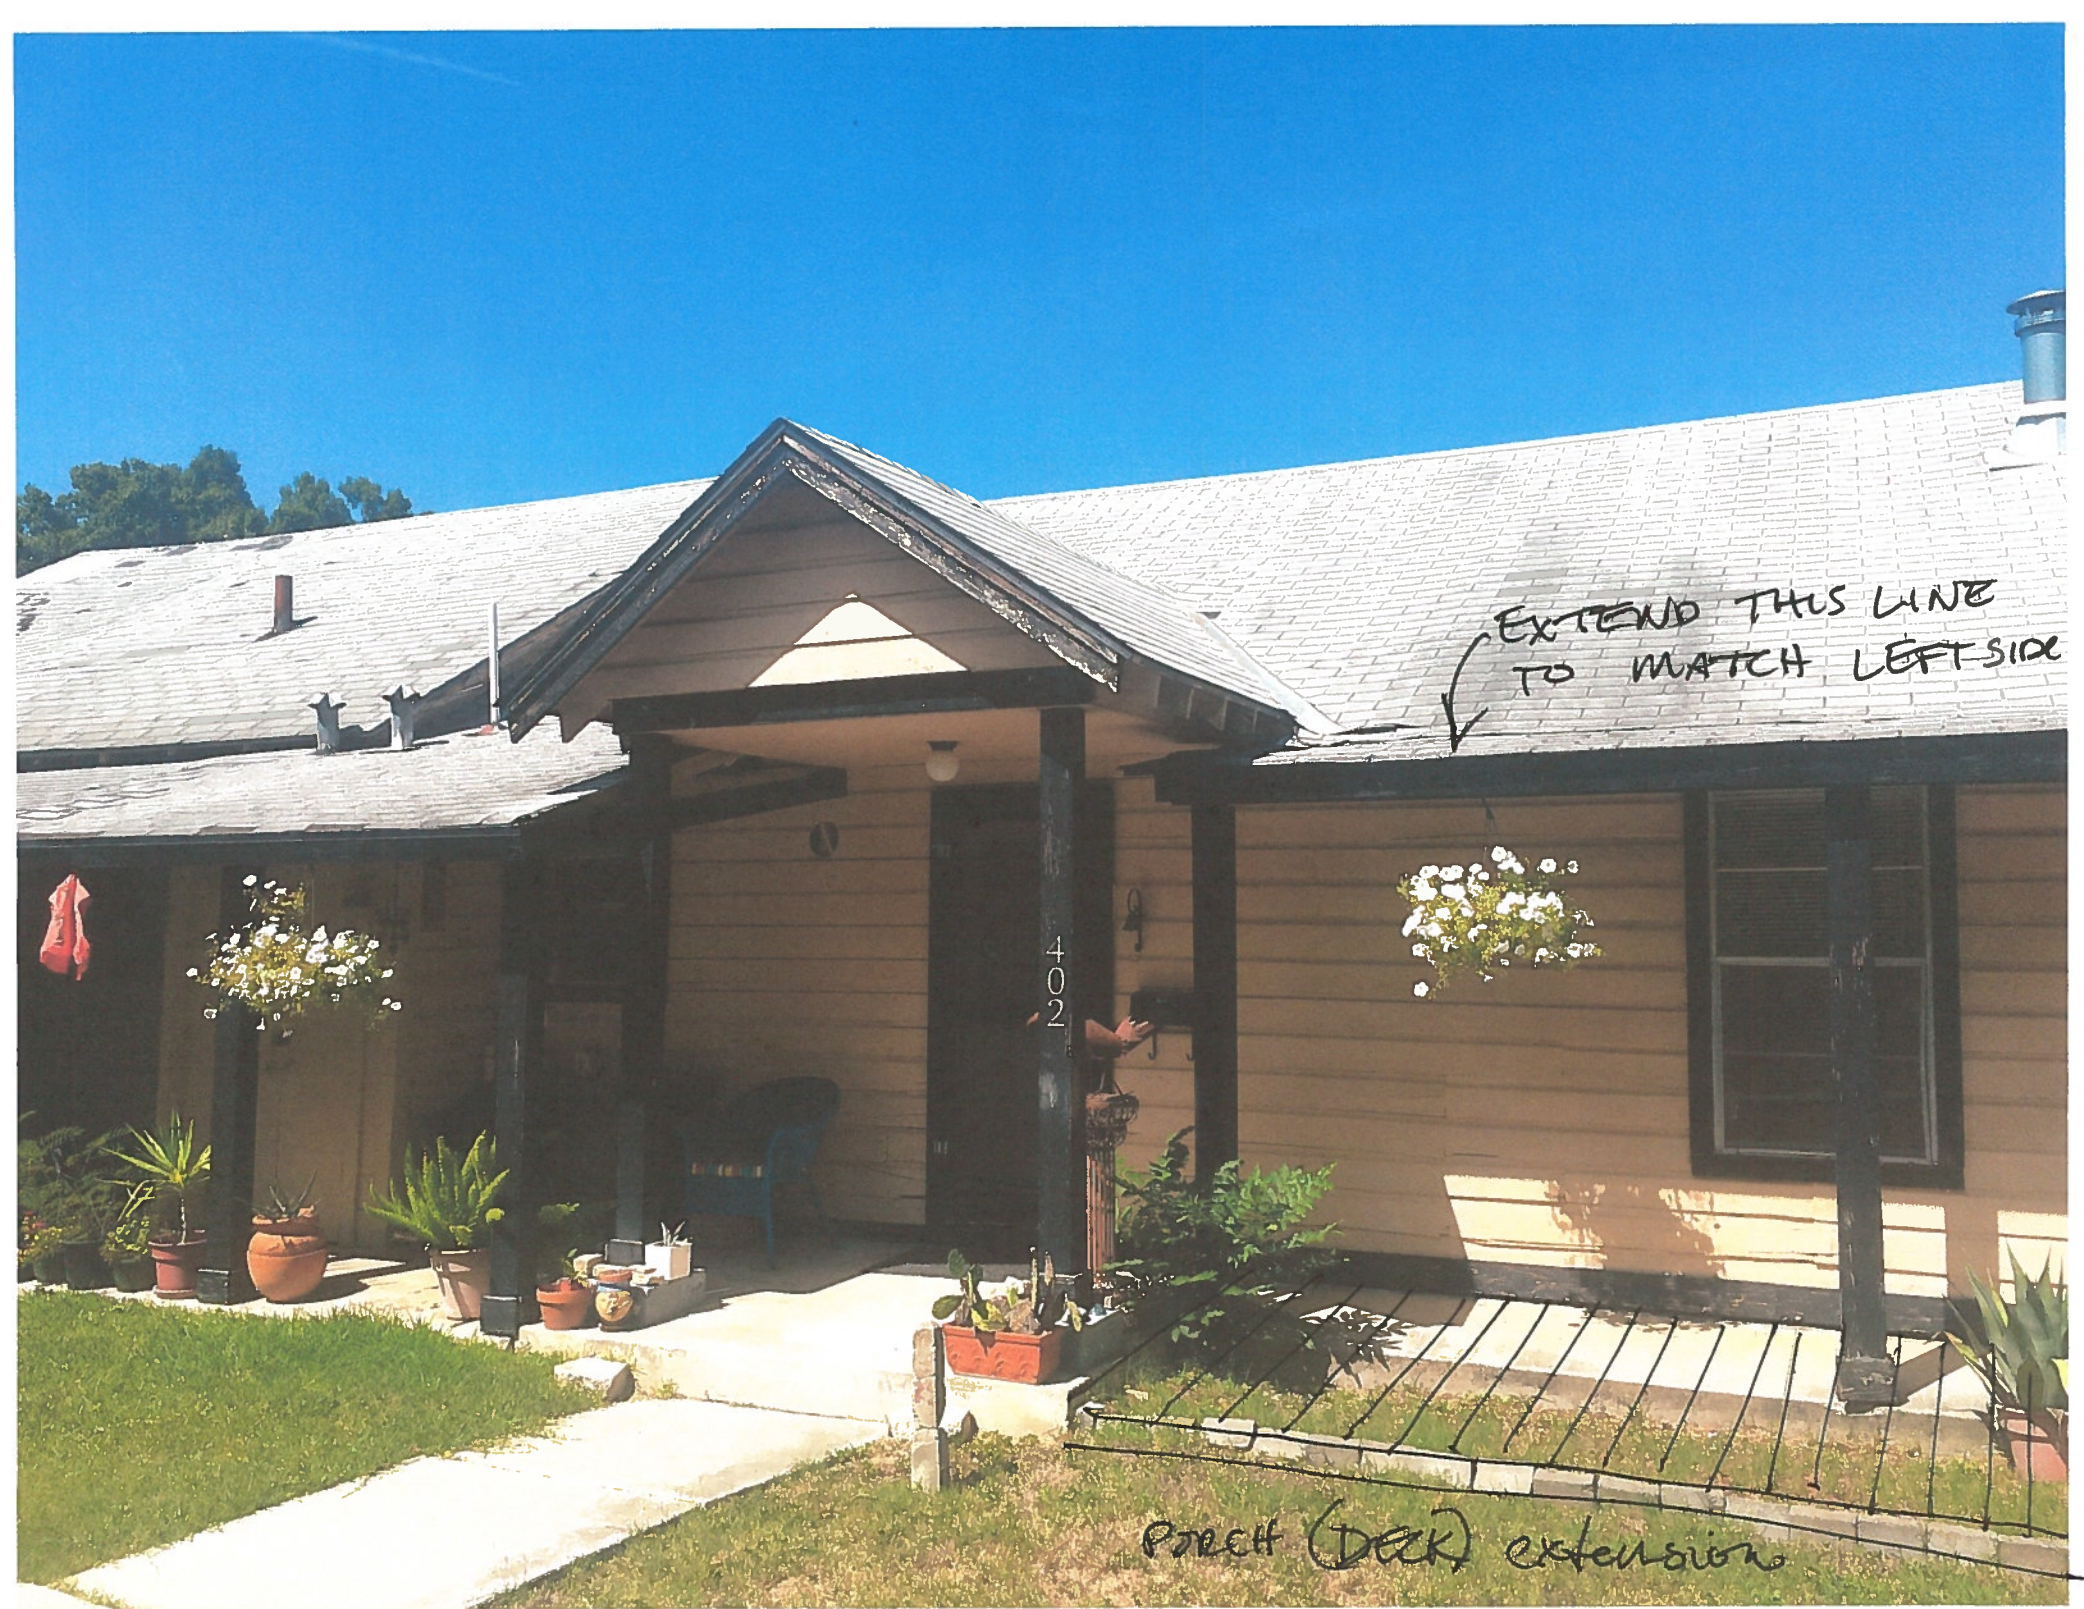
Porch (Deck) extension

EXTEND THIS LINE  
TO MATCH LEFT SIDE

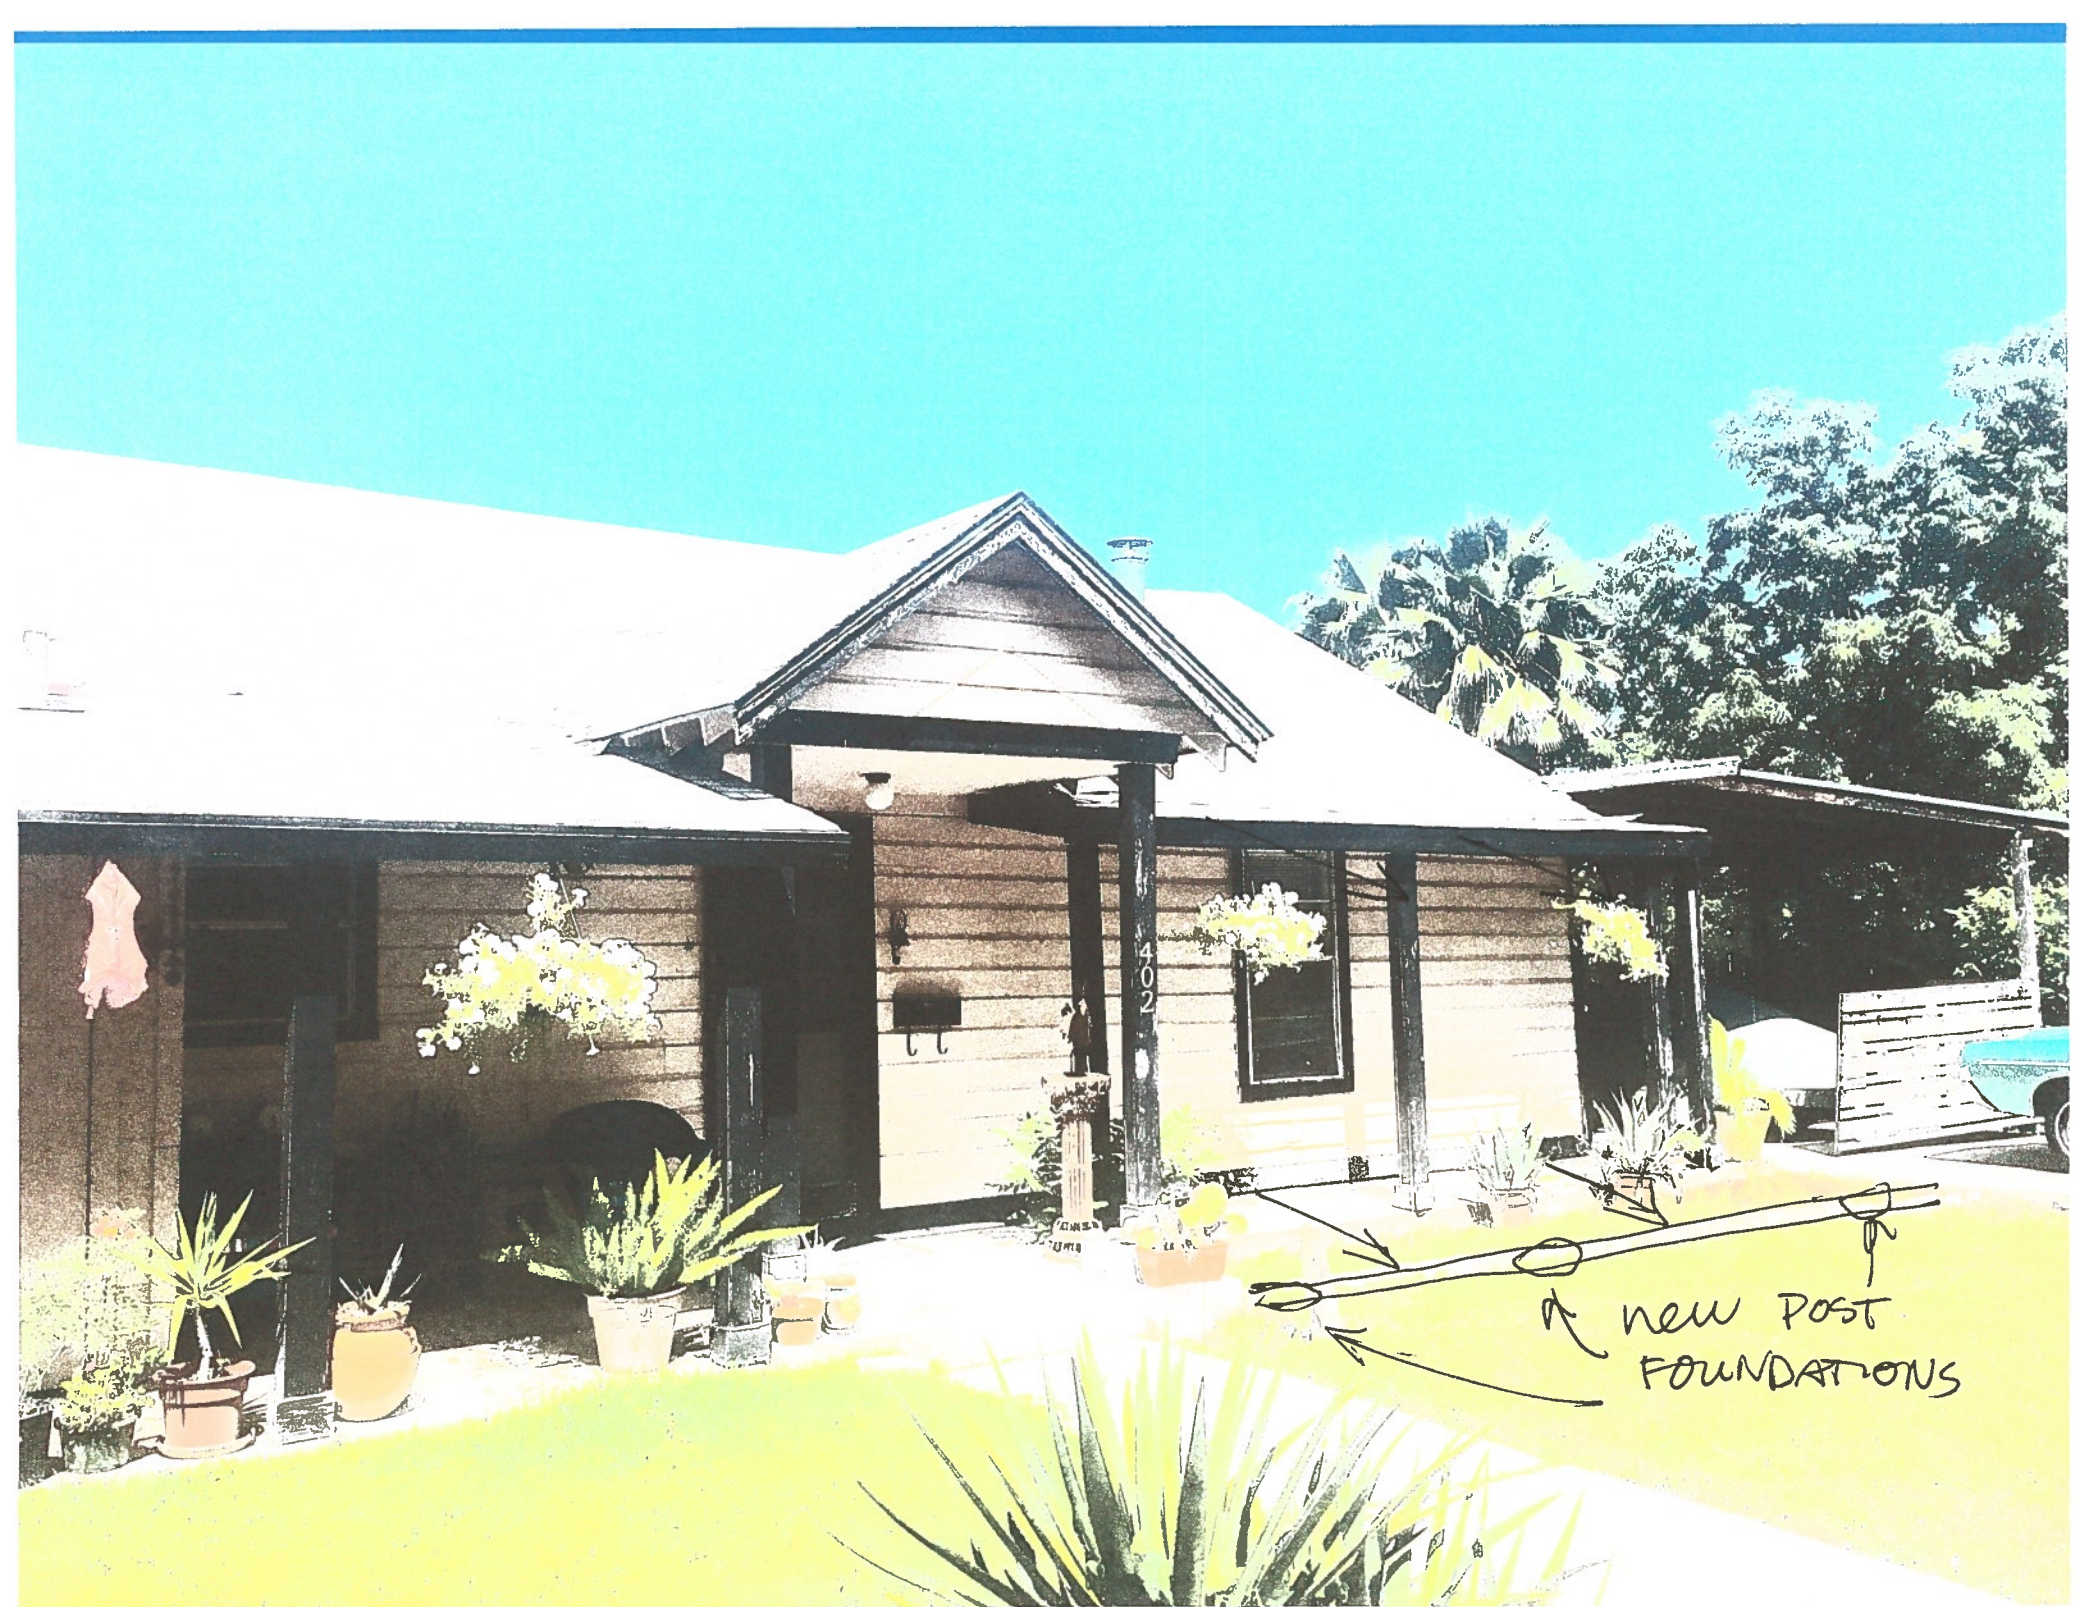
new post  
foundations

Remove this  
SLAB

THIS STAYS
