# HISTORIC AND DESIGN REVIEW COMMISSION

**HDRC CASE NO:** 2018-354  
**ADDRESS:** 402 CEDAR ST  
**LEGAL DESCRIPTION:** NCB 2966 BLK 1 LOT 6  
**ZONING:** RM-4, H  
**CITY COUNCIL DIST.:** 1  
**DISTRICT:** King William Historic District  
**APPLICANT:** Mark Hogensen  
**OWNER:** Mark Hogensen  
**TYPE OF WORK:** Exterior modifications, reconstruction of existing additions, replace porch decking, roof replacement  
**APPLICATION RECEIVED:** July 5, 2018  
**60-DAY REVIEW:** September 3, 2018  
**REQUEST:**

The applicant is requesting a Certificate of Appropriateness for approval to:

1. Reconstruct an existing laundry room and hot water heater closet addition on the west (Cedar Street) elevation.
2. Construct a front porch addition to include a new porch roof to match that found on the left side of the west elevation and perform front porch modifications.
3. Replace the existing porch decking with a composite decking material.
4. Replace the existing, asphalt shingle roof with a standing seam metal roof.

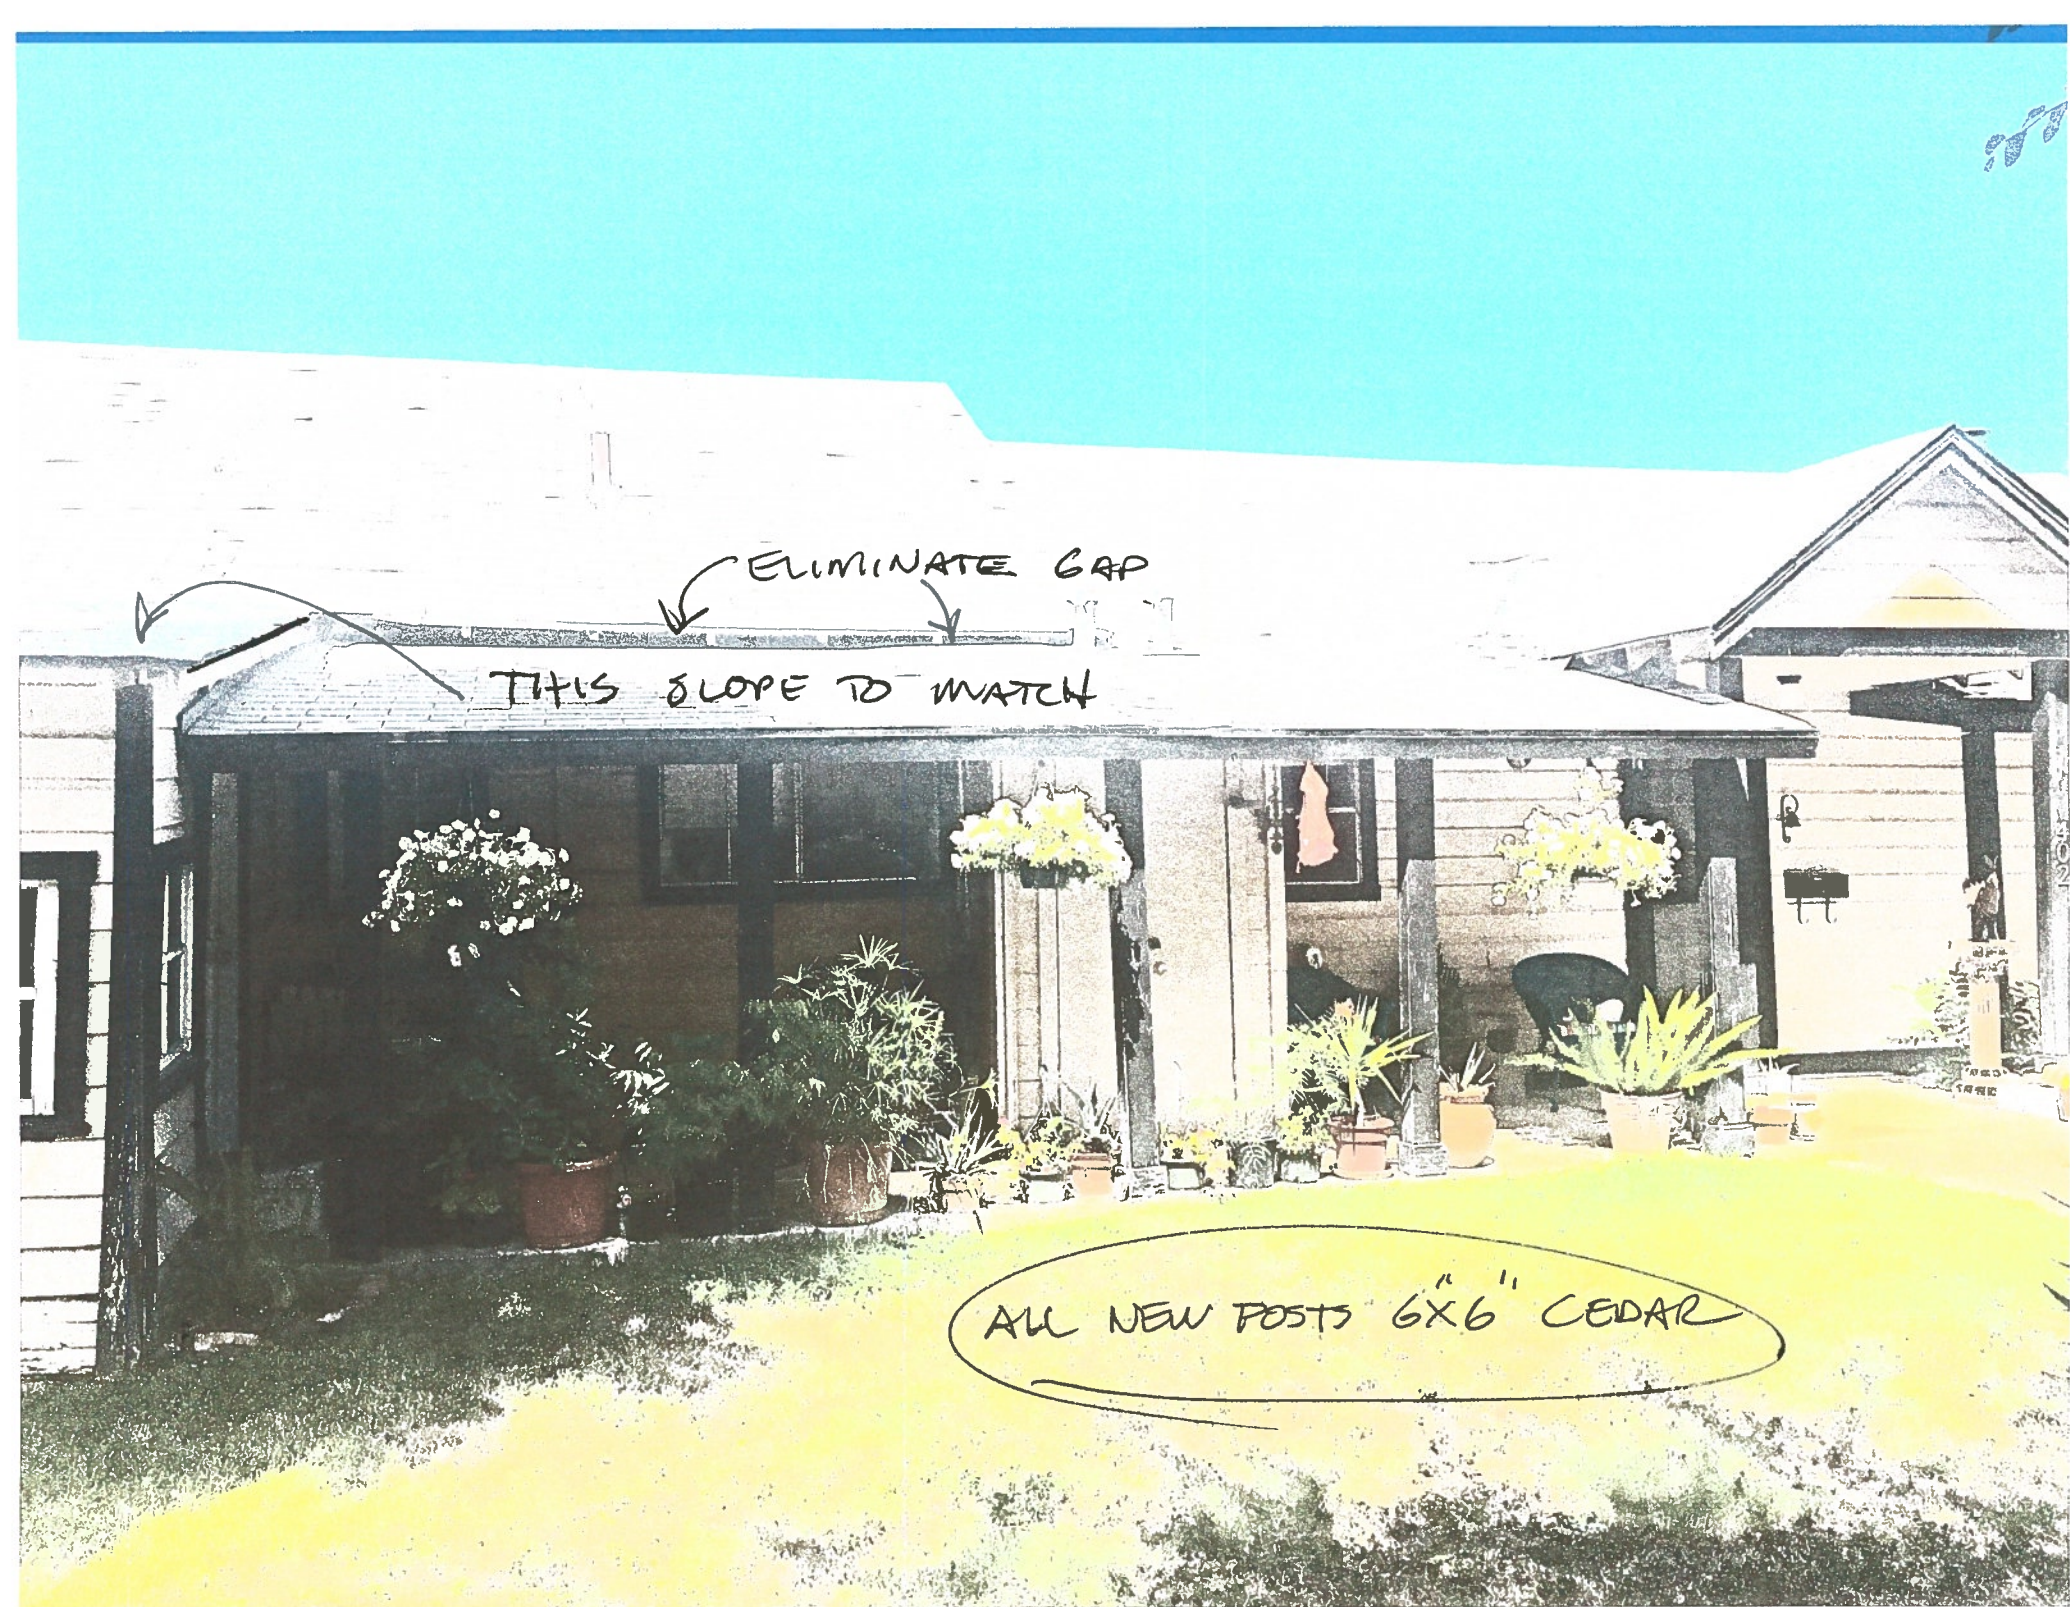
ELIMINATE GAP

THIS SLOPE TO MATCH

ALL NEW POSTS 6x6" CEDAR

SEPARATION →

PROPOSE:  
RAISING THIS SLOPE

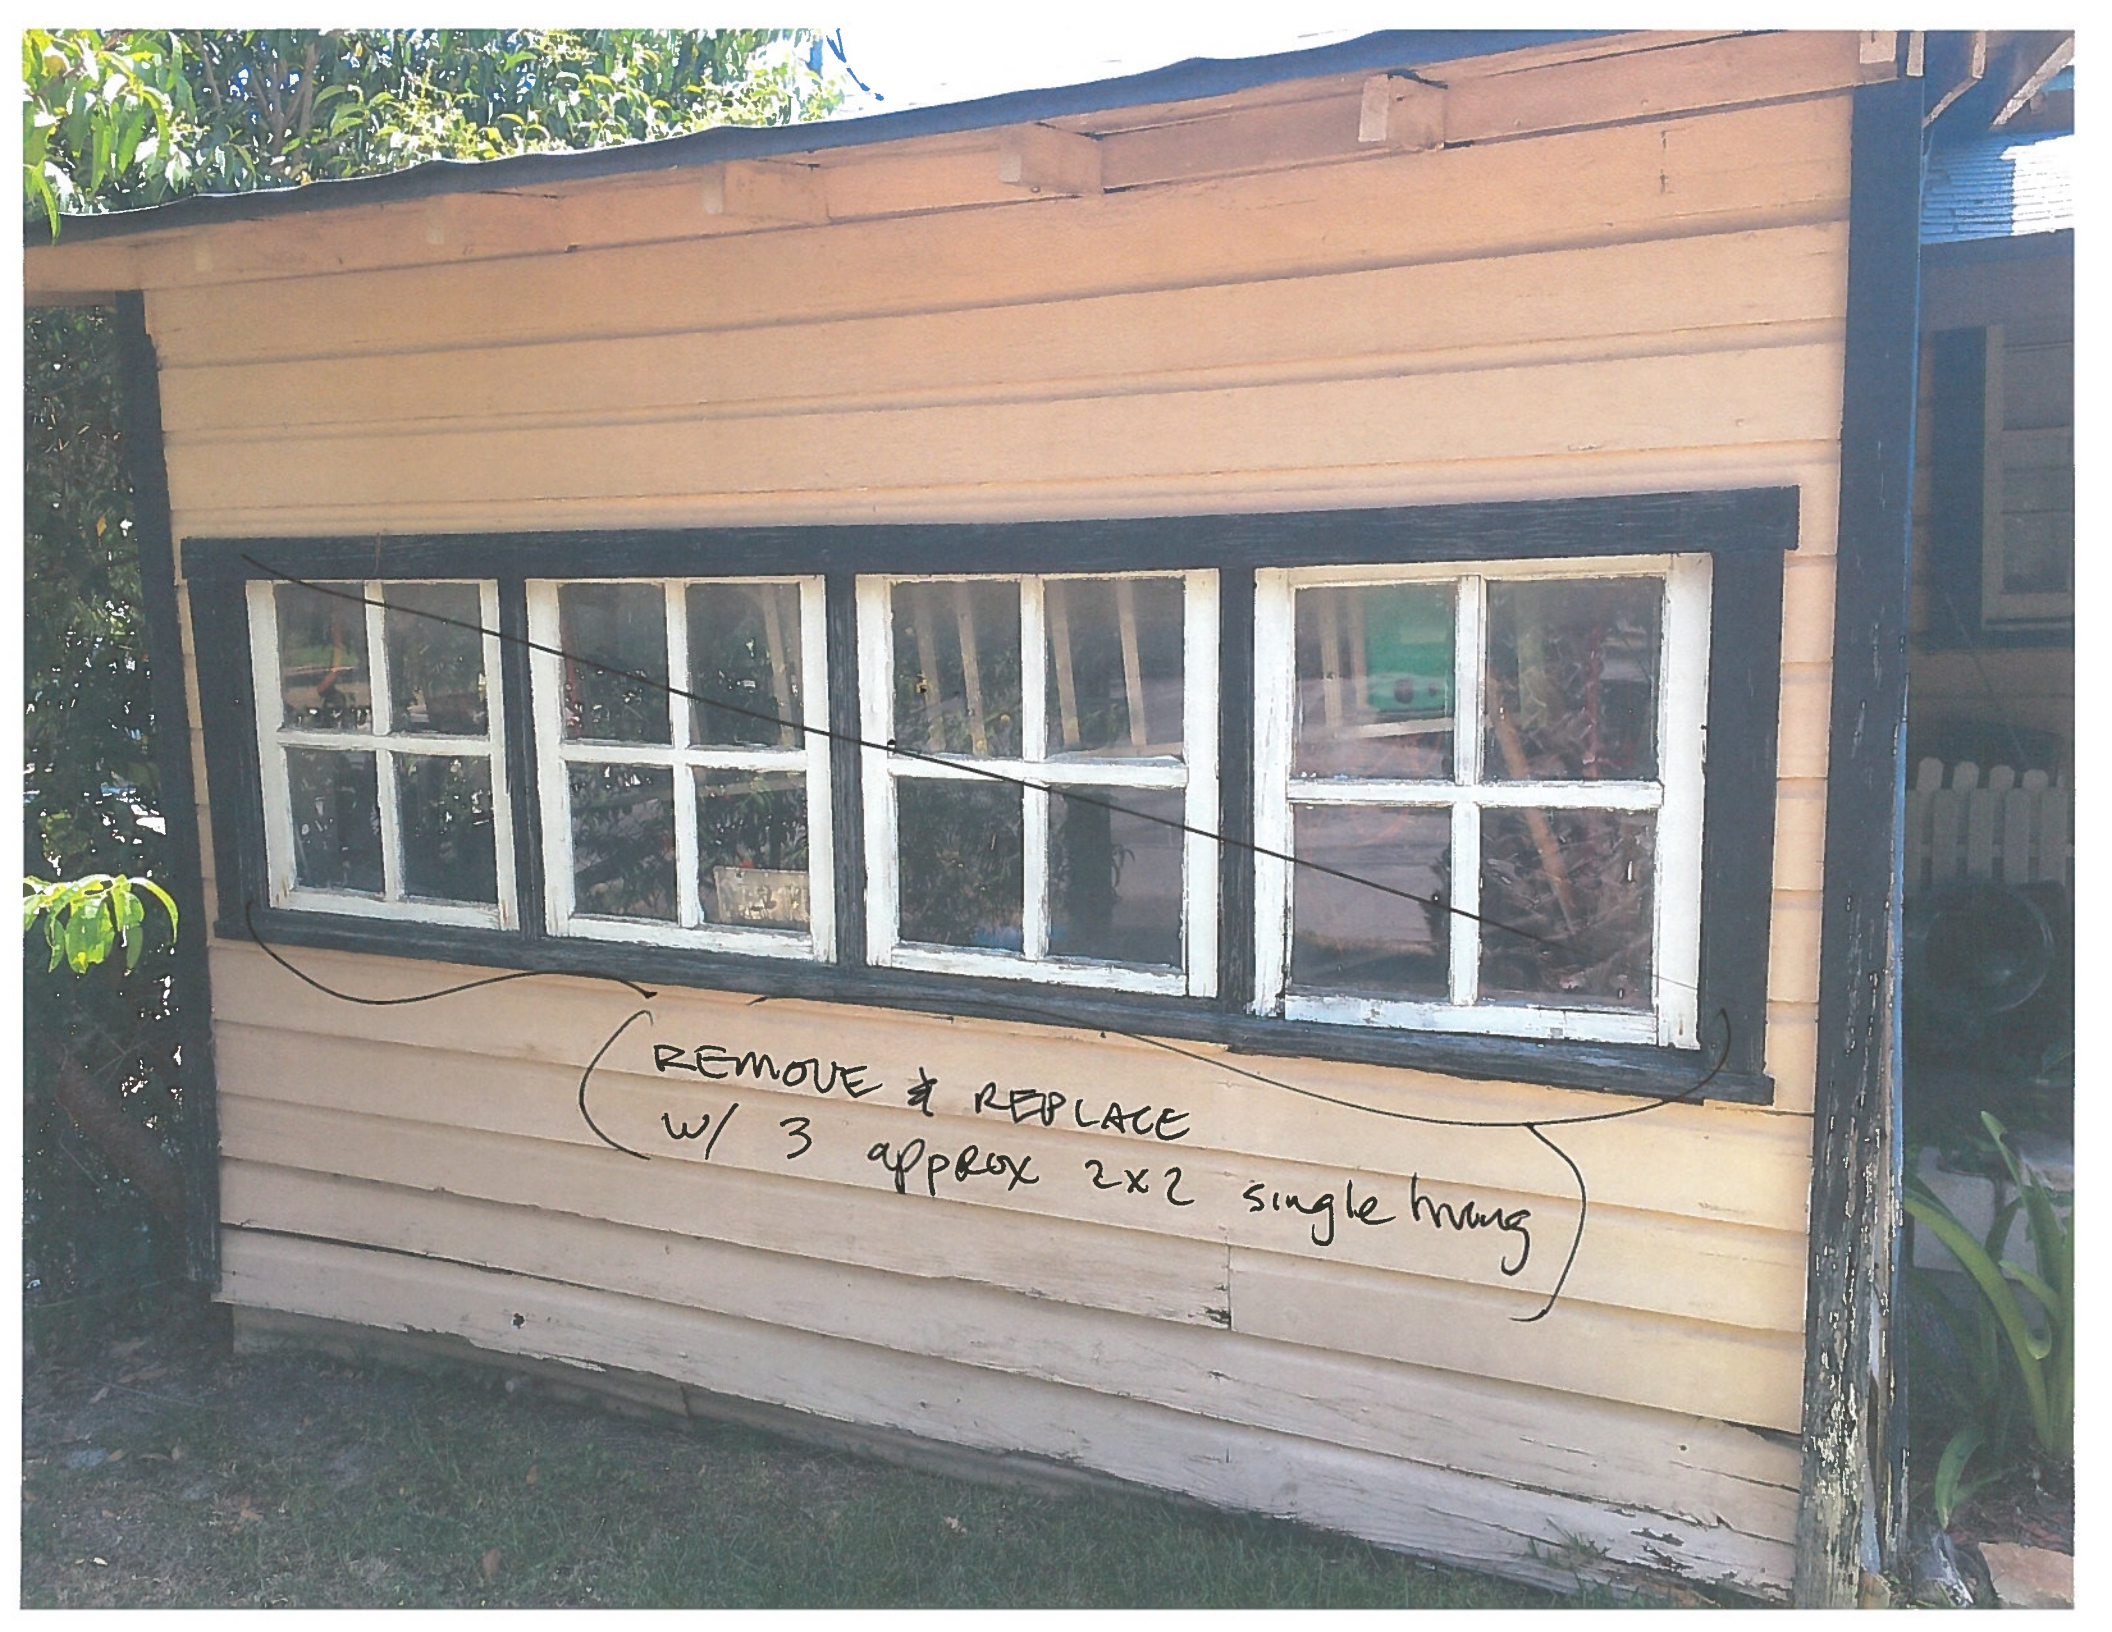
FACING CEDAR ST

REMOVE & REPLACE  
w/ 3 approx 2x2 single hung
