HISTORIC AND DESIGN REVIEW COMMISSION

HDRC CASE NO: 2018-446
ADDRESS: 925 BURLESON ST
LEGAL DESCRIPTION: NCB 1302 BLK 3 LOT 18
ZONING: R-5, H
CITY COUNCIL DIST.: 2
DISTRICT: Dignowity Hill Historic District
APPLICANT: Mario Herrera
OWNER: Chris Lee
TYPE OF WORK: Rehabilitation, construction of a rear addition, exterior modifications
APPLICATION RECEIVED: August 31, 2018
60-DAY REVIEW: October 30, 2018
REQUEST:

The applicant is requesting a Certificate of Appropriateness for approval to:

1. Perform rehabilitative scopes of work that include foundation repair, roof repair and wood window repair.
2. Install a new attic vent to replace a non-original window.
3. Install new porch columns to replace the existing, wrought iron columns.
4. Construct a rear addition of approximately 580 square feet.

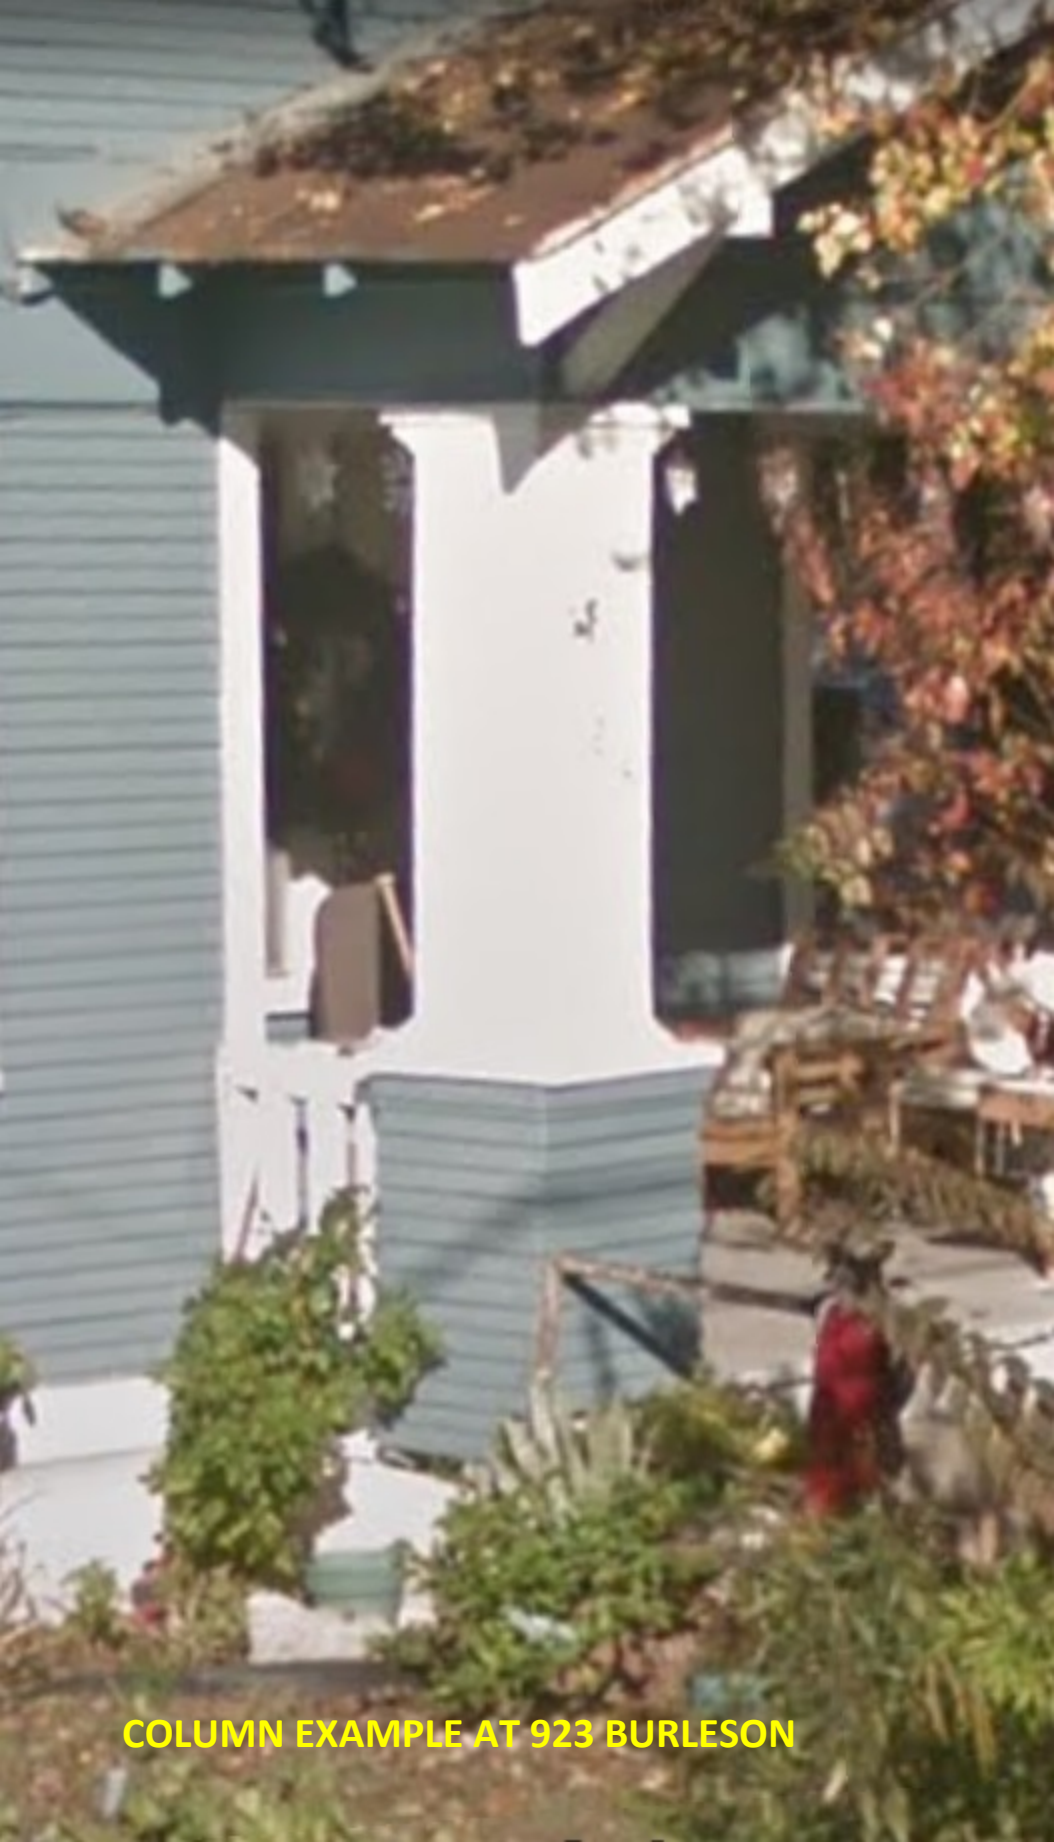
COLUMN EXAMPLE AT 923 BURLESON

- 3. Staff recommends approval of item #3, column replacement based on finding d with the following stipulations:
 - i. That columns comparable to those found at 923 Burleson, featuring a pediment with a 117 siding profile and square columns be installed. A detailed drawing should be submitted to staff for review and approval.
