HISTORIC AND DESIGN REVIEW COMMISSION

September 19, 2018

HDRC CASE NO: 2018-463
ADDRESS: 833 W CYPRESS
835 W CYPRESS
LEGAL DESCRIPTION: NCB 129 BLK 1 LOT 1,2 AND W 5.3 FEET OF 3
ZONING: R-4, HS
CITY COUNCIL DIST.: 1
LANDMARK: House
APPLICANT: Francisco Rodriguez
OWNER: Francisco Rodriguez
TYPE OF WORK: Roof material change, window replacement, deck addition, paint
APPLICATION RECEIVED: August 27, 2018
60-DAY REVIEW: October 26, 2018
REQUEST:

- 1) Replace the existing, standing seam metal roof with an asphalt shingle roof.
- 2) Replace the existing wood windows with vinyl windows.
- 3) Construct a rear covered deck.

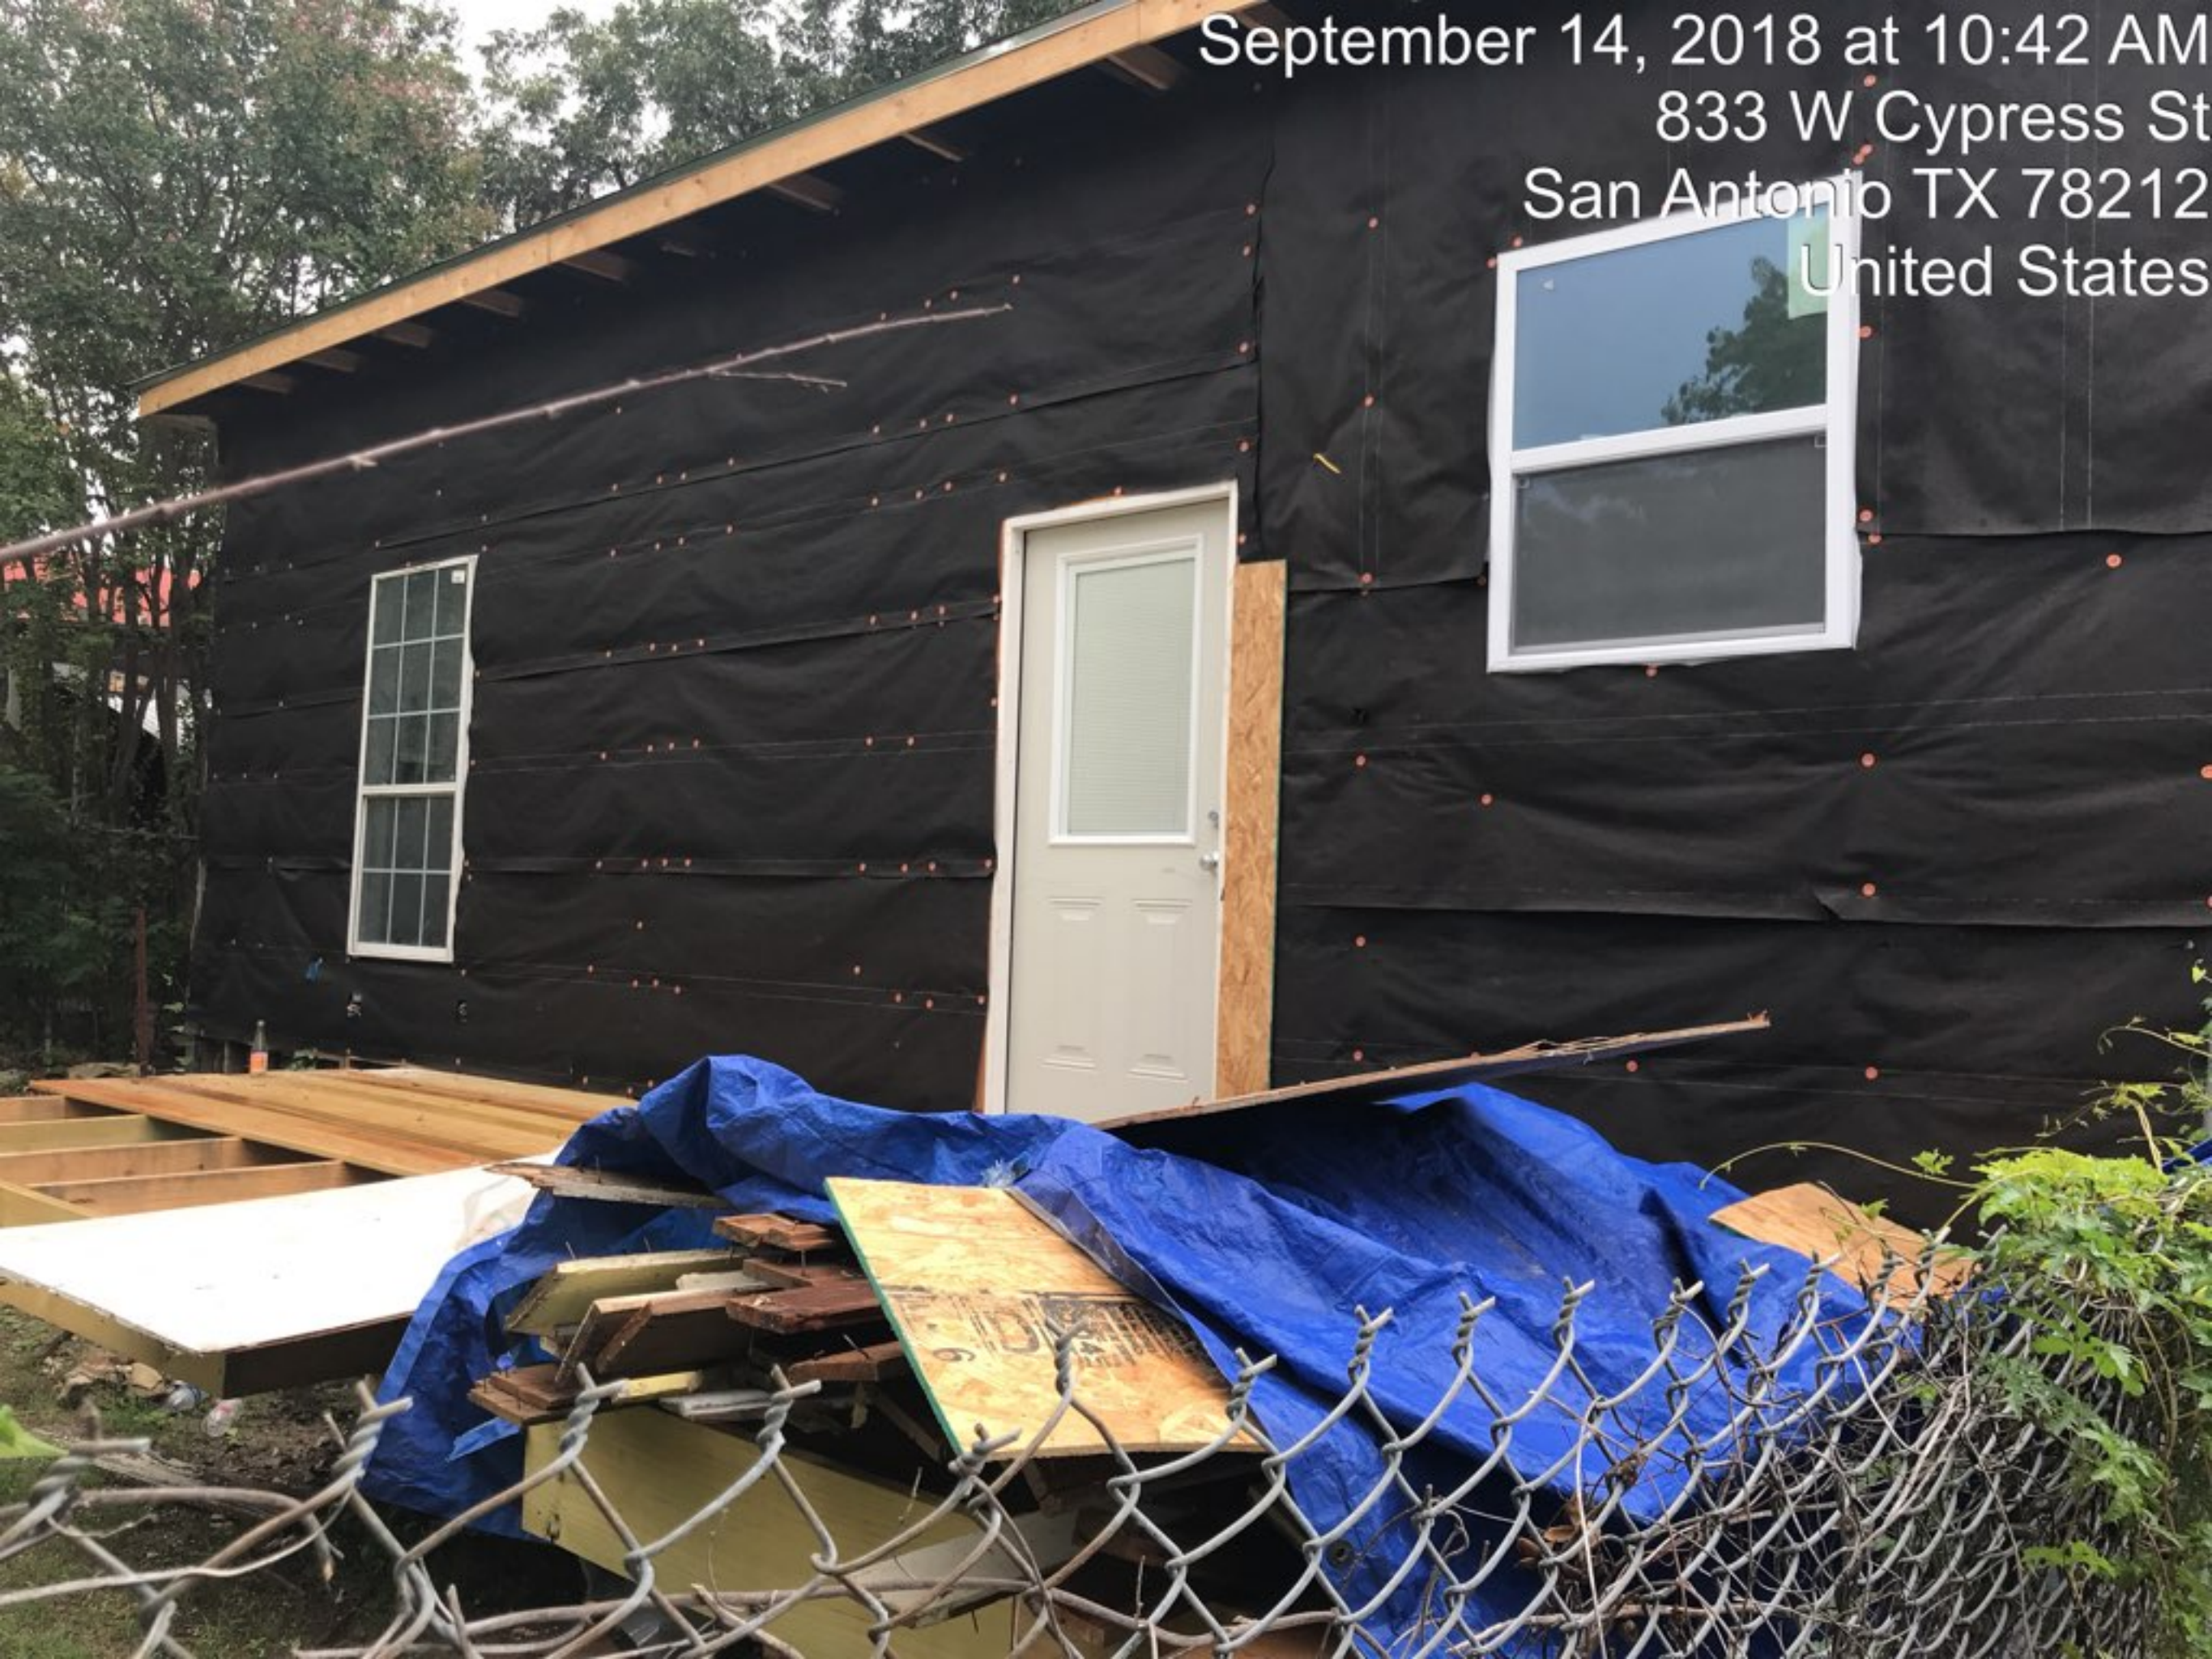
833 W Cypress

Roofing old metal To : Shingle

Deck 8 wide 21 Long

Roof over Deck 10 wide Long 32

- c. **ROOF REPLACEMENT**– The applicant is proposing to replace the existing, standing seam metal roof with an asphalt shingle roof. Per the Guidelines for Exterior Maintenance and Alterations 3.B.iv. roofing materials should be replaced in-kind whenever possible when the roof must be replaced. Staff finds that the standing seam metal roof is a character-defining feature and is featured on the property on the 1912 Sanborn map. Staff finds that the proposed change in roofing material is inconsistent with the Guidelines. The standing seam metal roof should be repaired in-place or replaced in-kind. New metal roofs must adhere to the following specifications: panels should be 18-21 inches wide, seam should be 1-2 inches tall and appropriate to the slope of the roof, a crimped ridge seam that is consistent with the historic application is to be used along with a standard galvalume finish. Vented ridge caps are not to be used, and a low-profile ridge cap/v-crimp panels will require HDRC approval.

- e. **REAR COVERED DECK** – The applicant has proposed to install a rear covered deck featuring eight (8) feet in width and 21 feet in depth. Per the Guidelines for Exterior Maintenance and Alterations 7.B.ii, side and rear porches should result in a space that functions and is visually interpreted as a porch. Staff finds that the proposal is generally appropriate given that the current rear elevation is an un-fenestrated wall. However, the applicant has not provided sufficient documentation including elevation drawings with rear window, door, and railing, and foundation detail and site plan noting the roof form and materials.
