HISTORIC AND DESIGN REVIEW COMMISSION

HDRC CASE NO: 2018-507
ADDRESS: 614 BARBE ST
LEGAL DESCRIPTION: NCB 2912 MARIA C GUERRA SUBD, BLOCK 1 LOT 24
ZONING: RM-4, H
CITY COUNCIL DIST.: 1
DISTRICT: King William Historic District
APPLICANT: Christine Jacques
OWNER: Christine Jacques
TYPE OF WORK: Exterior modifications to two, rear accessory structures
APPLICATION RECEIVED: September 4, 2018
60-DAY REVIEW: November 3, 2018
REQUEST:

The applicant is requesting a Certificate of Appropriateness for approval to:

- 1) Replace the existing garage door with two new vinyl windows on the southern rear accessory structure.
- 2) Replace both existing garage doors with two new vinyl windows and relocate the door on the northern rear accessory structure.
- 3) Remove a second-story window opening on the northern rear accessory structure.
- 4) Reapply stucco to the front porch enclosure.

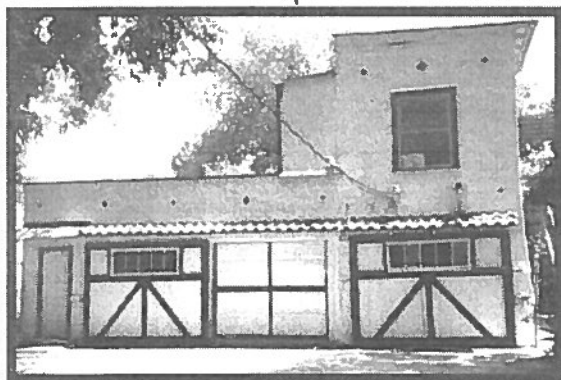
34'6" length of Building
 Windows 36"x48" aluminum frame.
 (view 1)
 Door 36"x80" Glass + steel prehung door
 Remove upper window + stucco

- c. NORTHERN REAR GARAGE – The structure is primarily a single-story garage with partial second-story dwelling unit as first depicted on the 1951 Sanborn map. The structure features a stucco façade, two wood carriage doors flanking a centered traditional garage door, a door at the northern corner, a second-story front façade window, and a meta staircase providing access to the second-story dwelling unit. The structure also features a rear portion with asbestos siding covering wood lap siding. The applicant is requesting to replace two existing wood carriage doors with two new vinyl windows and infill with stucco matching the rest of the façade. Additionally, the applicant has requested to remove the existing north corner door and install a new steel door with full light in a central location. While the structure has been subject to non-conforming alterations, staff finds that the proposed modifications would further detract from the primary historic structure, the other historic accessory structure, and are inconsistent with the Guidelines for Exterior Maintenance and Alterations. Staff also finds that the submitted documents are insufficient for final approval.

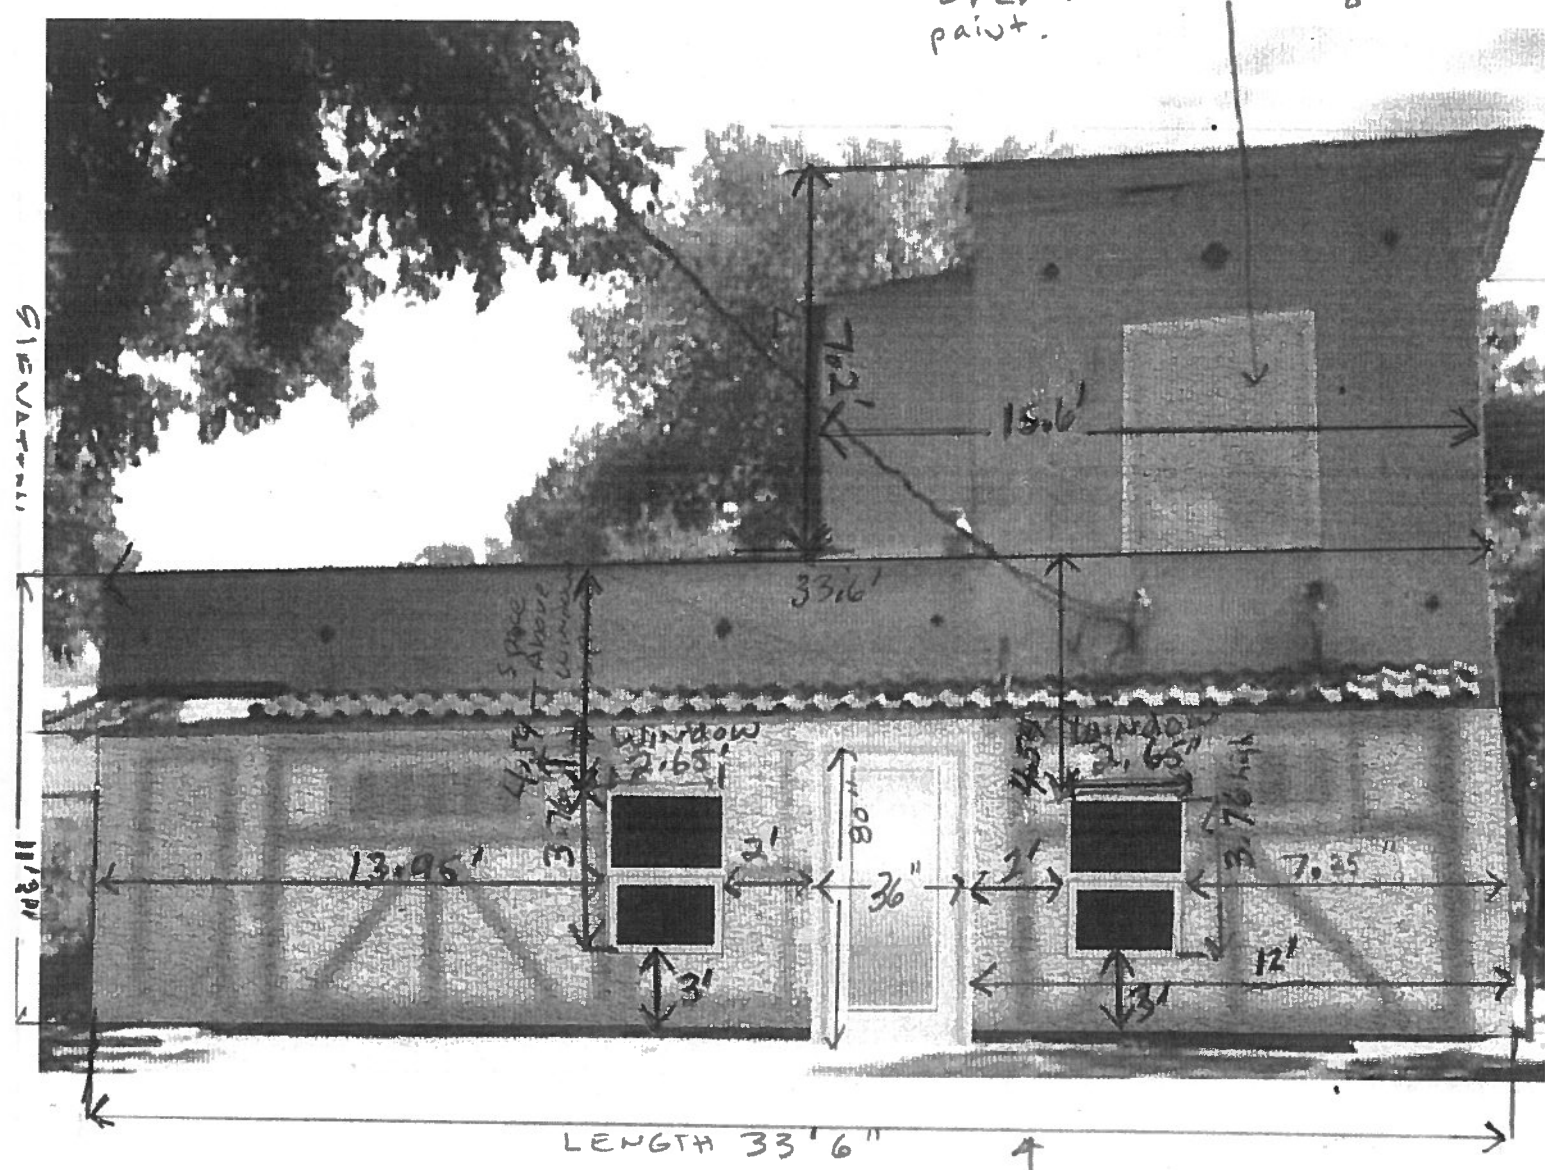
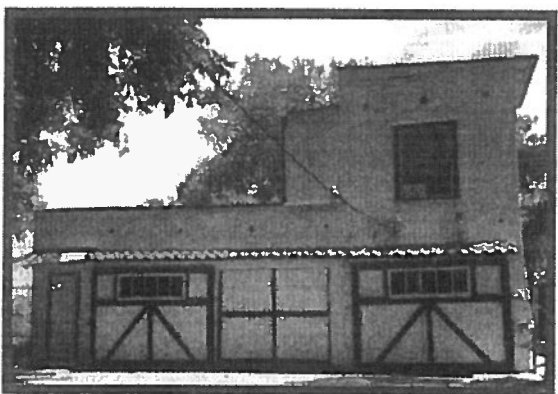
Existing Window to be stucco over with matching stucco paint.

THE GARAGE DOORS, entrance door + upper win will be gotten rid of. 2'x4 wood placed in 16" center for all openings then covered with treated wood. Finally, Stucco will be applied to match the original stucco painted white to match.

- d. WINDOW REMOVAL – The applicant has proposed to remove an existing, front-facing window on the second-story dwelling unit and infill the opening with stucco to match the rest of the facade. Staff finds that the proposed window removal would create a second-story wall plane that lacks fenestration, which is atypical of the historic development pattern found in the district. The proposed modifications are inconsistent with the Guidelines for Exterior Maintenance and Alterations.

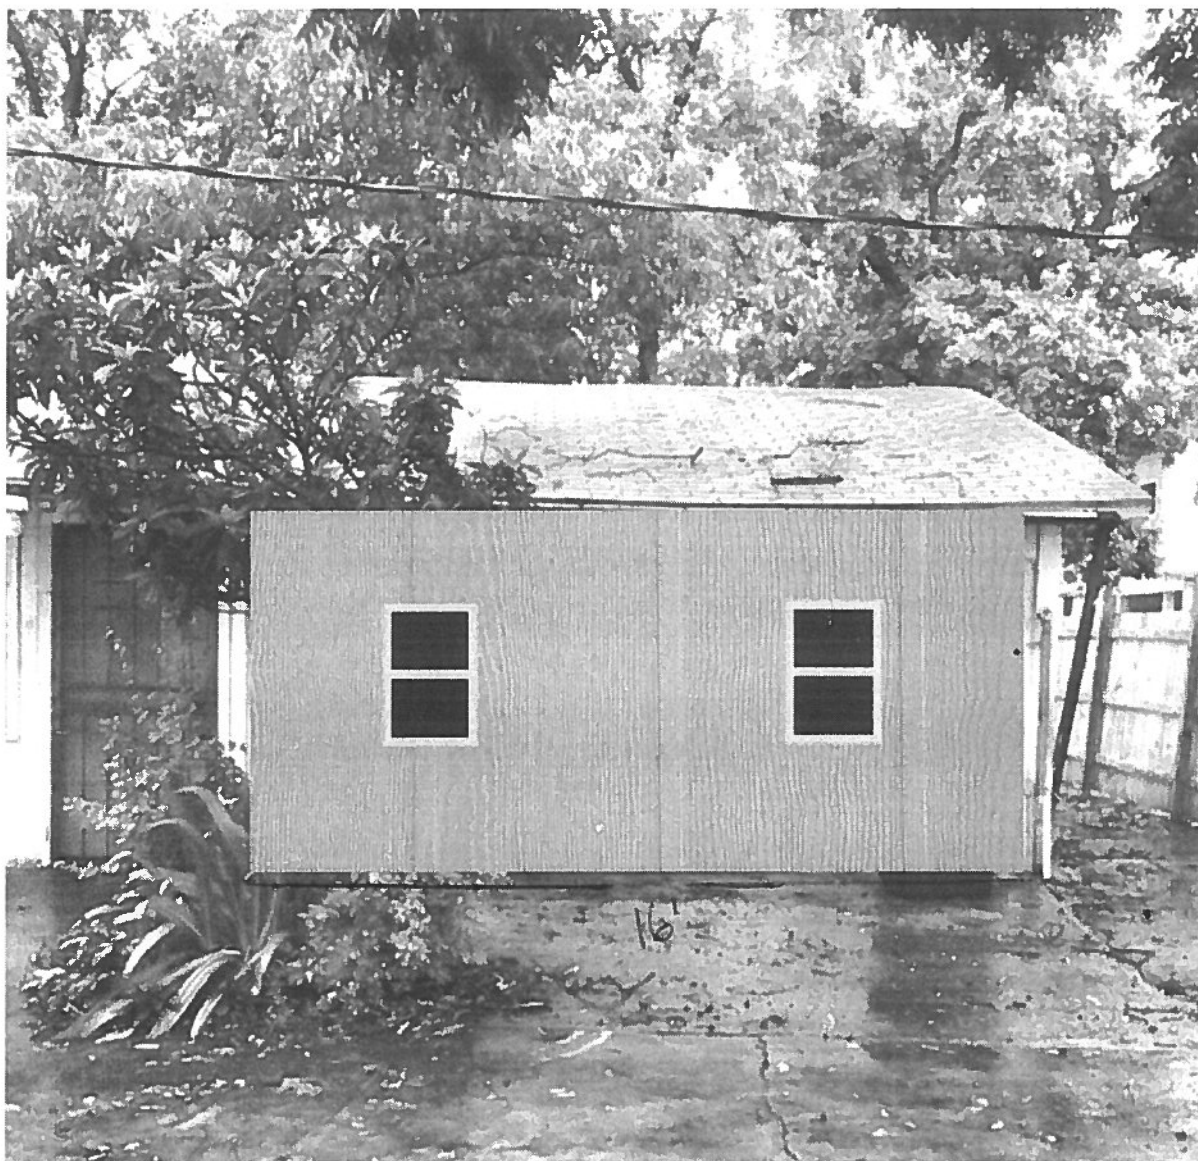
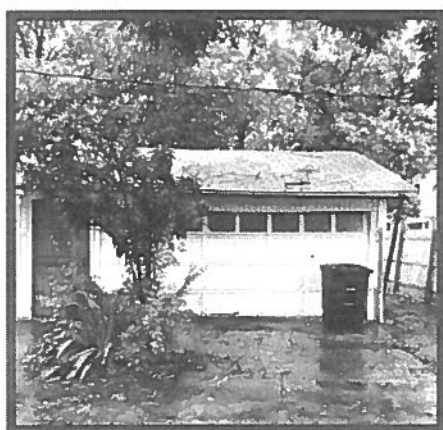
Windows vinyl 24" x 36"
Hardiebacker siding in white paint!

- b. SOUTHERN REAR GARAGE – The structure is a single-story garage featuring vertical Hardi siding, a primary front-facing gabled roof featuring composition shingles, a side addition, a wood-paneled garage door, two doors and a window, each covered with burglar bars. The structure first appears on the 1951 Sanborn map. The structure that once featured a covered parking area has been in-filled to feature the side-facing wooden garage door. The applicant is requesting to replace the existing garage door with two new vinyl windows and infill with Hardi board siding on the side elevation of the rear right accessory structure. While the structure has been subject to non-conforming alterations, staff finds that the proposed modifications would further detract from the primary historic structure, the other historic accessory structure, and are inconsistent with the Guidelines for New Construction 5.A. Staff also finds that the submitted documents are insufficient for final approval.

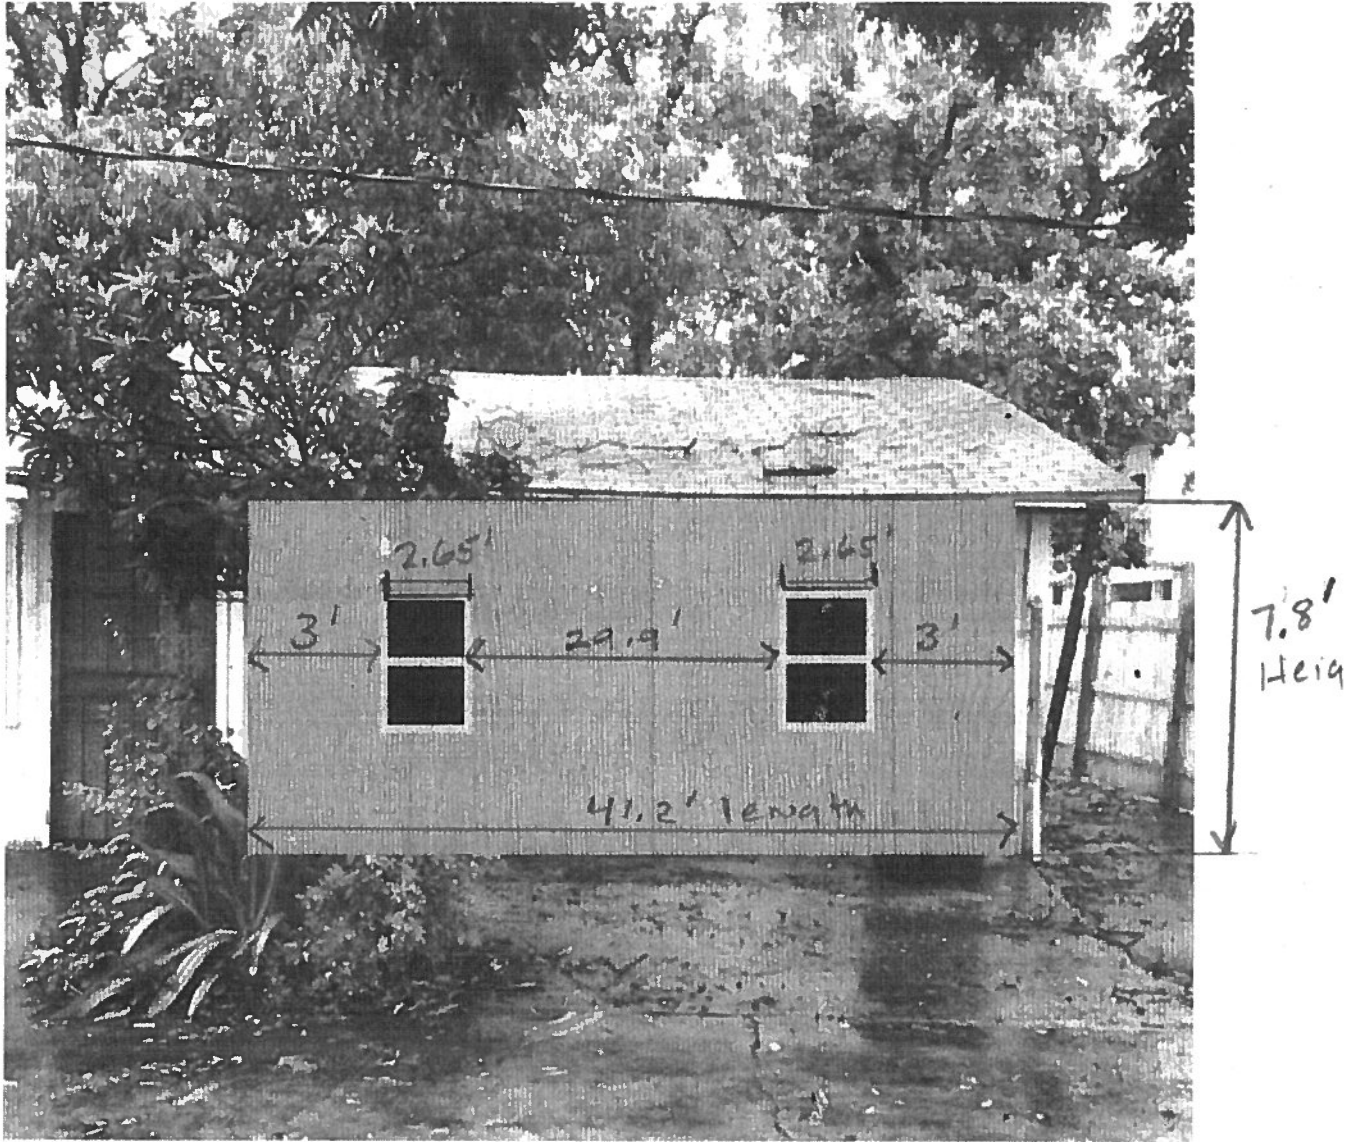
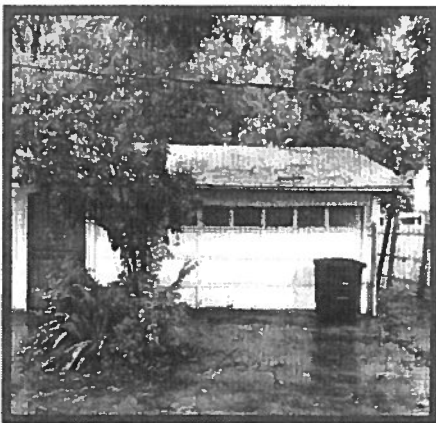
Remove Garage door + replace with hardie backer board that matches the remaining building. $2 \times 4 \times 8'$ boards placed at 16" centers to support hardie board. Paint white to match

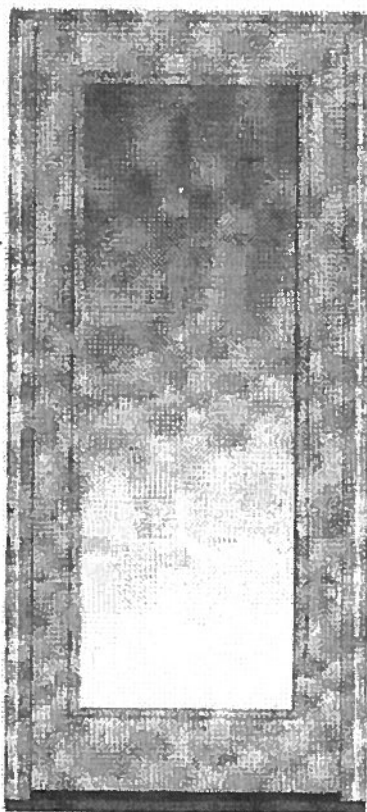
Model # Z000783L Internet #206450100

MMI Door Majestic Steel Front Door unit comes with our MSystem 2-warranty on both the Door Component and the Base Prehung System, as well as a 10-year warranty on the Glass Lite. All of our Majestic Step¹ doors are galvanized to resist rust and corrosion, are comprised of 24-Gauge, high quality steel with 22-Gauge steel stiles and rails for additional strength and security and come with a one-piece, high density polystyrene core delivering excellent insulation allowing it to meet or exceed current energy code standards. Door size is 36 in. x 80 in. Unit dimension is 37.5 in. x 81.75 in. The suggested rough opening is 38 in. x 82.25 in. This unit comes with a 4-9/16 in. wide primed finger jointed frame.
