HISTORIC AND DESIGN REVIEW COMMISSION

HDRC CASE NO: 2018-530
ADDRESS: 520 DAWSON ST
LEGAL DESCRIPTION: NCB 568 BLK 17 LOT W 41 FT OF 5
ZONING: RM-4 H
CITY COUNCIL DIST.: 2
DISTRICT: Dignowity Hill Historic District
APPLICANT: Gaspar Rivera
OWNER: Poma Properties LLC
TYPE OF WORK: General repairs; rear addition; window replacement
APPLICATION RECEIVED: October 08, 2018
60-DAY REVIEW: December 07, 2018
REQUEST:

The applicant is requesting a Certificate of Appropriateness for approval to:

1. Install a 220 square foot rear addition.
2. Install vinyl windows where historic windows are missing or deteriorated.
3. Replace existing doors.

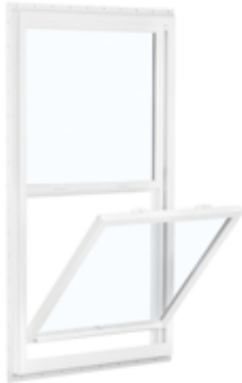
ReliaBilt 150 Vinyl Double
Pane Single Strength New
Construction Single Hung
Window

- h. ADDITION ARCHITECTURAL DETAILS- Generally, staff finds the proposed architectural details to be appropriate.
- i. WINDOW REPLACEMENT – The applicant has proposed to install vinyl windows with a hopper sash on the primary historic structure where windows are missing or deteriorated beyond repair. The Guidelines for Exterior Maintenance and Alterations 6.B.iv. notes that new windows are to match the historic or existing windows in terms of size, type, configuration, material, form, appearance, and detail when original windows are deteriorated beyond repair. Staff does not find the proposed windows to be consistent with the Guidelines. Wood windows are to be repaired in-place and may only be considered for in-kind replacement when deteriorated beyond repair. Window openings with missing windows may be eligible for replacement with vinyl or aluminum-clad on a case by case basis. All window replacements should adhere to the standard stipulations: *Meeting rails that are no taller than 1.25" and stiles no wider than 2.25". White manufacturer's color is not allowed, and color selection must be presented to staff. There should be a minimum of two inches in depth between the front face of the window trim and the front face of the top window sash. This must be accomplished by recessing the window sufficiently within the opening or with the installation of additional window trim to add thickness. Window trim must feature traditional dimensions and an architecturally appropriate sill detail. Window track components must*

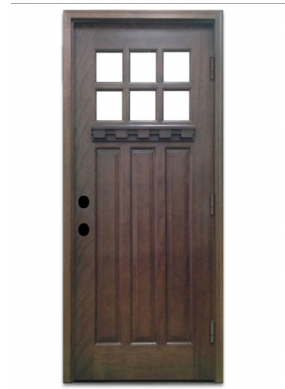
Front Door: Craftstman 6
Lite Stained Mahogany
Wood Prehung

- j. DOOR REPLACEMENT – The applicant has proposed to replace the missing front door with a wood Craftsman door and the rear back door with a divided-light fiberglass door. Per the Guidelines for Exterior Maintenance and Alterations 6.B.i, doors, hardware, fanlight, sidelights, pilasters, and entablatures should be replaced in-kind when possible and when deteriorated beyond repair. When in-kind replacement is not feasible, ensure features match the size, material, and profile of the historic element. Staff finds that the proposed door replacements are consistent with the Guidelines.
