HISTORIC AND DESIGN REVIEW COMMISSION

HDRC CASE NO: 2018-584
ADDRESS: 107 PASO HONDO
LEGAL DESCRIPTION: NCB 591 BLK 4 LOT 14
ZONING: RM-4, H
CITY COUNCIL DIST.: 2
DISTRICT: Dignowity Hill Historic District
APPLICANT: Cotton Estes/High Cotton Architects
OWNER: Anthony Corbin, William Carson
TYPE OF WORK: Modifications to the original roof form, window replacement
APPLICATION RECEIVED: November 16, 2018
60-DAY REVIEW: January 15, 2019
REQUEST:

The applicant is requesting conceptual approval to perform rehabilitative scopes of work to the historic structure at 107 Paso Hondo as well as perform exterior modifications. Within this request, the applicant has proposed the following:

Address: 107 Paso Hondo Street
Owners: William Carson & John Corbin
Conceptual Design 11.16.2018
HighCotton Architects

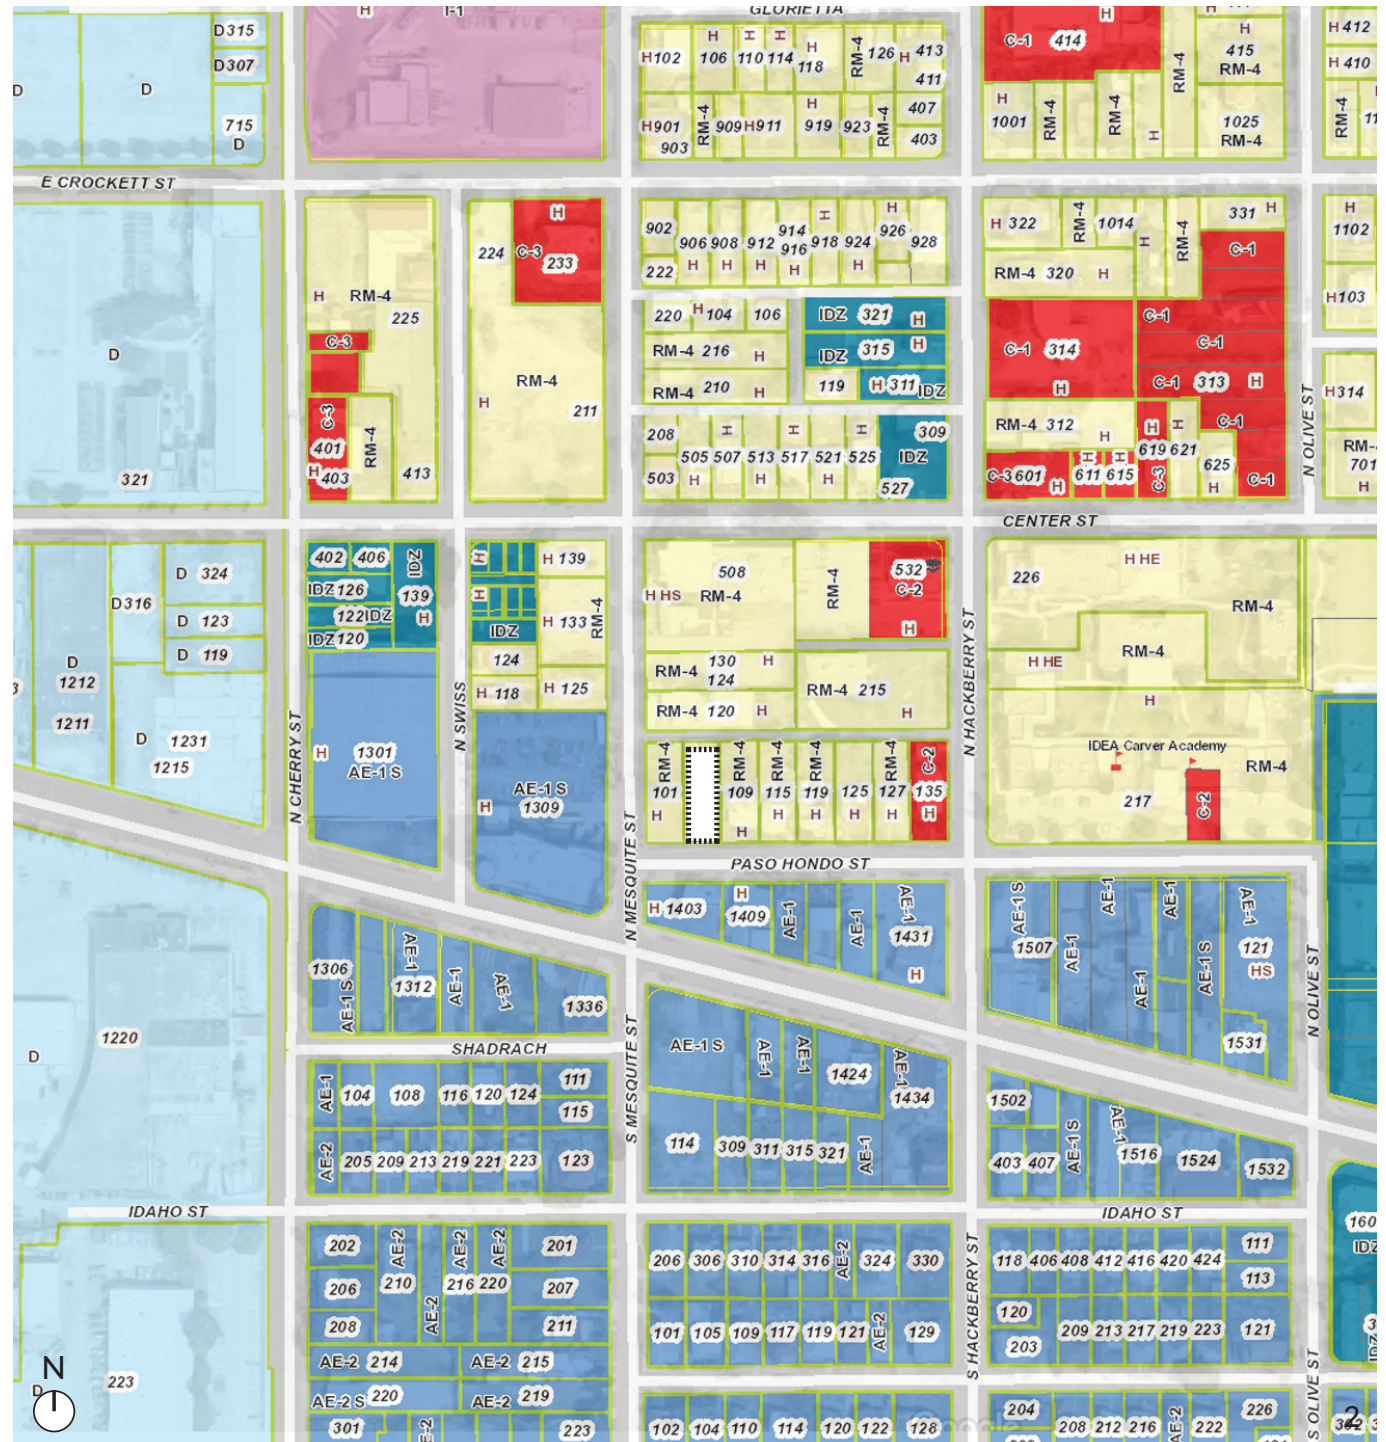
CONTEXT MAP: Adjacent Uses

The immediate neighbors of 107 Paso Hondo consist of one vacant residence (east), a gas station (south), a 6-story Holiday Inn and parking lot (west), and a medicare service center (north). Commercial uses surround this residential block on all four sides.

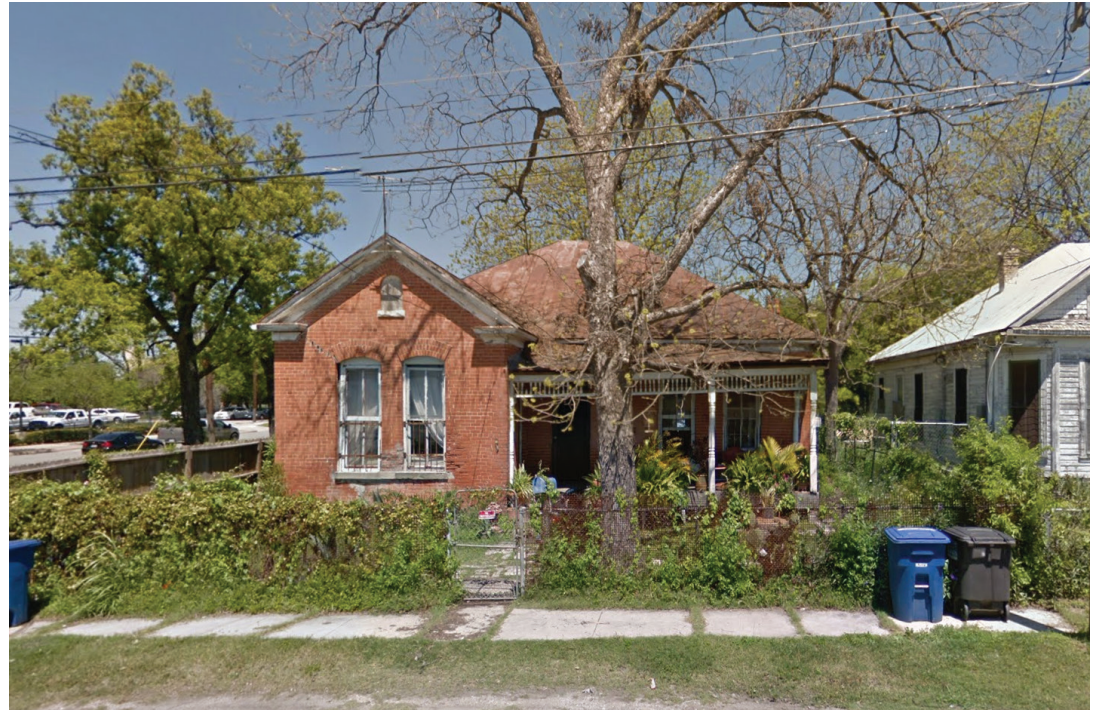
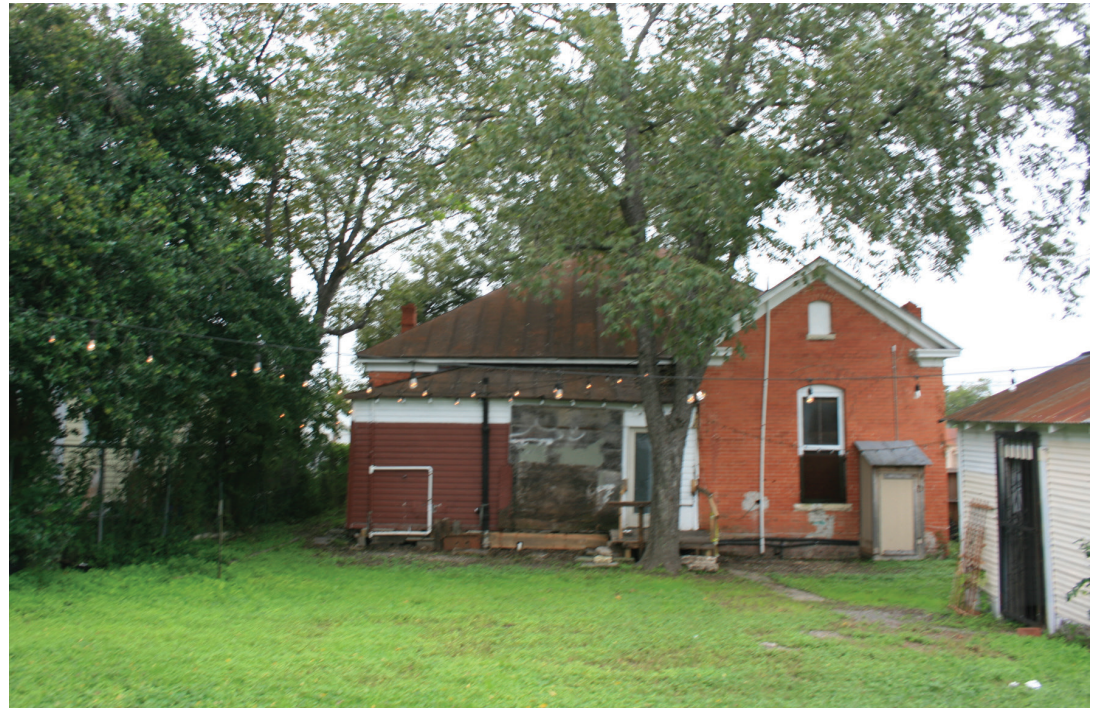
Top:
South Elevation (view from Paso Hondo Street)

Bottom:
North Elevation (view from Backyard)

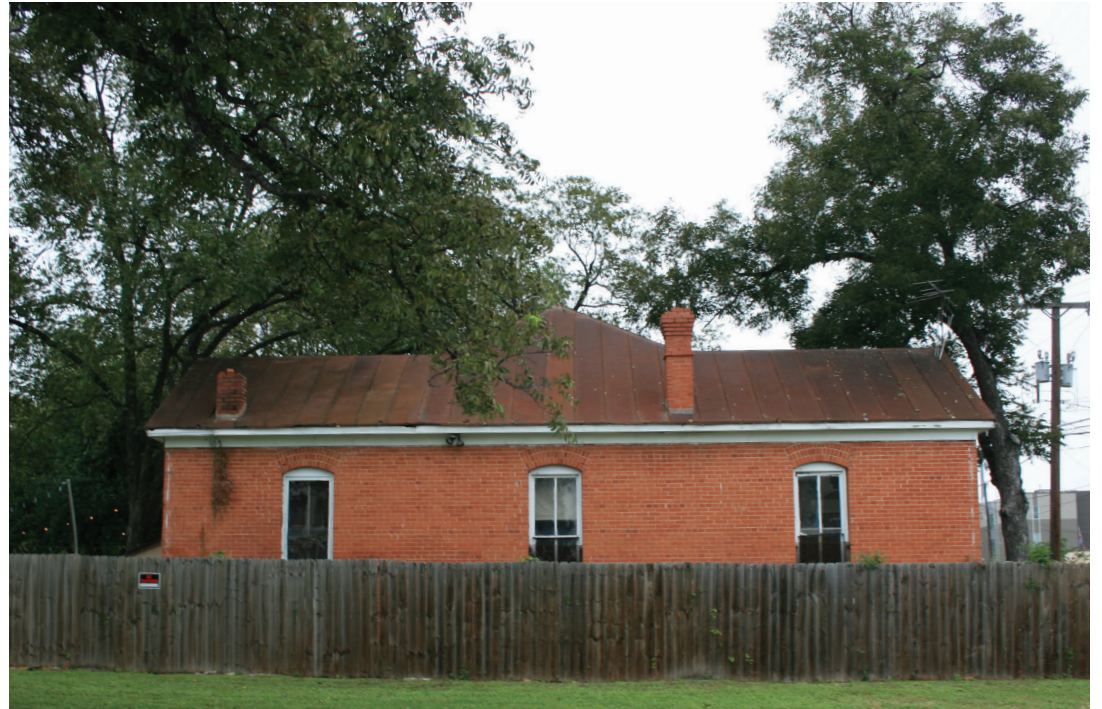
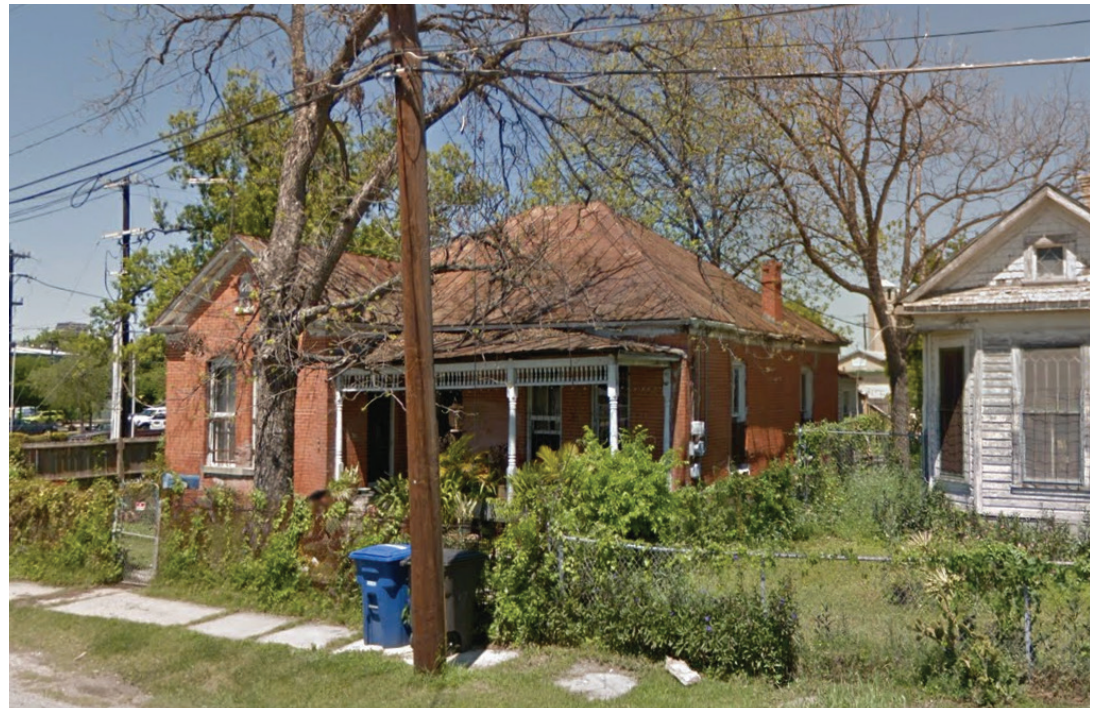
Top:
West Elevation (view from N Mesquite St.)

Bottom:
East Elevation (view from Paso Hondo St. looking northwest)

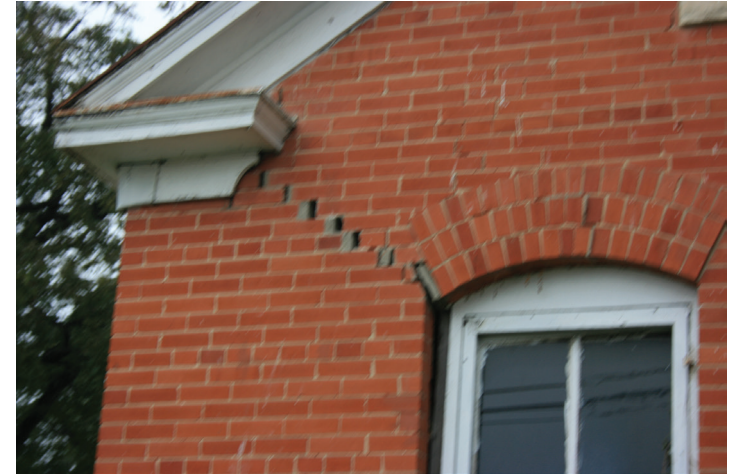
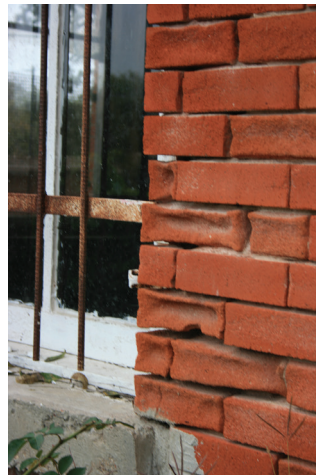
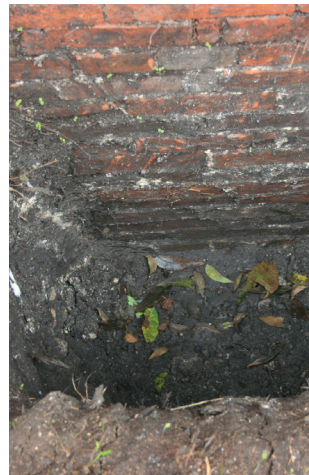
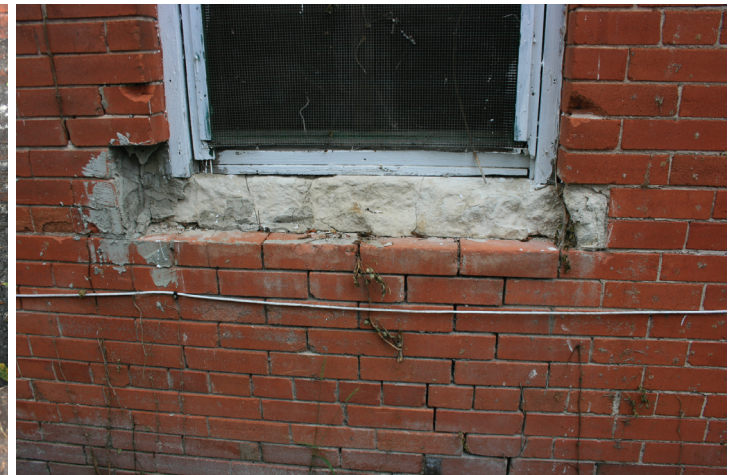
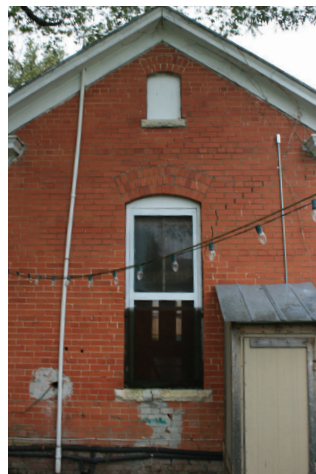
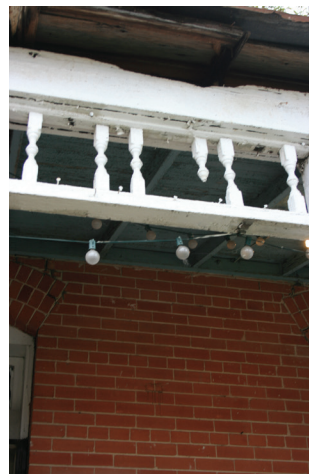
Additional Views & Existing Conditions:

- Foundation appears to be 42" deep continuation of brick walls set on rubble base
- Erosion of stone sills and brick next to windows due to splashback from poorly repaired sills
- Exterior wood trim, soffits, cornices, posts and spindles require intensive restoration work
- Extensive brick patching, repointing and select reconstruction may be needed

Although in dire disrepair, the original architecture is largely in tact. The original exterior walls are constructed of double-wythe brick, extending at least 42" below grade. Due to the brick construction of the exterior wall foundations, re-leveling the brick foundation is not an option based on the opinion of several engineers. Instead, new piers will be poured within the original footprint in order to re-level the floors and avoid any further damage to the existing foundation. Insulated walls will be built on top of the new piers, honoring the existing fenestration.
