HISTORIC AND DESIGN REVIEW COMMISSION March 20, 2019

HDRC CASE NO: 2019-106

ADDRESS: 516 WILLOW ST

TYPE OF WORK: Construction of a rear addition, siding replacement, roof replacement, column

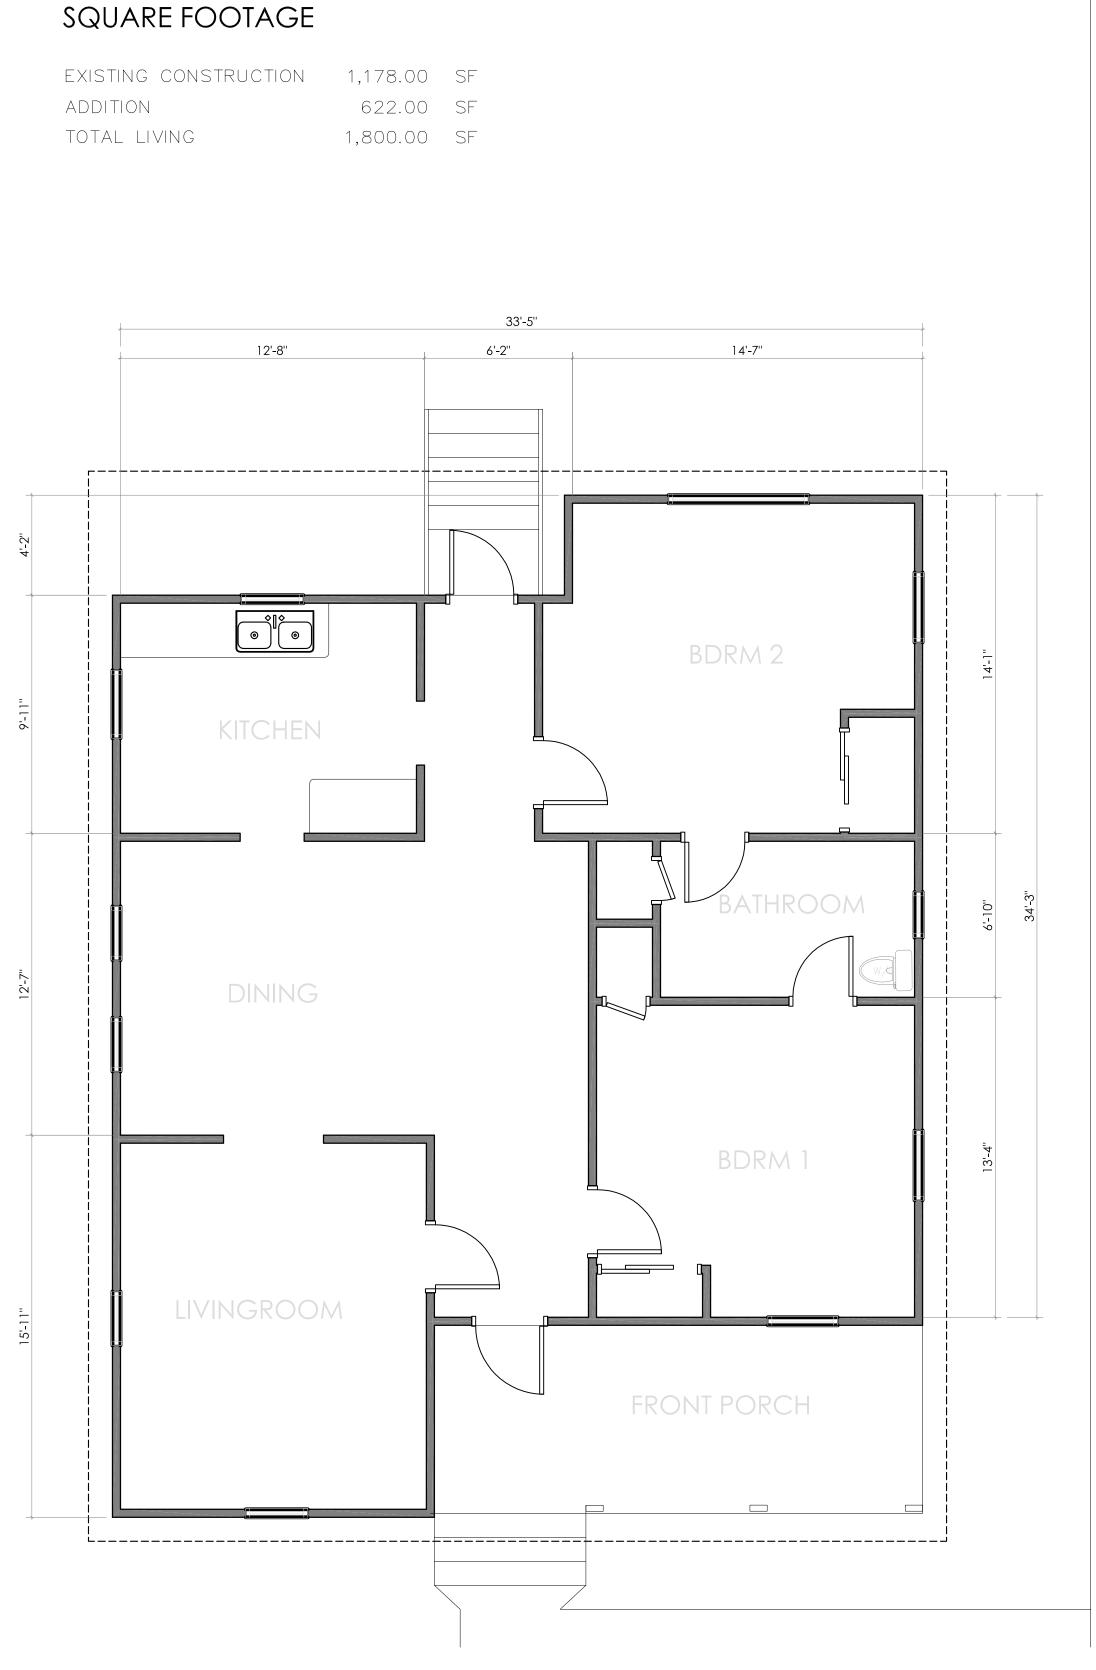
EXISTING FLOOR PLAN

1/4' = 1'-0" LIVING 1,178.00 SF

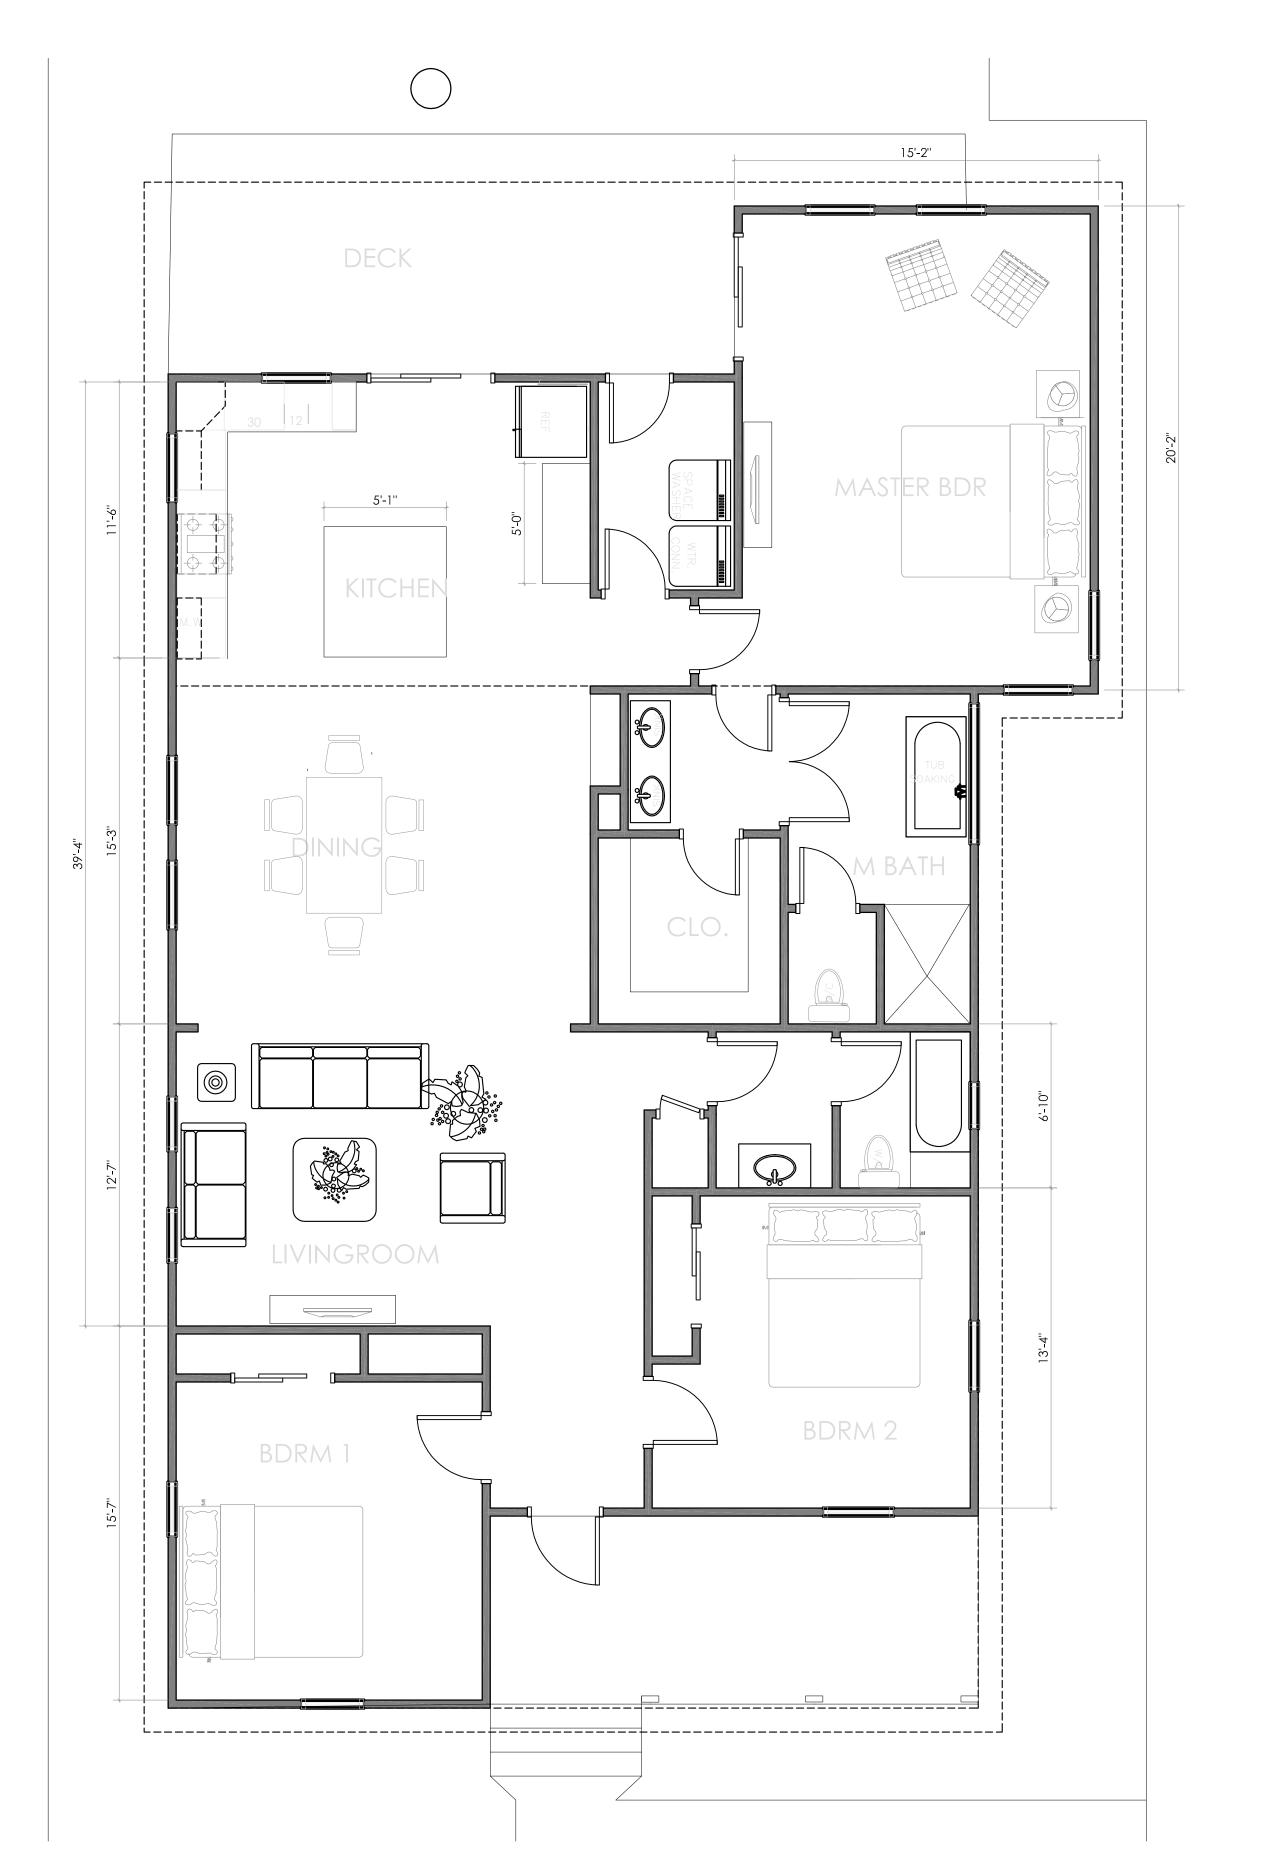
PROPOSED FLOOR PLAN

1/4' = 1'-0" LIVING 1,800.00 SF

- 7. Staff recommends approval of item #8, the construction of a rear addition based on findings i through m with the following stipulations:
 - i. That the applicant modify the proposed design to feature an inset from both wall planes of the historic structure.
