HISTORIC AND DESIGN REVIEW COMMISSION

HDRC CASE NO: 2019-226
ADDRESS: 933 BURNET ST
LEGAL DESCRIPTION: NCB 1656 BLK D LOT S 131 FT OF 18
ZONING: RM-6, H
CITY COUNCIL DIST.: 2
DISTRICT: Dignowity Hill Historic District
APPLICANT: Travis Louie
OWNER: Yet Homes LLC
TYPE OF WORK: Exterior modifications, fenestration modifications, installation of porch railings
APPLICATION RECEIVED: April 11, 2019
60-DAY REVIEW: June 12, 2019
CASE MANAGER: Edward Hall
REQUEST:

The applicant is requesting a Certificate of Appropriateness for approval to:

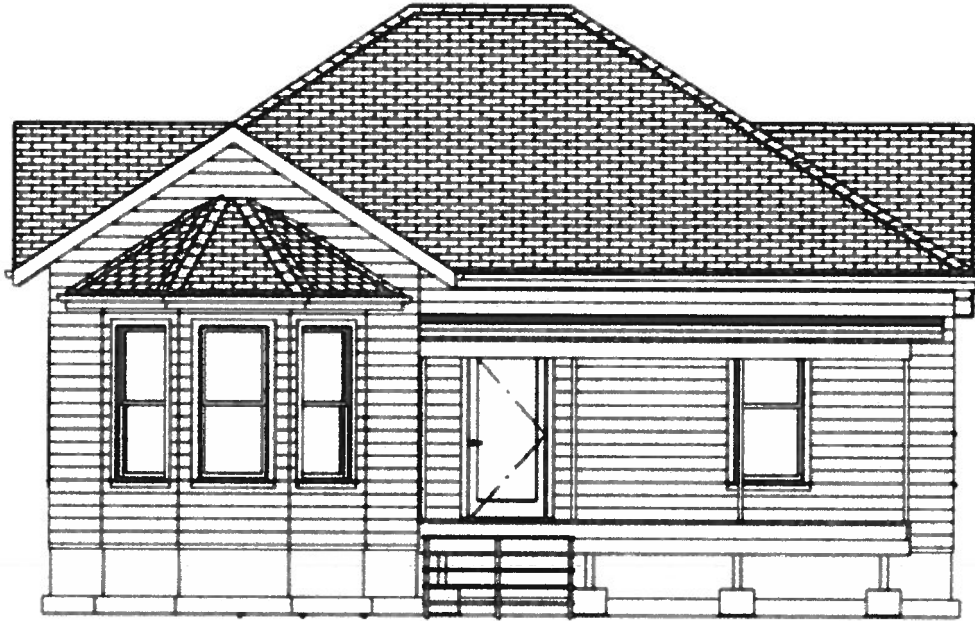
South

Existing elevations

- a. The historic structure located at 933 Burnet was constructed circa 1910 in the Folk Victorian architectural style and is found on the 1912 Sanborn Map. The structure features a protruding front bay with a front facing gabled roof, side gables and a primary hipped roof. The structure is contributing to the Dignowity Hill Historic District.

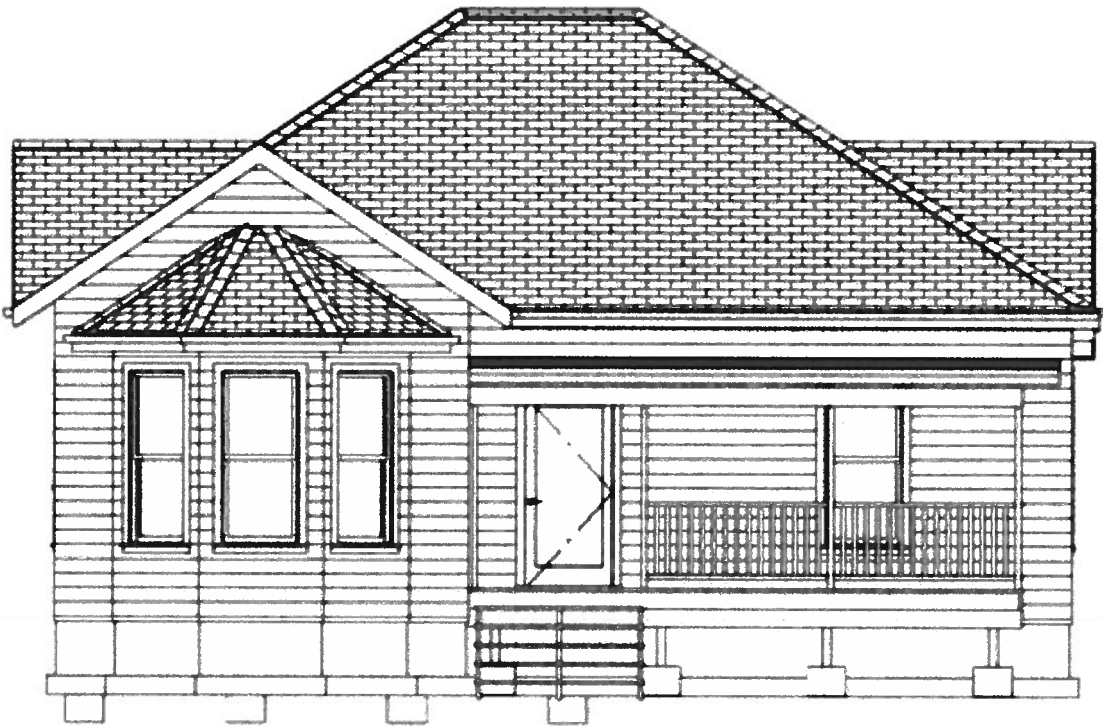
South

Proposed Elevations

- c. PORCH RESTORATION – The applicant has proposed to restore the front porch, which currently does not feature its original porch columns. Staff finds that repairs to the existing porch are appropriate; however, new columns should be six (6) inches square and feature both capital and base trim. A skirting should be installed that is appropriate for the
