HISTORIC AND DESIGN REVIEW COMMISSION

HDRC CASE NO: 2019-279
ADDRESS: 133 W CRAIG PLACE
LEGAL DESCRIPTION: NCB 1860 BLK 1 LOT 21
ZONING: MF-33,H
CITY COUNCIL DIST.: 1
DISTRICT: Monte Vista Historic District
APPLICANT: Carolanne Bright
OWNER: Carolanne Bright
TYPE OF WORK: Window replacement
APPLICATION RECEIVED: May 15, 2019
60-DAY REVIEW: July 14, 2019
CASE MANAGER: Stephanie Phillips

The applicant is requesting a Certificate of Appropriateness for approval to replace historic one over one wood windows with new vinyl windows. 6 windows are located in the primary structure and approximately 16 windows are located in the carriage house.

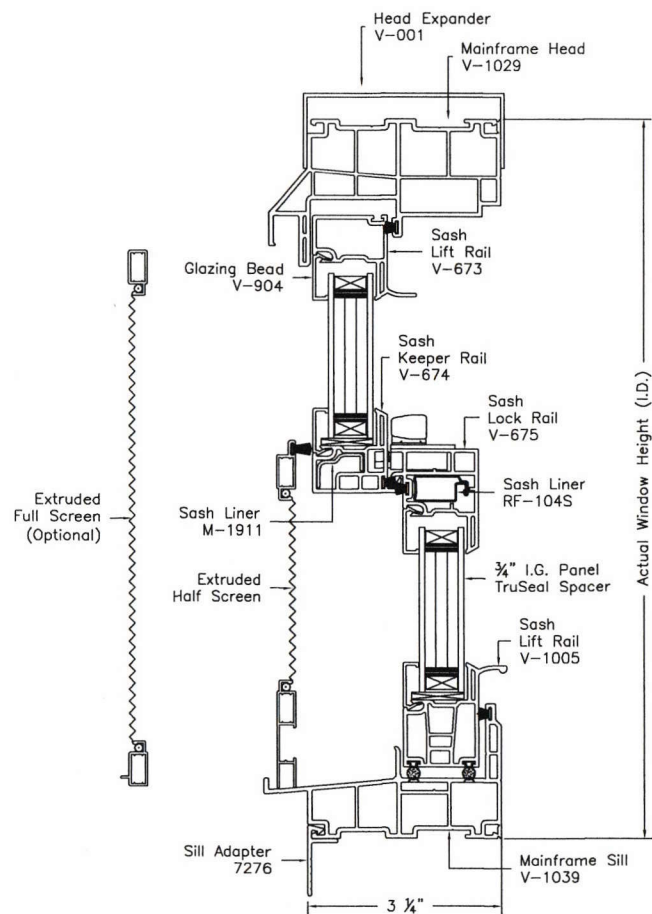
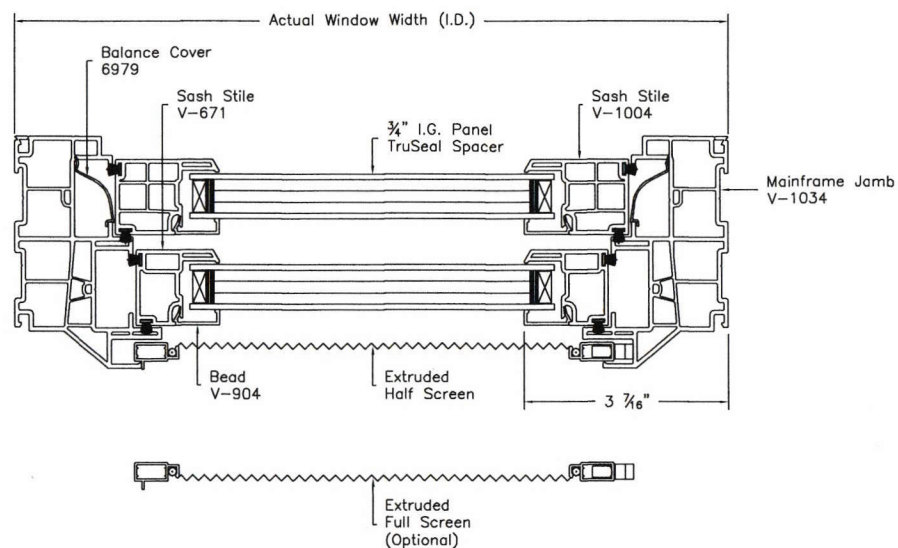
Hardware - Sash balancing mechanisms to consist of stainless steel constant force springs. Two hybrid, recessed mount, cam-type sweep locks are to be located equidistant from each end of the interlocking rail. Two metal, recessed sweep lock keepers to be fastened to the exterior interlocking rail. One injection molded thermo-plastic tilt latch shall be used at the ends of the top rail of each sash. A vinyl sash stop shall be used at the bottom of each exterior jamb track and a rigid vinyl balance cover on the interior jamb track. All screws, clips and other fasteners to be made of non-corrosive materials compatible with reinforcements.

MATERIAL:		MIWD MI WINDOWS AND DOORS <small>650 WEST MARKET STREET, SUITE, PA 17033-0070</small> The information, design or data shown on this document or electronic media is the exclusive property of MI Windows and Doors, LLC. It is considered confidential and proprietary and is made available for limited use only. Its use or reproduction without the expressed written consent of MI Windows and Doors, LLC., is prohibited.	DESCRIPTION: 1650 Series Double Hung with Finless Mainframe	
				FINISH:	UNSPECIFIED WALL:			
				AREA:				
				WEIGHT:	BREAK ALL CORNERS R.015, UNLESS OTHERWISE SPECIFIED			
B	095A-17 116A-17	Removed pile from top sash Increased sash height 1/16"	11-6-17	VMR		PRODUCT: 1650DH SCALE: 1:2 DFTM: BRS	DATE: 01/08/16	
A	163A-16	Added optional DP Upgrade liner	12/27/16	VMR			PART NUMBER:	
LTR	ECN #	REVISIONS	DATE	BY	PERIMETER:		DRAWING NUMBER: CS-000279

We are trying to achieve a uniform look and consistency in the Main house to match the current replacement windows. All of the replacement windows will have meeting rails of 1-3/4”, stiles that are 1-5/8” and are white.
