HISTORIC AND DESIGN REVIEW COMMISSION

HDRC CASE NO: 2019-343
ADDRESS: 414 DONALDSON AVE
LEGAL DESCRIPTION: NCB 1932 BLK 39 LOT 26 AND 27
ZONING: R-6,H
CITY COUNCIL DIST.: 7
DISTRICT: Monticello Park Historic District
APPLICANT: KKW Donaldson
OWNER: San Antonio San Antonio/KKW Donaldson
TYPE OF WORK: Window replacement, painting brick, replace siding
APPLICATION RECEIVED: May 22, 2019
60-DAY REVIEW: July 21, 2019
CASE MANAGER: Stephanie Phillips
REQUEST:

The applicant is requesting a Certificate of Appropriateness for approval to:

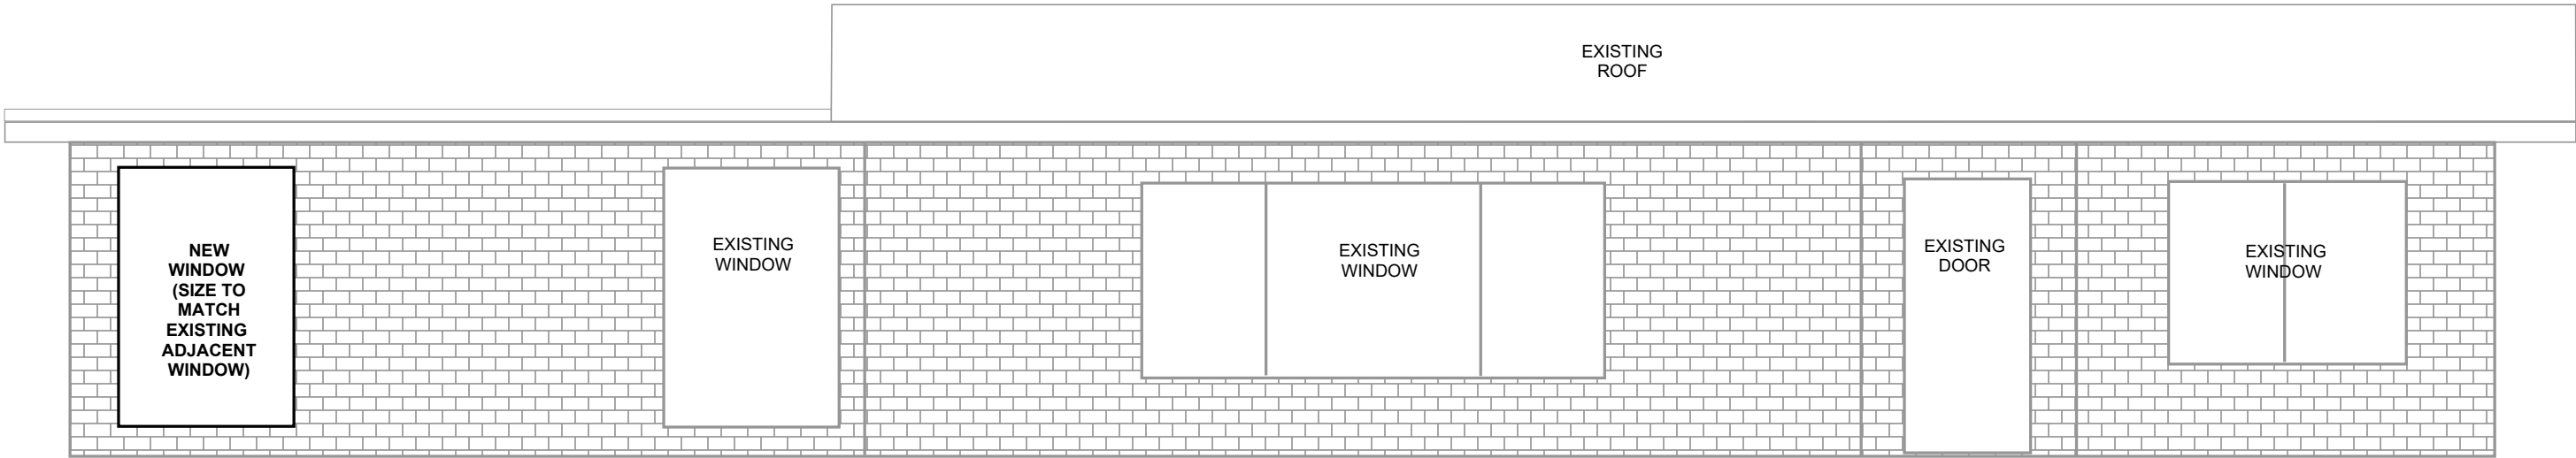
414 DONALDSON - ADDITION OF (1) WINDOW - ELEVATION

- e. WINDOW INSTALLATION – The applicant has proposed to install a new window on the front façade. The window is to match the size, material, and configuration of the proposed replacement window noted in finding d. The new window will be visible from the public right-of-way. Staff generally finds the location appropriate, but does not find a square window to be appropriate. Staff finds that a rectangular window that matches the existing size of the adjacent window in finding d be installed to add balance and maintain the original proportionality of the windows.

- i. That the window size matches the existing opening on the front façade as noted in finding d. The applicant is required to submit an updated window specification to staff with dimensions for review and approval.
