HISTORIC AND DESIGN REVIEW COMMISSION

HDRC CASE NO: 2019-415
ADDRESS: 813 BURLESON ST
LEGAL DESCRIPTION: NCB 1301 BLK 2 LOT 17
ZONING: R-5, H
CITY COUNCIL DIST.: 2
DISTRICT: Dignowity Hill Historic District
APPLICANT: Melissa Iruegas/River City Acquisitions
OWNER: Kyle Braunlich
TYPE OF WORK: Front porch modifications
APPLICATION RECEIVED: July 18, 2019
60-DAY REVIEW: September 16, 2019
CASE MANAGER: Edward Hall
REQUEST:

The applicant is requesting a Certificate of Appropriateness for approval to:

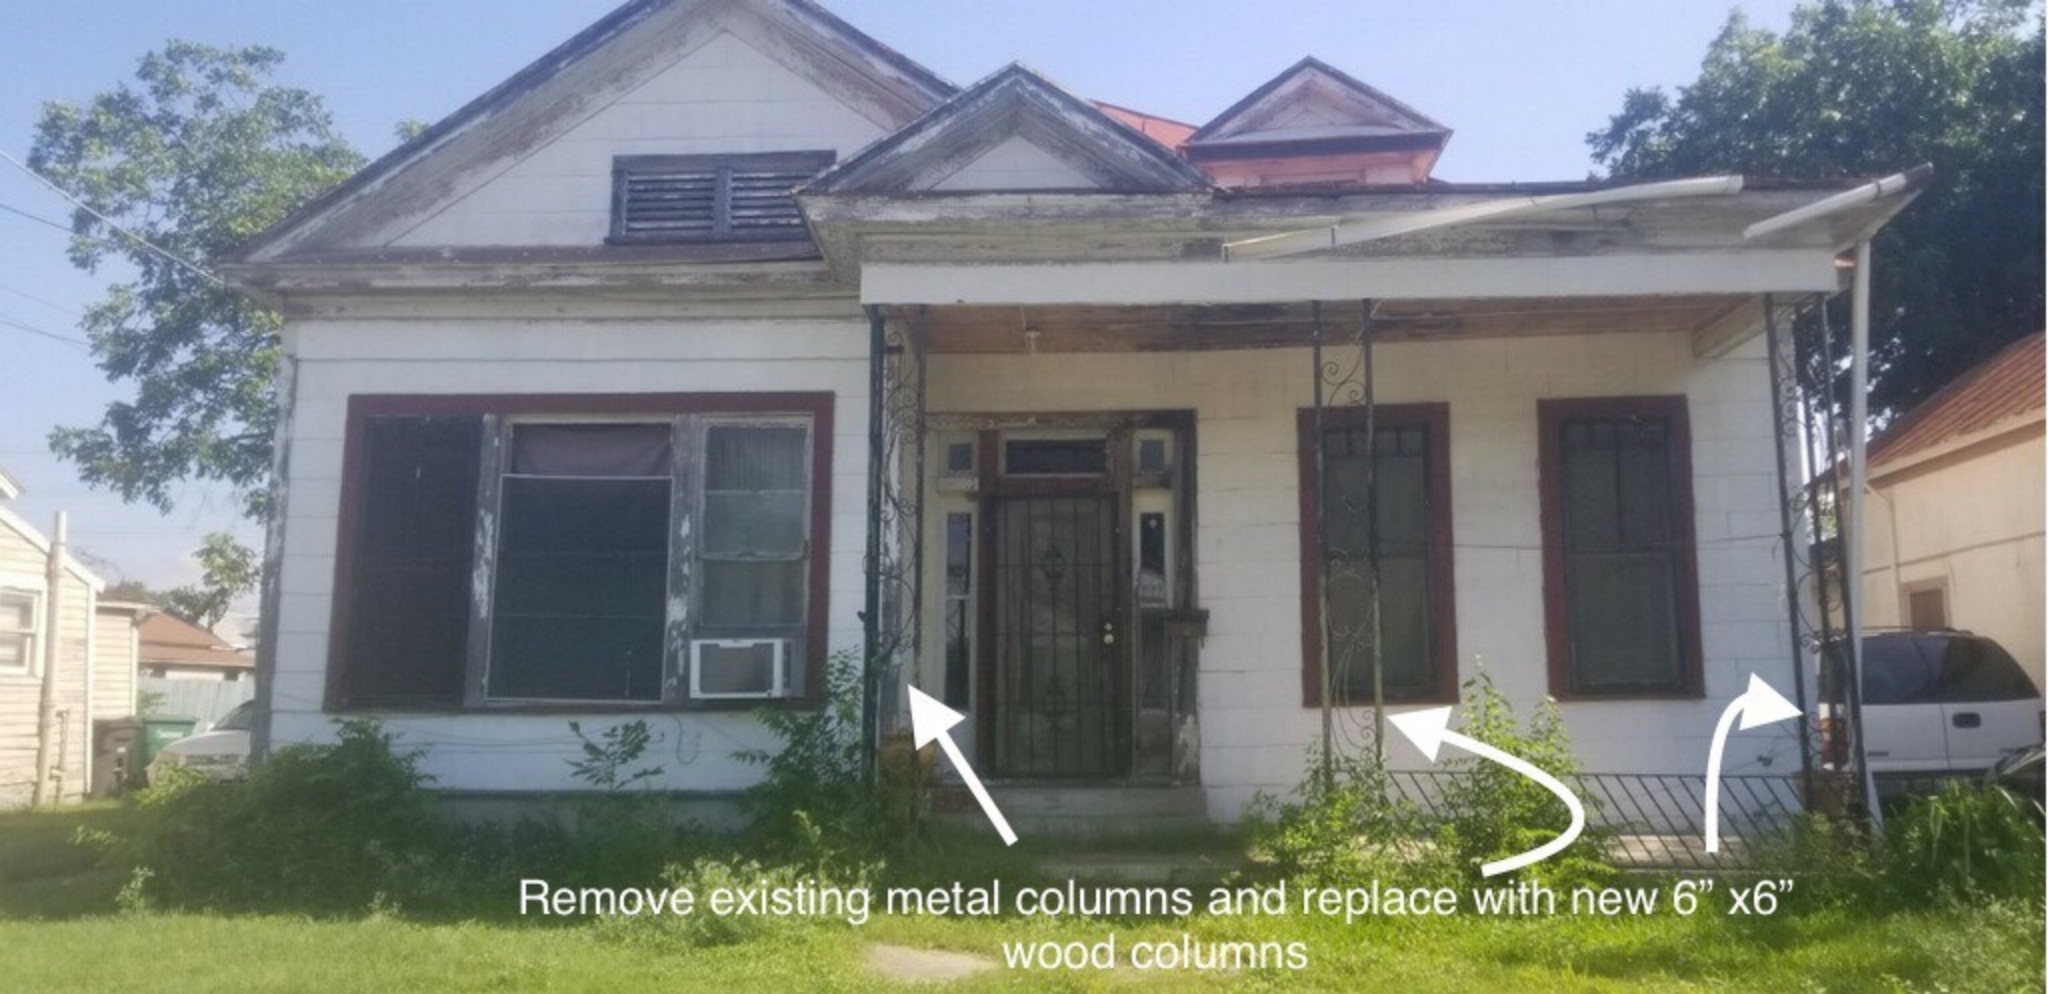
Remove existing metal columns and replace with new 6" x6"
wood columns

- e. PORCH COLUMNS – The applicant has proposed to replace the existing, non-original wrought iron porch columns with six inch square wood columns. The applicant has noted that the proposed columns will feature both base and capital trim. Staff finds the proposed column replacement to be appropriate; however, staff finds that the proposed columns should feature chamfered corners. An updated column detail is to be submitted to OHP staff for review and approval prior to the issuance of a Certificate of Appropriateness.

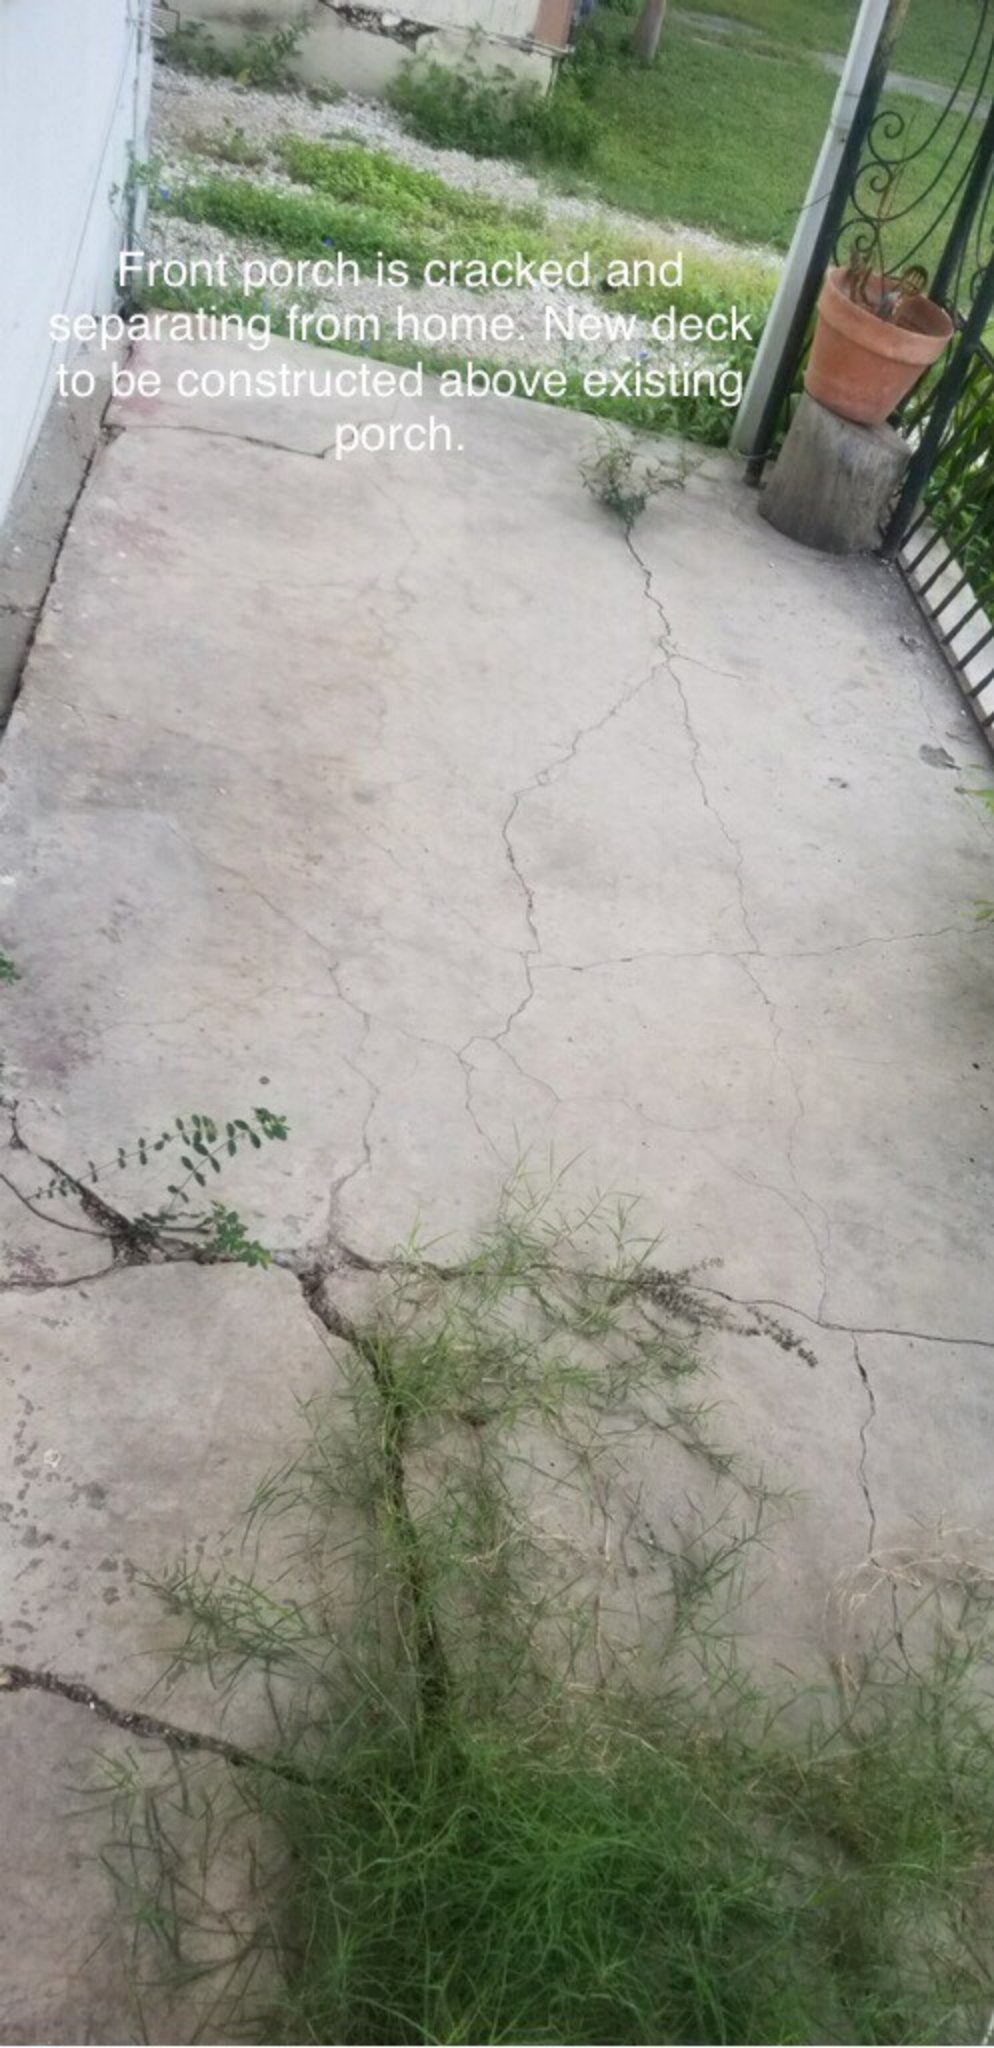
NEW FRONT
PORCH STEPS

2x6 floor joists

NEW 6" x 6" wood posts to
support existing porch cover

2x4 bottom
AND TOP
HORIZONTAL
RAIL

- d. PORCH STEPS – As noted in finding b, the structure currently features concrete steps that the applicant has proposed to demolish and replace with wood steps. Staff finds that the proposed porch steps should feature a common width of the sidewalk apron/flare. A detail of this width is to be submitted to OHP staff for review and approval prior to the issuance of a Certificate of Appropriateness.
