HISTORIC AND DESIGN REVIEW COMMISSION

HDRC CASE NO: 2019-505
ADDRESS: 268 THORAIN BLVD
LEGAL DESCRIPTION: NCB 9009 BLK 5 LOT 12 AND 13
ZONING: R-4,H
CITY COUNCIL DIST.: 1
DISTRICT: Olmos Park Terrace Historic District
APPLICANT: John Bonillas/CASA Exteriros
OWNER: RUEDA GABRIEL ANDRES & RUEDA JAIME & RUEDA LAURA E
TYPE OF WORK: Demolition of garage with new construction
APPLICATION RECEIVED: August 23, 2019
60-DAY REVIEW: October 22, 2019
CASE MANAGER: Stephanie Phillips
REQUEST:

1. Demolish the existing rear garage.
2. Reconstruct the rear garage in the same footprint, height, design, and configuration.

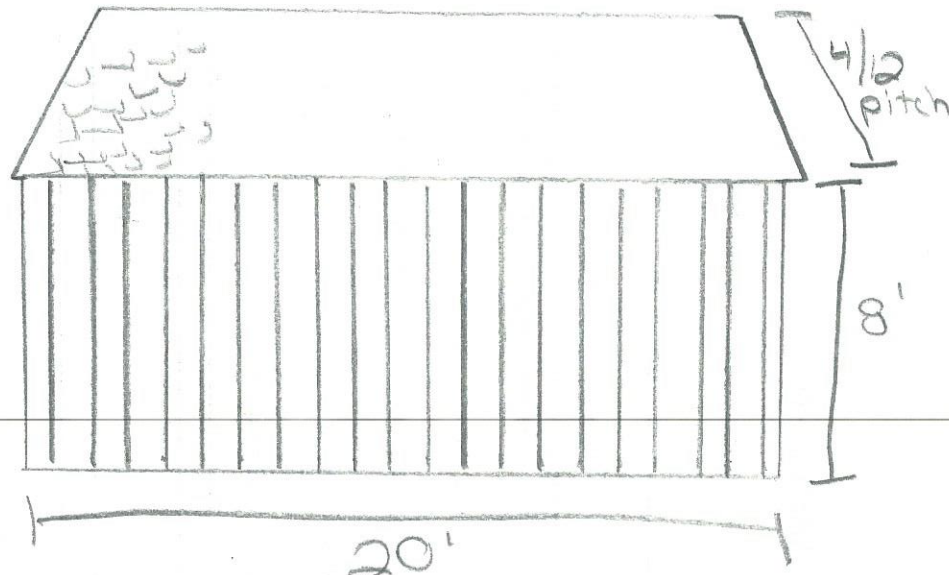
Elevation
Elevation

- Dimensional Shingle Roof
- Wood Board/Batten Siding
- No windows
- Exact dimensions/pitch as previous structure
- Follow IBC

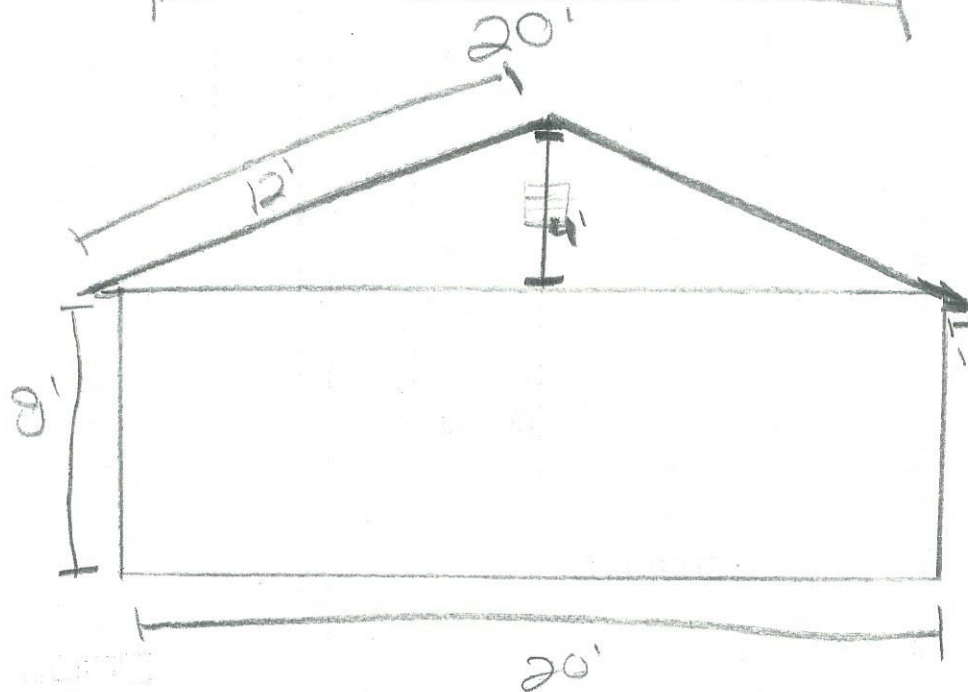
Rear Elevation

- Rear Gable Vent
- Wood Board/Batten Siding
- 1' overhang soffitt
- No windows
- Follow IBC

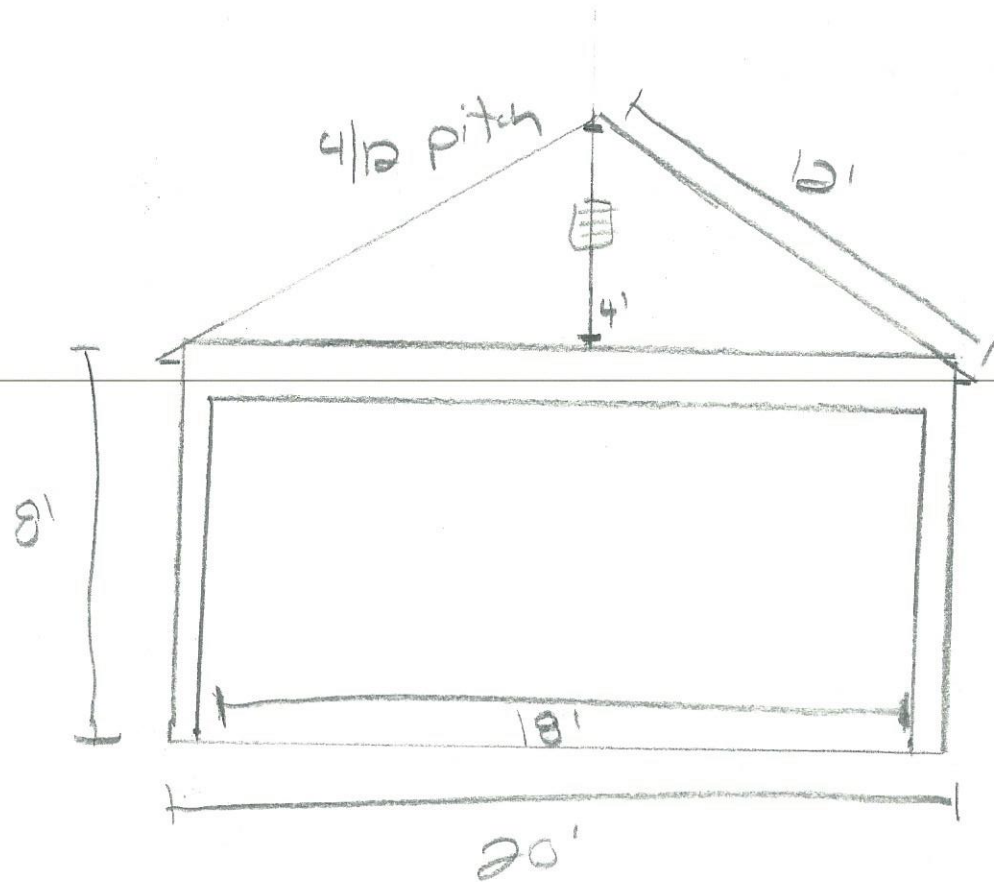
- No Garage Doors
- Double Car opening
- 1 Gable Vent
- Board/Batten Siding
- Follow IRC

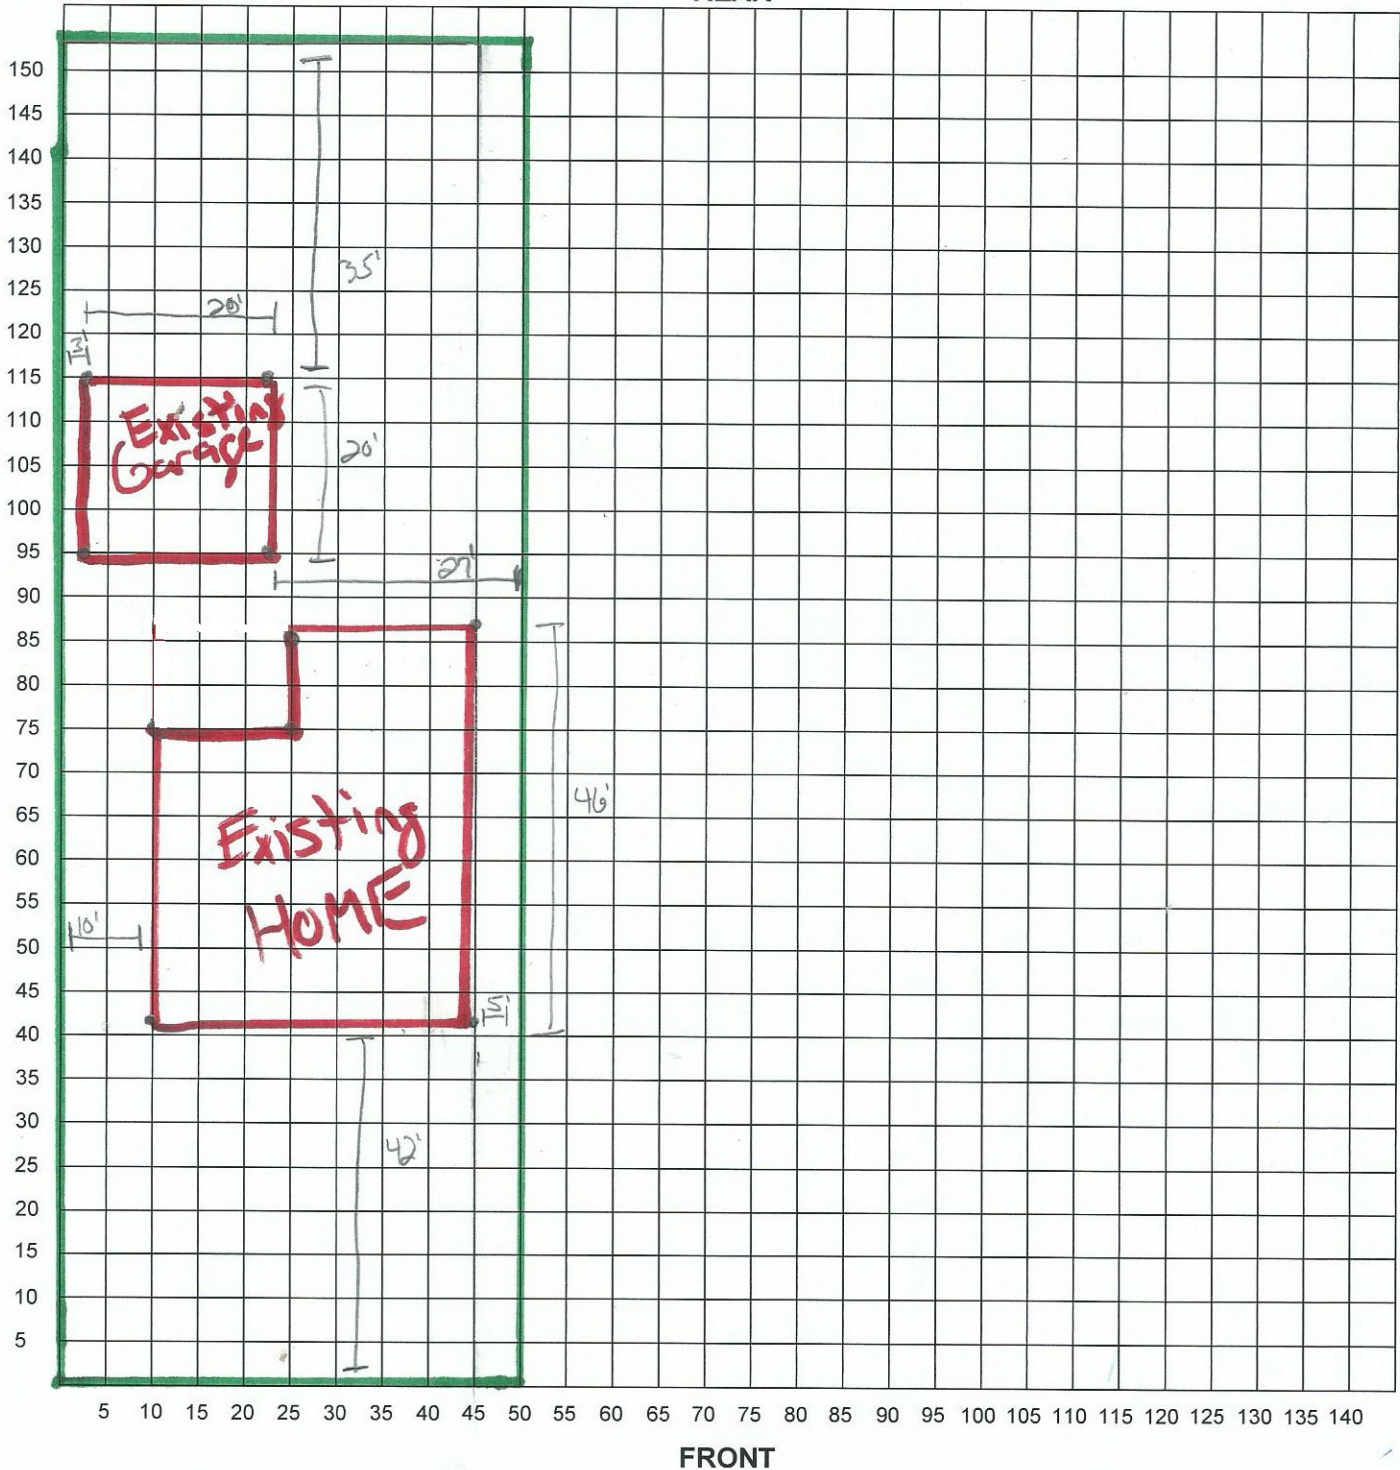
REAR

I certify that the above plot plan shows all improvements on this property and that there will be no construction over easements. I also certify that I will build in compliance with the UDC and the 2015 IRC.
