# HISTORIC AND DESIGN REVIEW COMMISSION

**HDRC CASE NO:** 2019-470  
**ADDRESS:** 323 LEIGH ST  
**LEGAL DESCRIPTION:** NCB 721 BLK 3 LOT S 80.04 FT OF 6  
**ZONING:** RM-4,H  
**CITY COUNCIL DIST.:** 1  
**DISTRICT:** Lavaca Historic District  
**APPLICANT:** Desiree Williams  
**OWNER:** Patrick Baccelieri  
**TYPE OF WORK:** Window replacement  
**APPLICATION RECEIVED:** September 23, 2019  
**60-DAY REVIEW:** November 22, 2019  
**REQUEST:**

The applicant is requesting a Certificate of Appropriateness for approval to replace nine (9) one over one wood windows with new windows. The four (4) one over one wood windows on the front façade will be retained.

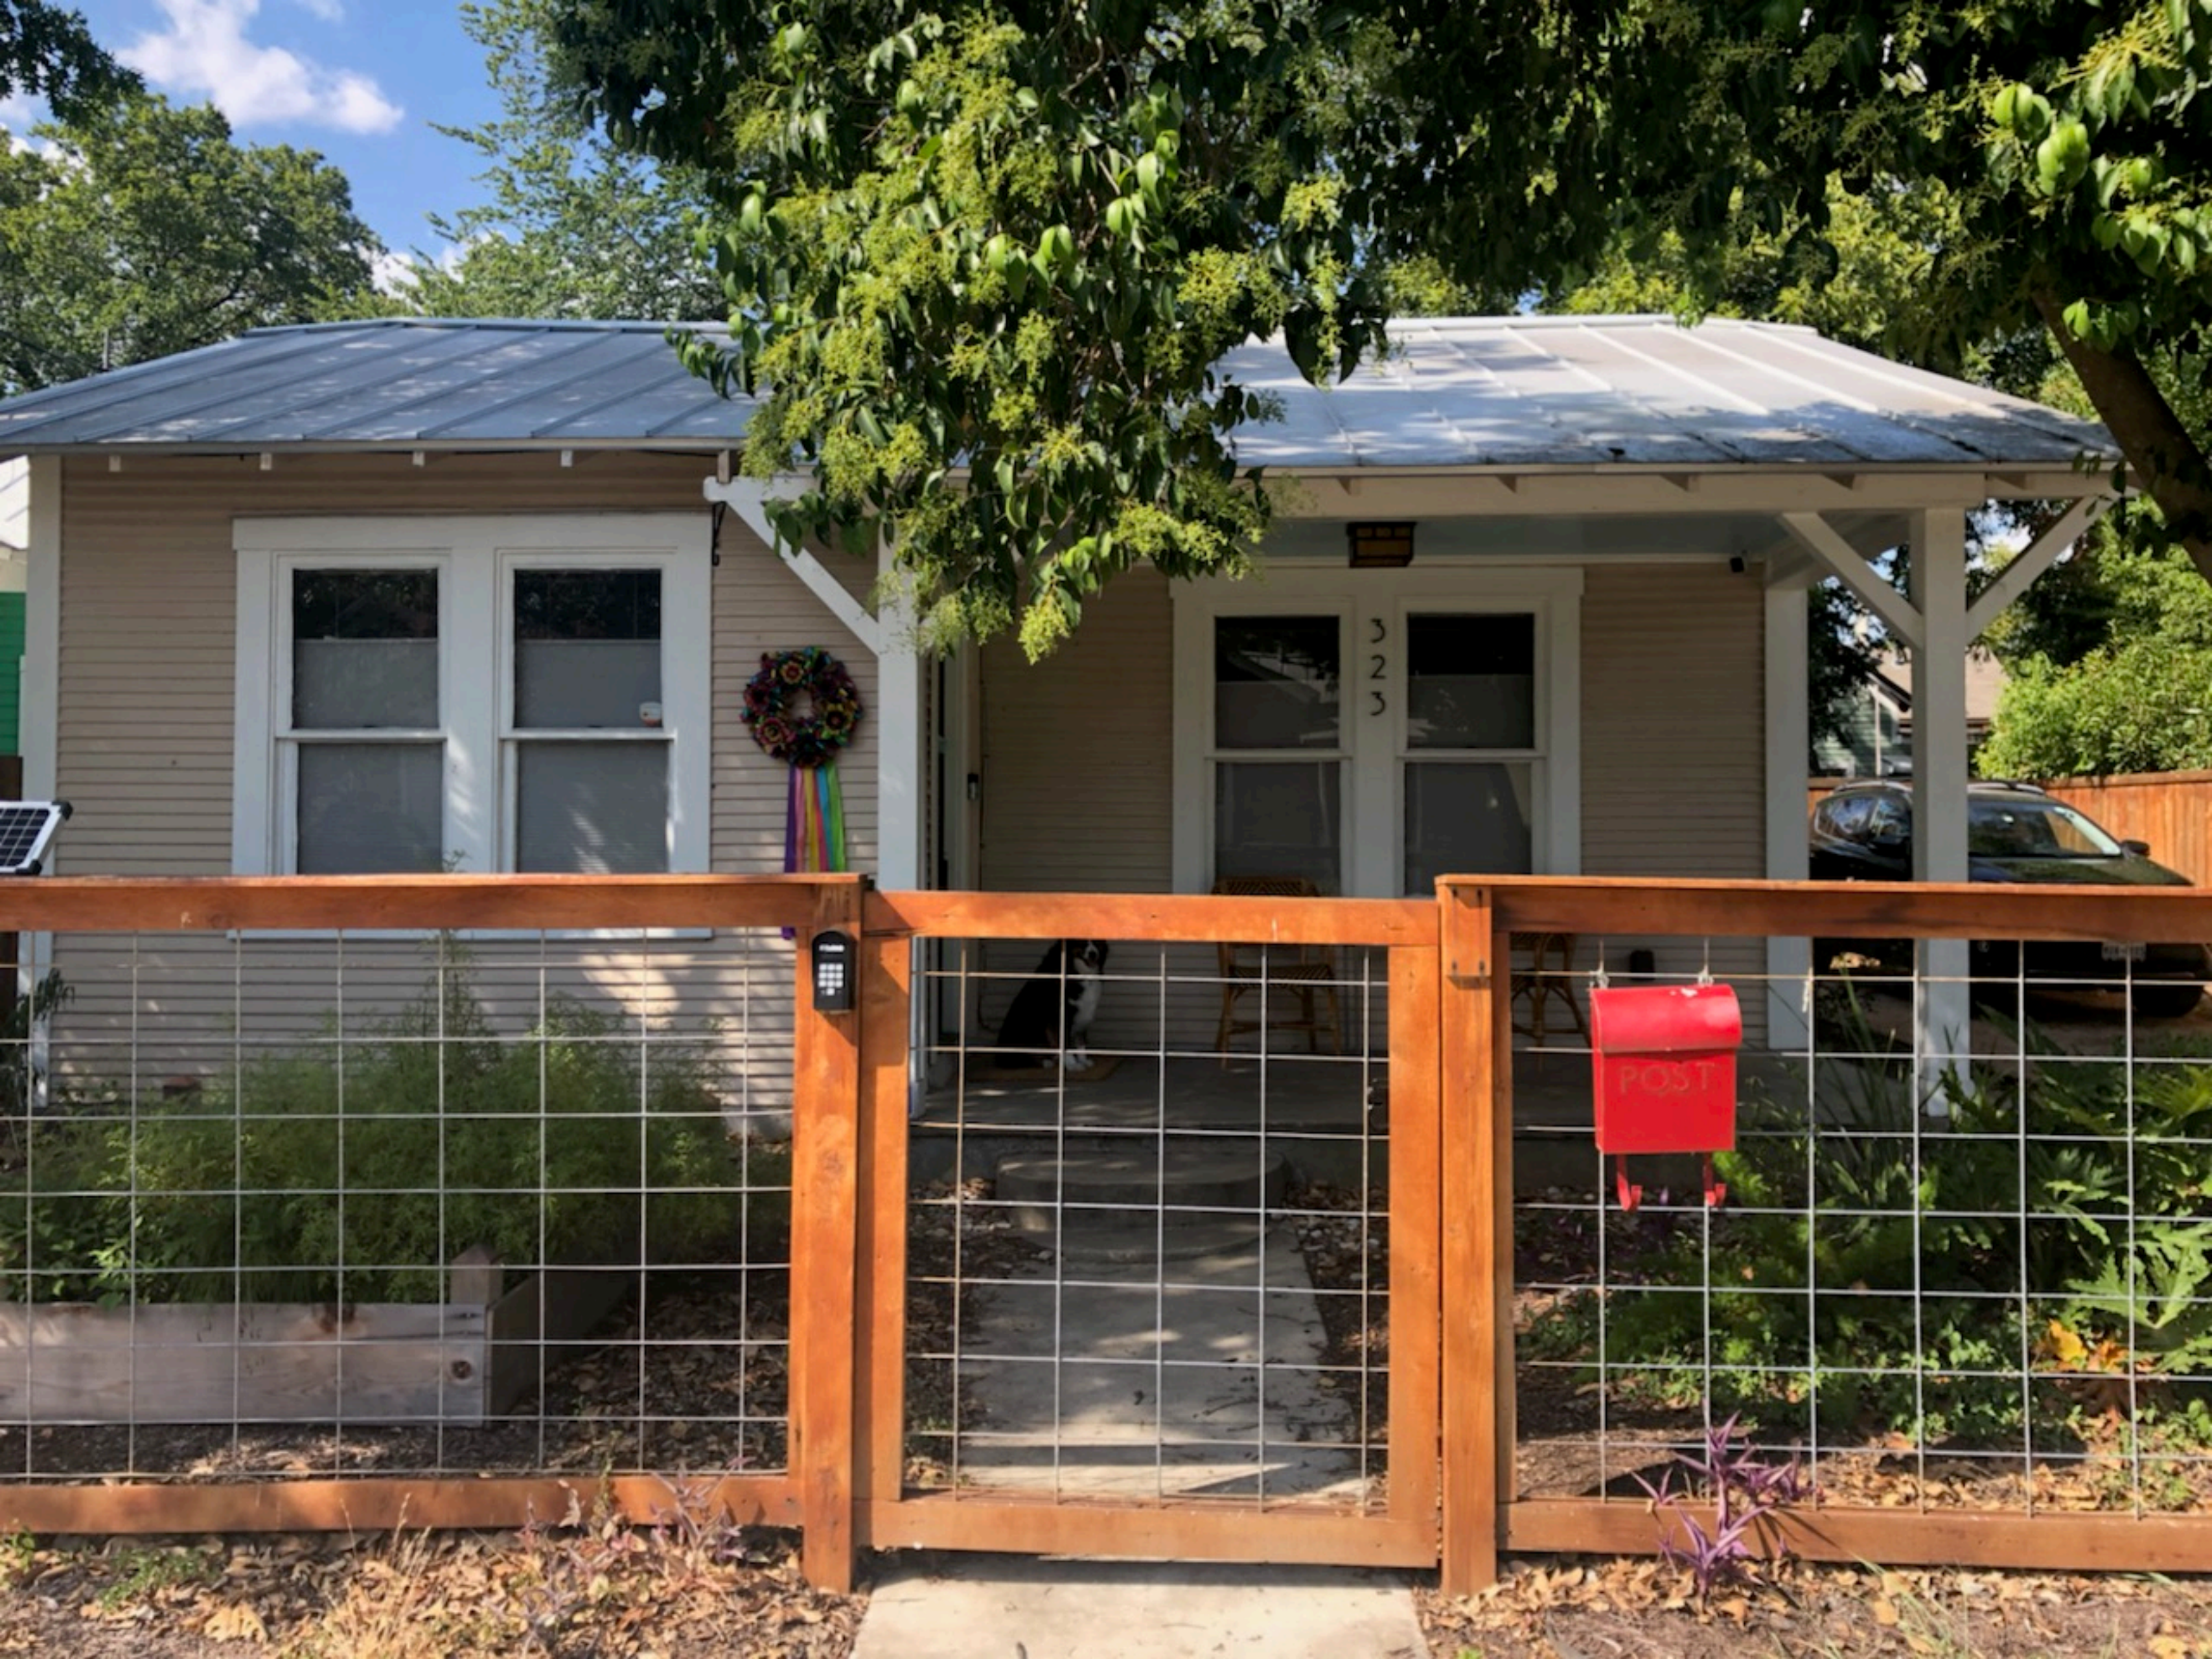
LEIGH ST.  
(PUBLIC R.O.W.)

SURVEYOR'S NOTE  
BASIS OF BEARING, TEXAS  
SOUTH CENTRAL NAD 83.

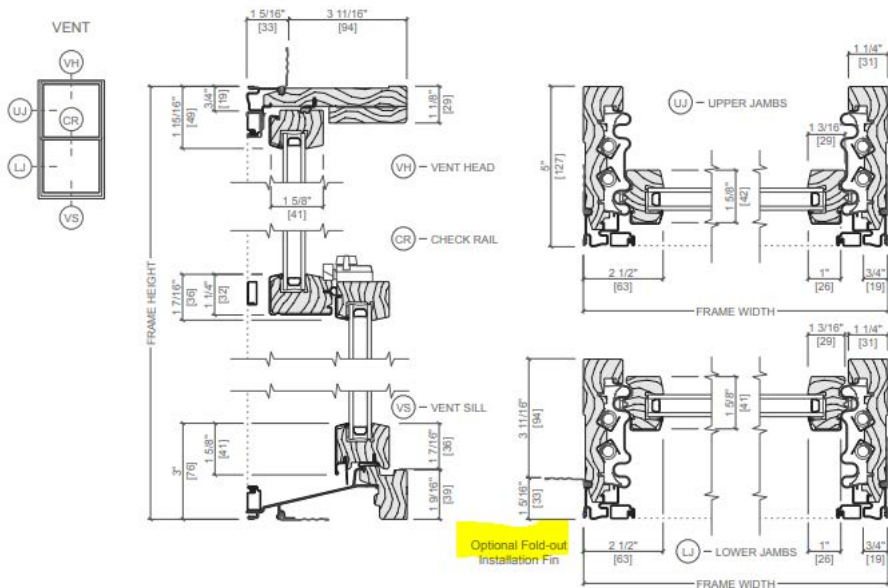
## Lifestyle Series Double-Hung

### Unit Sections
