HISTORIC AND DESIGN REVIEW COMMISSION

HDRC CASE NO: 2019-562
ADDRESS: 107 W CRAIG PLACE
LEGAL DESCRIPTION: NCB 1860 BLK 1 LOT 22 (LA FONDA MAIN)
ZONING: IDZ,H
CITY COUNCIL DIST.: 1
DISTRICT: Monte Vista Historic District
APPLICANT: Timothy Cone
OWNER: Power of Preservation Foundation
TYPE OF WORK: Restoration of front porch, exterior modifications
APPLICATION RECEIVED: September 13, 2019
60-DAY REVIEW: November 12, 2019
CASE MANAGER: Stephanie Phillips
REQUEST:

The applicant is requesting a Certificate of Appropriateness to:

WINCHESTER KELSO HOUSE

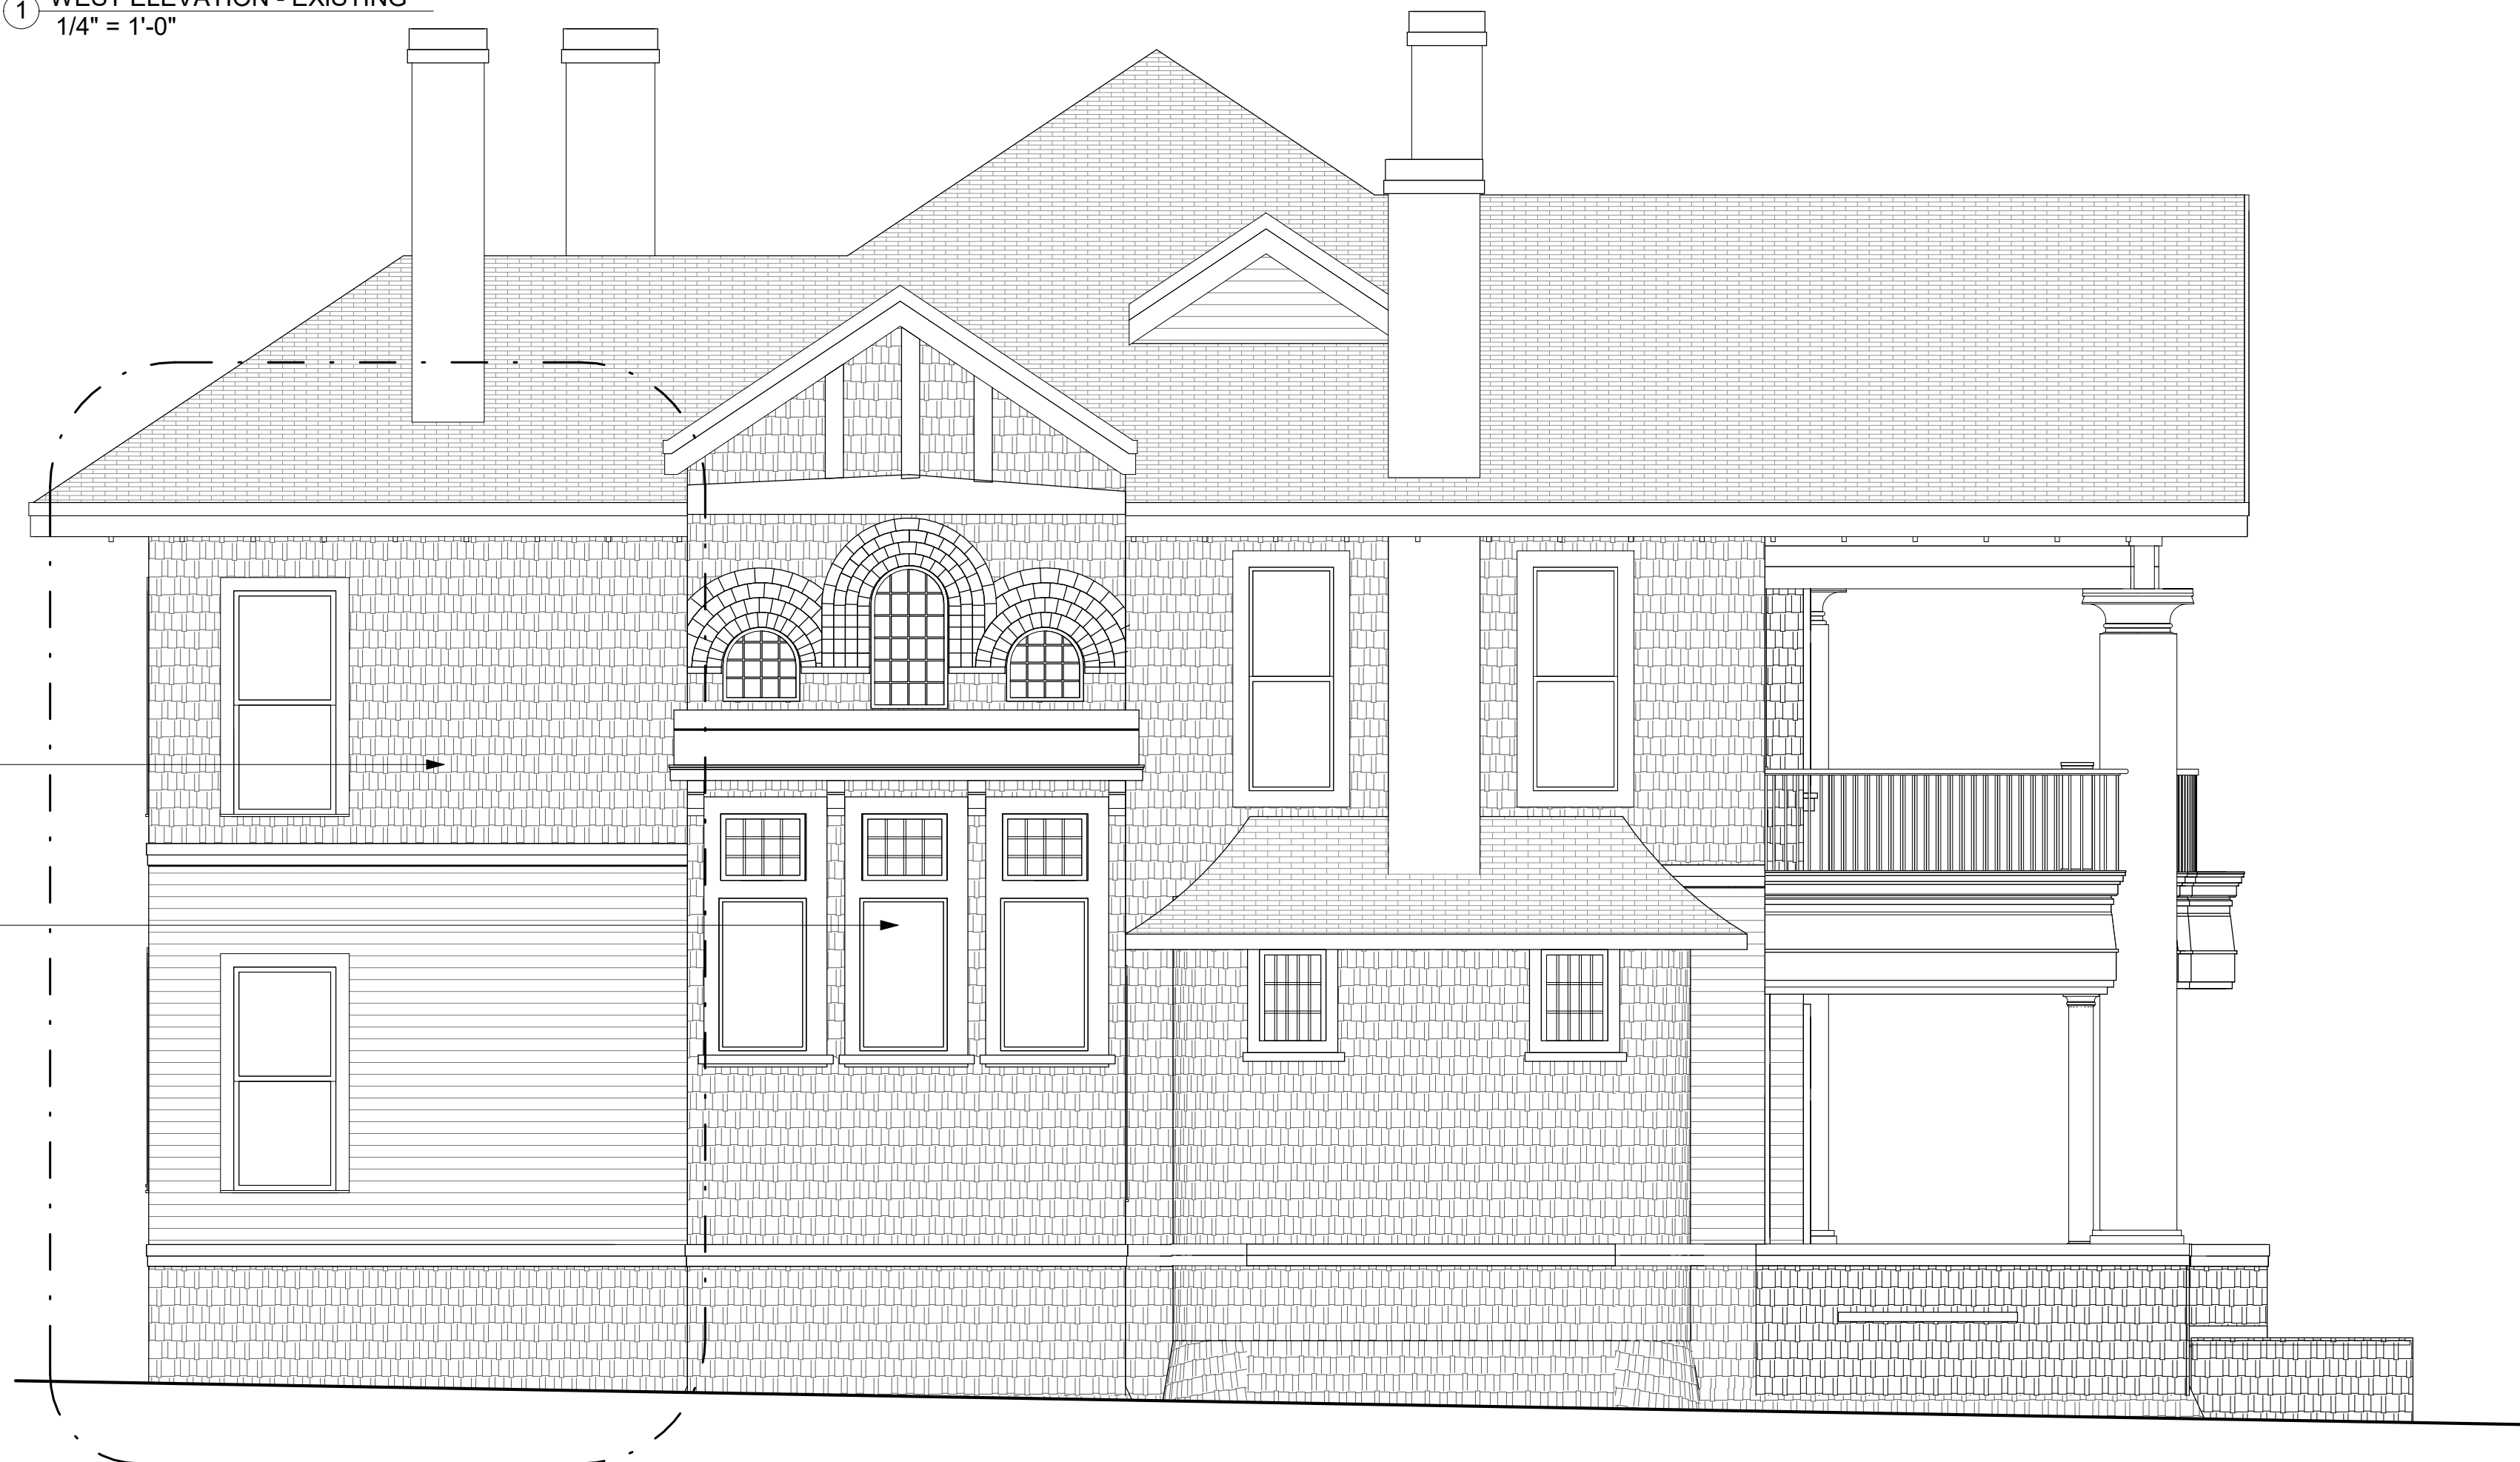
MATCH WALL FINISH WOOD
WINDOWS & DETAILS ADJACENT

REMOVE EXISTING DOOR &
REPLACE WITH NEW WINDOW &
TRIM TO MATCH ADJACENT
WINDOWS

Item 1, Staff recommends approval of the proposal to modify an existing door opening to a window on the west façade based on finding c with the following stipulations:

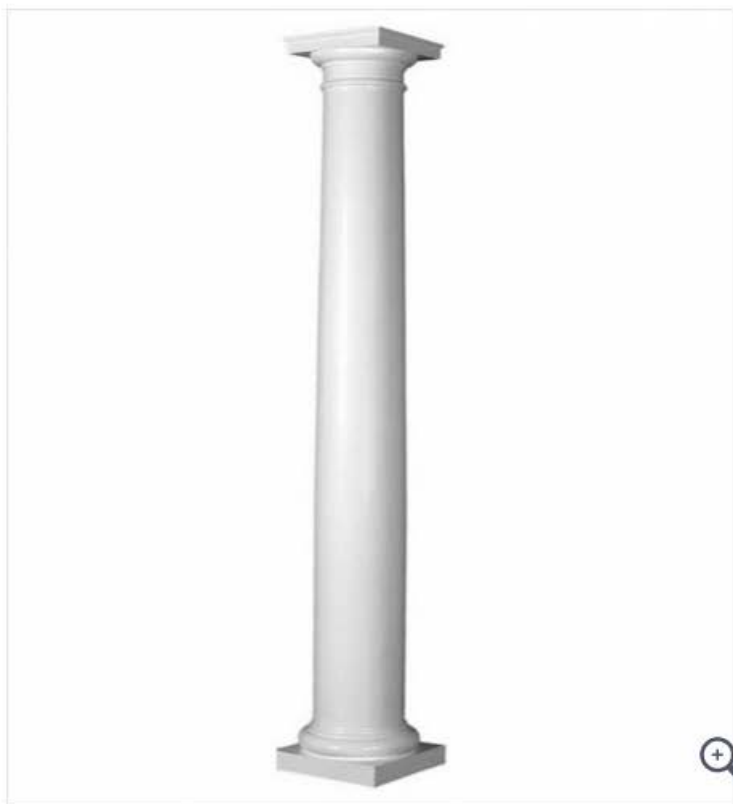
8" Round, Tapered, Smooth PermaCast Column

- f. PORCH COLUMNS – The applicant has proposed to replace six Doric-style columns on the first floor of the 2-story wraparound porch. The existing columns have been deteriorated by fire and deferred maintenance. The proposal includes installing fiberglass column shafts to match the original in dimension, height, and profile, and replicating the capital column and bases out of wood. Per the Guidelines for Architectural Features 7.B.iii, porches, balconies, porte-cocheres, and related elements such as ceilings, floors, and columns should be replaced in-kind when such features are deteriorated beyond repair. When in-kind replacement is not feasible, the design should be compatible in scale, massing, and detail while materials should match in color, texture, and dimensions, and finish. Staff finds that fiberglass column shafts that match the original in profile and dimensions is consistent with the Guidelines.
