## HISTORIC AND DESIGN REVIEW COMMISSION

**HDRC CASE NO:** 2020-064  
**ADDRESS:** 3801 BROADWAY  
**LEGAL DESCRIPTION:**  
**ZONING:** R-6, RIO-1, H  
**CITY COUNCIL DIST.:** 2  
**LANDMARK:** Brackenridge Park/Witte Museum  
**TYPE OF WORK:** Restoration of Twohig house  
**APPLICANT:** John Speegle  
**APPLICATION RECEIVED:** January 31, 2020  
**60-DAY REVIEW:** March 31, 2020  
**CASE MANAGER:** Edward Hall

The applicant is requesting conceptual approval to perform rehabilitation scopes of work at the Twohig House, located at the Witte Museum. Within this request, the applicant has proposed the following:

1. Install a new wood shingle roof.
2. Paint the exterior and perform masonry repair as needed.
3. Repair the existing windows.
4. Replace eleven doors and door frames.
5. Construct an exterior stair.

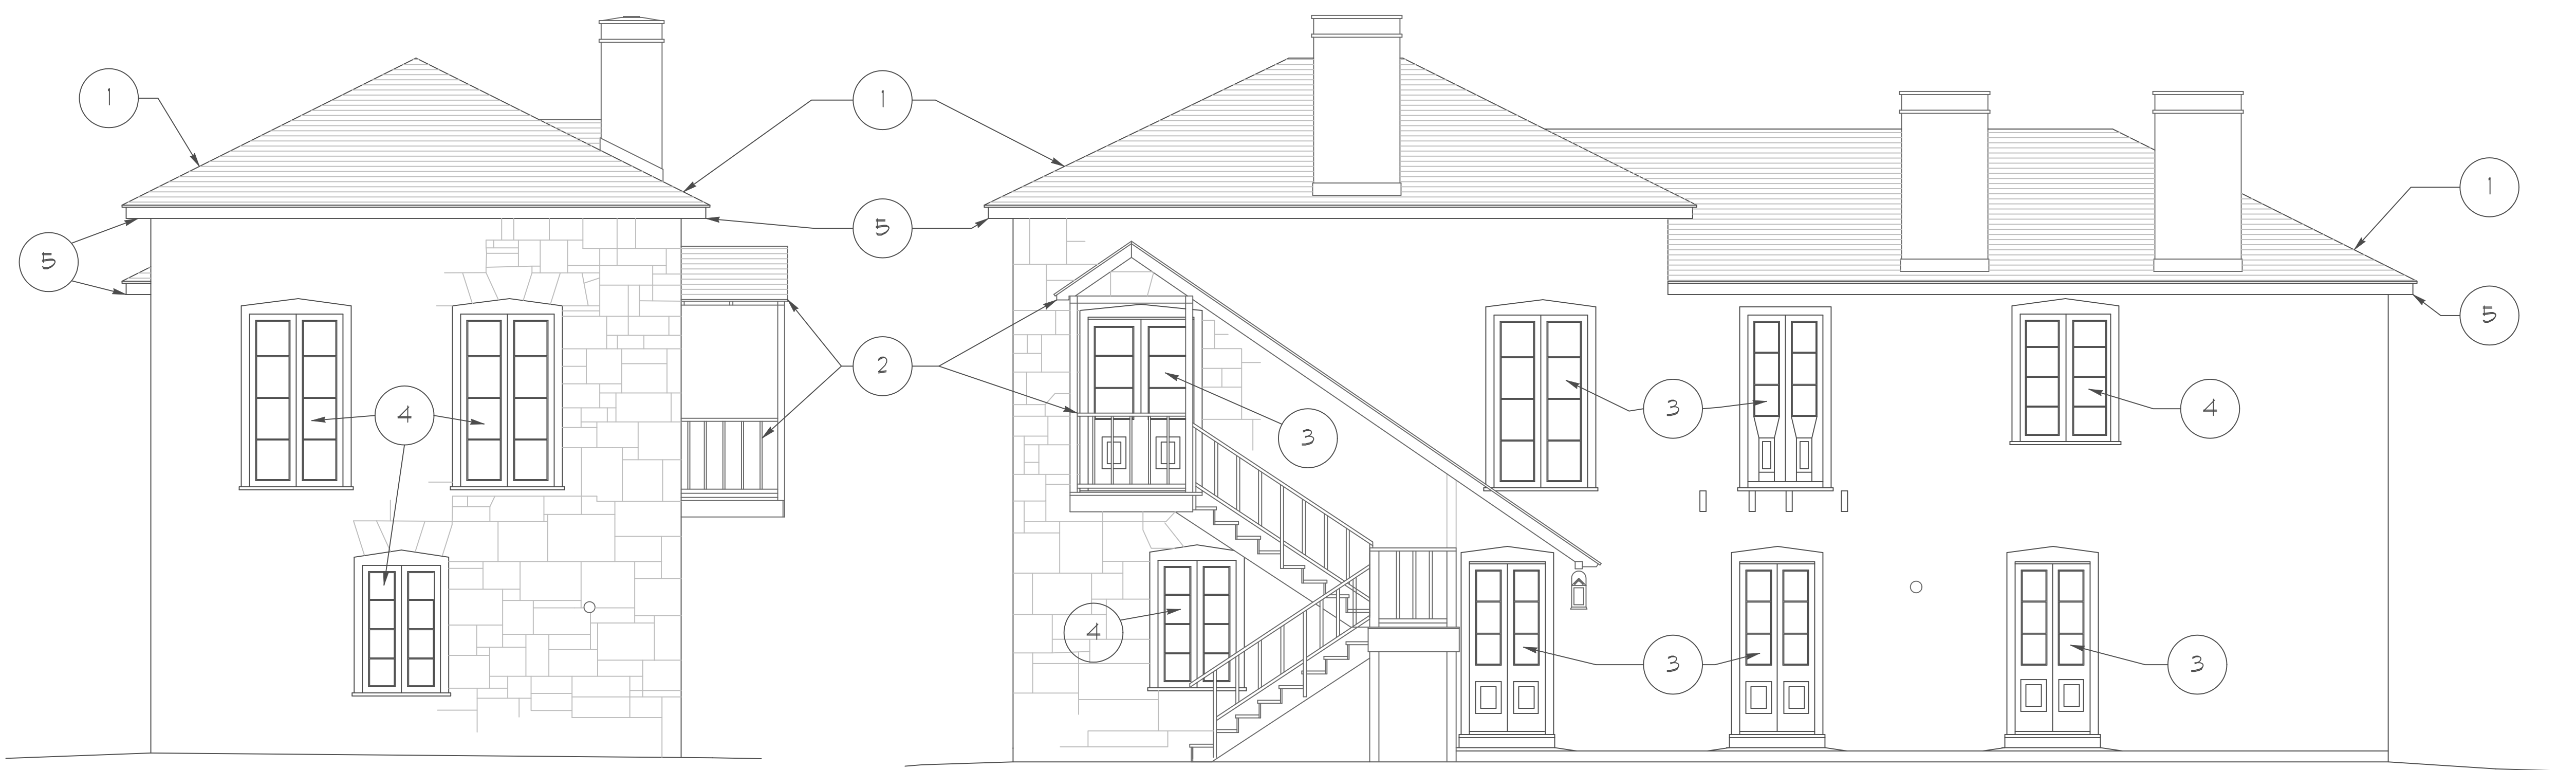
A-3.04 NORTH ELEVATION  
SCALE: 1/4" = 1' - 0"

A-3.01 WEST ELEVATION  
SCALE: 1/4" = 1' - 0"

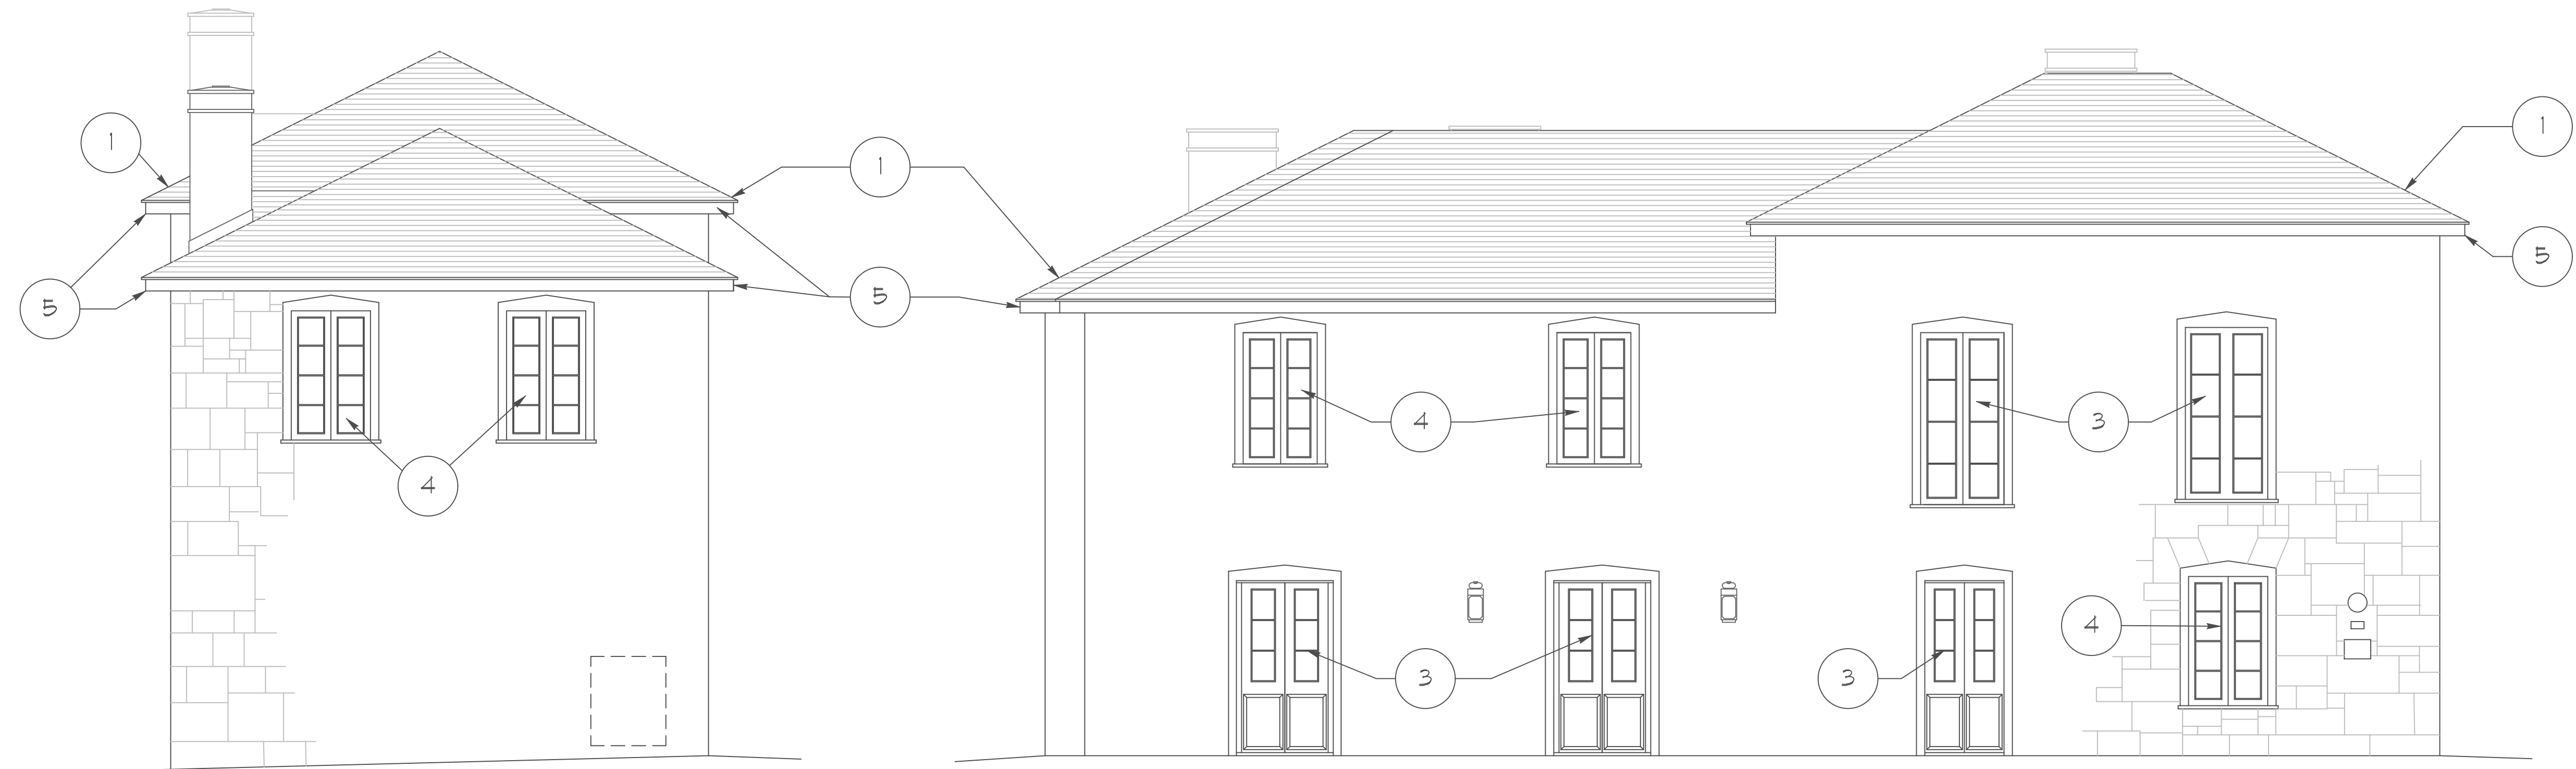
A-3.03 SOUTH ELEVATION  
SCALE: 1/4" = 1' - 0"

A-3.02 EAST ELEVATION  
SCALE: 1/4" = 1' - 0"

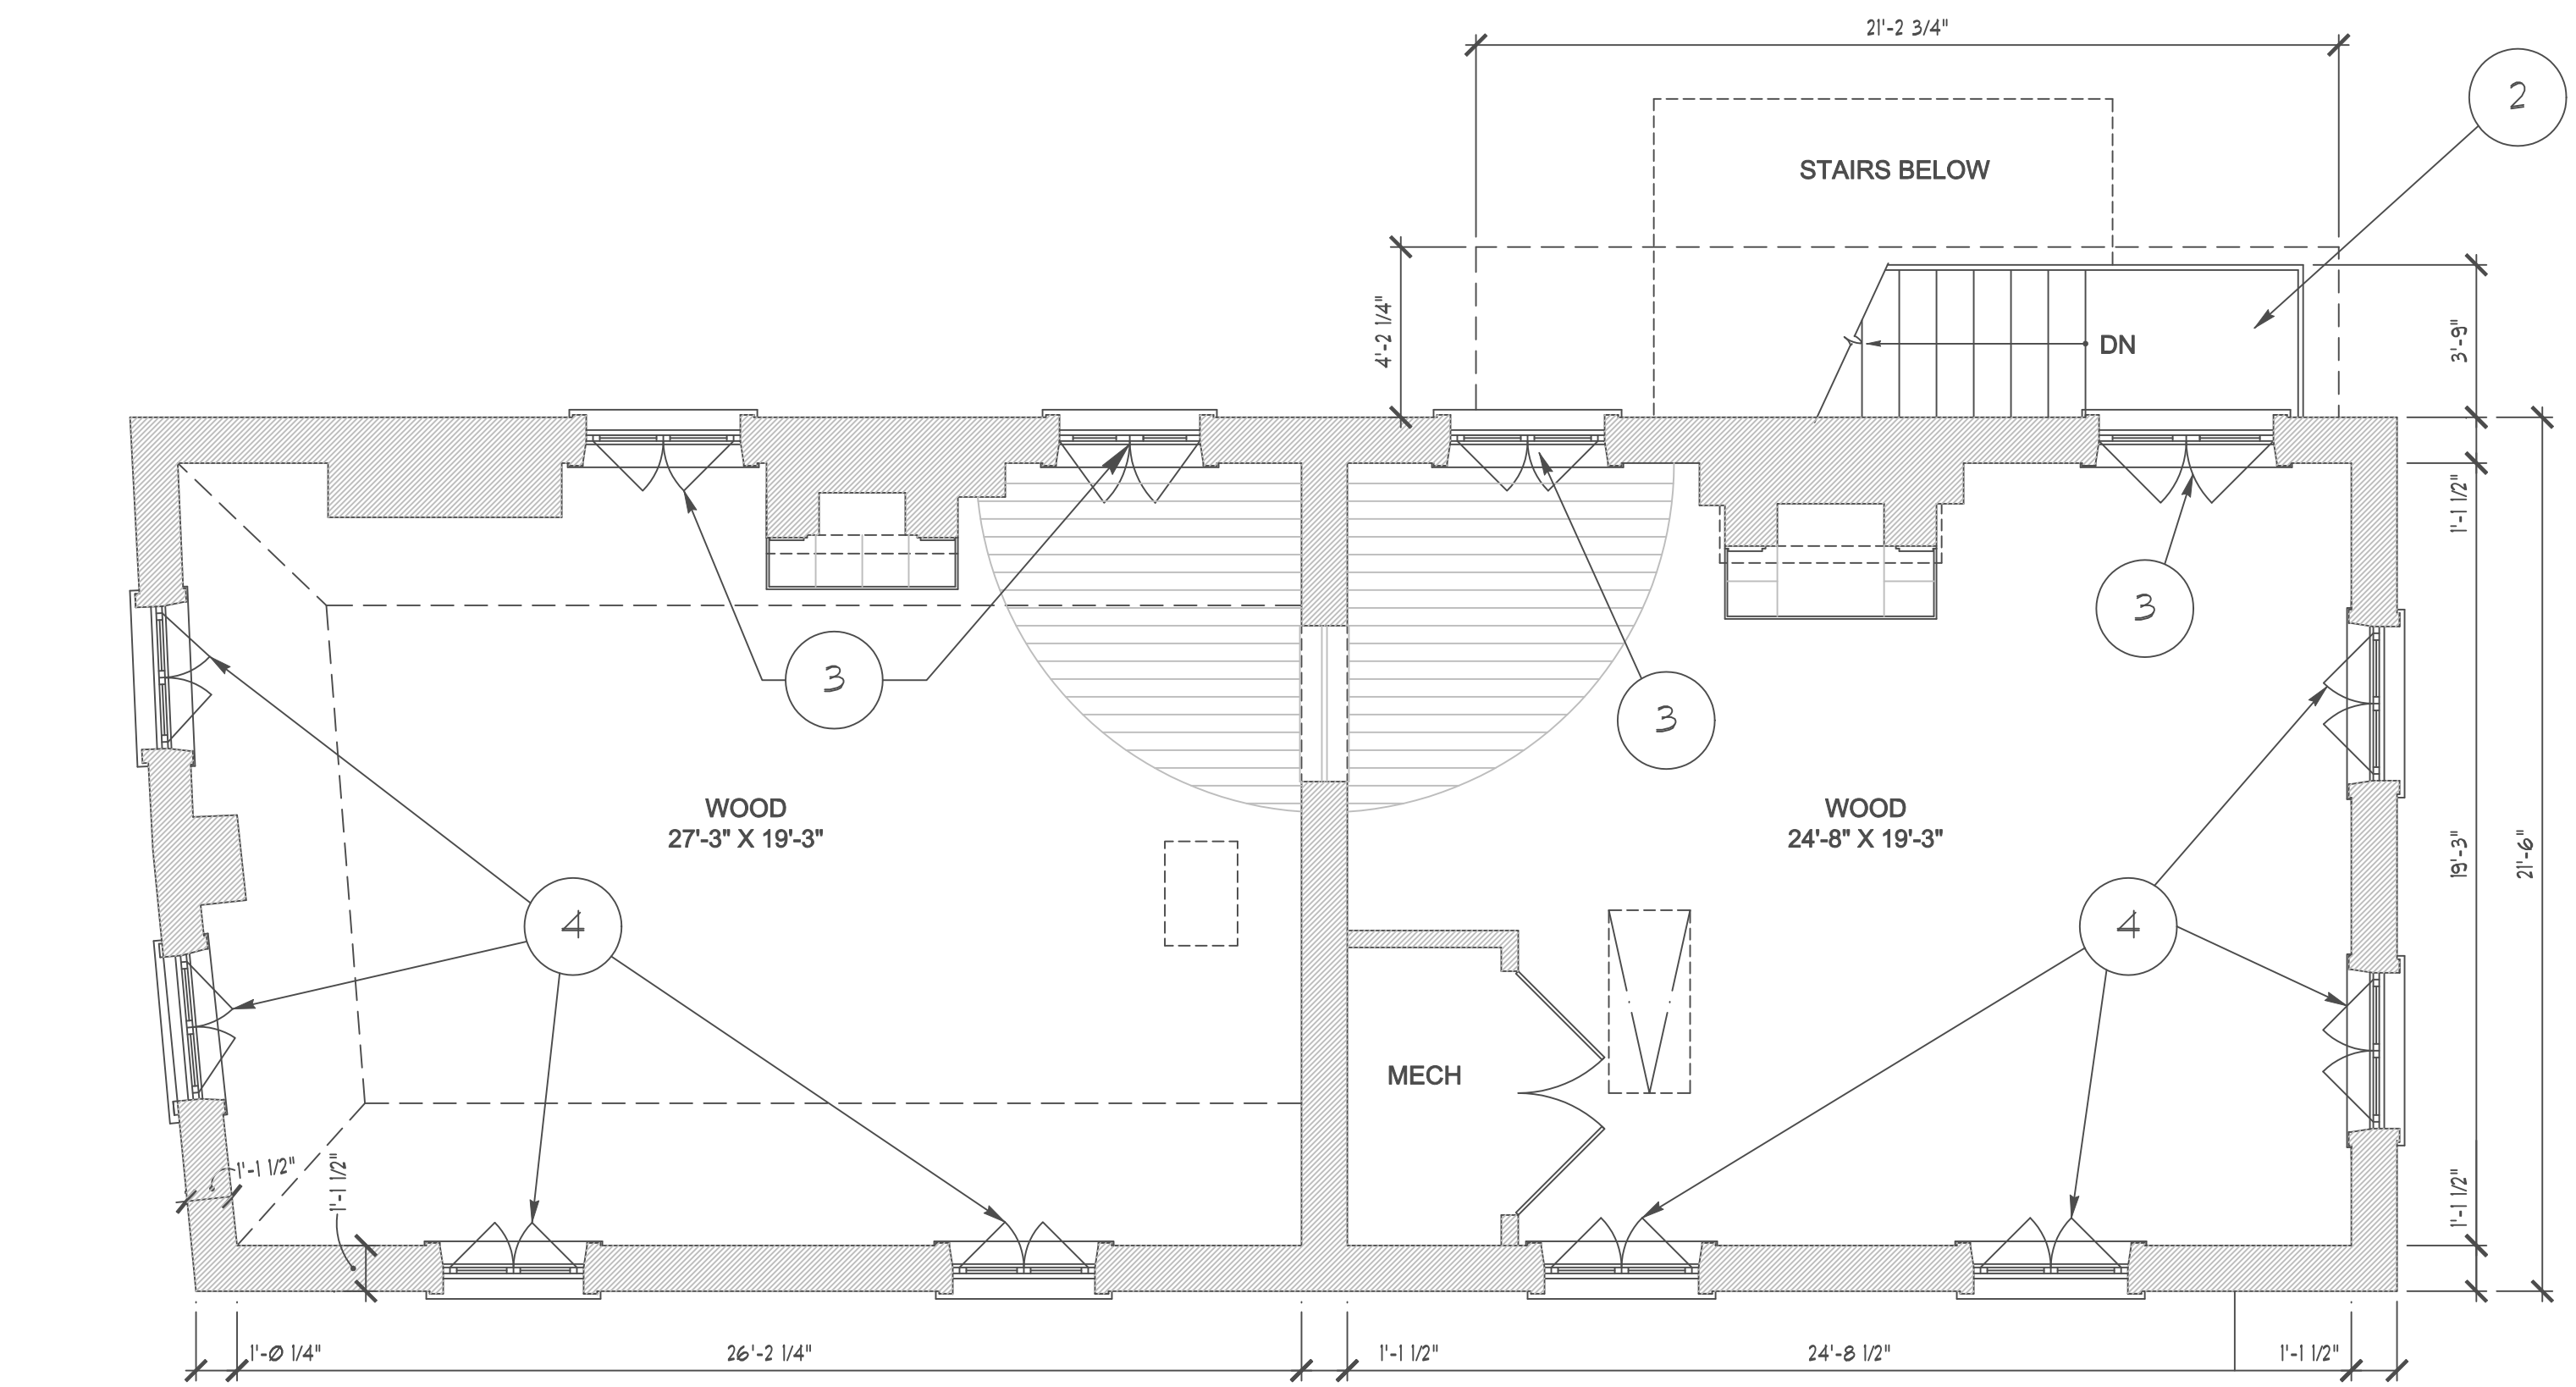
A-2.01 SECOND FLOOR PLAN  
SCALE: 1/4" = 1'-0"

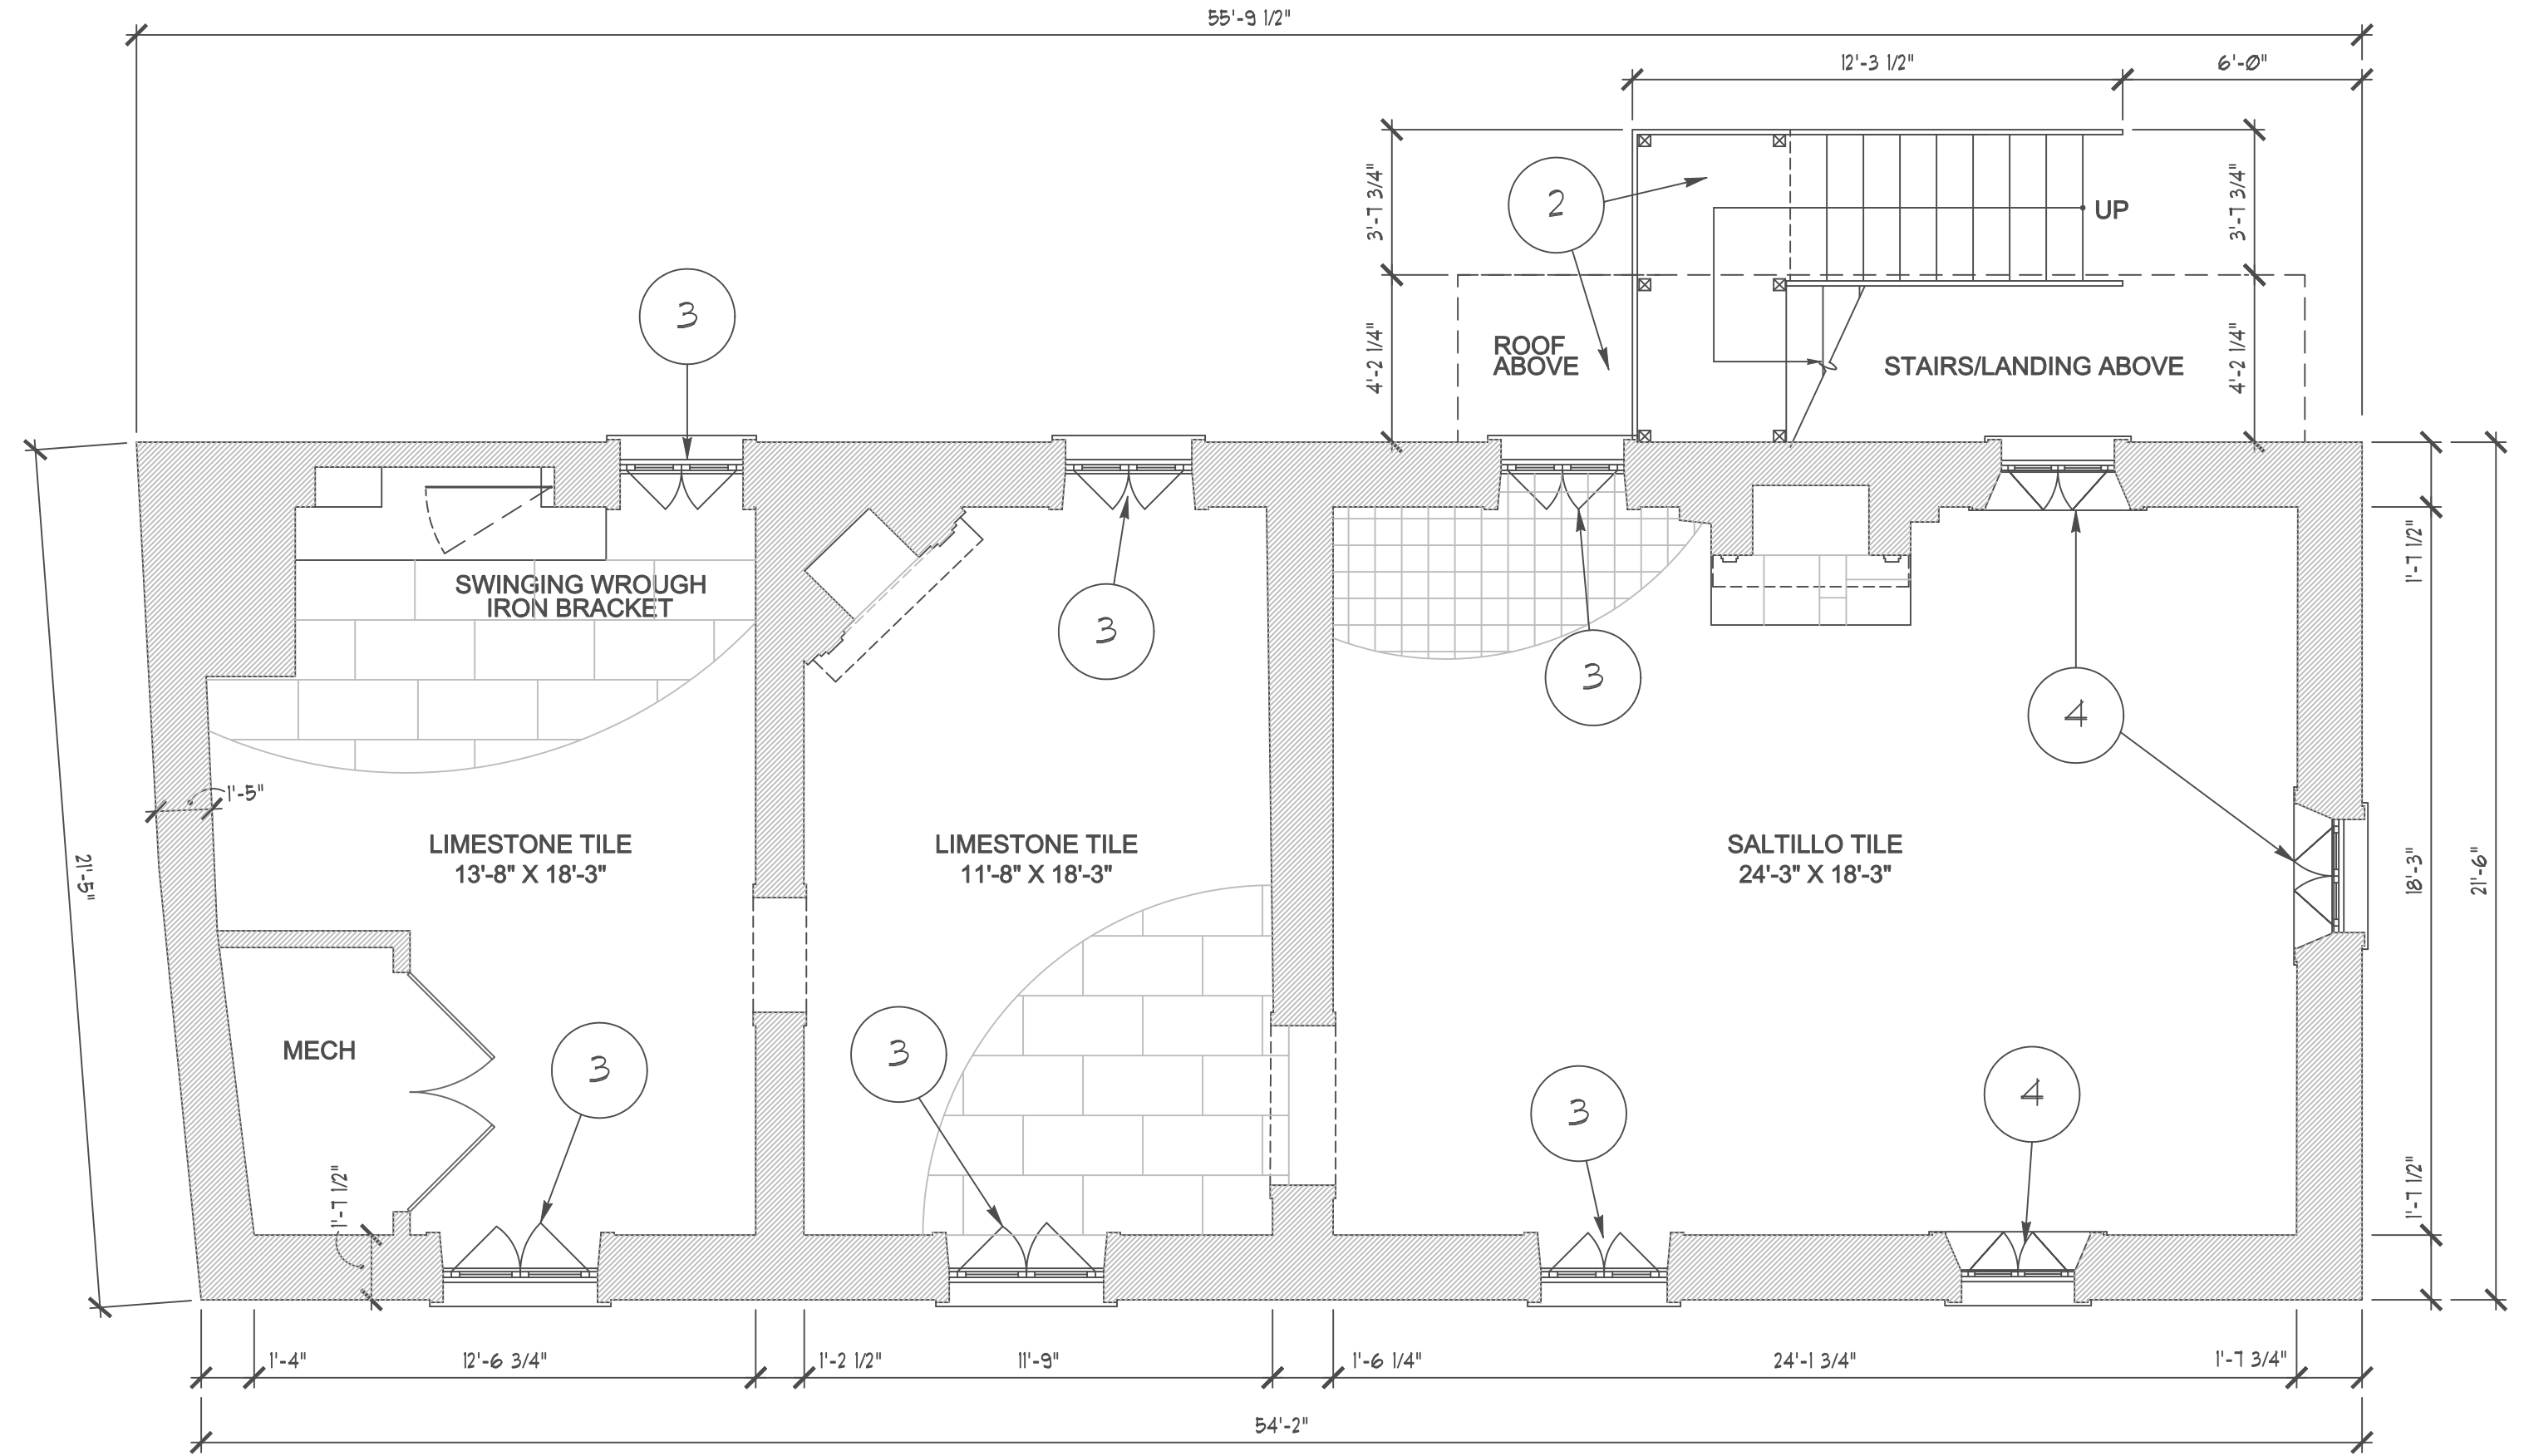
A-2.02 FIRST FLOOR PLAN  
SCALE: 1/4" = 1'-0"

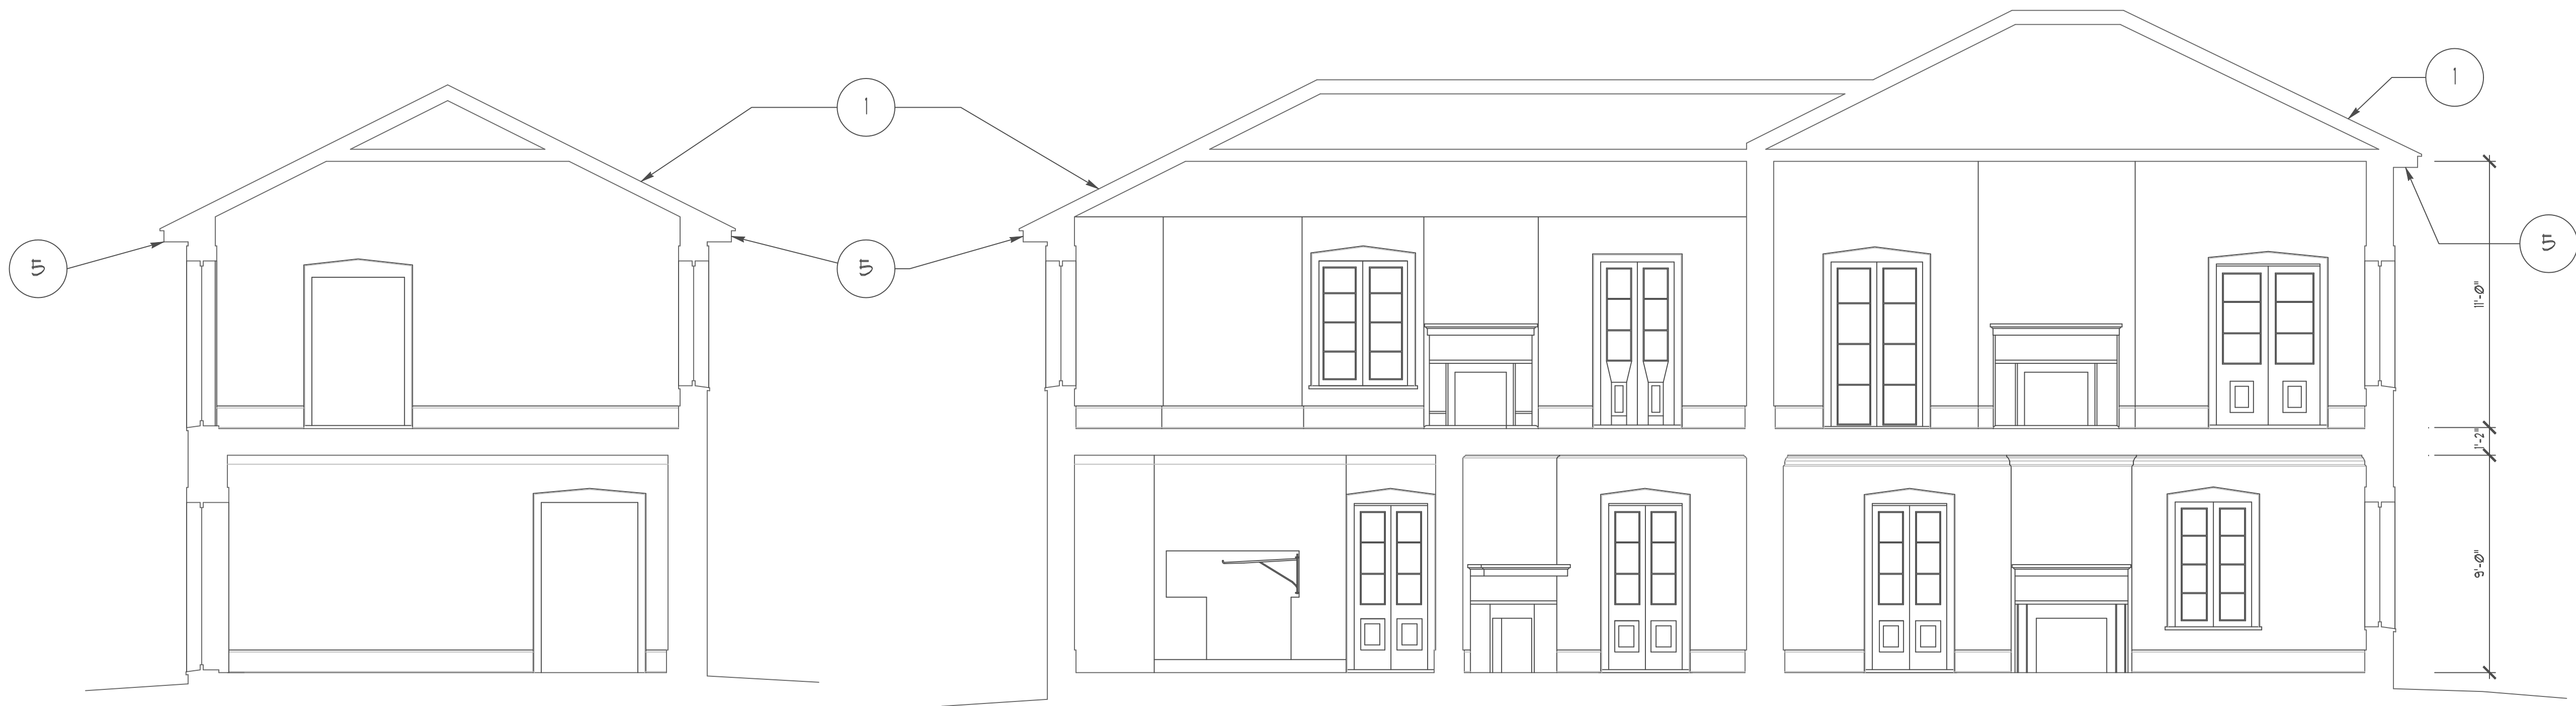
A-4.01 BUILDING SECTION - WEST TO EAST  
SCALE: 1/4" = 1' - 0"

A-4.02 BUILDING SECTION - SOUTH TO NORTH  
SCALE: 1/4" = 1' - 0"
