# HISTORIC AND DESIGN REVIEW COMMISSION

**HDRC CASE NO:** 2020-239  
**ADDRESS:** 210 LAVACA ST  
**LEGAL DESCRIPTION:** NCB 713 BLK 10 LOT 11  
**ZONING:** RM-4, H  
**CITY COUNCIL DIST.:** 1  
**DISTRICT:** Lavaca Historic District  
**APPLICANT:** V Yuan/Lake/Flato Architects  
**OWNER:** HILL STACEY L  
**TYPE OF WORK:** Front yard landscape and hardscape, rear patio enclosure  
**APPLICATION RECEIVED:** May 19, 2020  
**60-DAY REVIEW:** Not applicable due to City Council Emergency Orders  
**CASE MANAGER:** Huy Pham  
**REQUEST:**

The applicant is requesting a Certificate of Appropriateness for approval to:

1. Replace the poured concrete walkway with limestone pavers.
2. Perform front yard landscaping including the installation of two berms flanking the walkway.
3. Install wood and steel screens to enclose a rear patio addition.
4. Replace the wood garage doors with metal and glass doors on a non-historic detached garage.

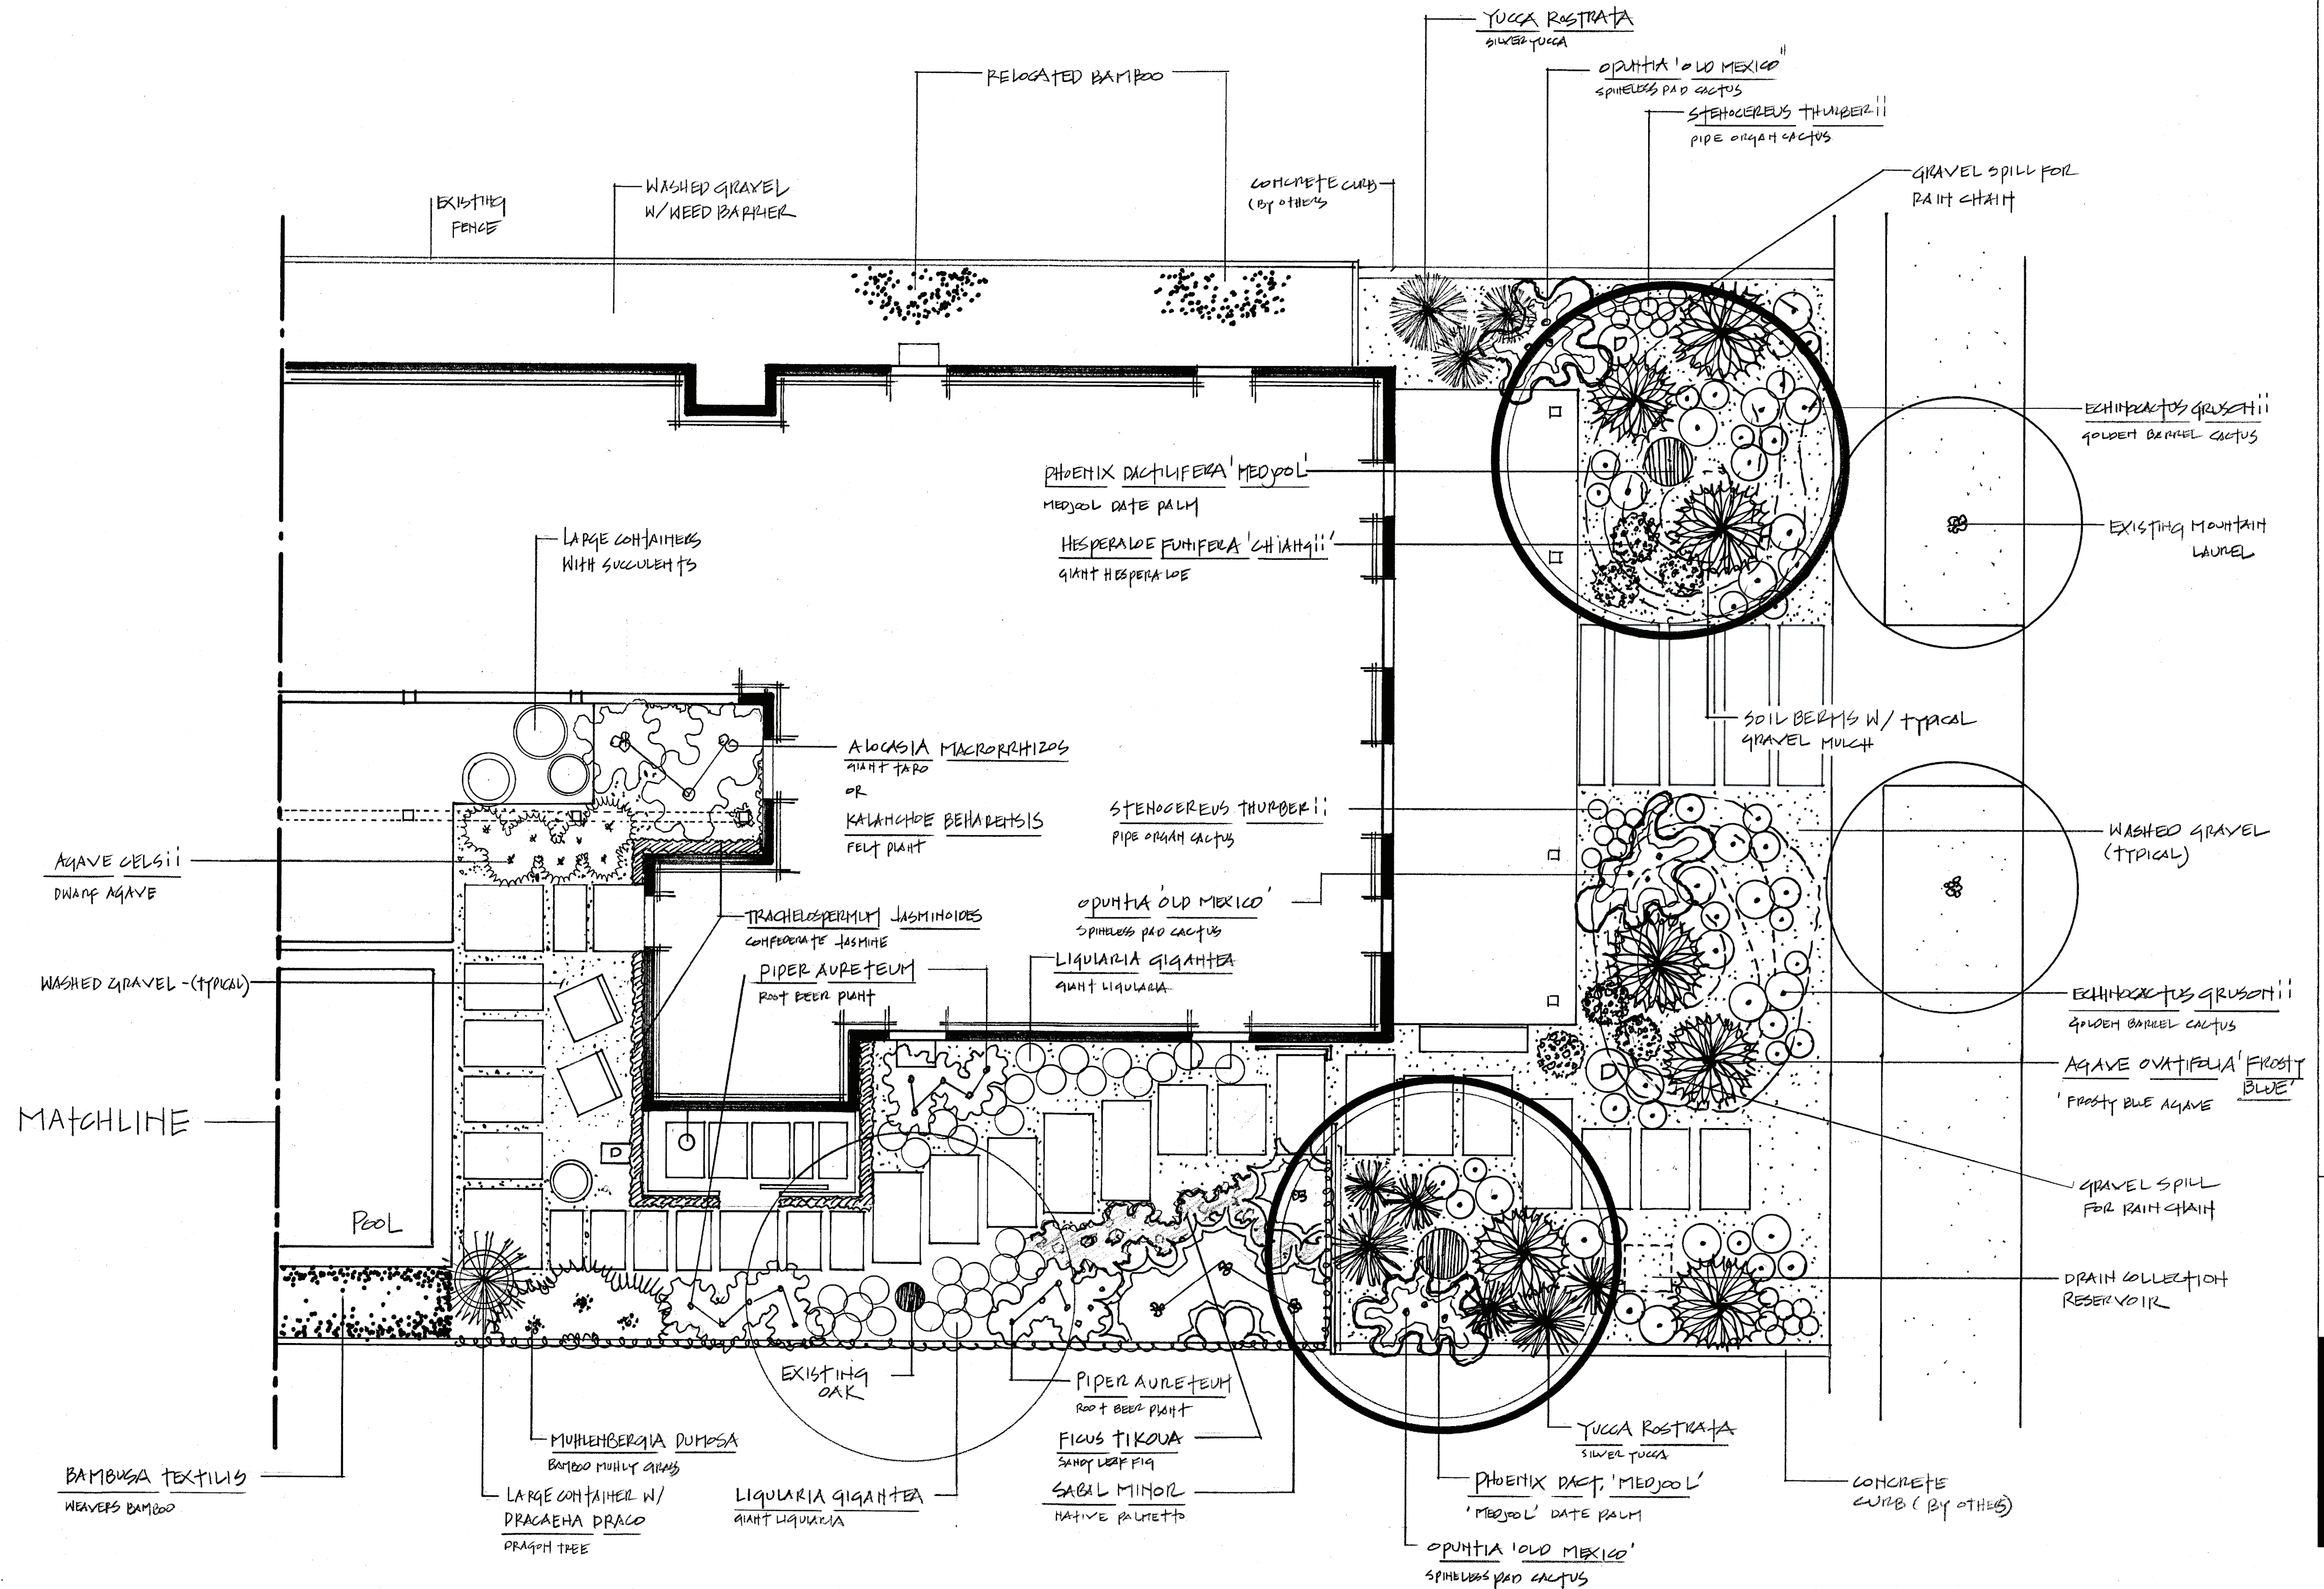
PROJECT:		LANDSCAPE REDEVELOPMENT - STACEY HILL HOUSE	
LOCATION:		210 LAVACA - SAN ANTONIO, TEXAS	
DESIGNER:		HECTOR J. VILLARREAL	
SCALE:	1/4" = 1'-0"	DATE:	4-13-20
PROJECT:		PLANTING LAYOUT	
DESIGNER:		SHEET L-1

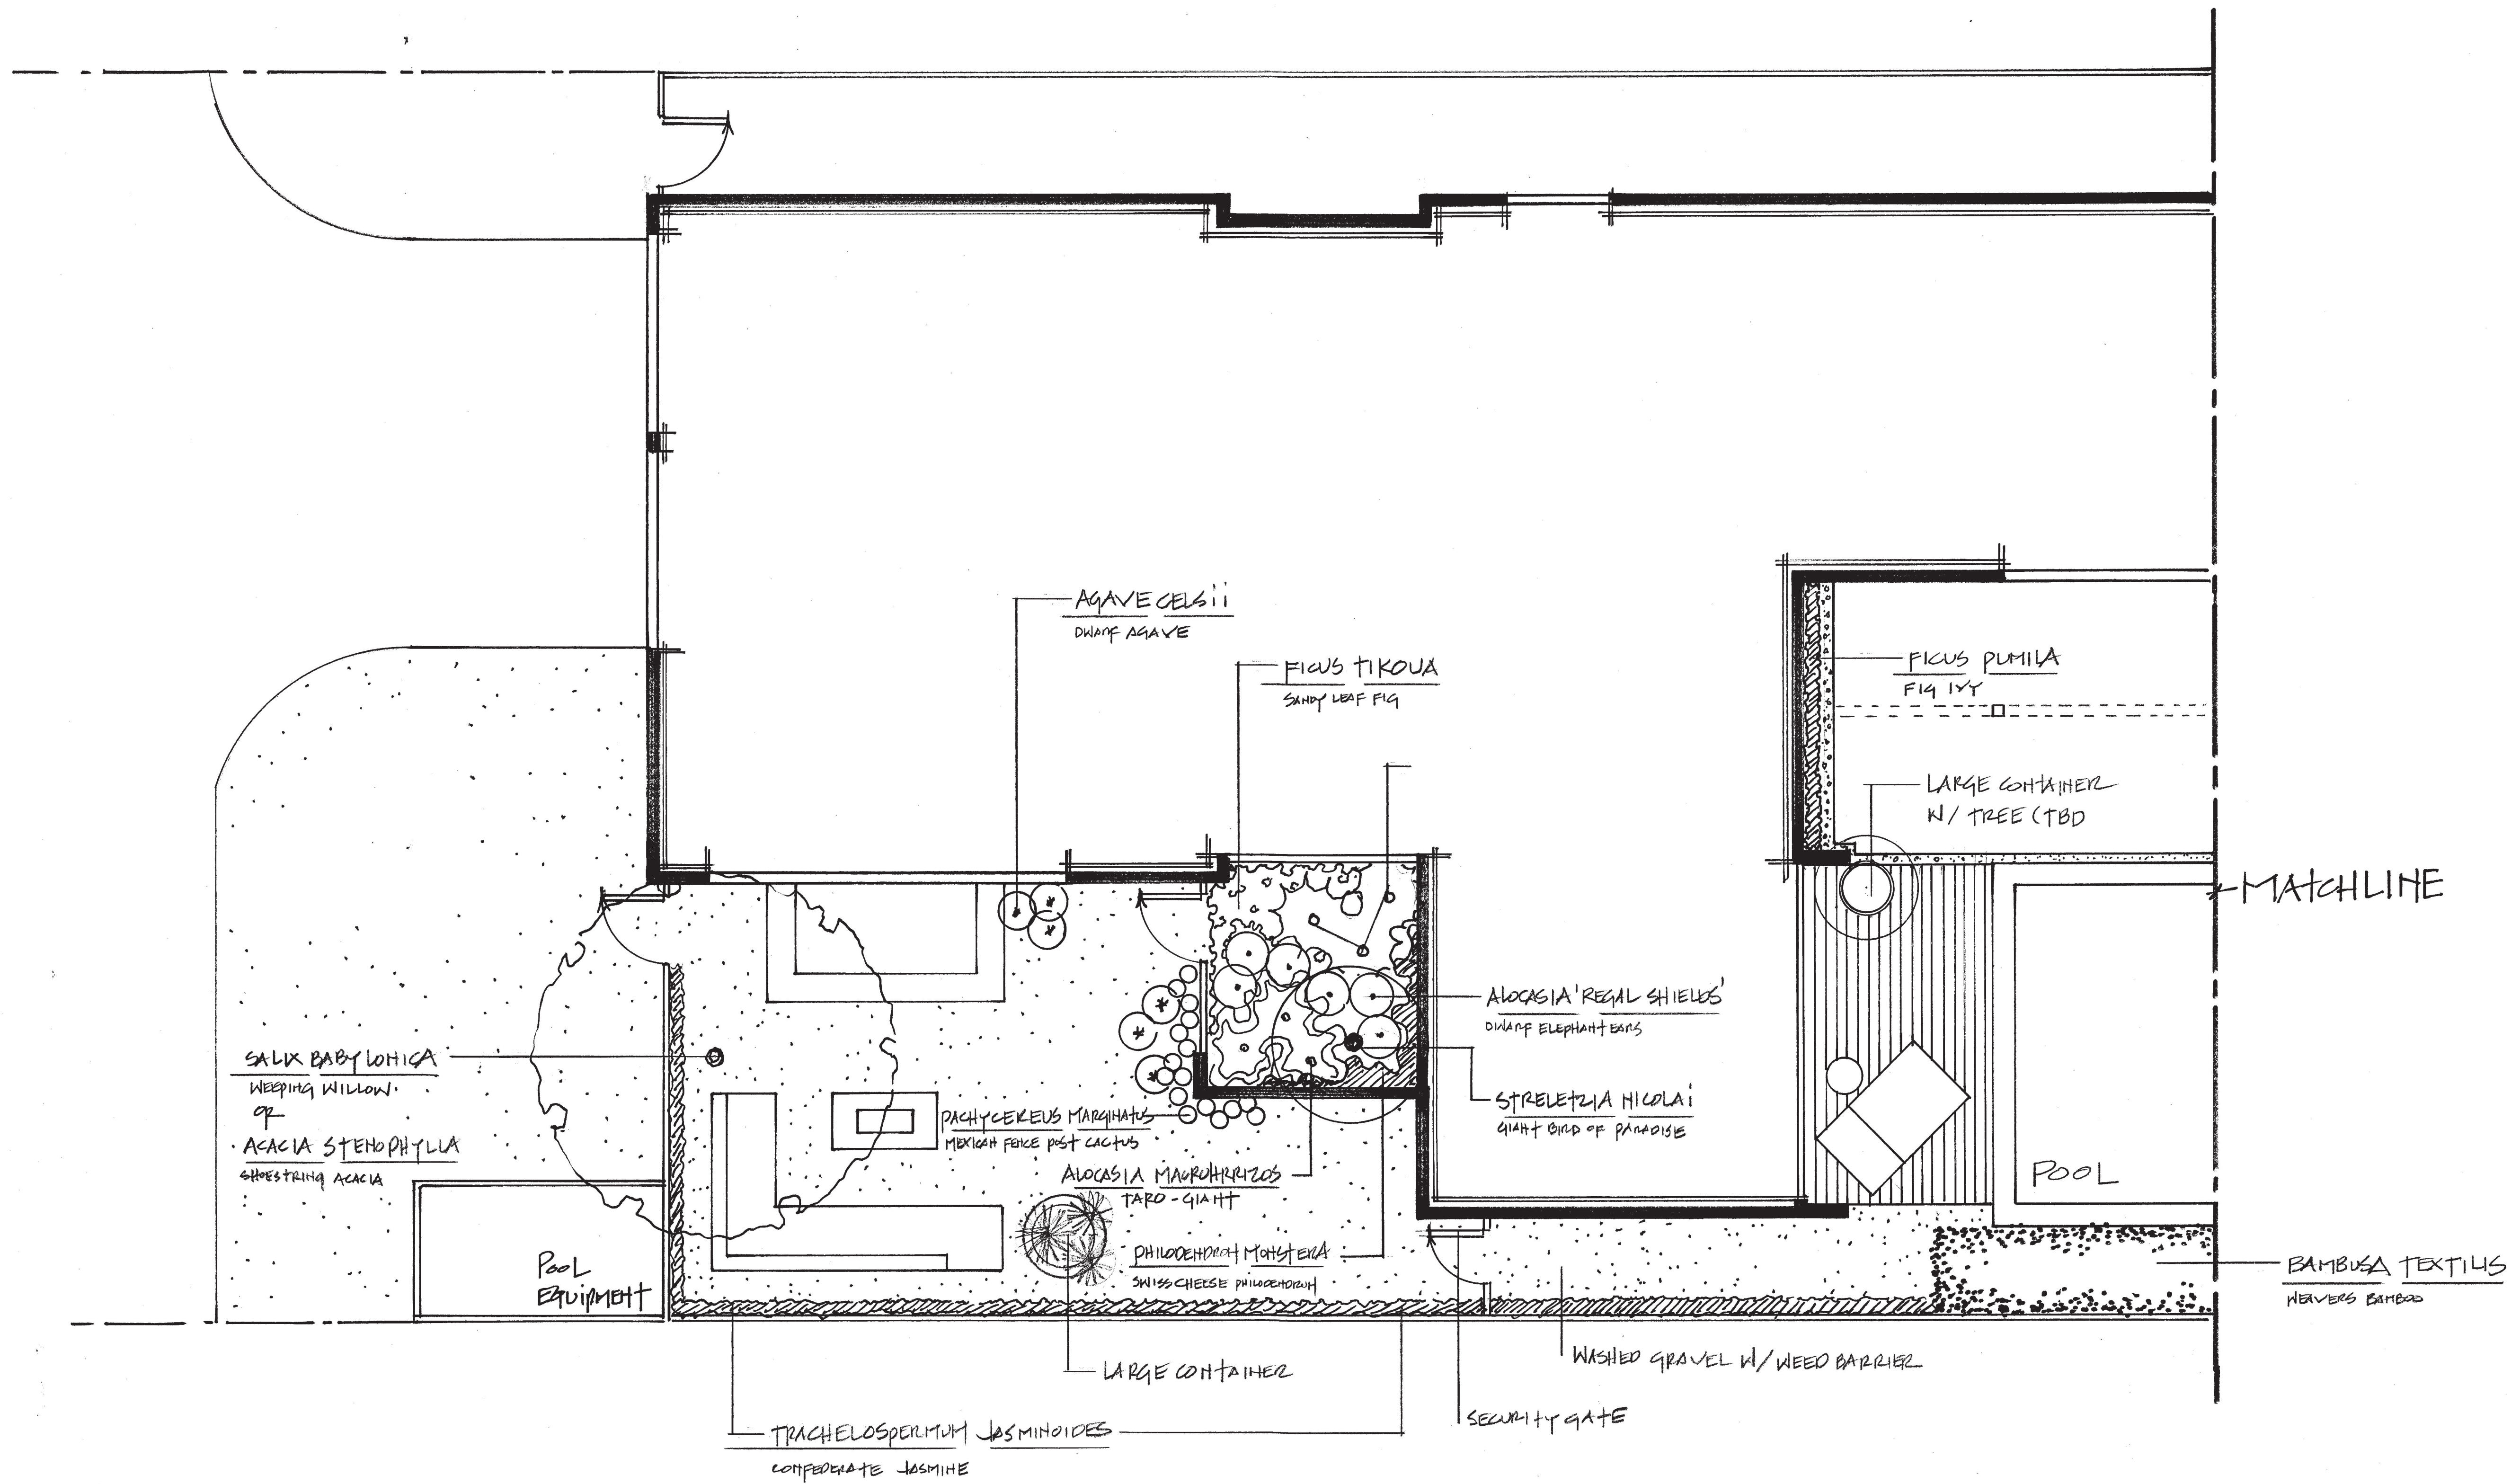
SOUTHERN LANDSCAPES & CONSTRUCTION	PROJECT:	LANDSCAPE REDEVELOPMENT • STACEY HILL HOUSE		
	LOCATION:	210 LAVACA, SAN ANTONIO, TEXAS		
	DESIGNER:	HECTOR J. VILLARREAL		
	SCALE:	1/4" = 1'-0"	PLANTING LAYOUT	
	DATE:	4-14-20	SHEET L-2

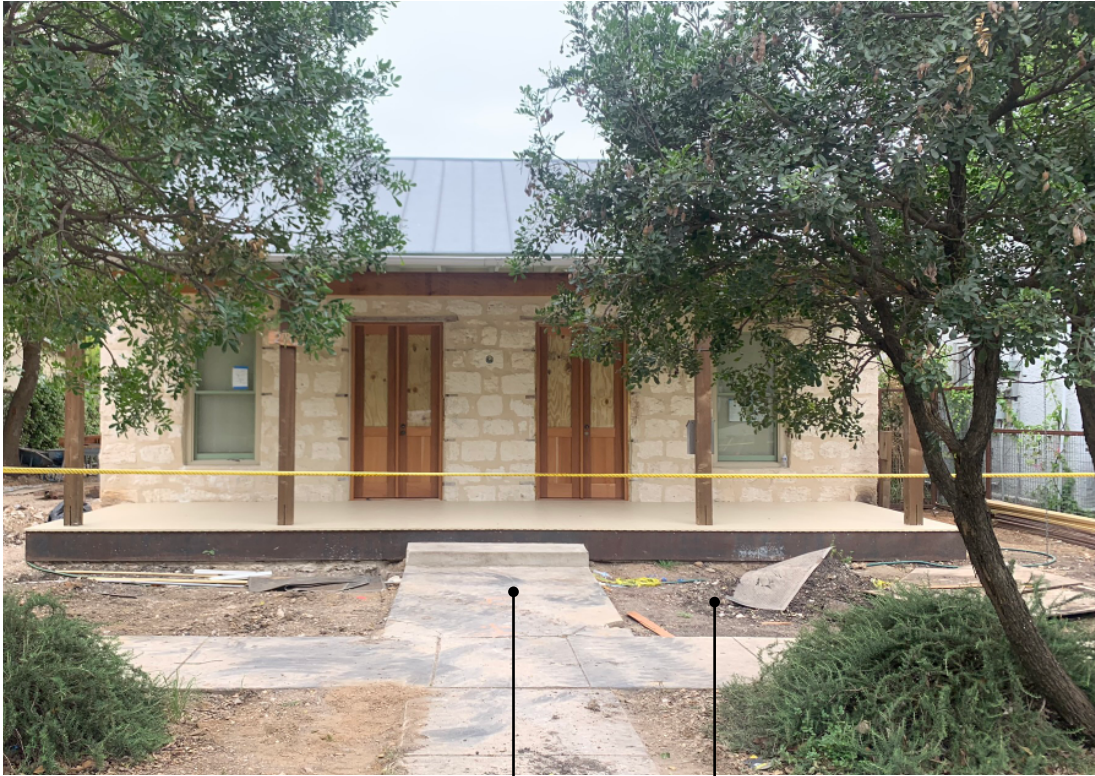
replace concrete walk with  
 stone pavers + stone step

new landscaping at  
 front yard, including  
 proposed trees

Lavaca Street Photograph -Current May 2020

- b. WALKWAY – The applicant has proposed to remove the poured concrete walkway to install limestone segmented pavers. Per the Guidelines for Site Elements 5.A.iii., applicant should follow the historic alignment, configuration, and width of sidewalks and walkways. Staff finds that the existing poured concrete walkway is not original the structure, does not relate to the period of significance for the structure, and is therefore eligible for an appropriate replacement. Staff finds that the proposed limestone pavers relate to vernacular step paths found in Lavaca if the pavers feature a natural color and texture. The proposed requested may not be substituted with segmented poured concrete paver limited to consideration for new construction and rear yards.

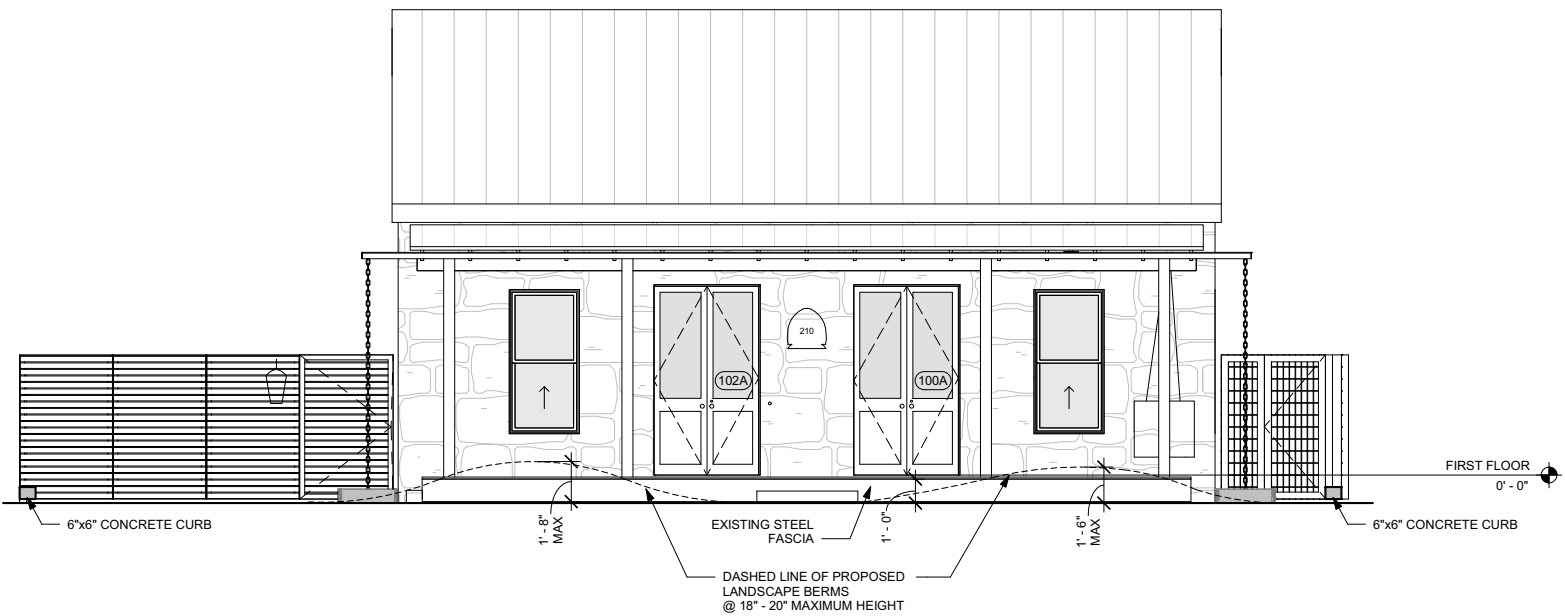
Lavaca Street Proposed Elevation with Landscape Berms

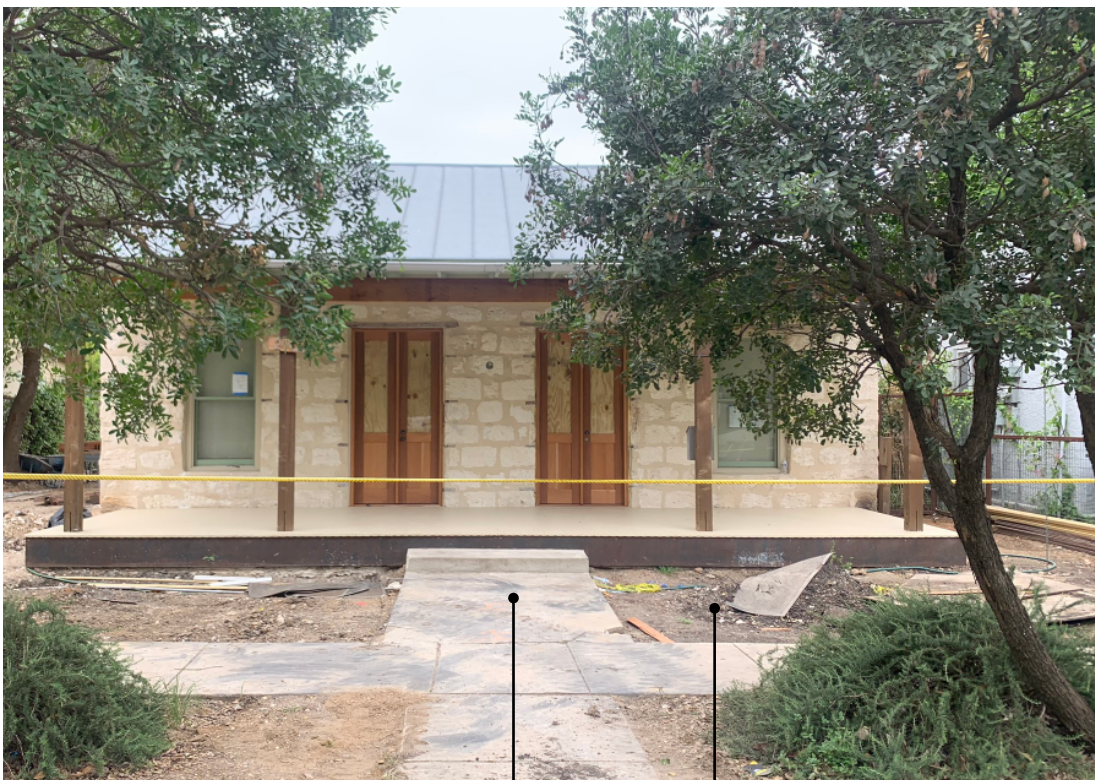
replace concrete walk with  
stone pavers + stone step

new landscaping at  
front yard, including  
proposed trees

Lavaca Street Elevation -Current May 2020

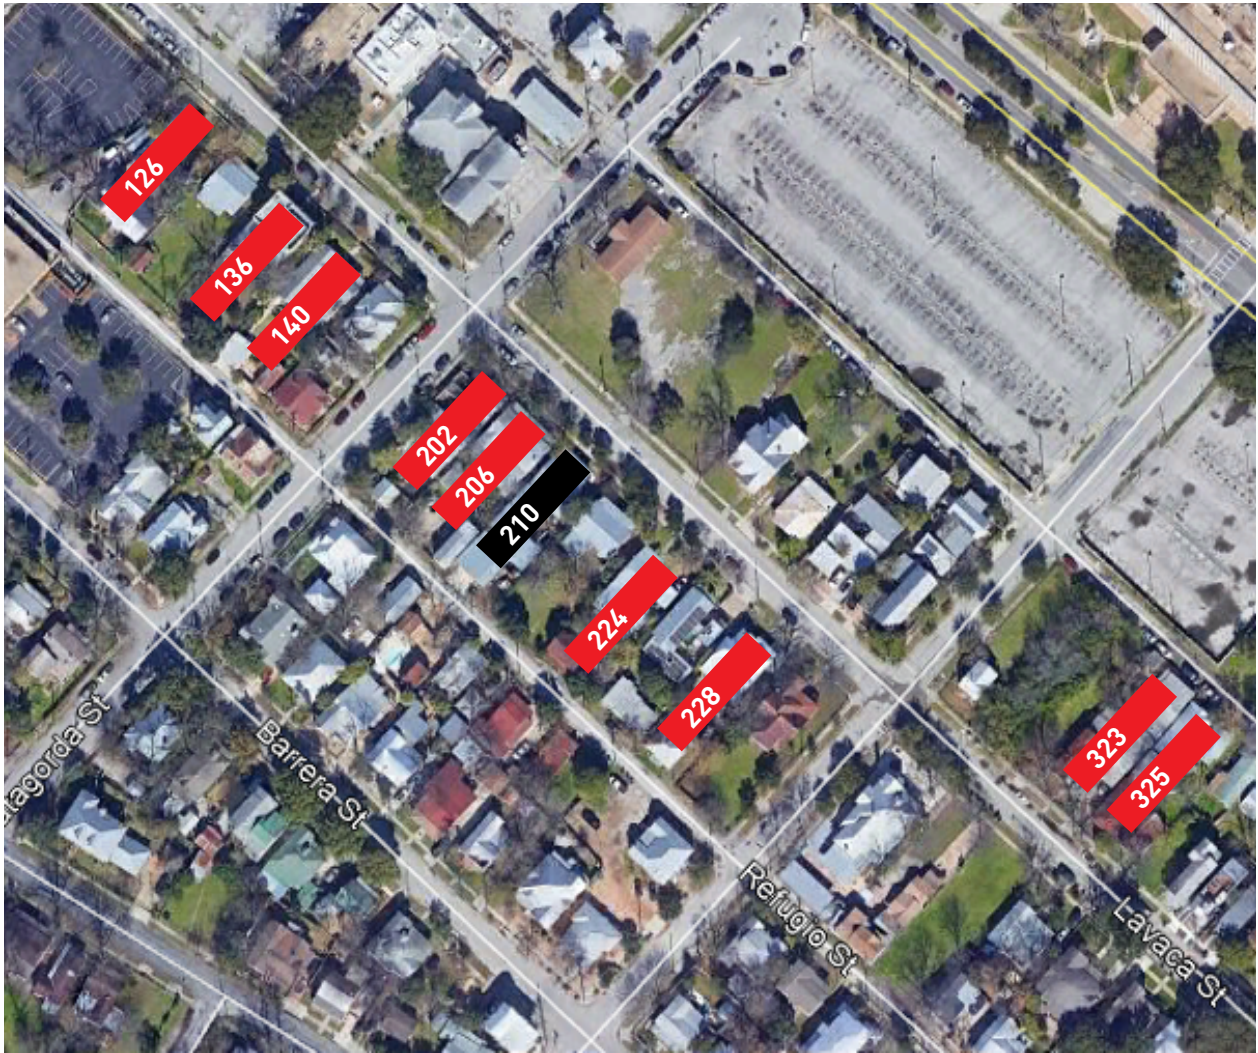
Lavaca Street - Diagram showing houses with pavers at front walk, with accompanying photos below

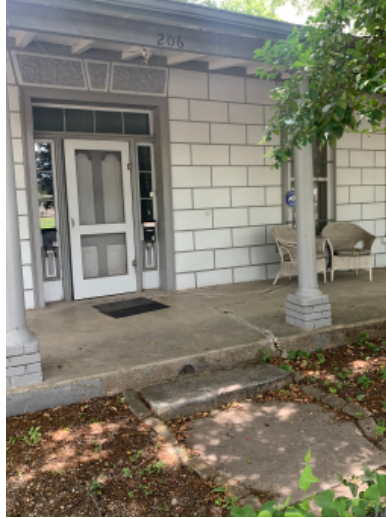
206 Lavaca  
Concrete with stone edges and  
stone step

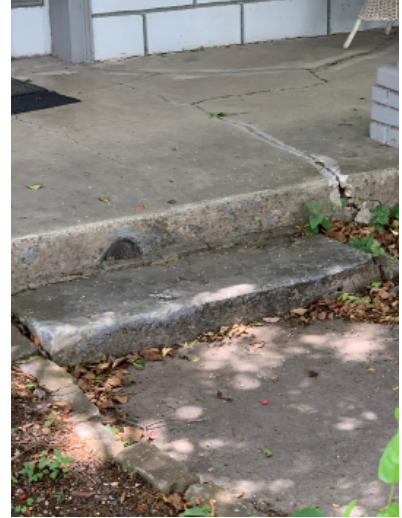
206 Lavaca  
Enlarged photo of stone step

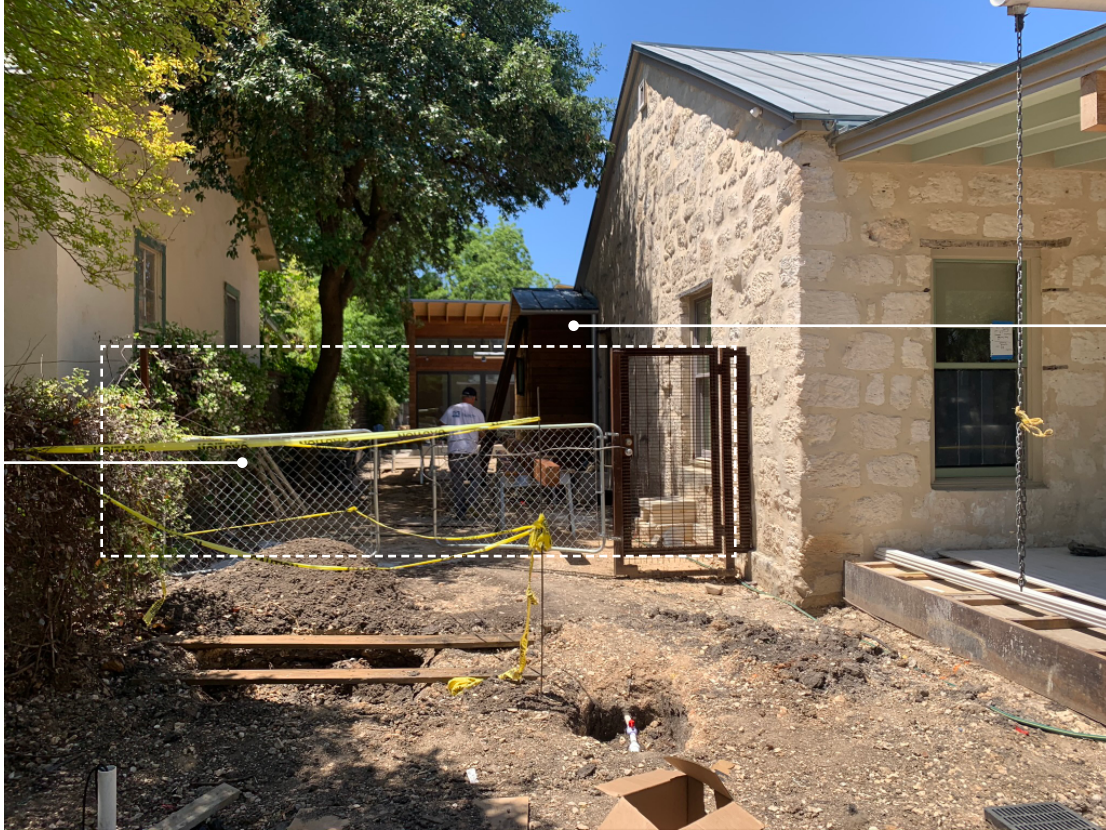
dashed line of new fencing and gate has been approved in separate COA

pool bath building beyond

Side Yard - Current May 2020

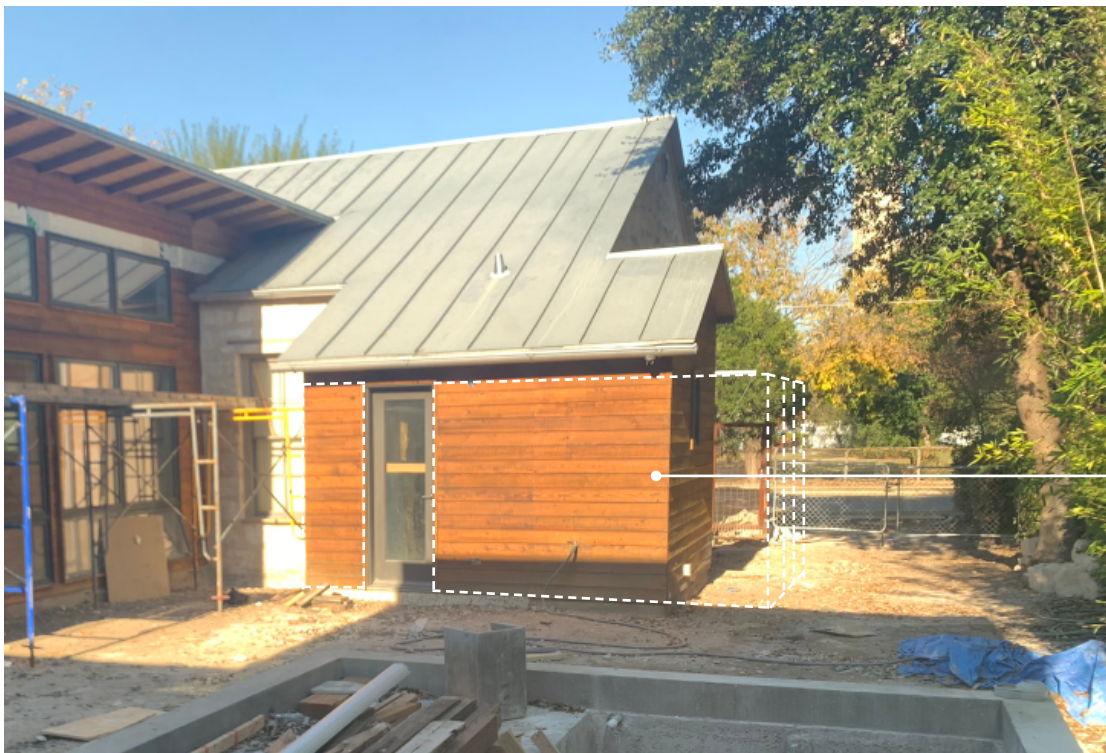
pool bath building with dashed line of fence enclosure

Pool Courtyard - Current May 2020

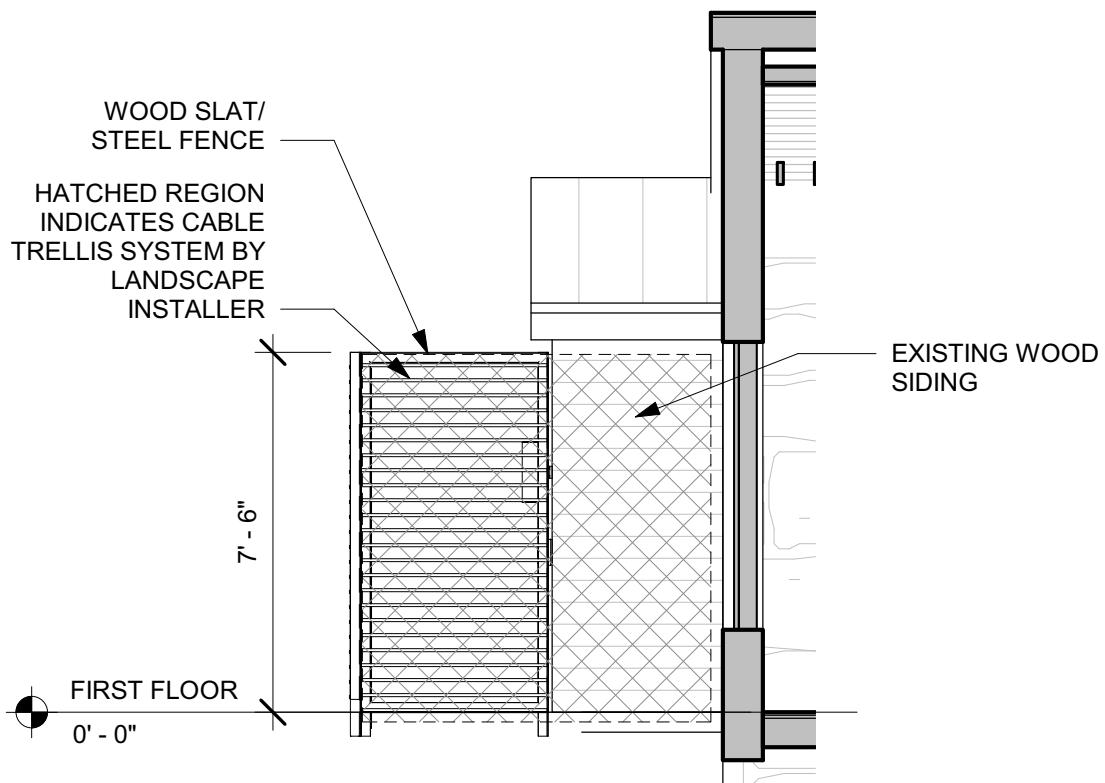
East Elevation - Pool Bath Building with proposed fence enclosure

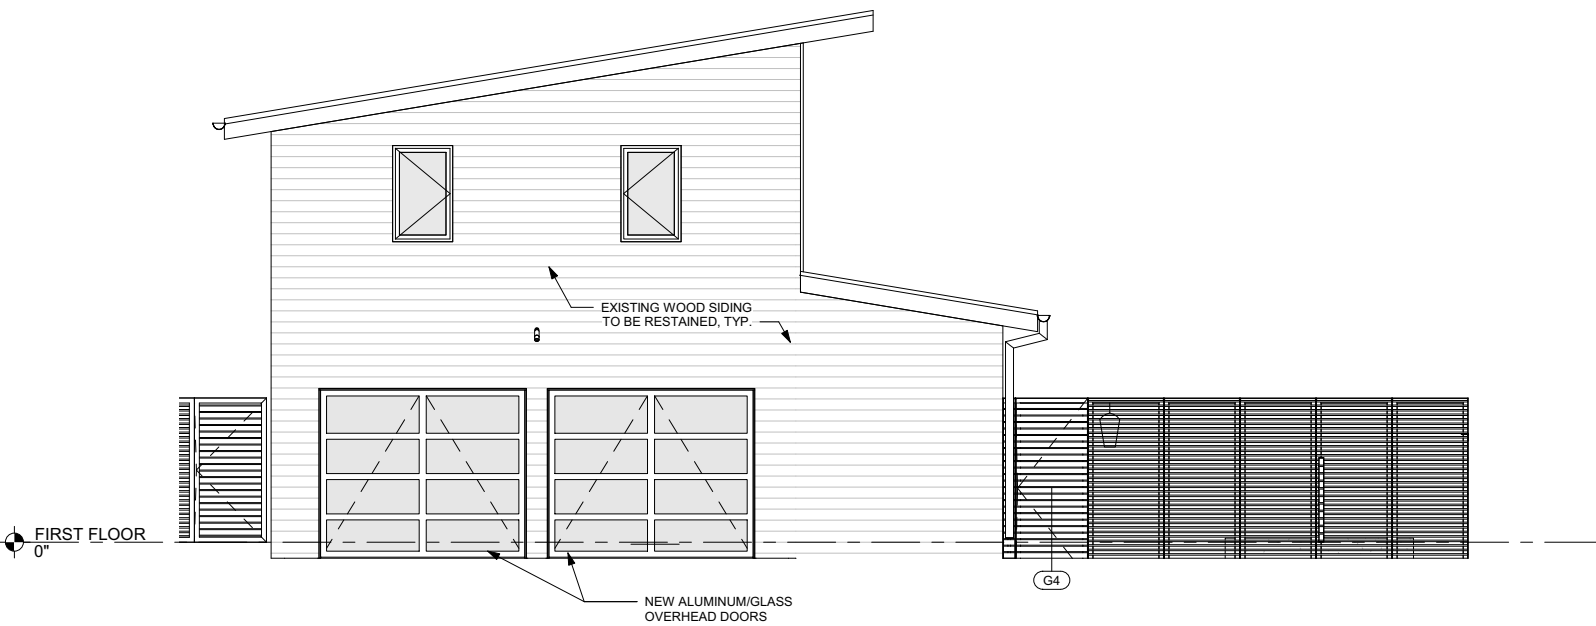
Refugio Alley Elevation with Aluminum and Glass Garage Doors

- e. GARAGE DOORS – The applicant has proposed to replace the horizontal wood plank garage doors on the non-historic, detached garage with new metal framed garage doors with opaque glass panels. Per the Guidelines for New Construction 5.A.v., applicants should incorporate garage doors with similar proportions and materials as those traditionally found in the district. Staff finds that the proportions remain appropriate, but the metal and glass configuration do not relate to garage doors traditionally found in the district and such modification is also highly visible on Refugio. Staff finds that a wood garage door with a band of windows across the top would be more appropriate than the proposed doors.

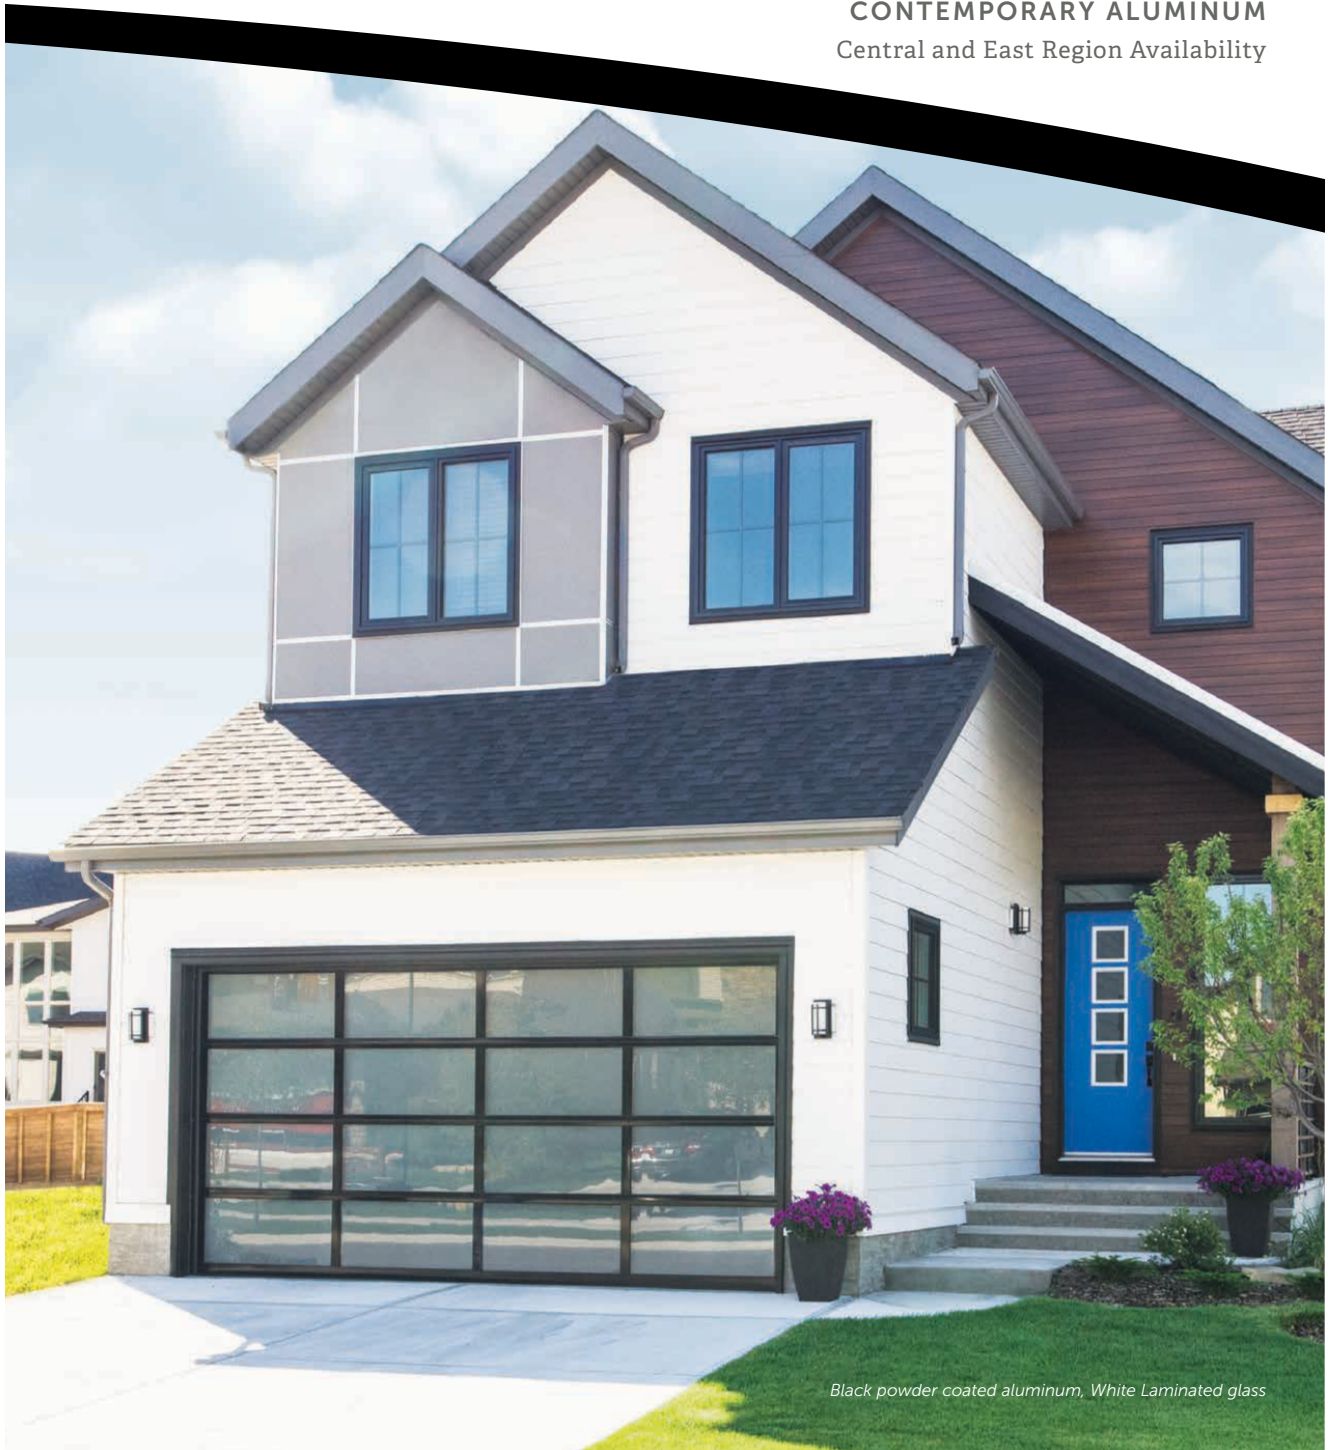
# 8850

CONTEMPORARY ALUMINUM  
Central and East Region Availability

*Black powder coated aluminum, White Laminated glass*

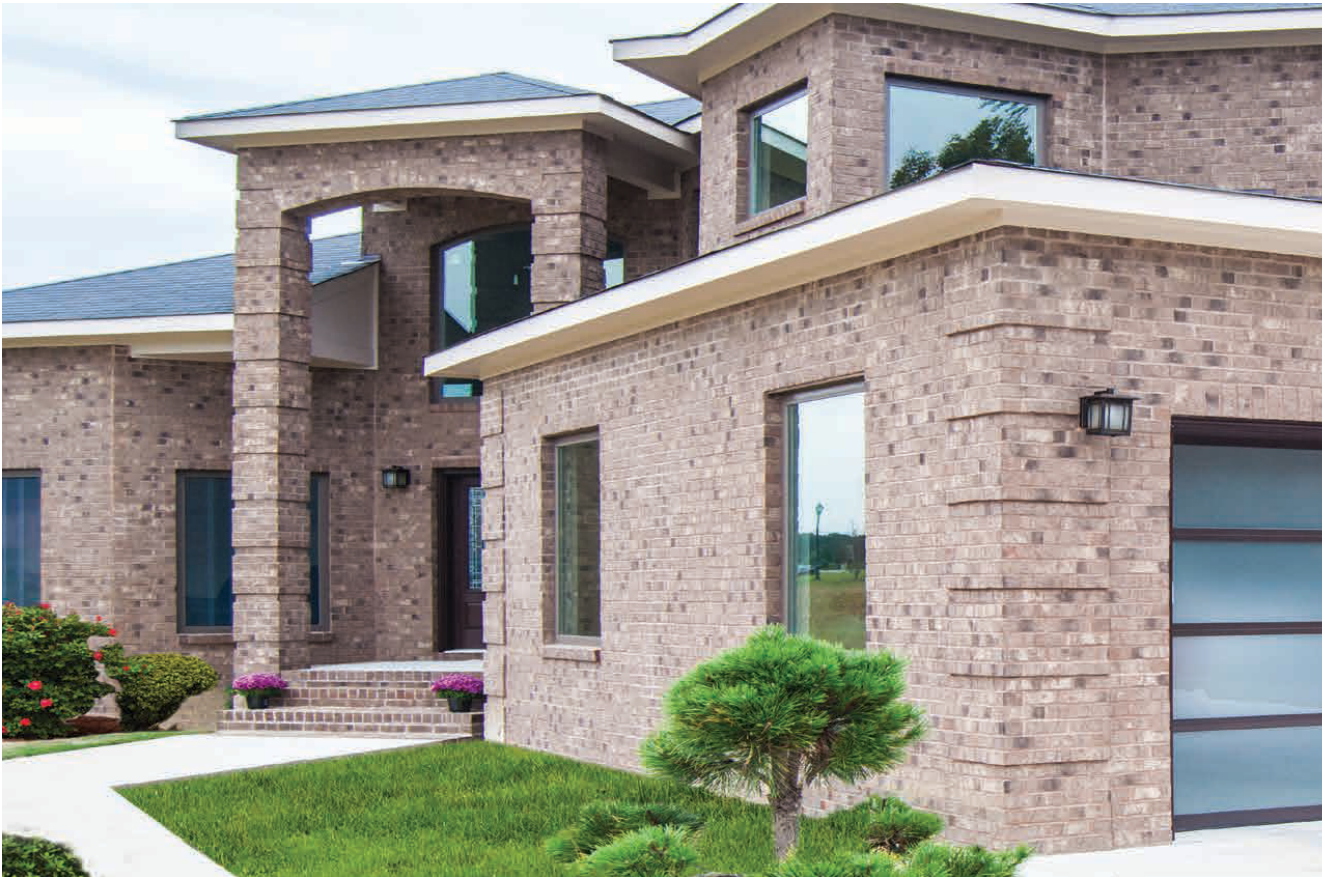
# 1 Choose Your Style

## Standard Frames

8' Wide (2 panel)\*

9'-12' Wide (3 panel)

Over 12' Wide (4 panel)

## Double-wide Frames

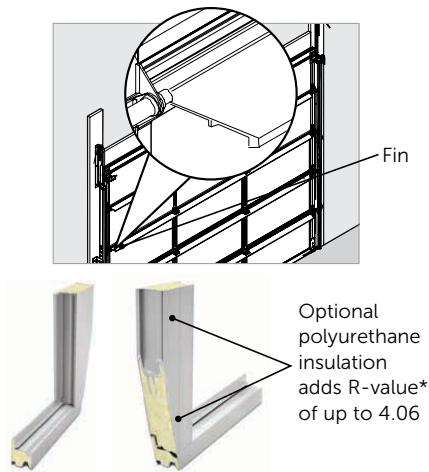
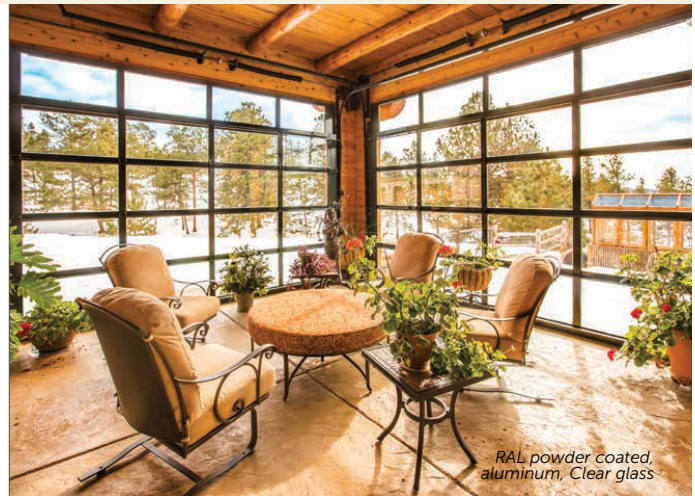
Wayne Dalton Contemporary Aluminum doors, constructed with a rugged, anodized aluminum frame, feature equal panel spacing for a clean modern look.

- Tongue-and-groove joints provide a great weather barrier
- Flexible vinyl bottom seal helps prevent dirt and elements from entering your garage
- Designed to be easy to maintain
- Constructed with rugged, anodized aluminum frame with equal panel spacing
- Reinforcing fins along with heavy-duty track and brackets help provide years of smooth, trouble-free operation (The fins are the extruded part of the door section that are not visible through the glass)
- Chose a 25,000 cycle spring for almost twice the life of a standard torsion spring
