HISTORIC AND DESIGN REVIEW COMMISSION

HDRC CASE NO: 2020-261
ADDRESS: 410 BARRERA
414 BARRERA
LEGAL DESCRIPTION: NCB 926 (EIM LAVACA), BLOCK 4 LOT 32
NCB 926 (EIM LAVACA), BLOCK 4 LOT 33
ZONING: IDZ, H
CITY COUNCIL DIST.: 1
DISTRICT: Lavaca Historic District
APPLICANT: Nathan Manfred/French and Michigan
OWNER: Adrian Gracia/EIM LV LLC
TYPE OF WORK: Amendment to feature standing seam metal roof
APPLICATION RECEIVED: June 02, 2020
60-DAY REVIEW: Not applicable due to City Council Emergency Orders
CASE MANAGER: Huy Pham

The applicant is requesting a Certificate of Appropriateness for approval to amend the rehabilitative scopes of work at 410 and 414 Barrera to include the installation of standing seam metal roofs with flat ridge caps on the historic structures and their additions.

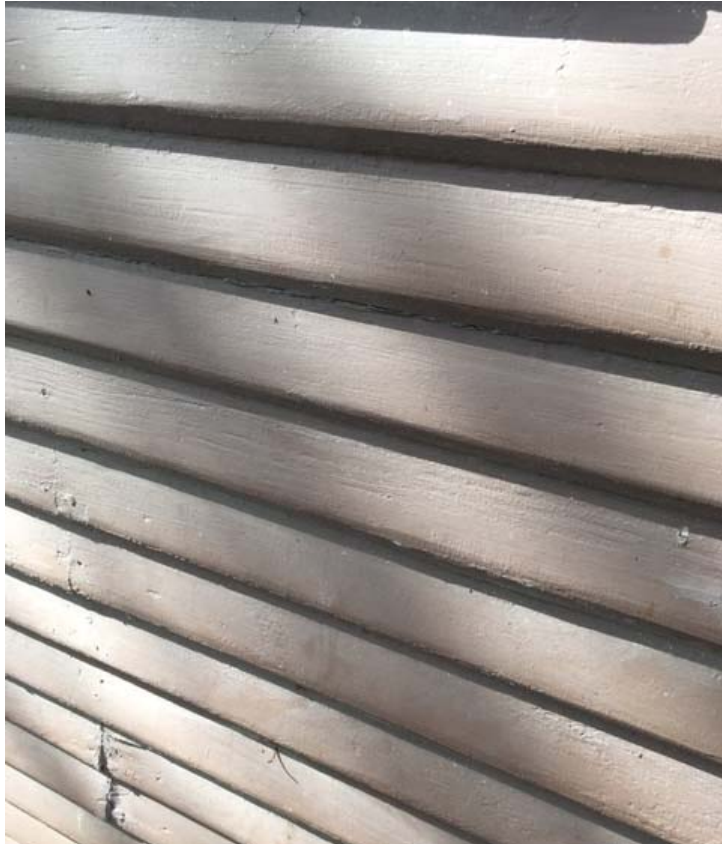
410 Barrera – Original Waterfall Wood Siding

- 1a. REHABILITATION (410 Barrera) – The applicant has proposed to repair and replace existing, deteriorated wood siding as needed and to restore the existing, wood windows. The applicant has noted this repair will be done in-kind. This is consistent with the Guidelines.
- 1b. EXTERIOR MODIFICATIONS – The applicant has proposed to remove one existing wood windows opening from the rear (south) façade and west elevations. These windows are on non-primary facades and are not full height windows. The applicant has noted that these windows will be reused in the construction of the proposed addition. Staff finds this to be appropriate.

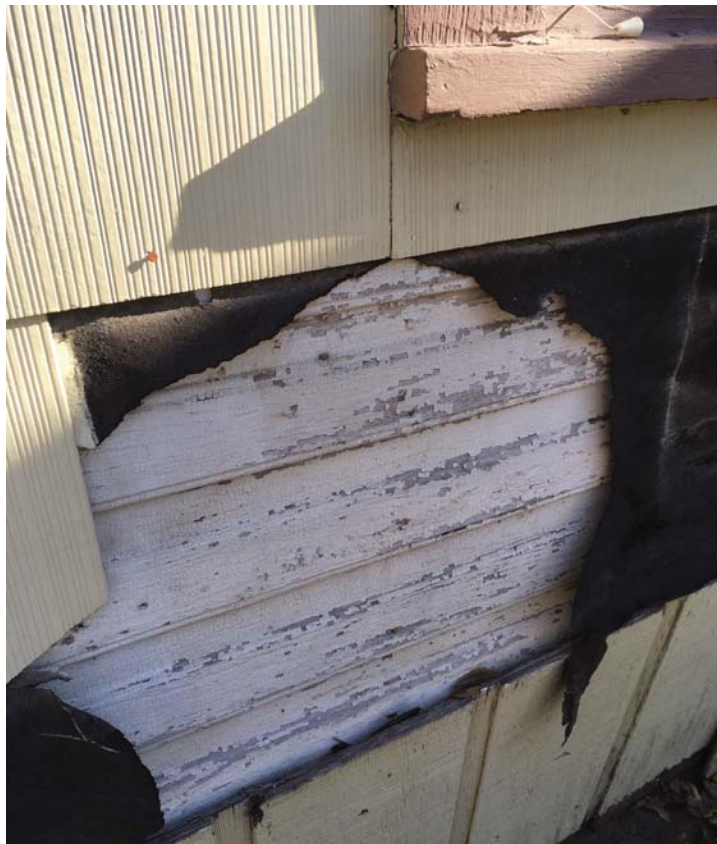
414 Barrera – Original Horizontal Wood Lap Siding
