HISTORIC AND DESIGN REVIEW COMMISSION

HDRC CASE NO: 2020-391
ADDRESS: 212 N ALAMO ST
LEGAL DESCRIPTION: NCB 425 BLK 23 LOT W 43 FT OF N 89.6 FT OF 2
ZONING: D, H
CITY COUNCIL DIST.: 1
LANDMARK: YWCA / Henry Terrell Building
APPLICANT: Mark Henderson
OWNER: Chris McMartin/ALAMO QOZB LLC
TYPE OF WORK: Repair and maintenance, addition, storefront installation
APPLICATION RECEIVED: August 28, 2020
60-DAY REVIEW: Not applicable due to City Council Emergency Orders
CASE MANAGER: Edward Hall

The applicant is requesting a Certificate of Appropriateness for approval to:

1. Replace the existing, concrete slab and first level floor.
2. Construct a new stair and elevator addition to the south façade to feature a painted stucco exterior.
3. Remove two existing fire escapes.
4. Perform repair and maintenance to the existing masonry including re-pointing, cleaning, painting, and replacement where necessary.
5. Replace all existing windows and install a new aluminum storefront system.
6. Install a new TPO roofing system.
7. Install entrance canopies on the N Alamo façade.

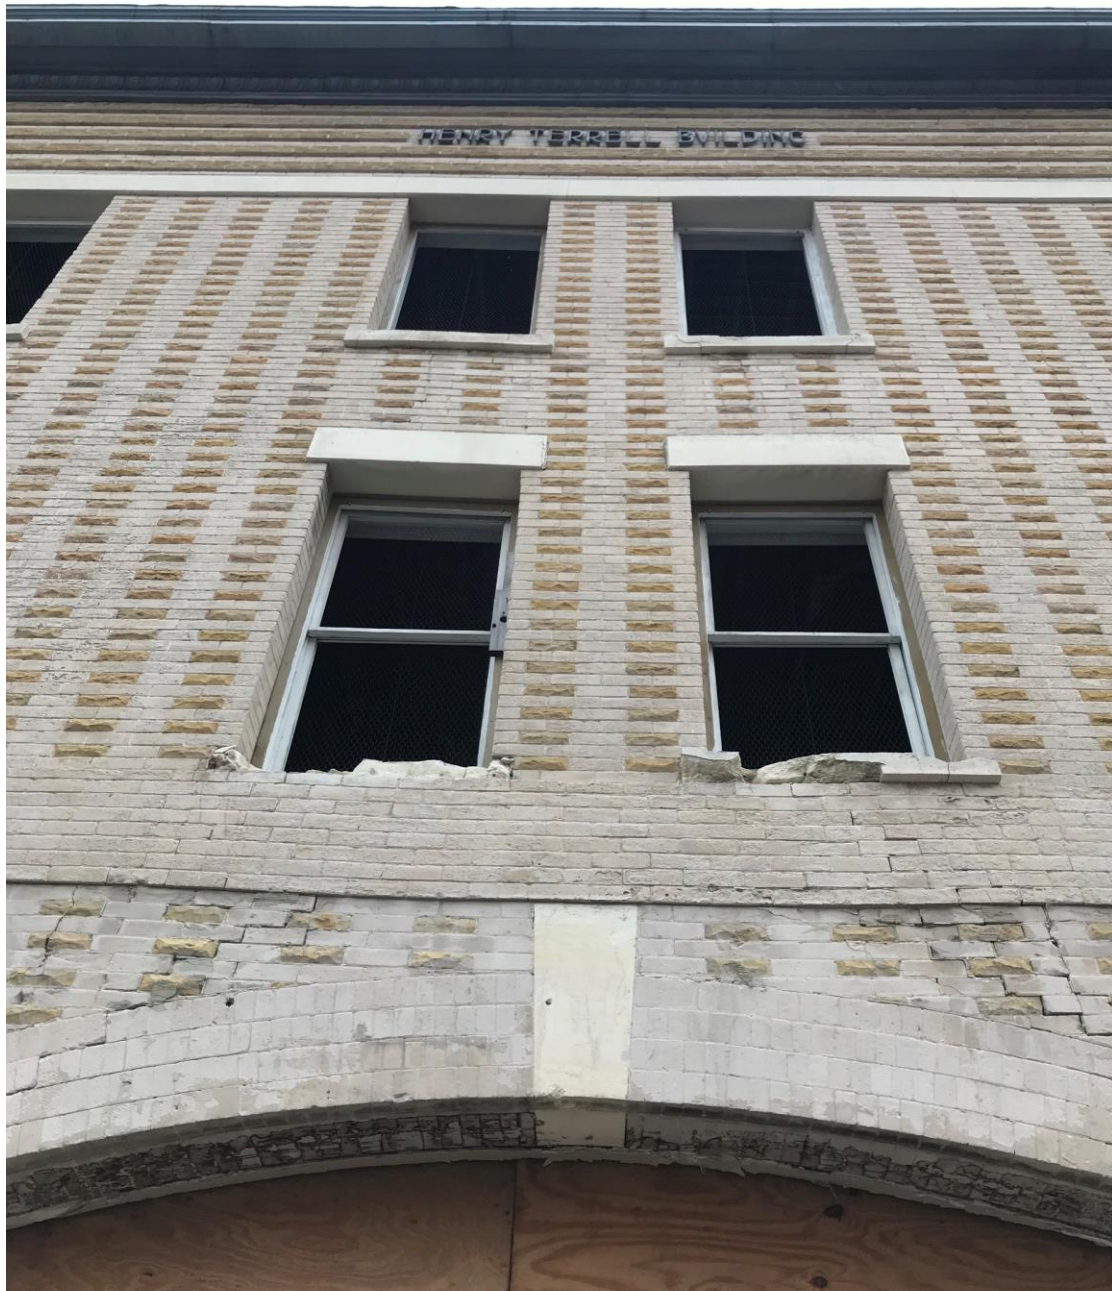
West façade typical fenestration – 212 North Alamo

The existing building has less than 20% of its windows and doors in place. As a result, replacement of all windows and storefront systems is proposed. The historic profiles and windows planes will be respected when trying to match the new window to the existing. The proposed windows will be thermally broken and constructed of wood with an Insulated glass unit for energy efficiency.

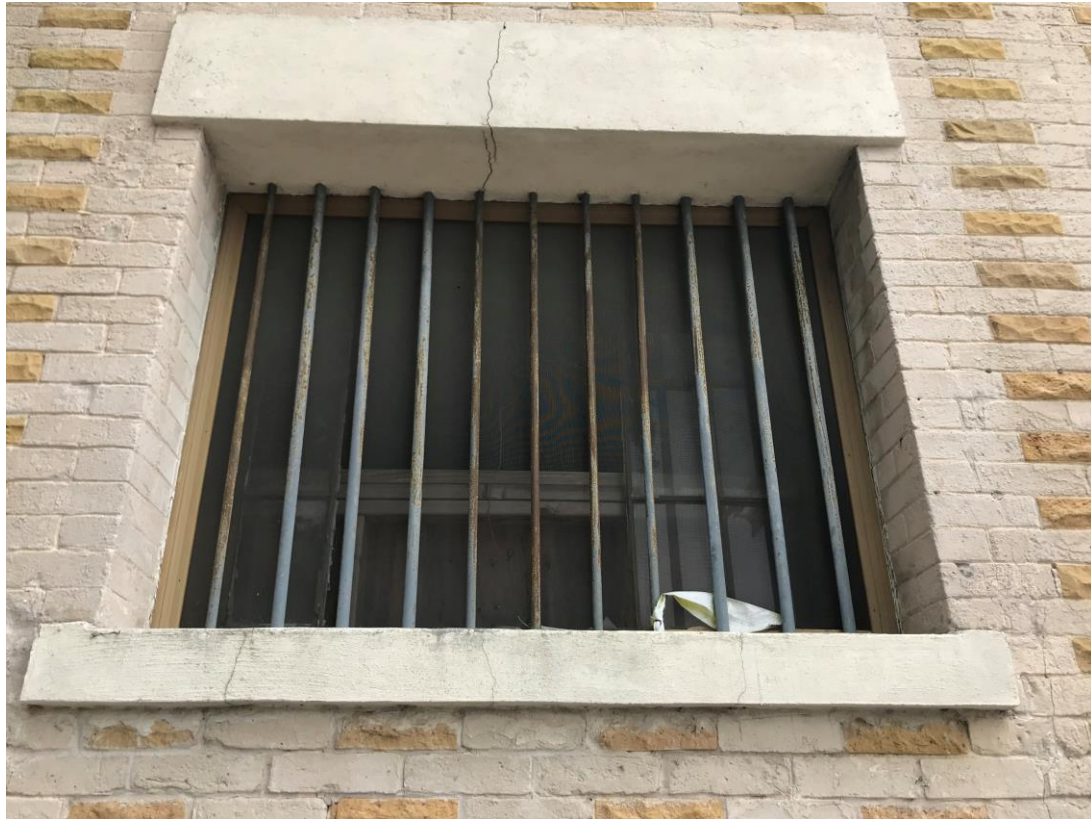
Window profile on north façade. Iron bars to be removed.

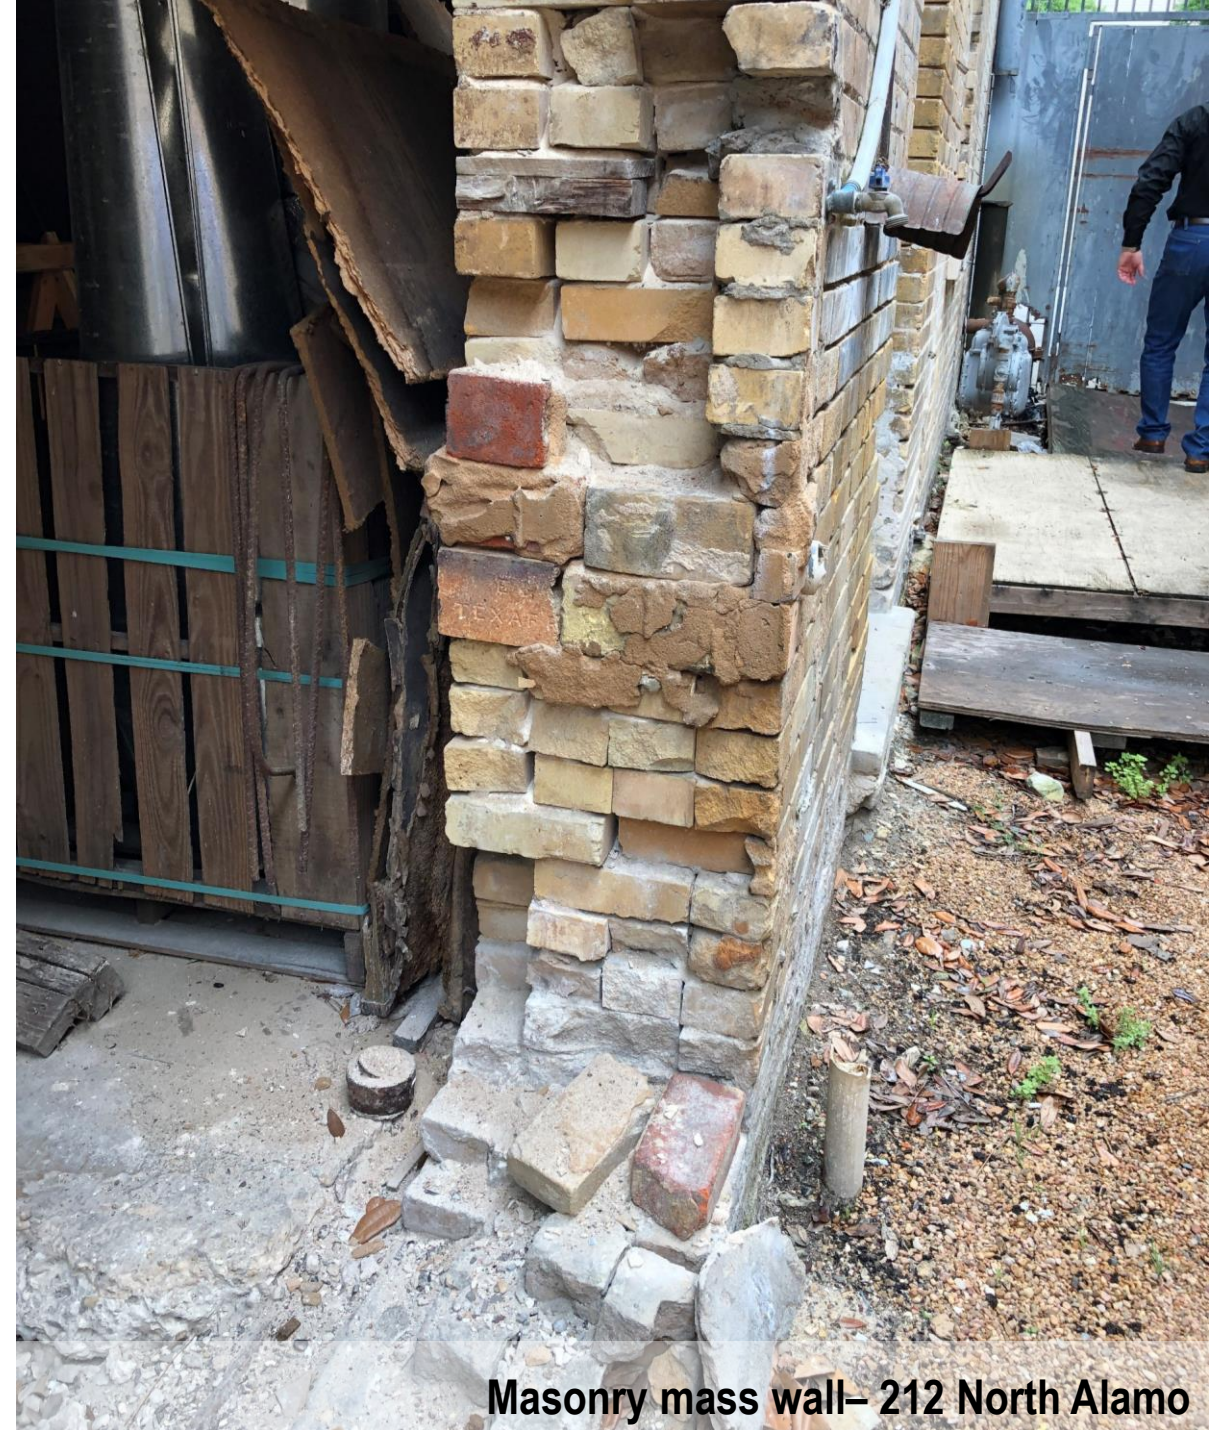
Masonry mass wall– 212 North Alamo

FPC will be re-pointing the masonry and mortar conditions around the building. The existing masonry will be cleaned and patched to a level appropriate for expressing as a finish material. Some masonry units need to be replaced where severely damaged, as well as some that need to be removed where used to infill previous window profiles.

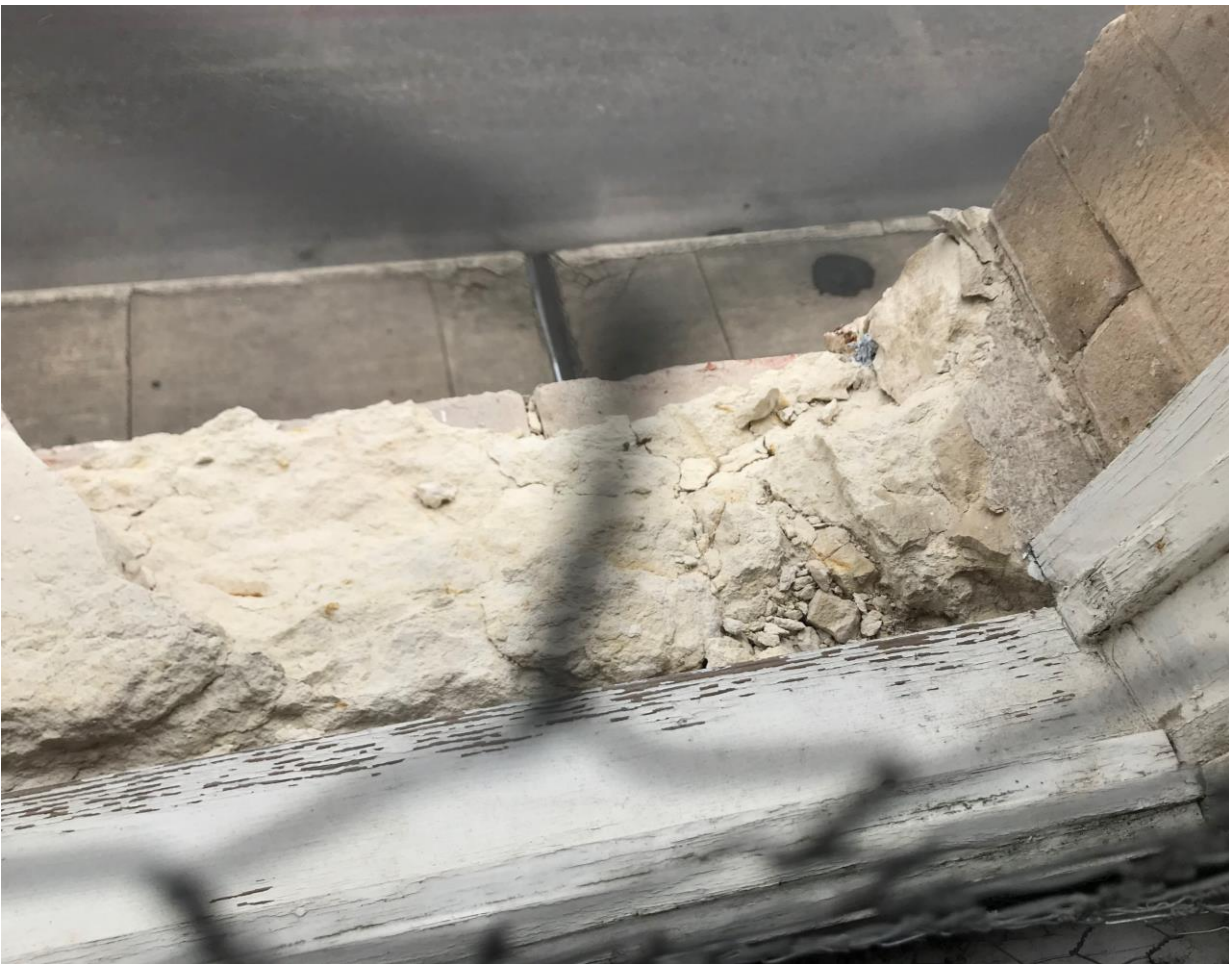
Typical window sill to be patched & repaired

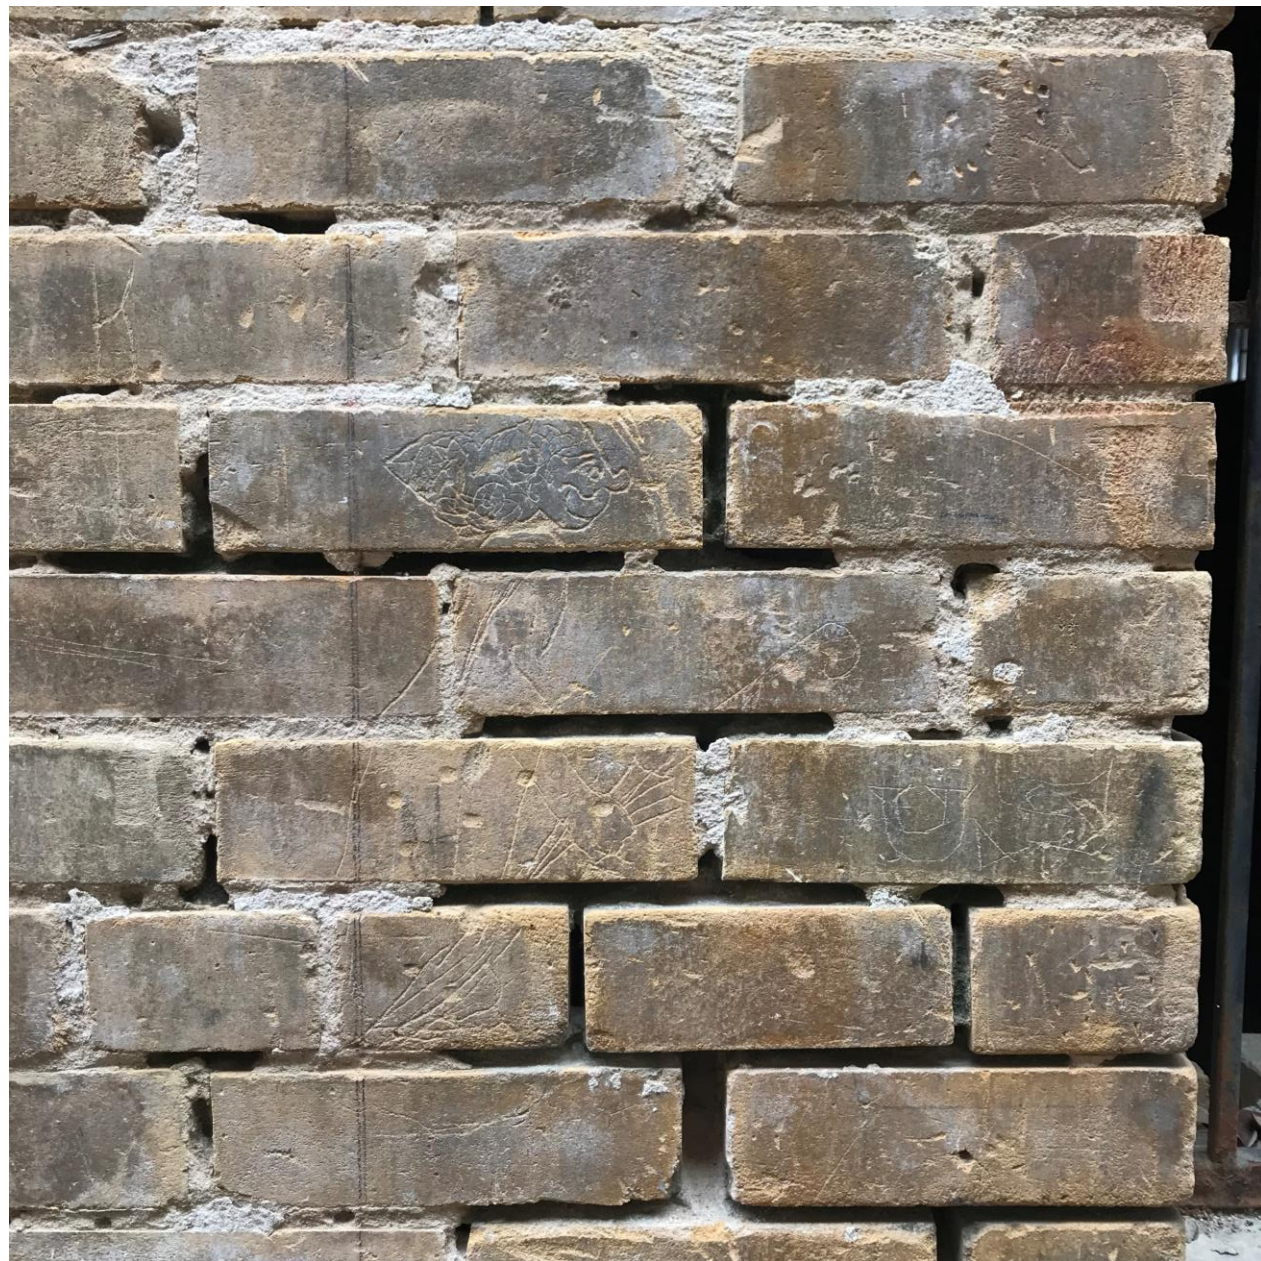
Exterior brick masonry to be repointed and repaired as necessary.

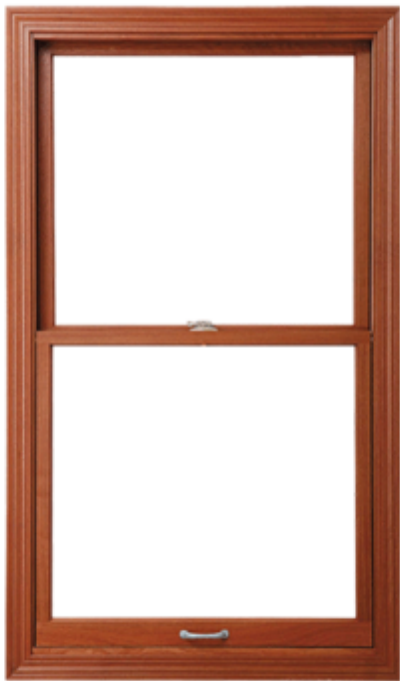
Pella Traditional, Reserve Series - Fixed Wood Windows

Double Pane -
Insulated Glass
Unit will be used

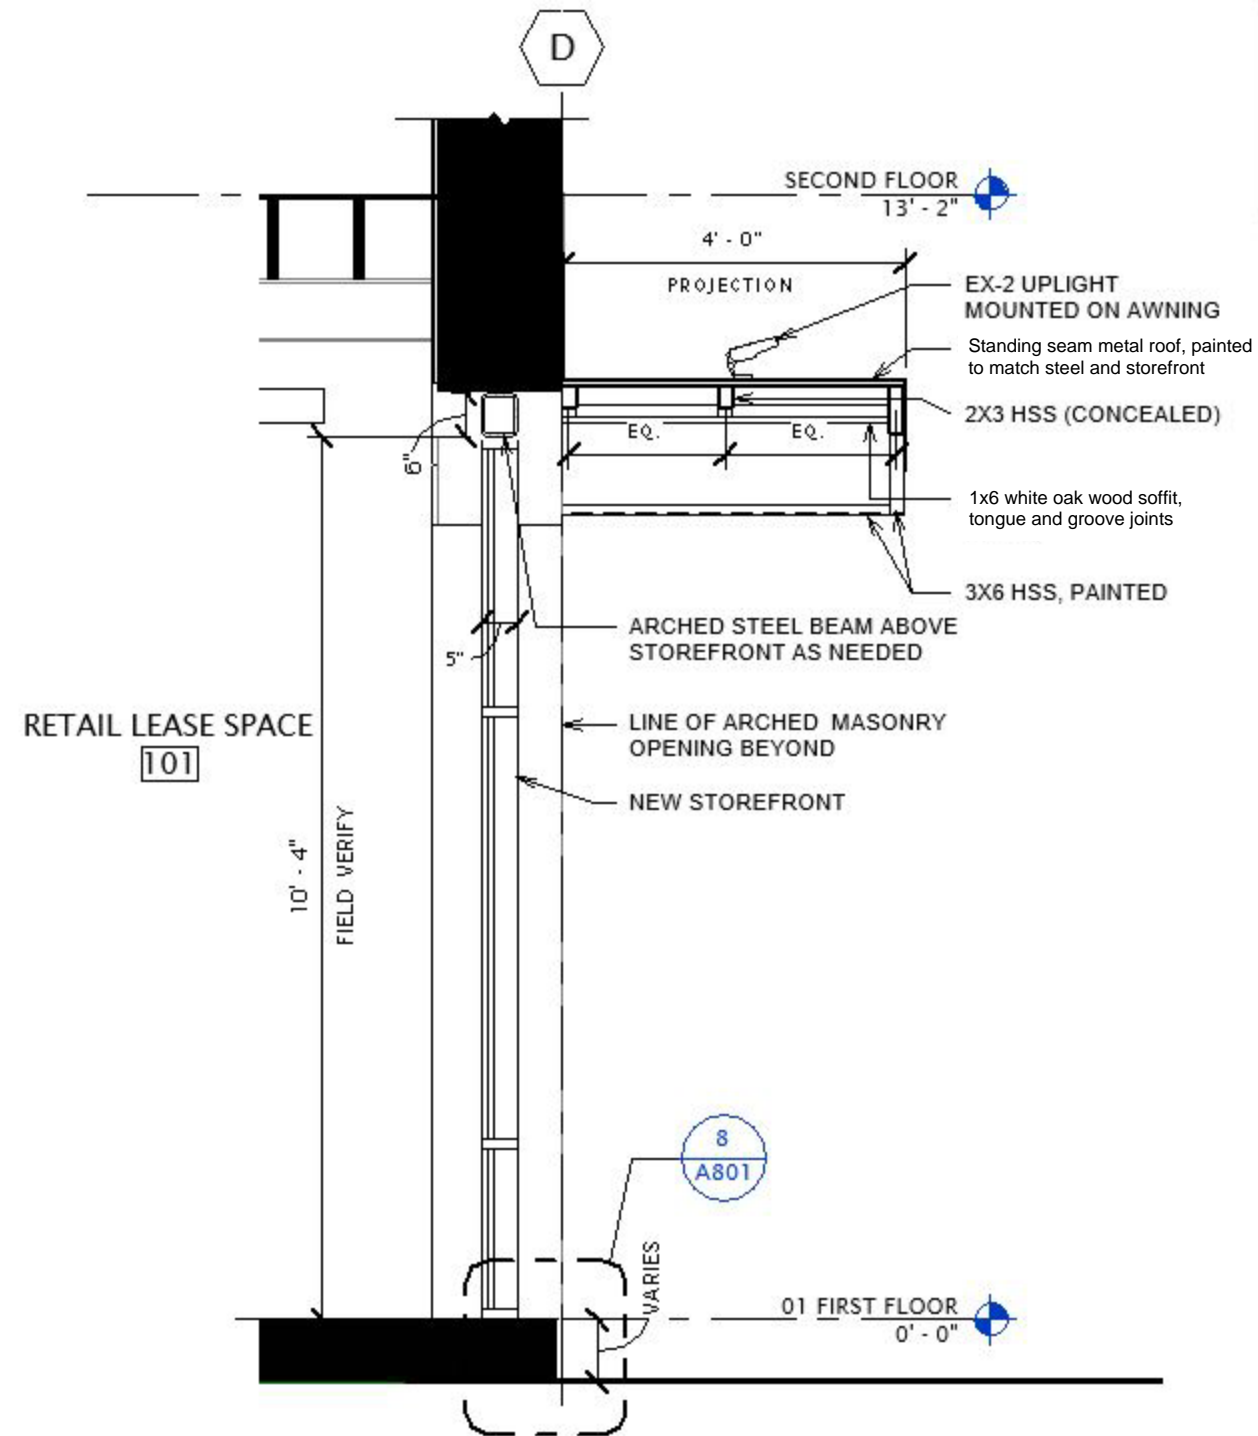
9 AWNING SECTION - TYPICAL
SCALE: 1/2" = 1'-0"

Standing seam metal roof, painted to match steel and storefront

1x6 white oak wood soffit, natural or clear stained, tongue and groove joints
