HISTORIC AND DESIGN REVIEW COMMISSION

HDRC CASE NO: 2020-403
ADDRESS: 1903 W MULBERRY AVE
LEGAL DESCRIPTION: NCB 1944 BLK 22 LOT 1
ZONING: R-6, H
CITY COUNCIL DIST.: 7
DISTRICT: Monticello Park Historic District
APPLICANT: Mario Cordero/CORDERO MARIO J & SYLVIA R
OWNER: Mario Cordero/CORDERO MARIO J & SYLVIA R
TYPE OF WORK: Replace existing garage doors and replace siding
APPLICATION RECEIVED: September 08, 2020
60-DAY REVIEW: Not applicable due to City Council Emergency Orders
CASE MANAGER: Huy Pham
REQUEST:

The applicant is requesting a Certificate of Appropriateness for approval to rehabilitate the rear garage structure to include:

1. Removing the existing tile and vertical board siding, repair damage, and install Hardie plank siding
2. Replace the existing wooden garage doors with two aluminum garage doors.

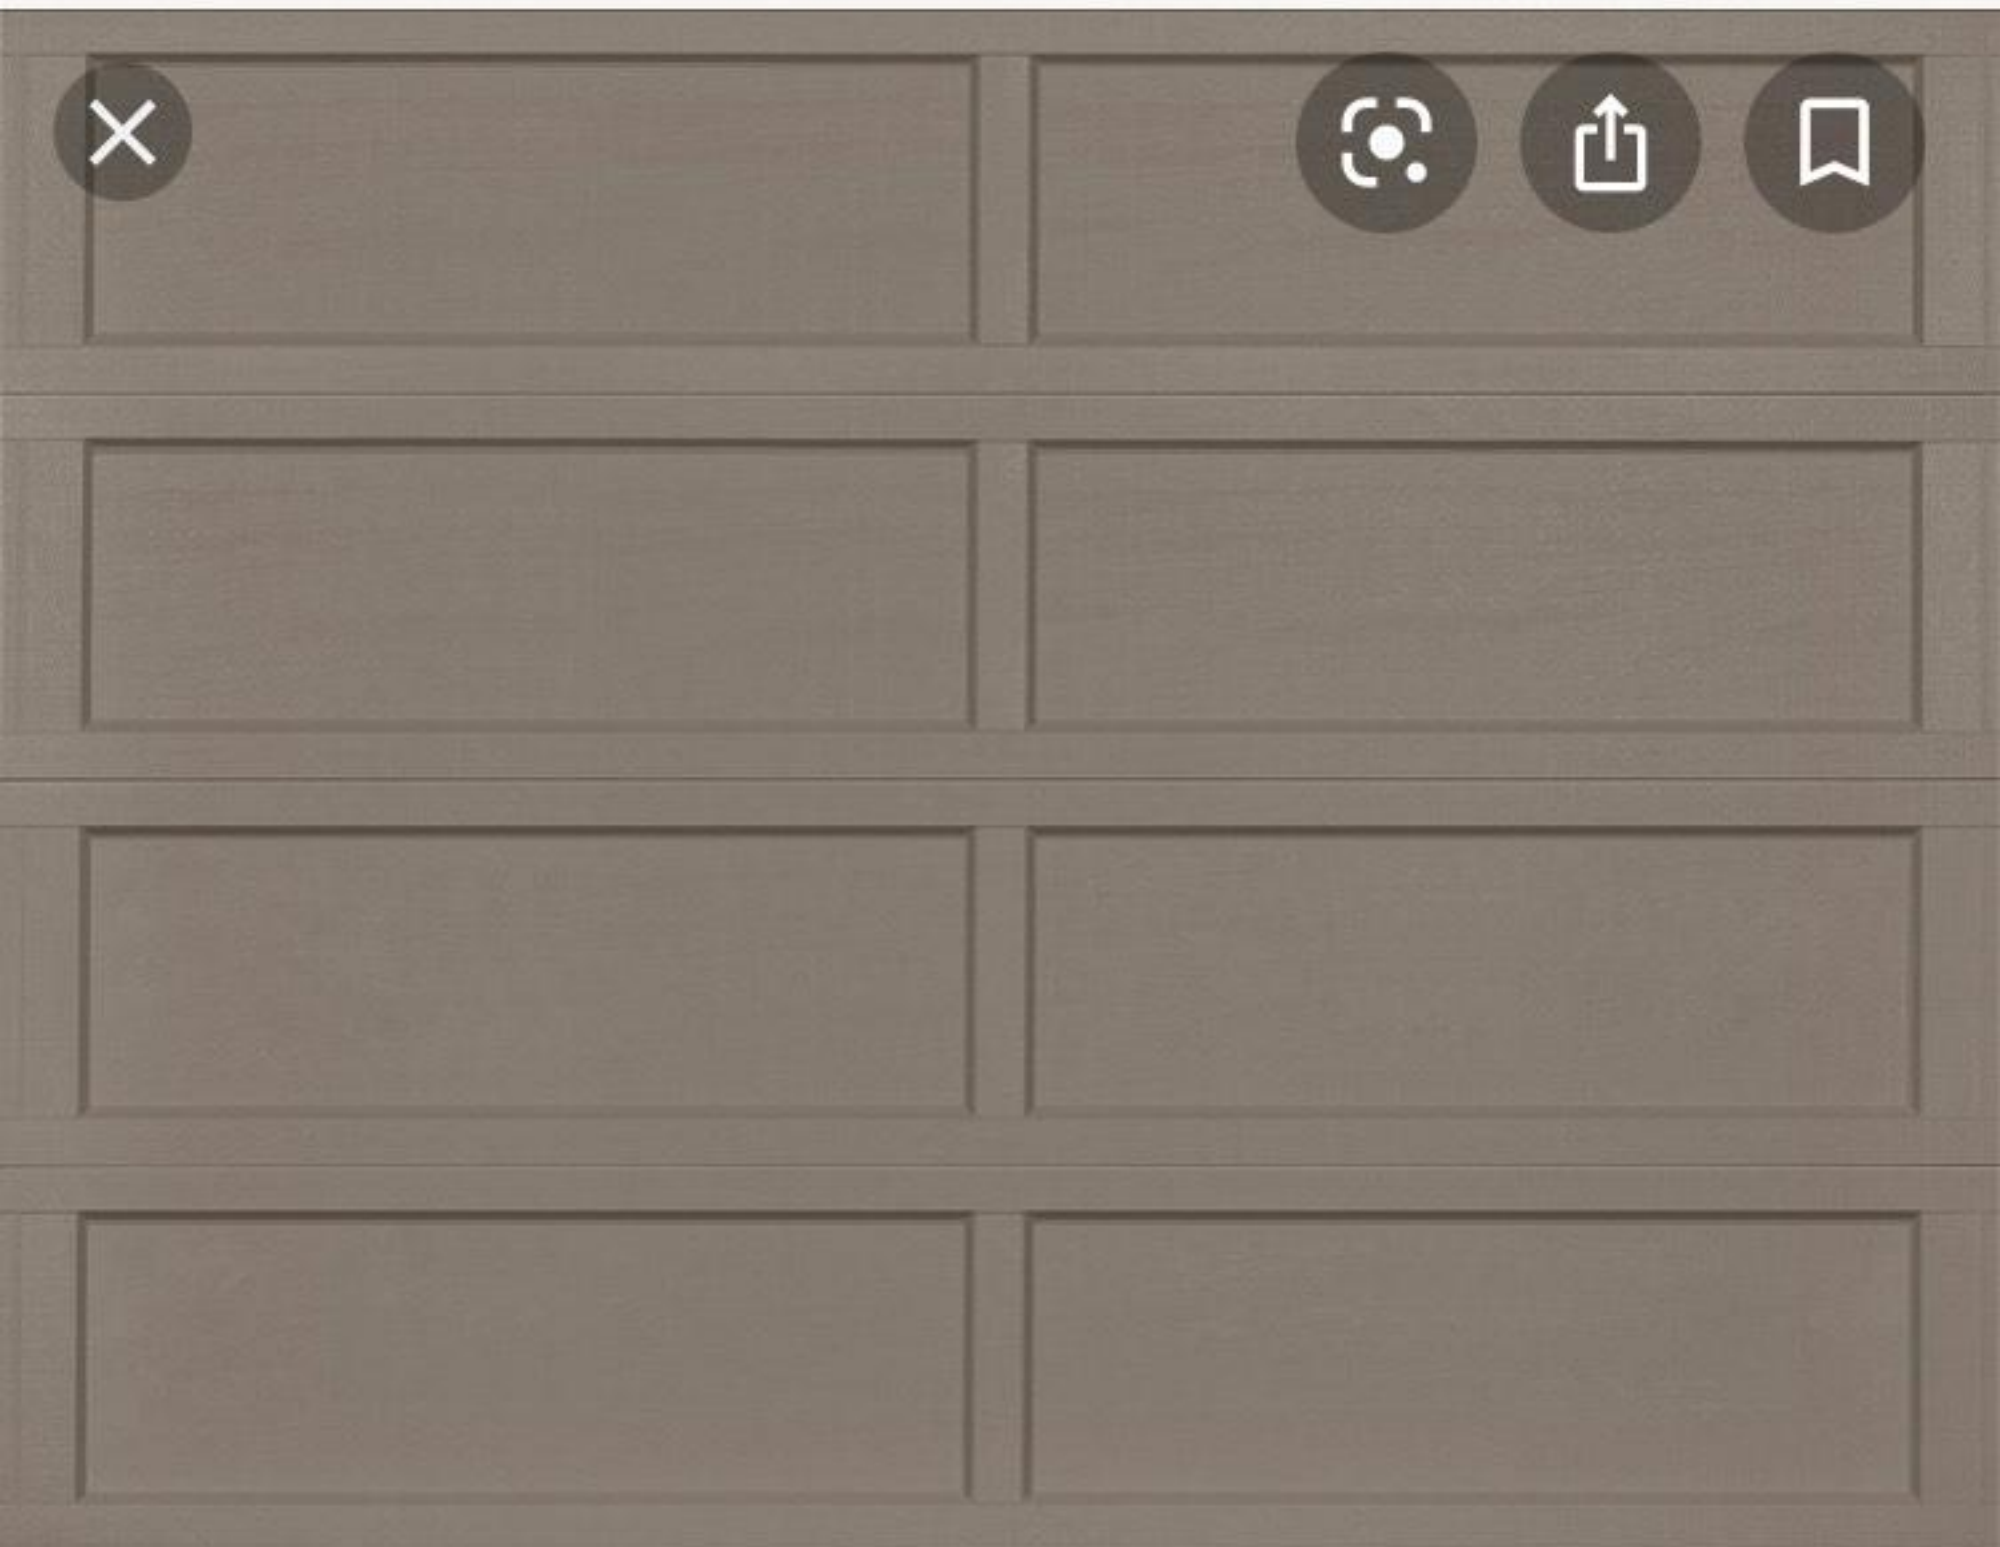
QUOTE

8'x7' Model 2294

Recessed Panel LP,

Steel Back Insulated,

Polyurethane, Solid,

Standard Color, Rope,

PWS, ORB, Top Strut,

Inside Lock, Standard

Lift

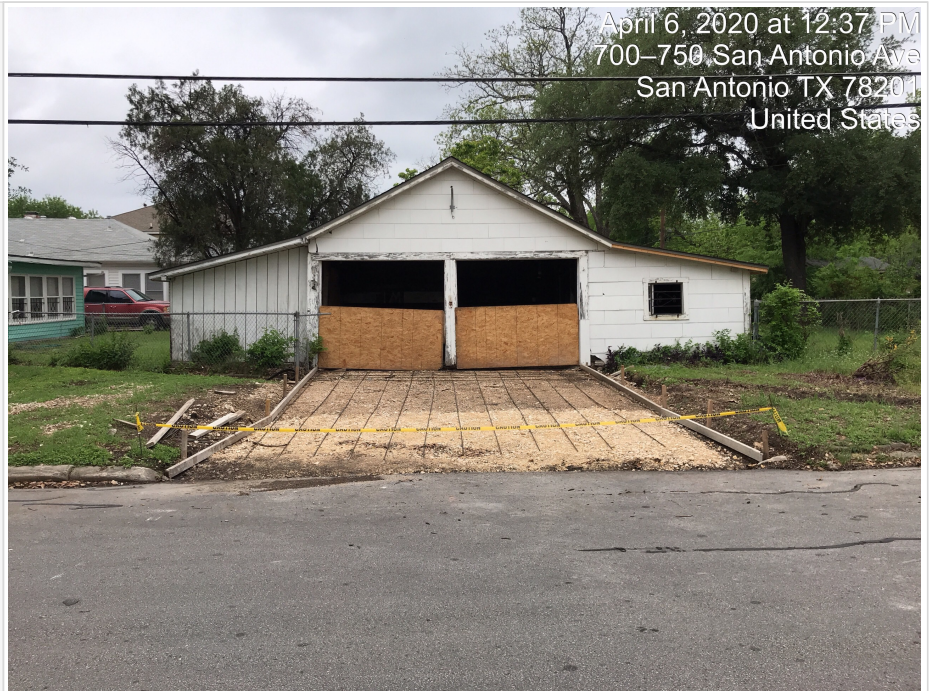
Investigation Report

Date	04/06/2020
Time	12:37 PM (-5 GMT)
Context	other [see field notes]
Present Staff	Huy Pham, Edward Hall
Present Individuals	None
Types of Work Observed	Site Elements
Amount of Work Completed	50%
Description of work	Removal of garage doors, driveway replacement.

04/06/2020 12:41 PM

- b. COMPLIANCE – On a site visit conducted on April 6, 2020, staff found that the original wood garage doors were removed and discarded prior to approval. The applicant complied with the Stop Work Order and submitted an application on September 8, 2020, including additional scopes of work to be heard at the next available commission hearing.
