# HISTORIC AND DESIGN REVIEW COMMISSION

**HDRC CASE NO:** 2021-032  
**ADDRESS:** 337 E SUMMIT AVE  
**LEGAL DESCRIPTION:** NCB 6882 BLK LOT 28, 29 & W 20 FT OF 30  
**ZONING:** R-5,H  
**CITY COUNCIL DIST.:** 1  
**DISTRICT:** Monte Vista Historic District  
**APPLICANT:** Samuel Asvestas/MONTEVISTA FOUNDATION INC  
**OWNER:** Samuel Asvestas/MONTEVISTA FOUNDATION INC  
**TYPE OF WORK:** Roof replacement, window replacement  
**APPLICATION RECEIVED:** January 19, 2021  
**60-DAY REVIEW:** Not applicable due to City Council Emergency Orders  
**CASE MANAGER:** Stephanie Phillips

1. Replace the existing asphalt shingle roof with a new standing seam metal roof in a galvalume finish.
2. Replace 22 single hung, single lite, aluminum windows with 22 single hung, single lite, black aluminum Don Young windows.

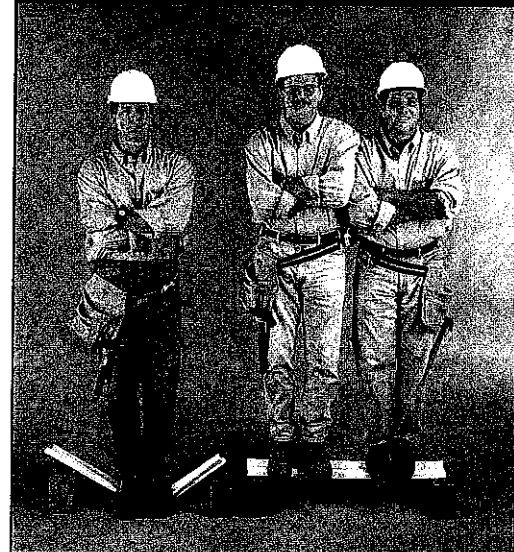
Some of our competitors get bent out of shape when we suggest their product can't stand up to our standards. Our sill section is substantially stronger than most windows on the market today, a feature that is especially important in supporting heavy insulated glass.

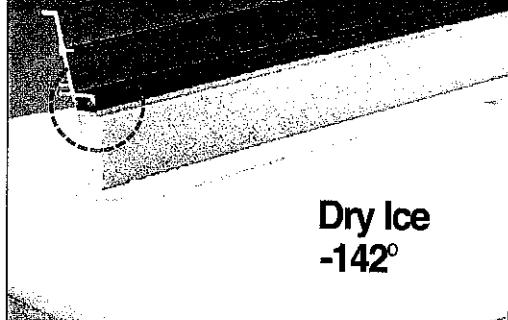
**Dry Ice  
-142°**

Ultra efficient insulated barrier used in frames and sashes dramatically reduces HEAT + COLD transfer through the aluminum, an exceptional insulator like wood and vinyl but with the durability of aluminum.

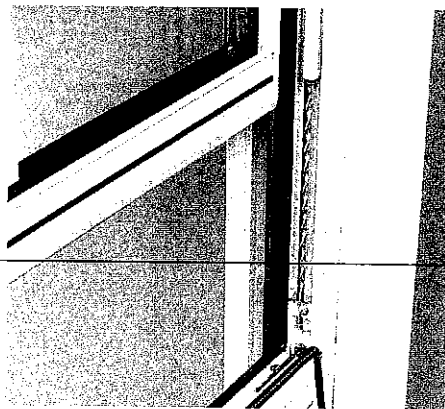
Heavy Duty metal spiral balances for dependable, smooth maintenance free operation. No ropes or pulleys to wear or break.
