HISTORIC AND DESIGN REVIEW COMMISSION

HDRC CASE NO: 2021-118
ADDRESS: 1003 N HACKBERRY ST
LEGAL DESCRIPTION: NCB 520 BLK 24 S 60 FT OF 17 & 18 ARB A17
ZONING: IDZ, H
CITY COUNCIL DIST.: 2
DISTRICT: Dignowity Hill Historic District
APPLICANT: Lawrence Briseno/MUNOZ LARRY GENE
OWNER: Lawrence Briseno/MUNOZ LARRY GENE
TYPE OF WORK: change in roofing material, front yard fencing
APPLICATION RECEIVED: January 28, 2021
60-DAY REVIEW: Not applicable due to City Council Emergency Orders
CASE MANAGER: Huy Pham

1. Replace the standing seam metal roof with a new composition shingle roof
2. Install a 4-foot tall wrought iron front yard fence along Lamar and N Hackberry

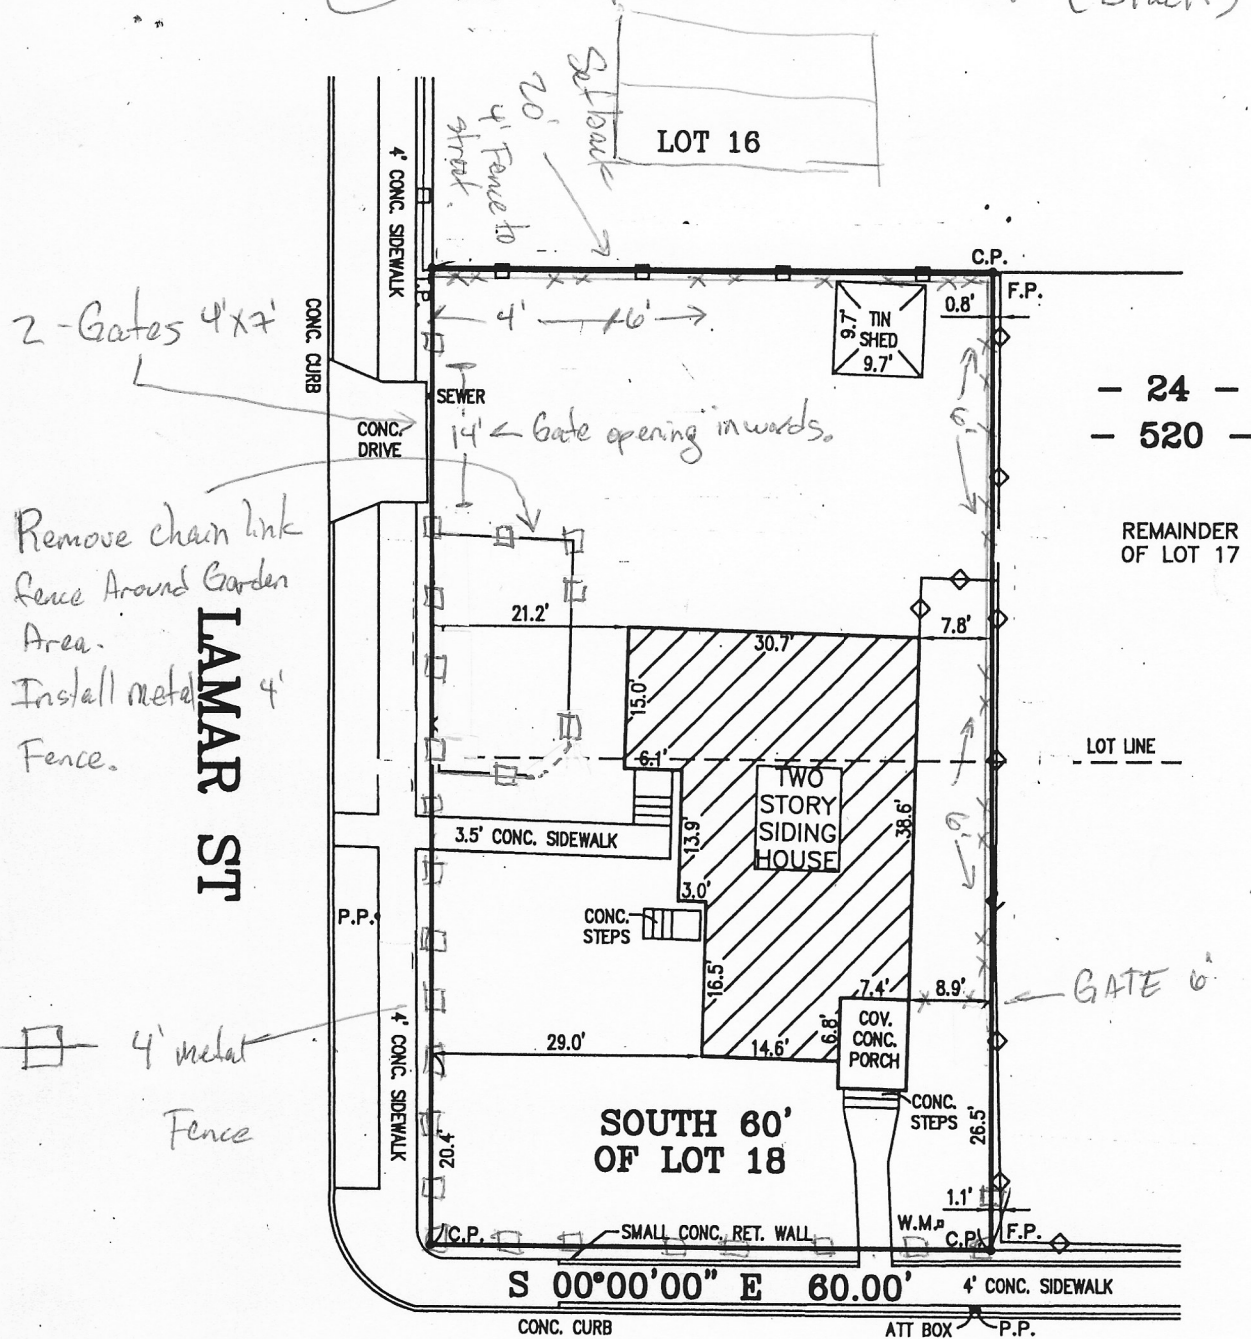
- (1) ~~XX~~ Proposed Cedar 6" Pickets, Private Fence, 6'
 (2) ~~XX~~ Proposed metal Fence 4' (Black)

N HACKBERRY ST

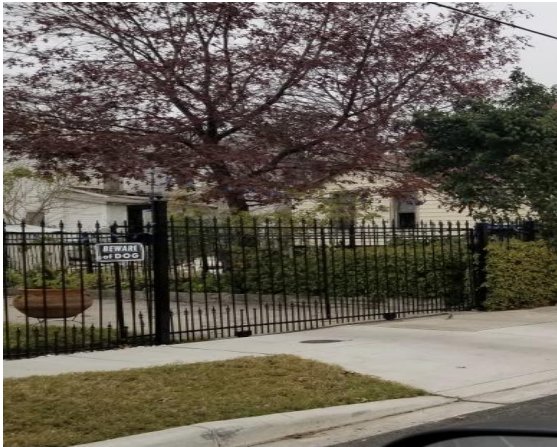
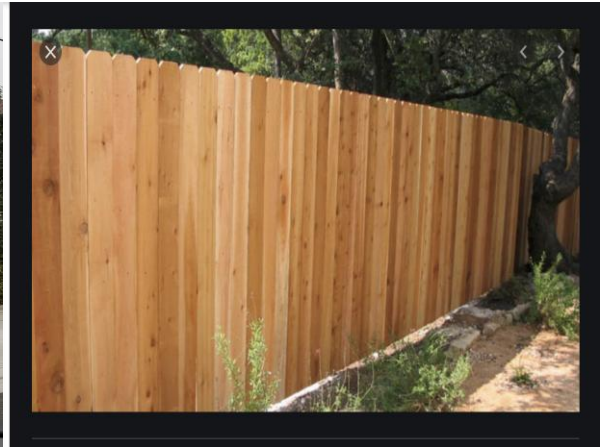
Fence

Rear of property to be 4' high at set back. (Cedar)

Samples of wrought iron fence (similar to neighbor on Lamar) and cedar fence.

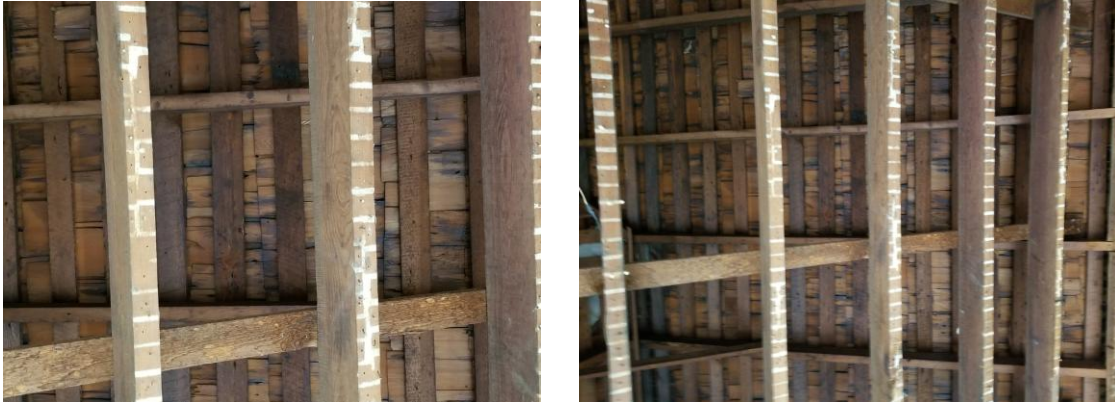
Evidence of existing wood shake shingle under metal roof.

- c. ROOFING – The applicant has proposed to replace the existing standing seam metal roof with a new composition shingle roof, based on the shake shingle roofing still present underneath. The structure features a combustible shake shingle roof on the 1904 and 1911 Sanborn map, and a noncombustible metal roof by the 1951 Sanborn map. Per the Guidelines for Exterior Alterations and Maintenance 3.B.vi. use metal roofs on structures that historically had a metal roof or where a metal roof is appropriate for the style or construction period. Staff finds that a standing seam metal roof was installed during the period of significance per finding b and is more appropriate than installing composition shingles. In-kind replacement of a standing seam metal roof is eligible for administrative approval with adherence to the standard specifications for metal roofs.

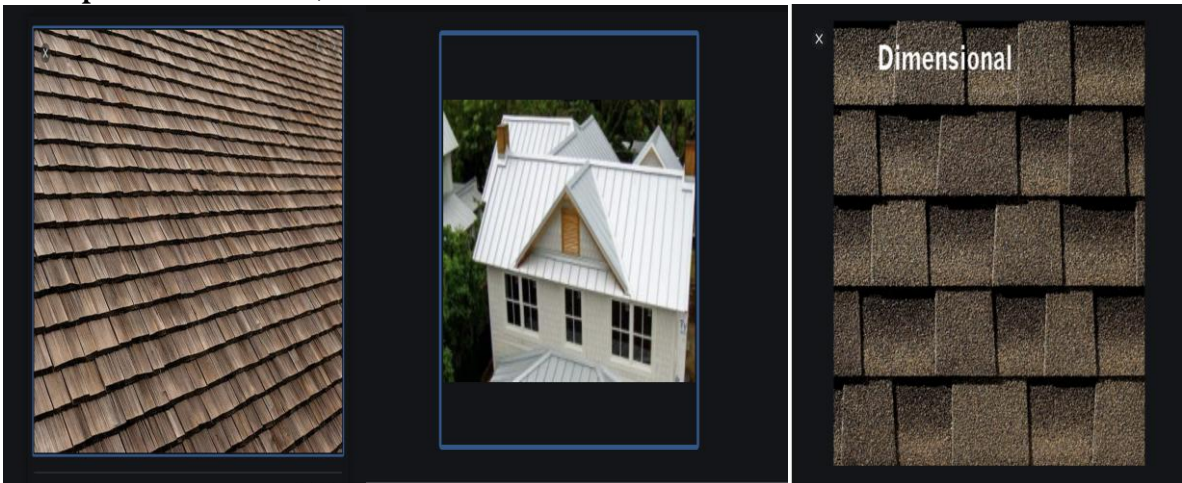
From the samples shown below, the 30 year dimensional roof seems to look the most similar to the original wood shake shingle.

Samples of Wood, Metal & 30 Yr. Dimensional Roof
