HISTORIC AND DESIGN REVIEW COMMISSION

HDRC CASE NO: 2020-045
ADDRESS: 515 WICKES
LEGAL DESCRIPTION: NCB 2916 BLK 5 LOT 16
ZONING: RM-4,H
CITY COUNCIL DIST.: 1
DISTRICT: King William Historic District
APPLICANT: David Hannan/FISHER HECK ARCHITECTS
OWNER: REBECCA CLAUSEWITZ
TYPE OF WORK: Construction of a 2-story rear addition, construction of a rear accessory structure, exterior modifications, site modifications
APPLICATION RECEIVED: March 19, 2021
60-DAY REVIEW: Not applicable due to City Council Emergency Orders
CASE MANAGER: Stephanie Phillips
REQUEST:

The applicant is requesting a Certificate of Appropriateness to:

1. Construct a 2-story rear addition, to include an added footprint of 225 square feet and a total of 600 additional square feet on the second story, which will be partially constructed atop the existing 1-story historic structure.
2. Remove a brick flue near the rear of the historic structure to accommodate the proposed addition.
3. Replace all existing wood windows with new aluminum clad wood windows to match the existing in size, proportion, configuration, and inset.
4. Modify the existing front porch design to feature battered Craftsman columns.
5. Replace the

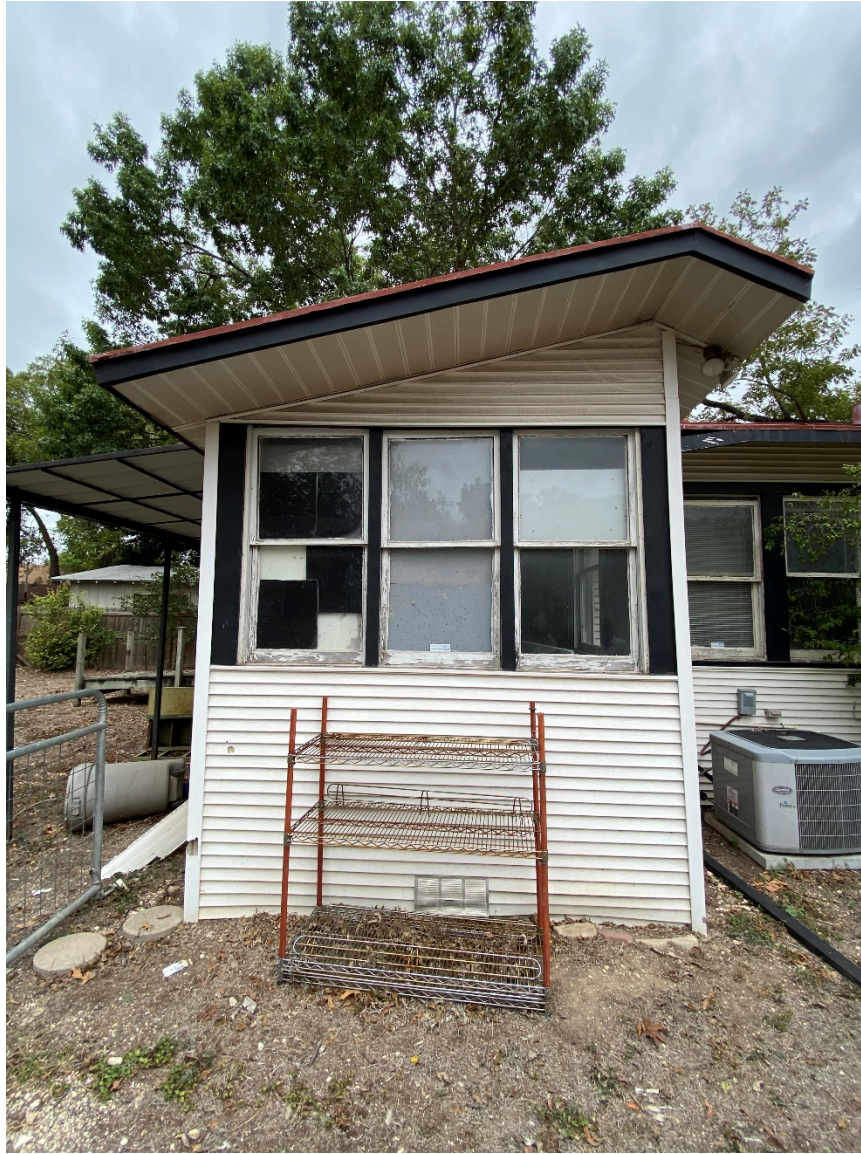
EXISTING ENCLOSED PORCH TO BE DEMOLISHED

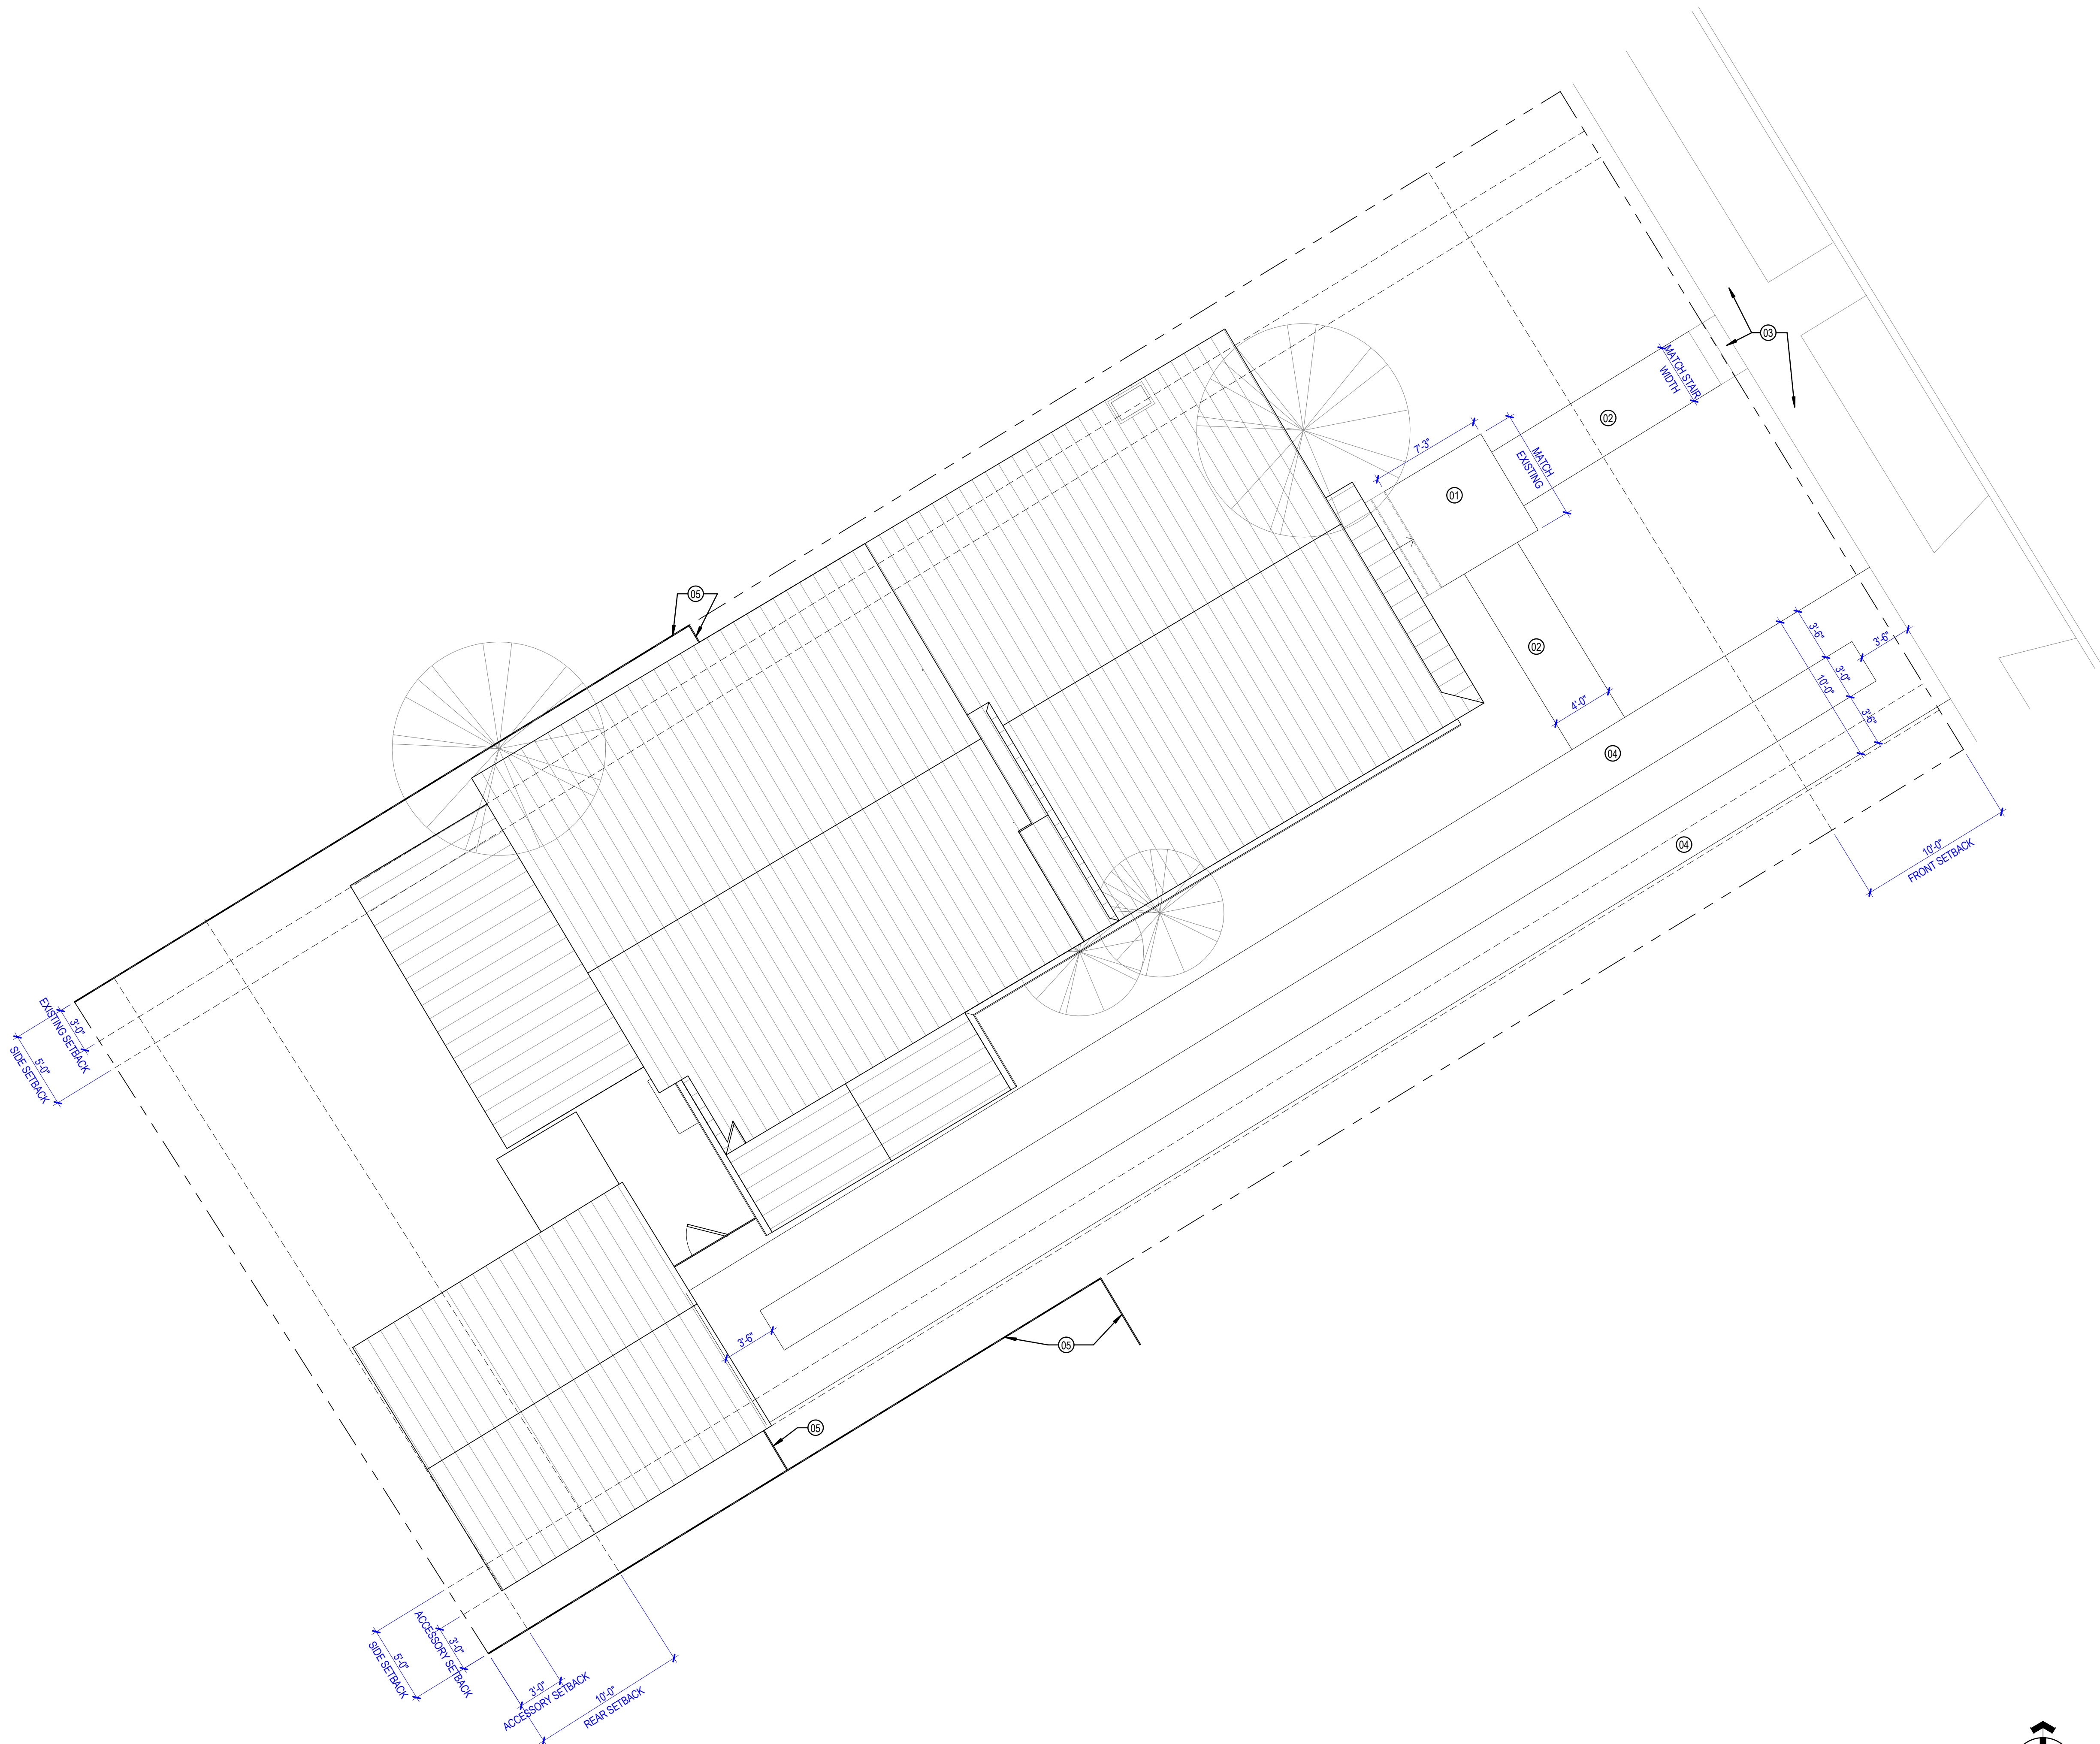
1 SITE PLAN
3/16" = 1'-0"

- ALL EXISTING ROOF MATERIAL SHALL BE DEMOLISHED. EXISTING DECKING SHALL BE INSPECTED AND ANY DAMAGED BOARDS ARE TO BE REPLACED IN KIND. TAPE ALL SEAMS WITH ZIP-SYSTEM TAPE PRIOR TO INSTALLING A SELF-ADHERED ICE AND WATER SHIELD MEMBRANE ON ENTIRE ROOF SURFACE.
- THE NEW ROOF SHALL BE A STANDING SEAM METAL ROOF WITH CRIMPED SEAMS AND A SMOOTH GALVALLUME FINISH AND NO RIDGE VENT. ALL SEAMS AND RIDGES SHALL BE CRIMPED.
- TRIM ALL TREES AS REQUIRED THAT ARE NON-THREATENING TO THE STRUCTURAL INTEGRITY OF THE HOUSE.

- v. That the standing seam metal roof features panels that are 18 to 21 inches wide, seams that are 1 to 2 inches tall, a crimped ridge seam and a standard galvalume finish with no striation. Ridges are to feature a double-munch or crimped ridge configuration; no vented ridge caps or end caps are allowed. An on-site inspection must be scheduled with OHP staff prior to the start of work to verify that the roofing material matches the approved specifications.
- vi. That the applicant complies with all setbacks as required by Zoning and applies for a variance from the Board of Adjustment, if applicable.
