HISTORIC AND DESIGN REVIEW COMMISSION

HDRC CASE NO: 2021-147
ADDRESS: 643 E NUEVA
LEGAL DESCRIPTION: NCB 13814 BLK 3 LOT IRR PART OF 12
ZONING: D, H, RIO-3
CITY COUNCIL DIST.: 1
DISTRICT: Hemisfair Historic District
APPLICANT: David Hannan/FISHER HECK ARCHITECTS
OWNER: CITY OF SAN ANTONIO
TYPE OF WORK: Stabilization, selective demolition of an addition
APPLICATION RECEIVED: March 19, 2021
60-DAY REVIEW: Not applicable due to City Council Emergency Orders
CASE MANAGER: Edward Hall

PROJECT:
KUSCH HOUSE REHABILITATION

CONSTRUCTION DOCUMENTS

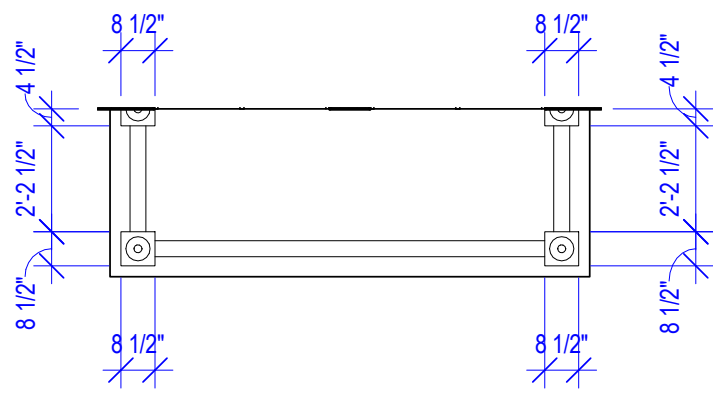
2 ENLARGED JULIET BALCONY PLAN

- 01 PROPOSED NEW TRANSFORMER LOCATION.
- 03 JULIET BALCONY PER DETAILS.
- 04 INSTALL NEW WOOD STEP TO REPLACE EXISTING STEP AND RAMP. PAINT TO MATCH PORCH FLOOR DECKING.

- 05 REBUILD BALLUSTRADE.
- 06 REPLACE ALL DAMAGED & DETERIORATED FLOOR FRAMING IN KIND AS REQUIRED. INSTALL NEW PORCH DECKING.
- 07 CONCRETE STAIR DOWN TO BASEMENT; RE-STRUCT.

- 08 STRIP, REPAIR AND REFINISH EXISTING WINDOW AND TRIM. REPLACE ALL DAMAGED WOOD MEMBERS WITH NEW TO MATCH EXISTING.
- 09 EXISTING GAS METER.
- 10 RELOCATE EXISTING PANEL AND METER TO EXISTING FREE-STANDING FRAME.

- 11 EXISTING PHONE/INTERNET BOX.
- 12 CAREFULLY REMOVE FLOOR BOARDS, THEN RELEVEL TO ACHIEVE A 1/4" PER FOOT SLOPE AWAY FROM BUILDING AND REPAIR PORCH FRAMING AS REQUIRED. EXISTING FLOOR BOARDS ARE TO BE REFINISHED AND THEN REINSTALLED.

- 13 INSTALL SALVAGED PAVERS TO REPLACE DEMOLISHED RAMP. BASE MATERIAL TO MATCH ADJACENT.
- 14 EXISTING BUILDING.
- 15 GALVANIZED METAL DOWNSPOUT W/ PRECASE SPLASH BLOCK AT GRADE.

- 16 INSTALL PRESSURE TREATED PLYWOOD OVER DOOR OPENING.
- 17 REBUILD WOOD BASEMENT DOOR TO MATCH PORCH DECKING. INSTALL NEW PULL AND HINGE HARDWARE.
- 18 STRIP, REPAIR AND REFINISH EXISTING DOOR, FRAME AND TRIM. REPLACE ALL DAMAGED WOOD MEMBERS WITH NEW TO MATCH EXISTING.

- 19 REBUILD ENTRY DOORS TO MATCH EXISTING DOOR PANELS.

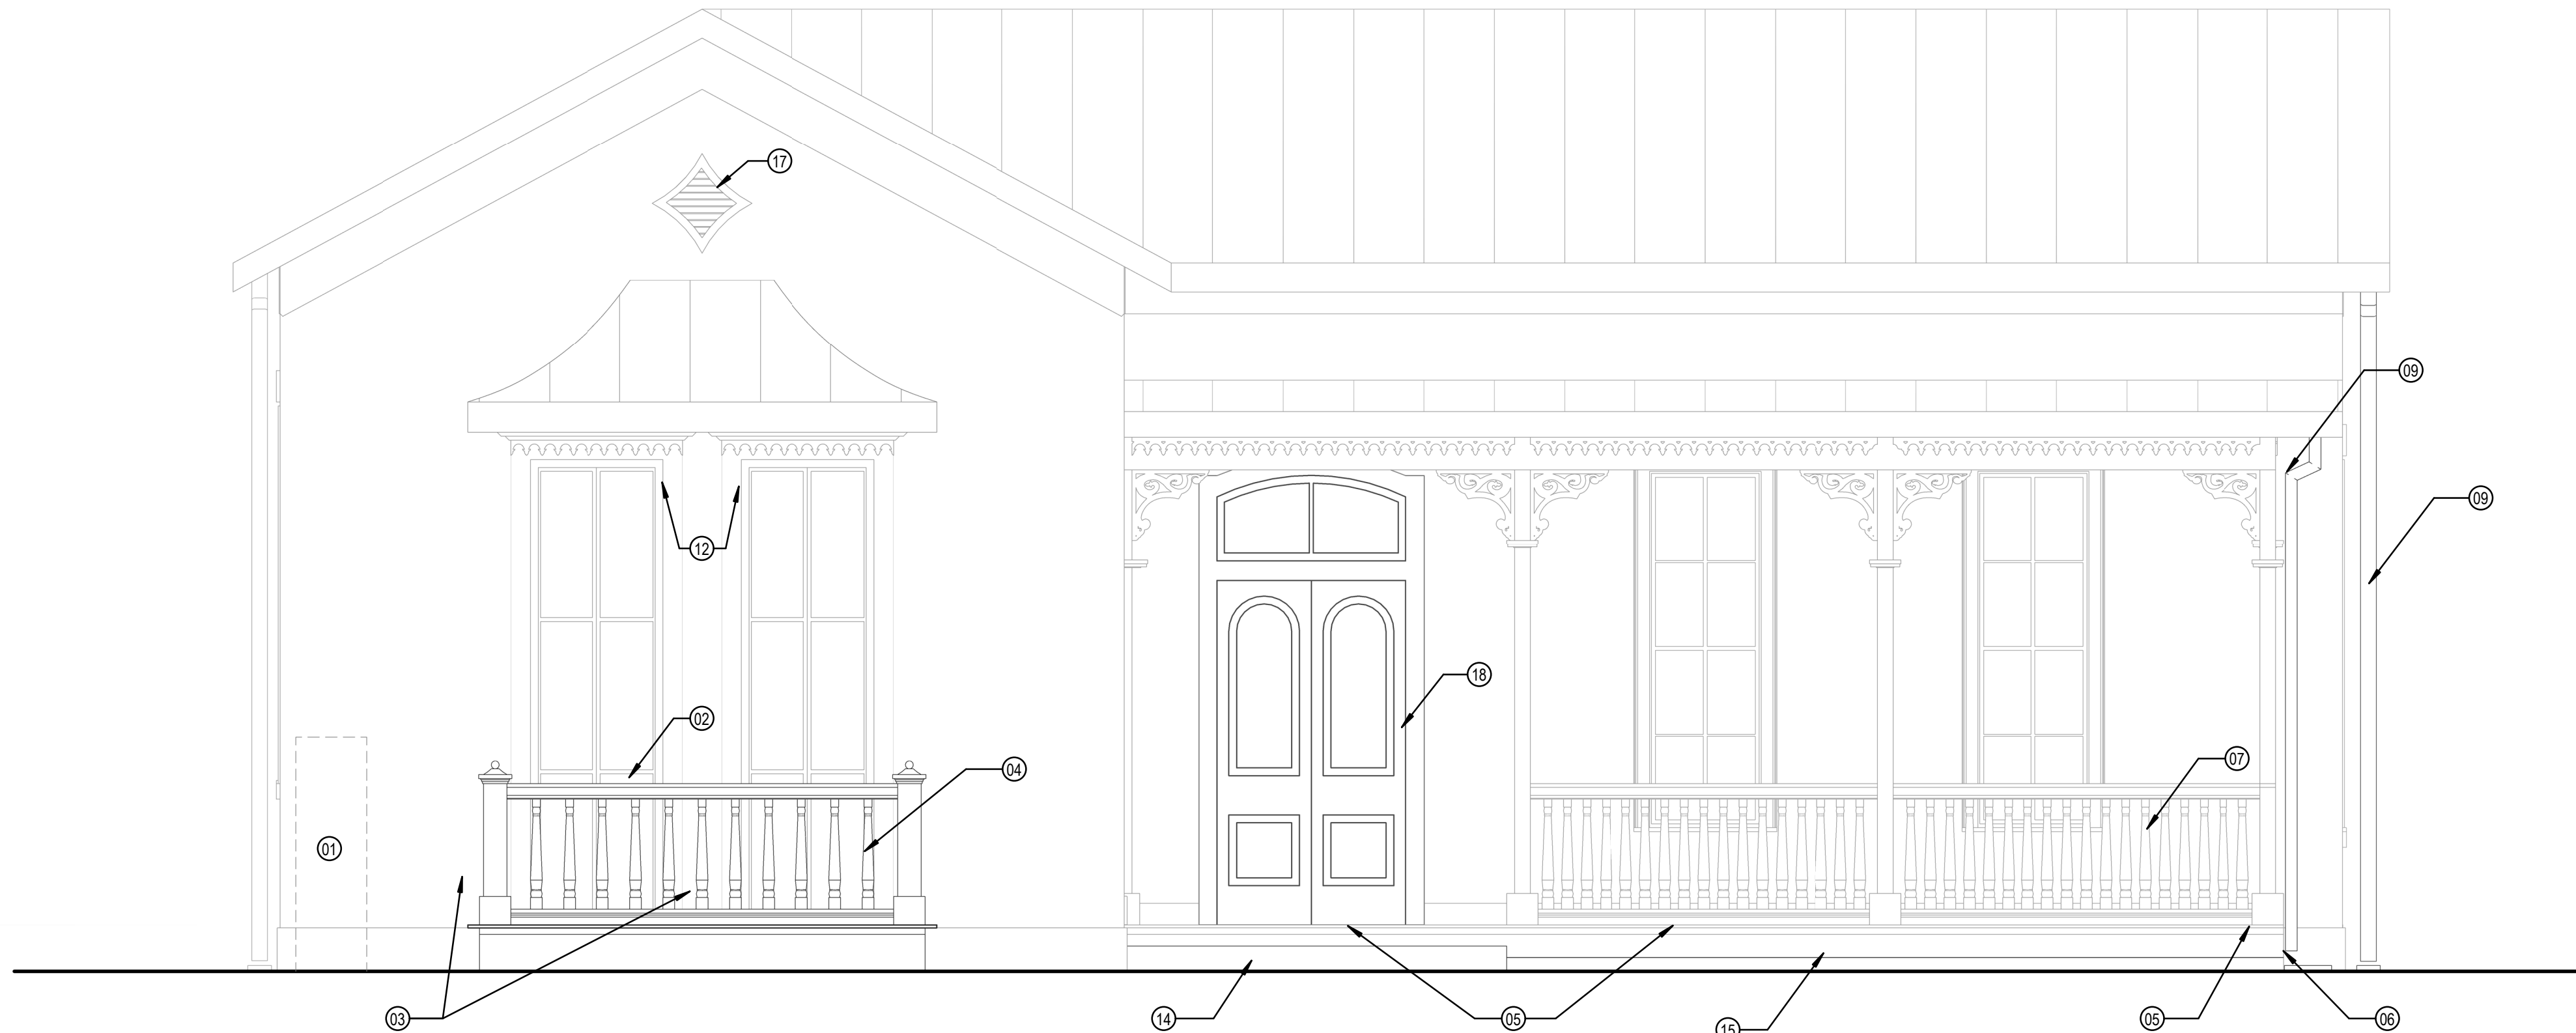
1 SOUTH EXTERIOR ELEVATION
3/8" = 1'-0"

- 18 REBUILT DOORS TO MATCH EXISTING, PAINTED.
- 19 INSTALL PRESSURE TREATED PLYWOOD OVER DOOR OPENING.

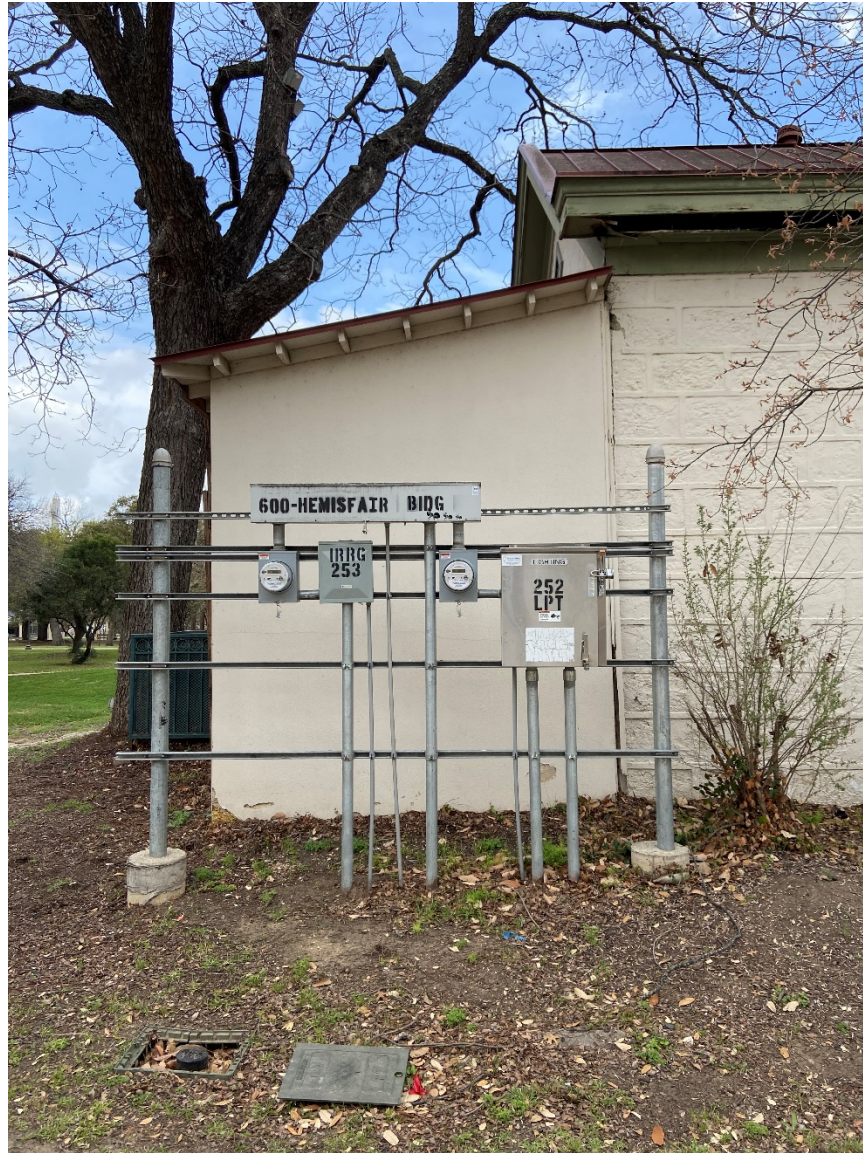
EXISTING SIDE (NORTHWEST) FAÇADE – NON-ORIGINAL ADDITION TO BE DEMOLISHED

1. Demolish an existing, rear addition.
2. Perform rehabilitative scopes of work including the reconstruction of several basement stone walls, repointing and repainting of plaster walls, repair and repainting of wood elements, window repair, porch repair and reconstruction, the reconstruction of a Juliet balcony and column repair and replacement.

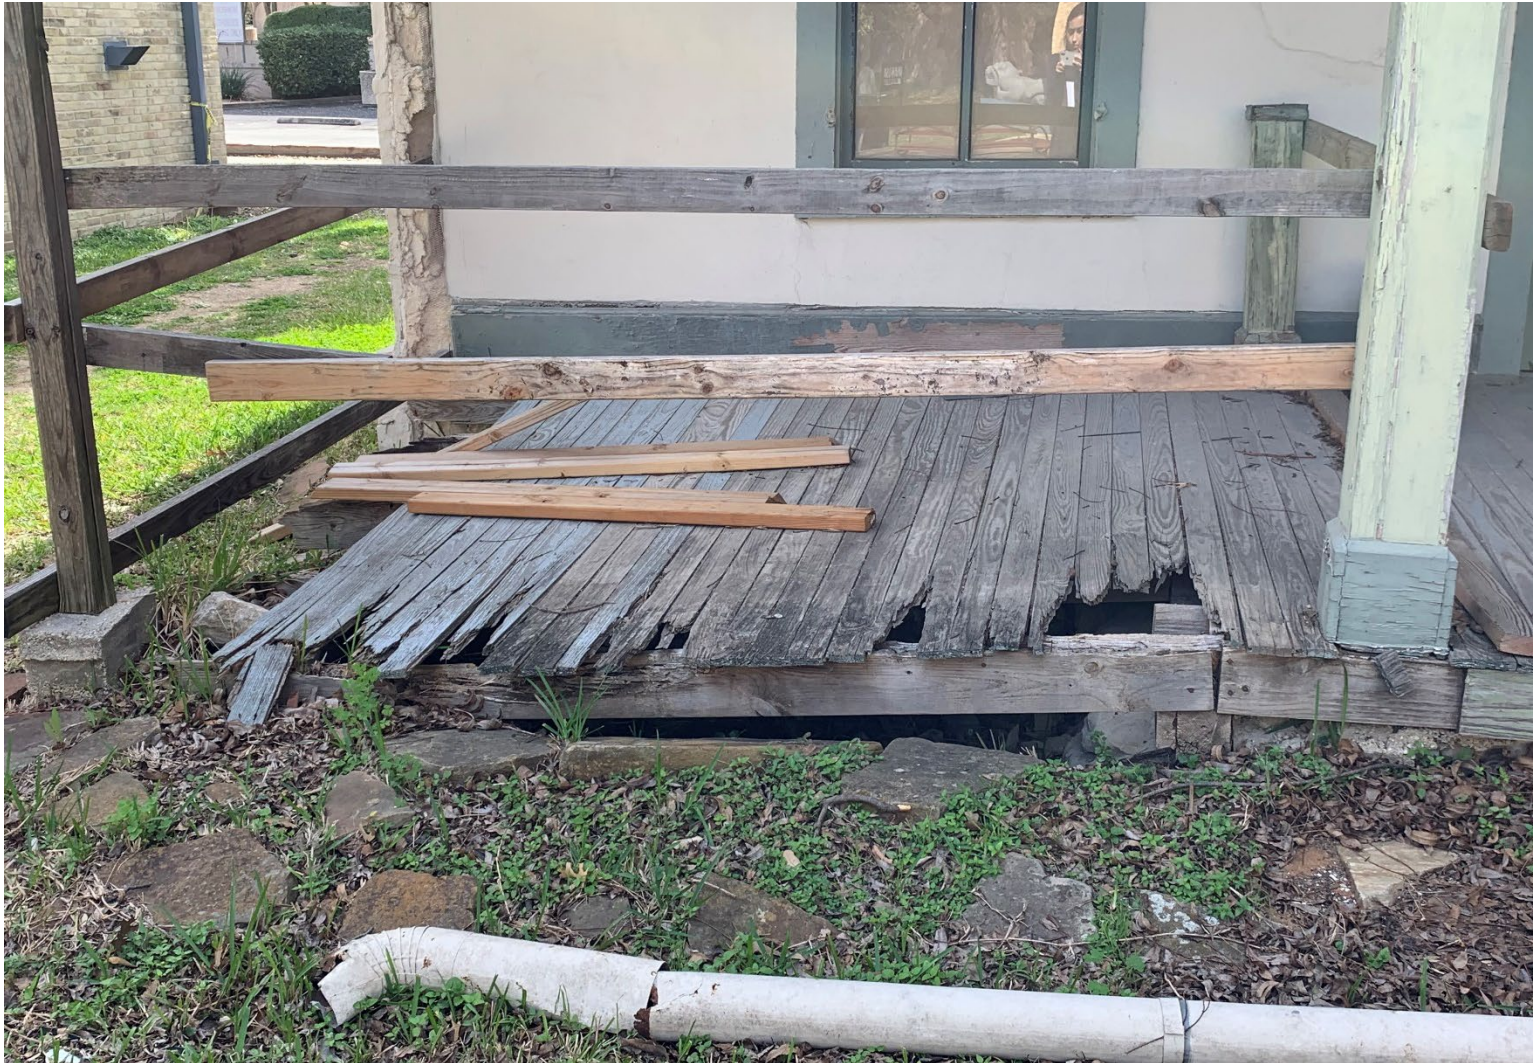
EXISTING NORTH PORCH FRAMING TO BE DEMOLISHED AND RE-BUILT
