HISTORIC AND DESIGN REVIEW COMMISSION

HDRC CASE NO: 2021-200
ADDRESS: 233 N MESQUITE ST
LEGAL DESCRIPTION: NCB 582 BLK 9 LOT 5&6
ZONING: C-3, H
CITY COUNCIL DIST.: 2
DISTRICT: Dignowity Hill Historic District
APPLICANT: Cotton Estes
OWNER: Cotton Estes
TYPE OF WORK: Exterior modifications, rehabilitation
APPLICATION RECEIVED: April 16, 2021
60-DAY REVIEW: Not applicable due to City Council Emergency Orders
CASE MANAGER: Edward Hall

Industrial Renovation for Architecture Office & Carpentry Shop
Application for Historical COA 04.15.2021
Dignowity Hill Historic District

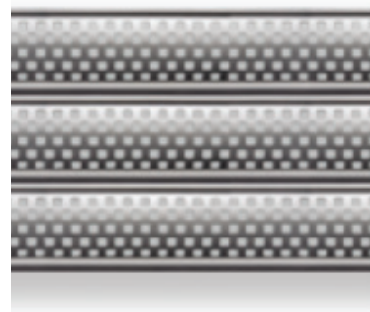
Perforation Style 51
(Annodized)

Proposed doors to be Vision Profile Security Shutters by QMI with AL7 punch style 51 in annodized aluminum. The door dimensions (9'-2" W x 8'-0" H) will match the existing masonry openings. When open, the bottom security rail will be concealed behind the existing masonry beam (see detail 2/A2).

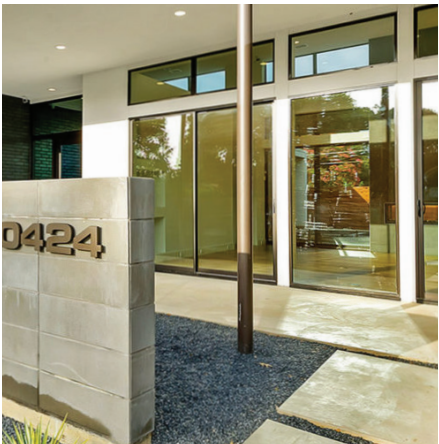
Example of MetalCraft Doors

We proposed to enclose the office portion of the building with aluminum sliding doors in an annodized bronze finish with single pane, non-coated glazing by MetalCraft. These doors will be fully shaded, allow for passive ventilation through the building, and connections outdoors to the north and south. The sliding doors will be fabricated to match the existing masonry openings and will sit inside the security doors (see detail 2/A2 and 3/A2). These doors also feature slender stiles and rails (1 3/4"- 2"), similar to the thin muntins and sashes of the original steel windows.

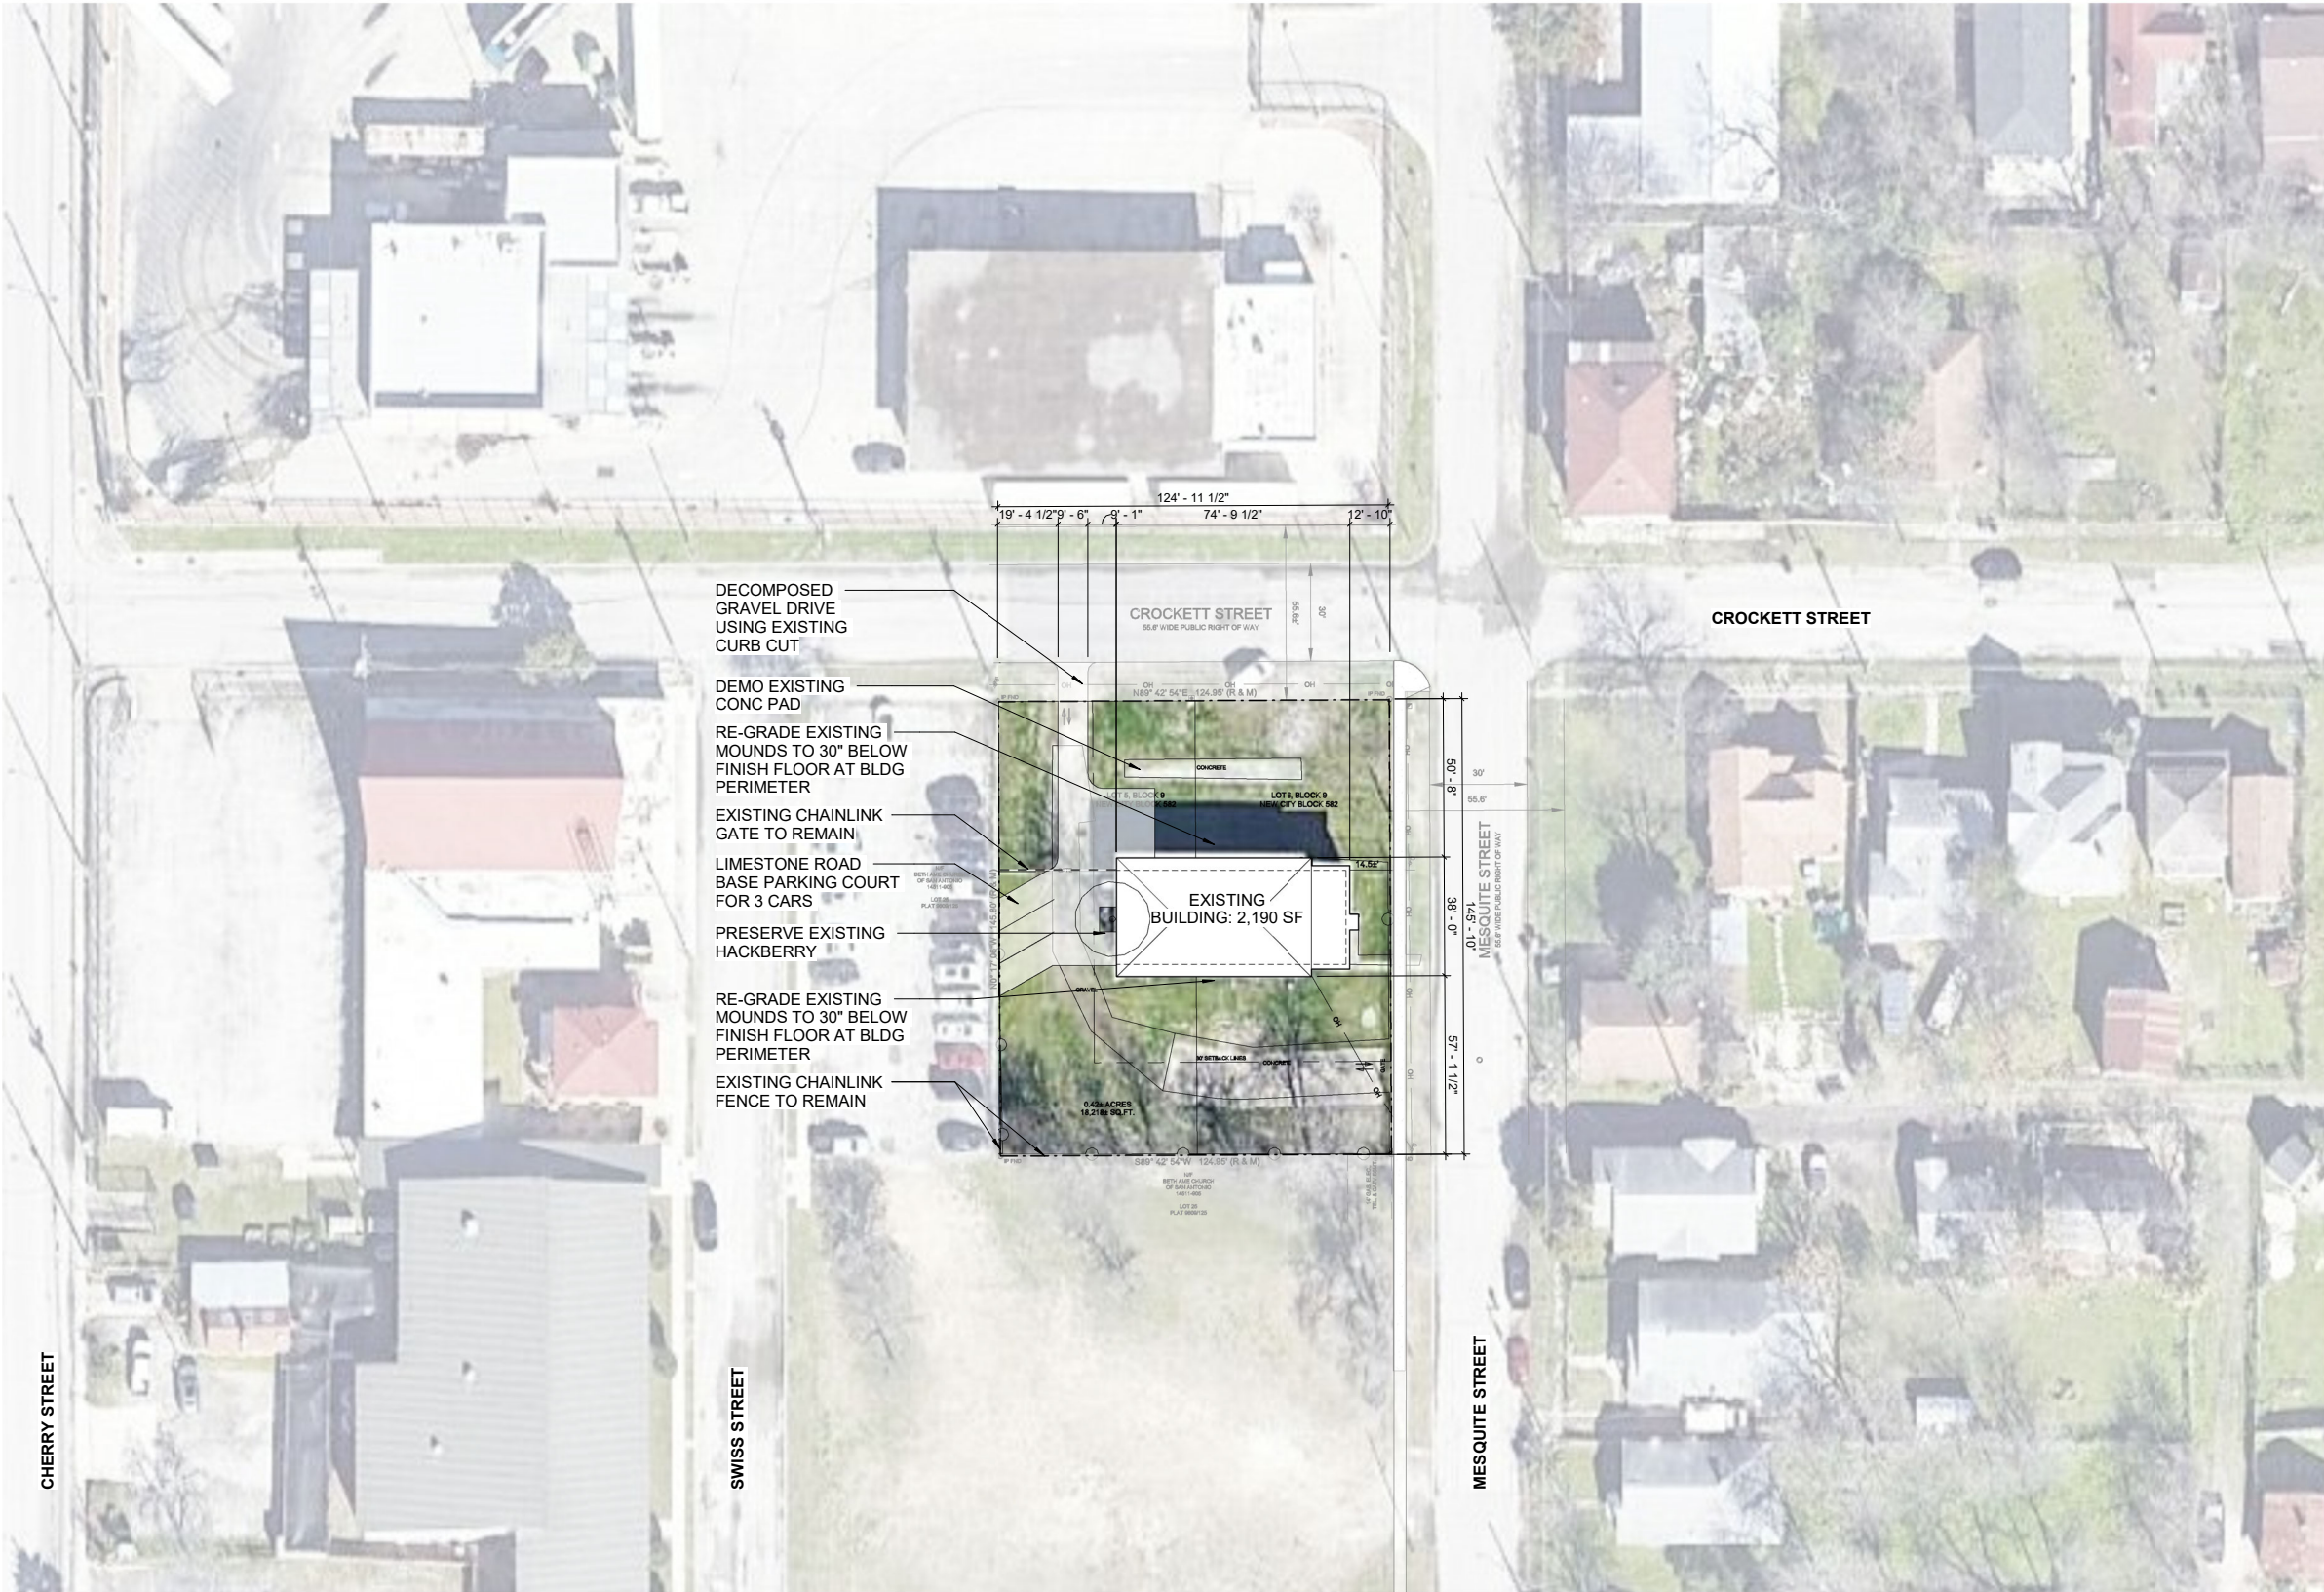
SITE PLAN & MAP

232 N MESQUITE STREET:	
HISTORIC DISTRICT:	DIGNOWITY HILL
EXISTING ZONING:	C-3, Commercial District
PROPOSED ZONING:	IDZ-1 Low Intensity Infill Development Zone
PROPOSED USE:	Utilize existing vacant building for professional office and architectural fabrication/ carpentry shop.
LAND AREA:	0.4161 AC/ 18,125 SF
BUILDING AREA:	2,200 SF
GENERAL NOTES	
The proposed improvements to 232 N Mesquite do not affect the existing building footprint, height, or setbacks and do not increase the ratio of pervious cover on site.	
Landscaping improvements such as plantings, new walkways, replacement of the existing chainlink fence and removal of large existing concrete slabs will be submitted as a separate application at a later date.

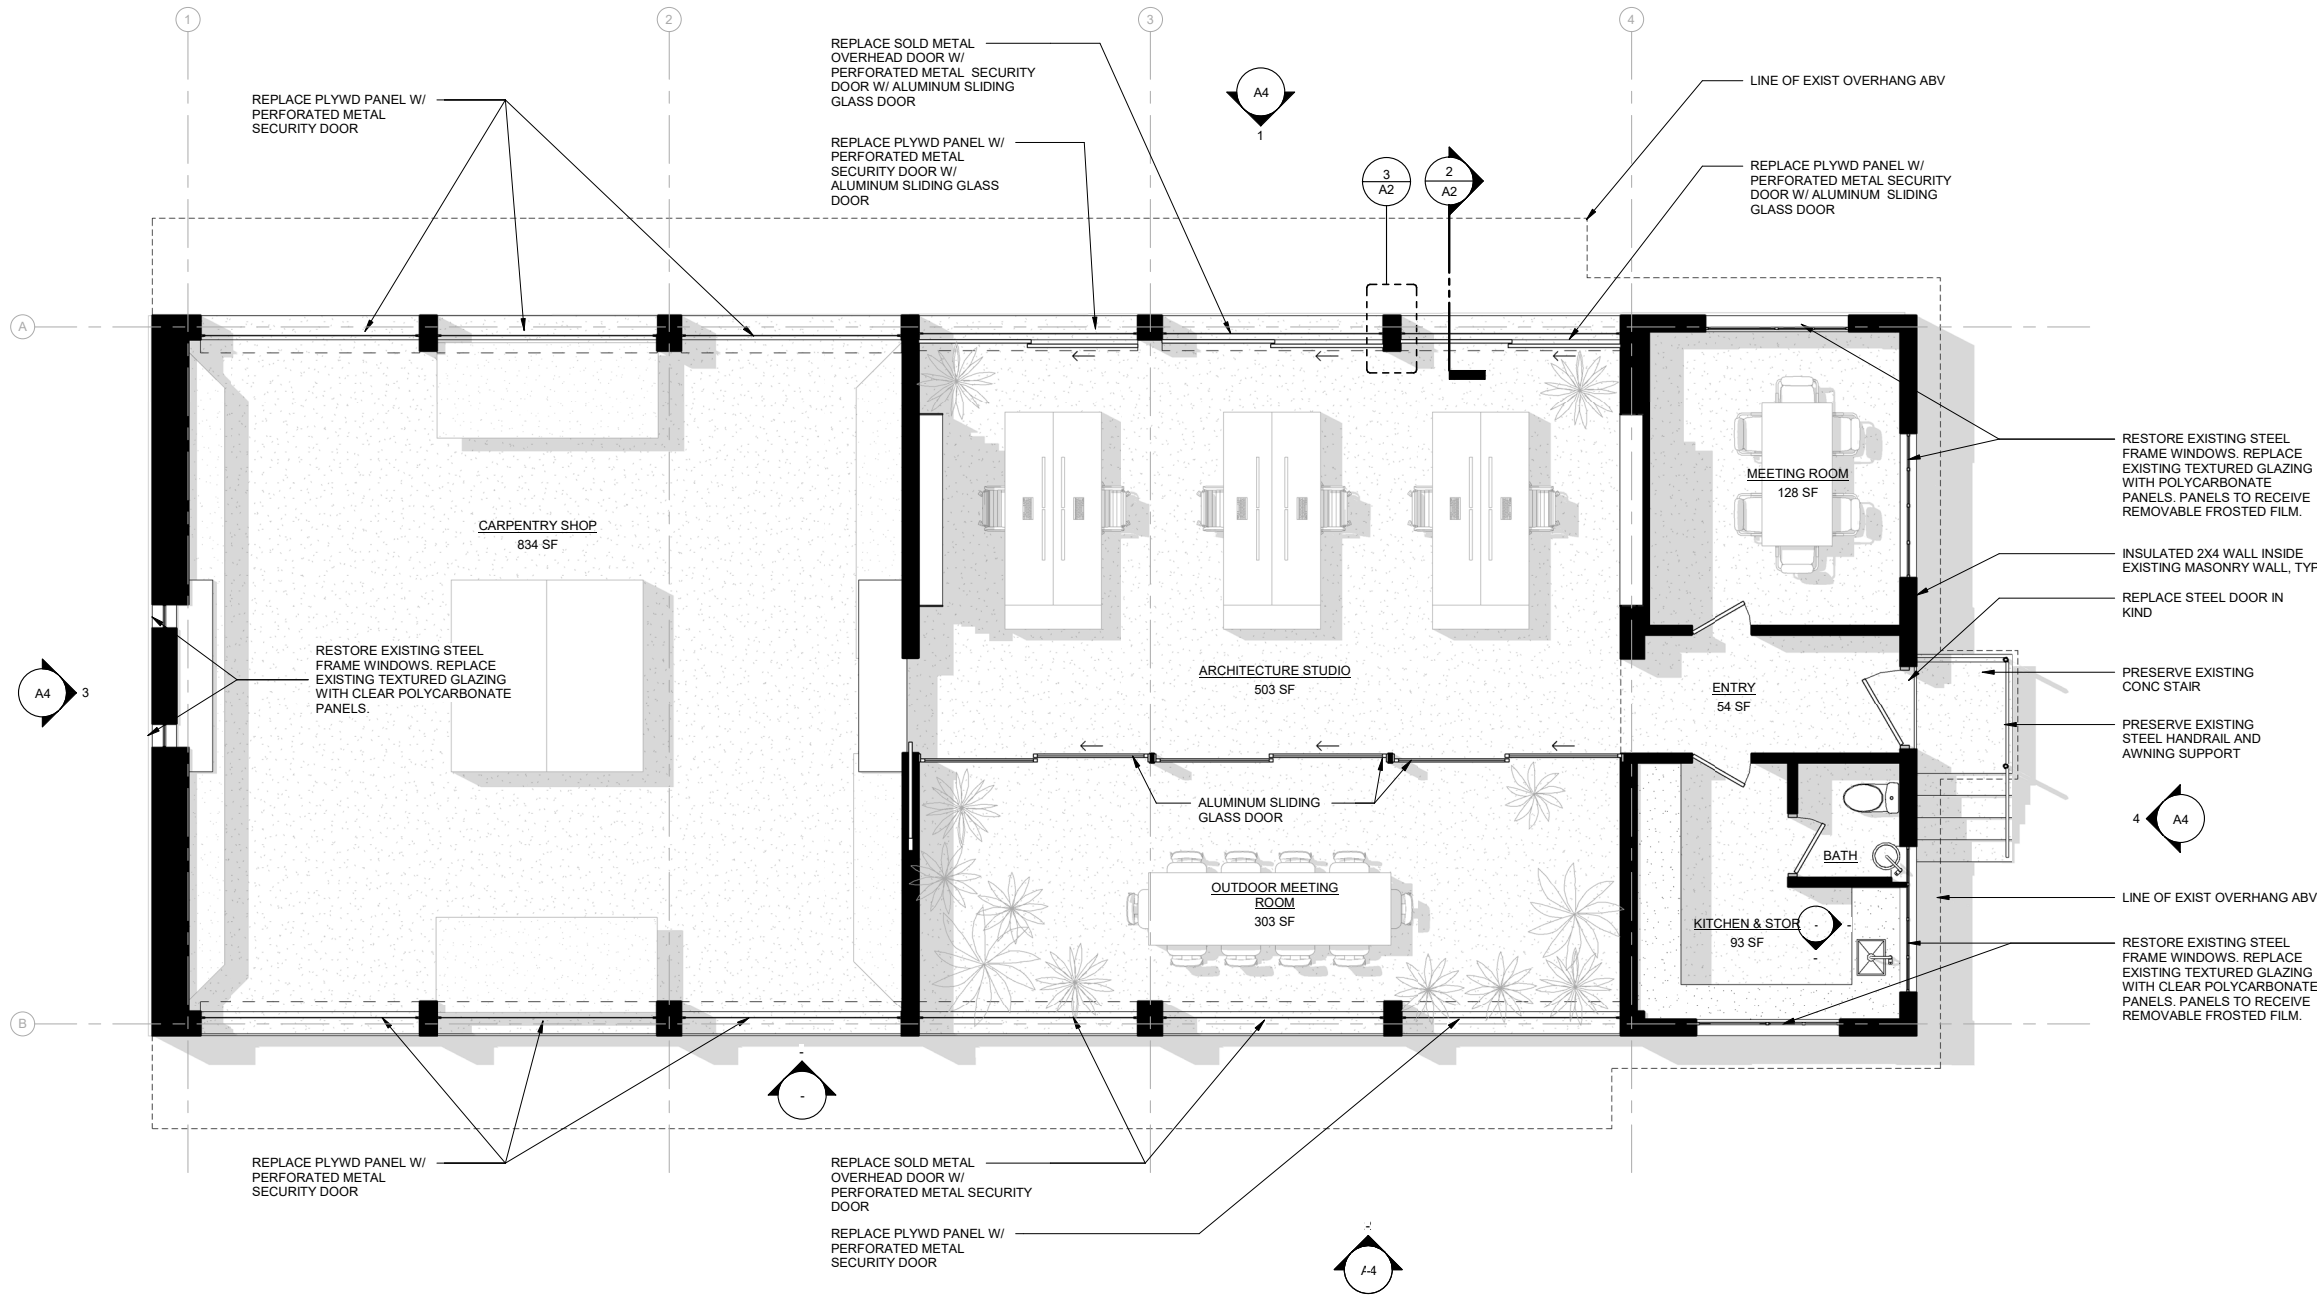
1 FLOOR PLAN.
SCALE: 1/4" = 1'-0"

REPLACE PLYWD PANEL AND
SOLID METAL SECURITY DOOR W/
PERFORATED METAL SECURITY
DOOR W/ ALUMINUM SLIDING
GLASS DOOR

RESTORE EXISTING STEEL FRAME
CASEMENT WINDOWS. REPLACE
EXISTING TEXTURED GLAZING WITH
CLEAR POLYCARBONATE PANELS.
PANELS TO RECEIVE REMOVABLE
FROSTED FILM.

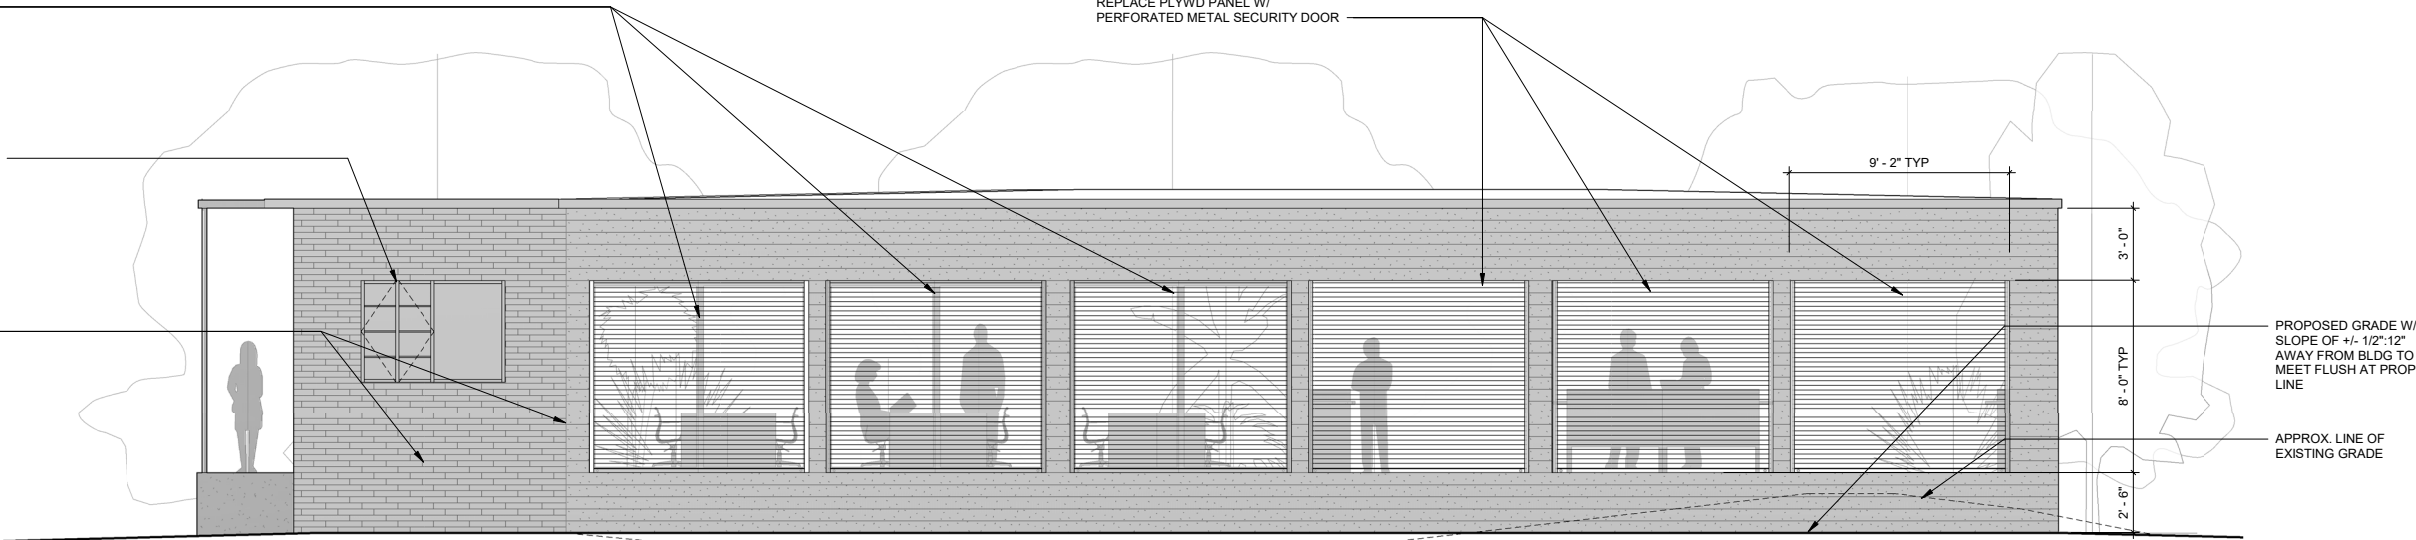
1 NORTH
SCALE: 1/4" = 1'-0"

REMOVE EXISTING TOP COAT OF
PAINT ON EXTERIOR CMU AND
CONCRETE WALLS, REPOINT
BRICK WHERE NECESSARY AND
REMOVE REBAR CUT OFFS. PAINT
AND SEAL ALL EXTERIOR WALLS
WITH MINEAL BASED
LIMEWASH

REPLACE PLYWD PANEL W/
PERFORATED METAL SECURITY DOOR

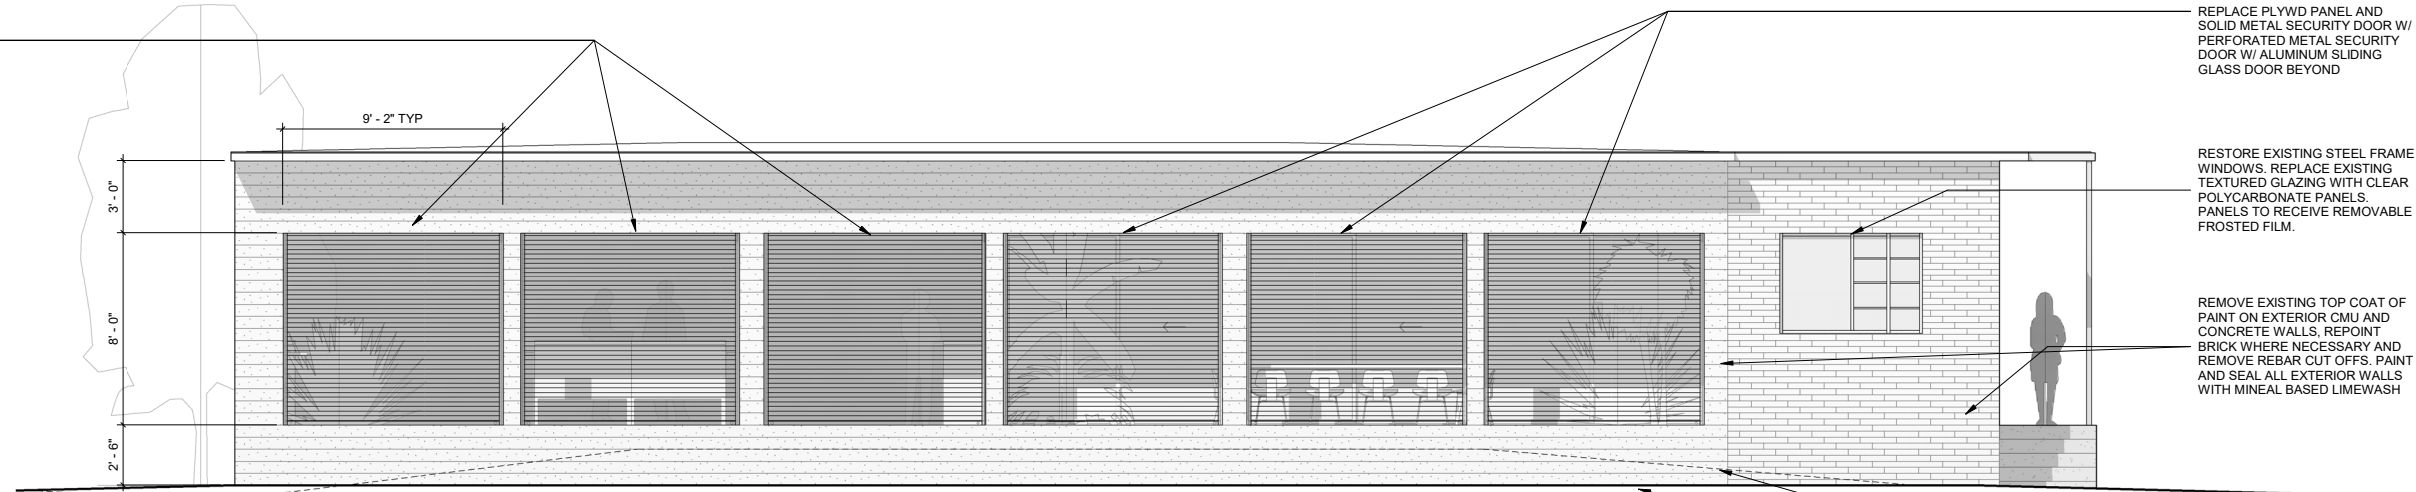
2 SOUTH
SCALE: 1/4" = 1'-0"

REPLACE PLYWD PANEL W/
PERFORATED METAL
SECURITY DOOR
