# HISTORIC AND DESIGN REVIEW COMMISSION

**HDRC CASE NO:** 2021-182  
**ADDRESS:** 370 QUENTIN DR  
**LEGAL DESCRIPTION:** NCB 7026 BLK 5 LOT 23, E 43 FT OF 22 & W 4 FT OF 24  
**ZONING:** R-6, H  
**CITY COUNCIL DIST.:** 7  
**DISTRICT:** Monticello Park Historic District  
**APPLICANT:** San Antonio San Antonio/DOMINGUEZ ORLANDO & ALICIA  
**OWNER:** San Antonio San Antonio/DOMINGUEZ ORLANDO & ALICIA  
**TYPE OF WORK:** Fenestration changes  
**APPLICATION RECEIVED:** April 05, 2021  
**60-DAY REVIEW:** Not applicable due to City Council Emergency Orders  
**CASE MANAGER:** Rachel Rettaliata  
**REQUEST:**

The applicant is requesting a Certificate of Appropriateness for approval to:

1. Replace the window and door at the center of the south (rear) elevation with steel French doors.
2. Remove the east-facing rear porch window and enclose the opening.
3. Replace the non-original window on the south (rear) elevation with a custom-made wood window to match the adjacent square windows.
4. Remove and enclose 2 windows on the south and west elevations.

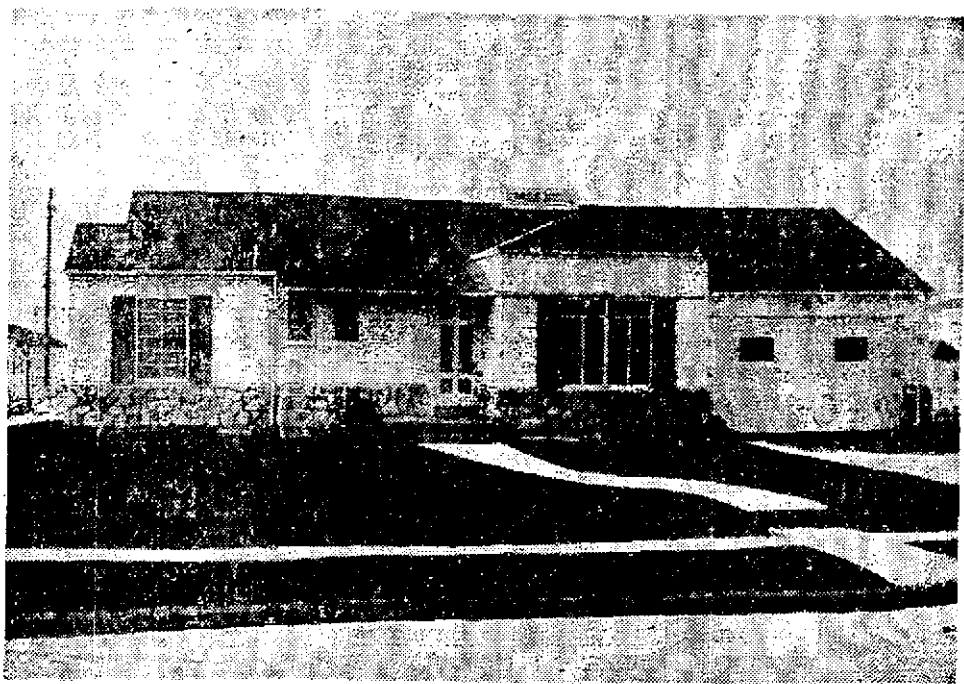
**CALIFORNIA COLONIAL**—This rock and asbestos home at 370 Quentin Drive, north of Jefferson High School, near Kampmann Blvd., has a number of features. There are ornamental iron grilles between the living and dining rooms and the lot is landscaped. Steel studio windows add to the appearance and there is a rear flower porch. N. Straus Nayfach is the architect.—Photo by Studer.

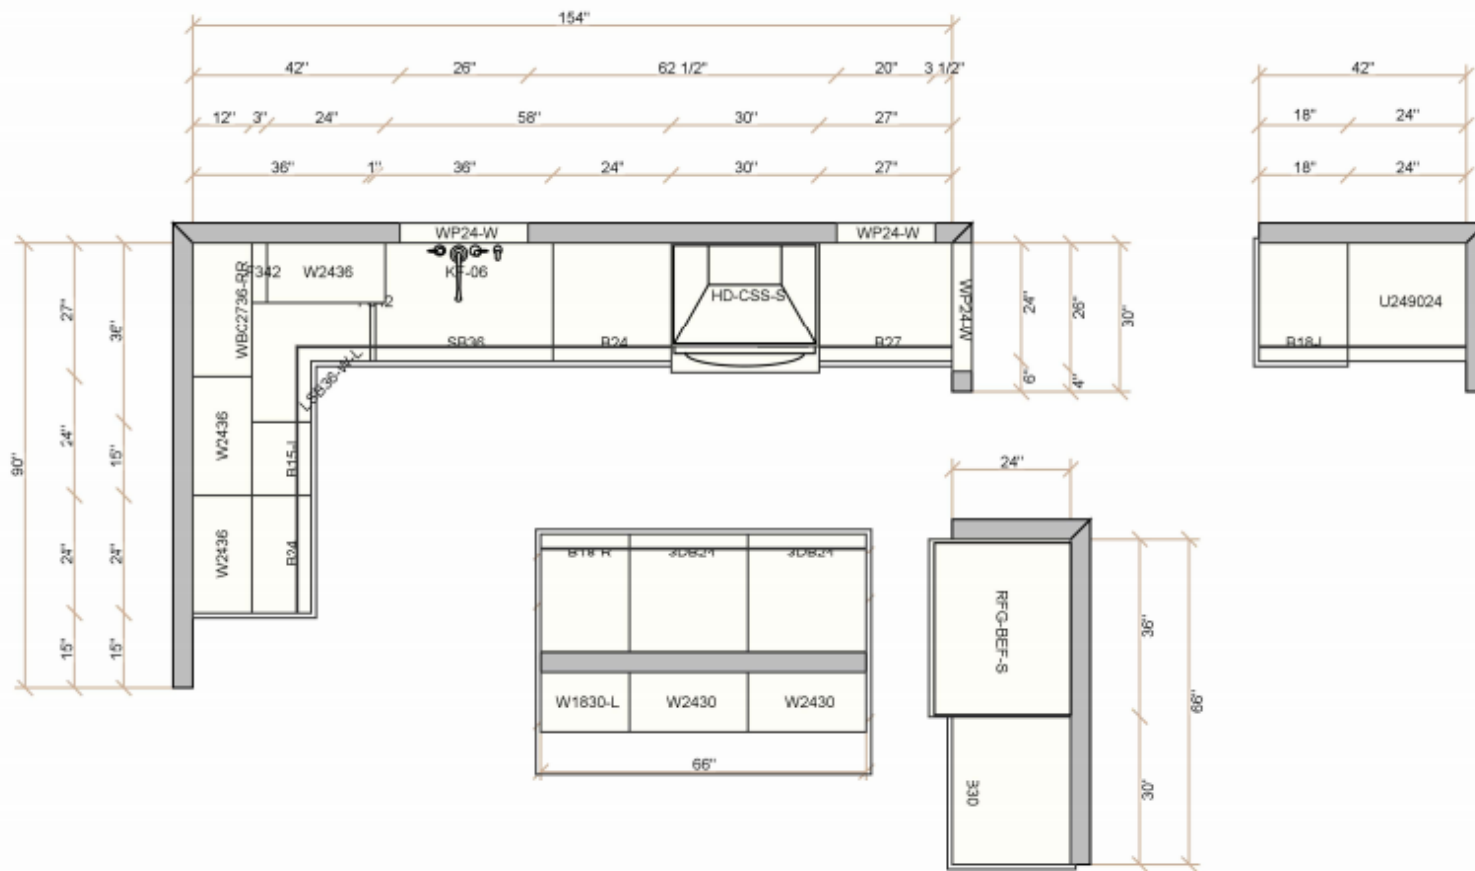
Left side of the kitchen is where we would like to close off window #13 and the adjacent door. Upper and lower cabinets to be installed along the wall.

Window #14 over sink is the window we would like to resize and relocate and built to match the existing window, wooden material, single pane, single hung window. The sill for window #13 is 19" from the floor which is lower than the base cabinets.

We would like to remove and enclose windows 13 and the adjacent door. The plan is to close off the wall for the purpose of installing base and overhead cabinets on the interior side. Neither window nor the door is believed to be original. The door is a metal door with blinds built into the glass. The window is not constructed like the other windows given no rope and weights are used.

Window 14 will be resized and built of wood to match the existing windows. The plan is to install base cabinets and relocate the sink along the back wall. Window Windows 15 & 16 will be reconditioned to appear new.

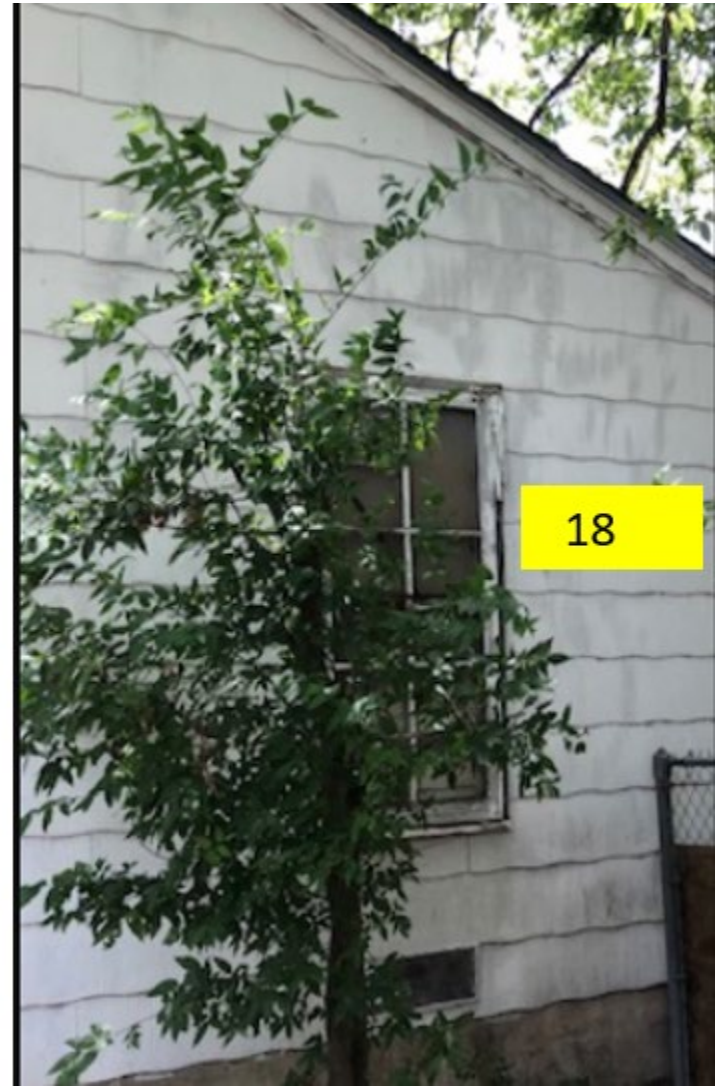
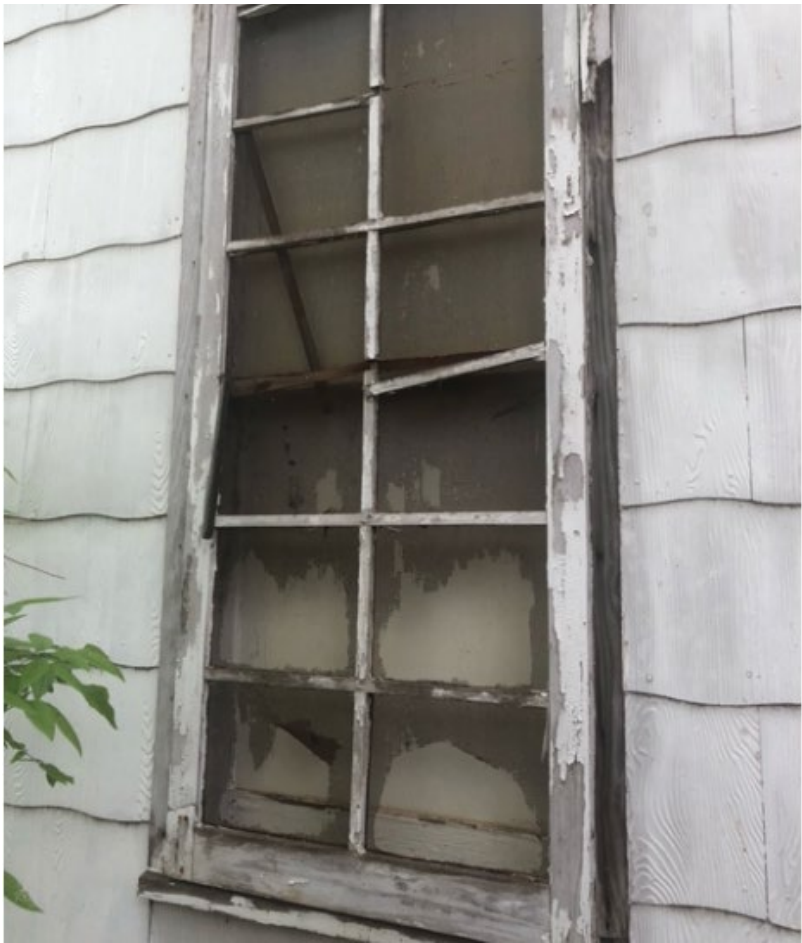
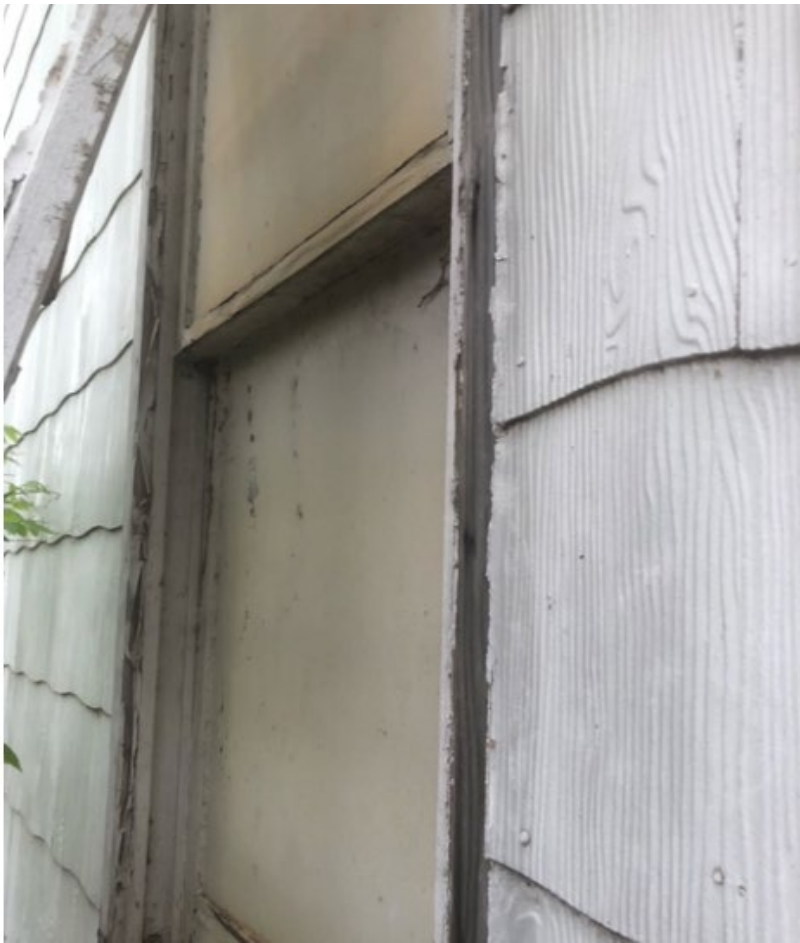
18

View of window #18, 2<sup>nd</sup> picture screen is raised. Windows had been painted white.

We would like to remove and enclose windows 17 & 18. The plan is to create a laundry area. The washer and dryer are to go against the wall where window #17 exists. The sill of this window is 18" from the floor. Would like the washer and dryer vent, water and electrical source to be on this wall. Window #18 cannot be seen from the interior as the window along with the other wall is covered by wooden planks.

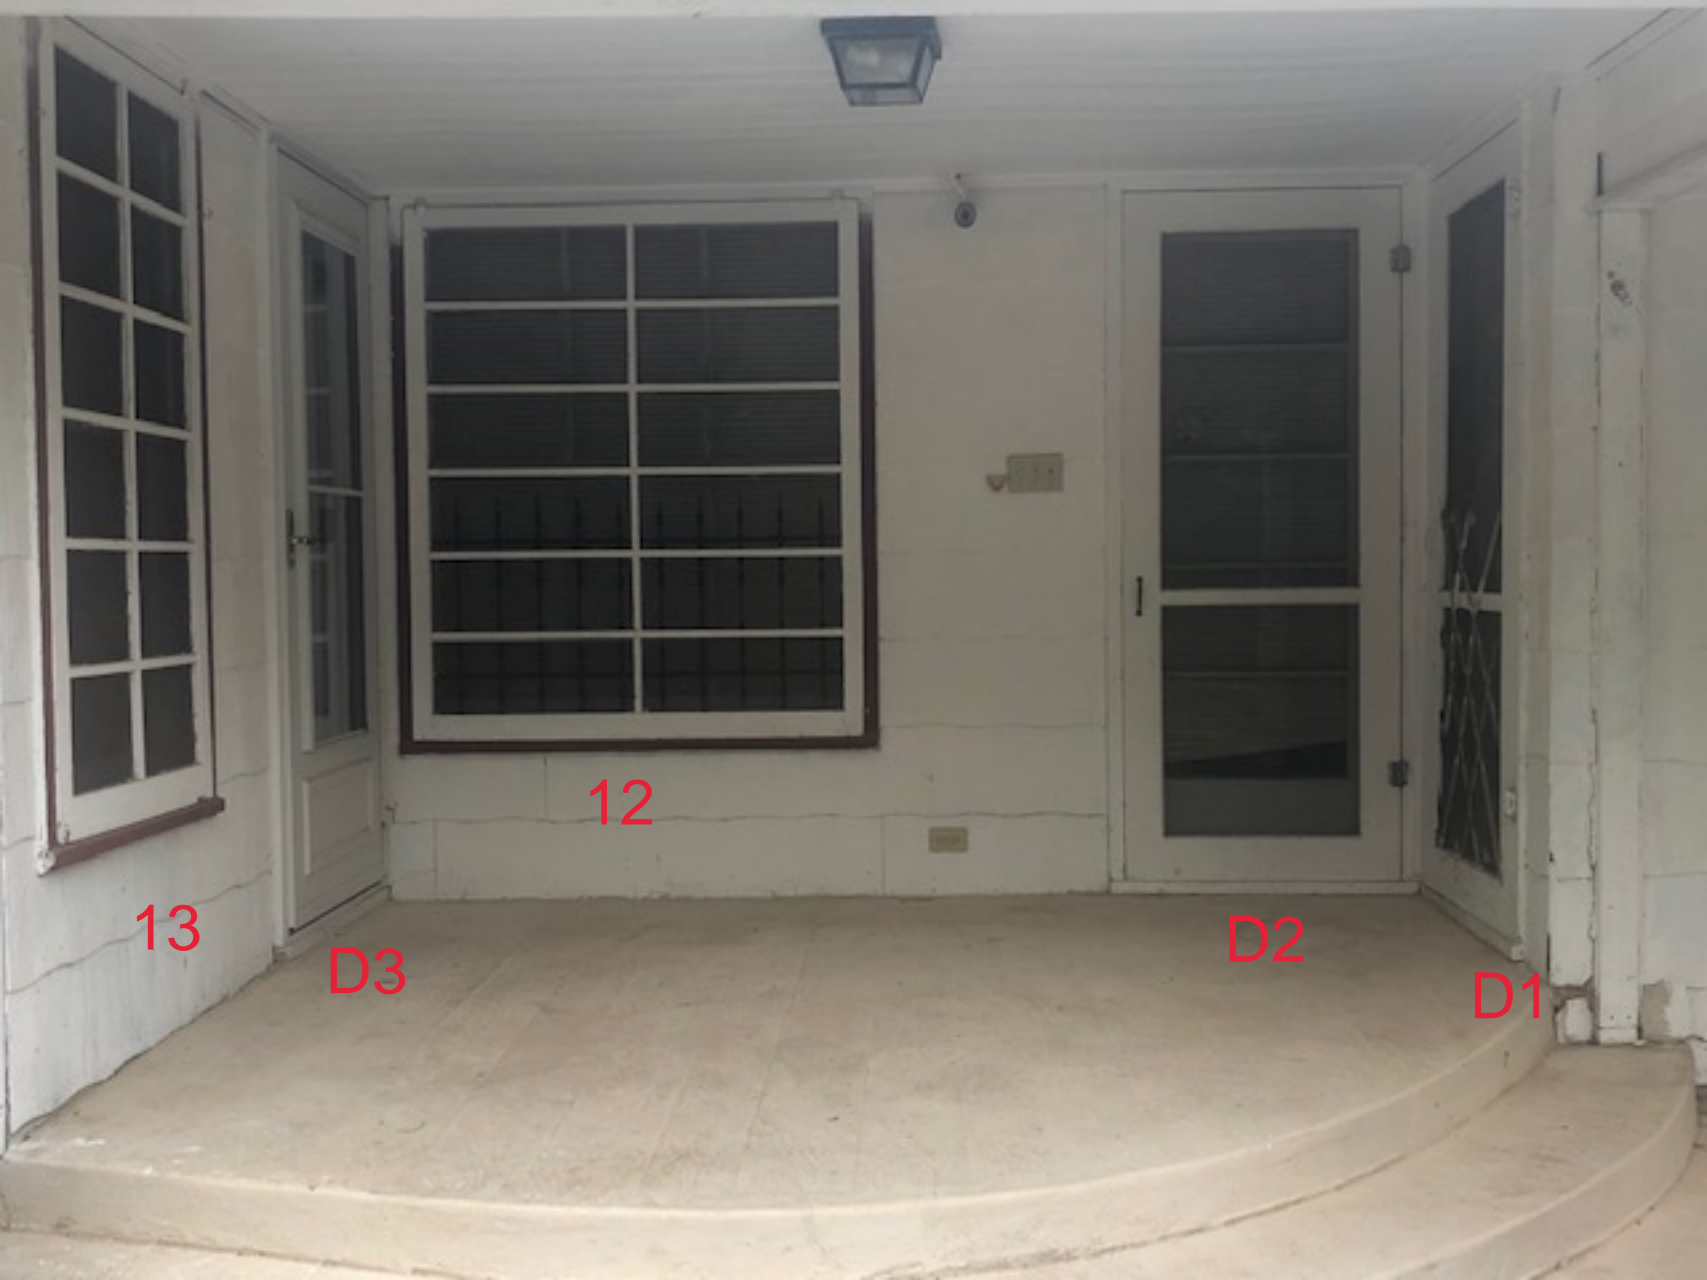
Window #13 on left and adjacent door. Would like to close up. Window on right is window #12.

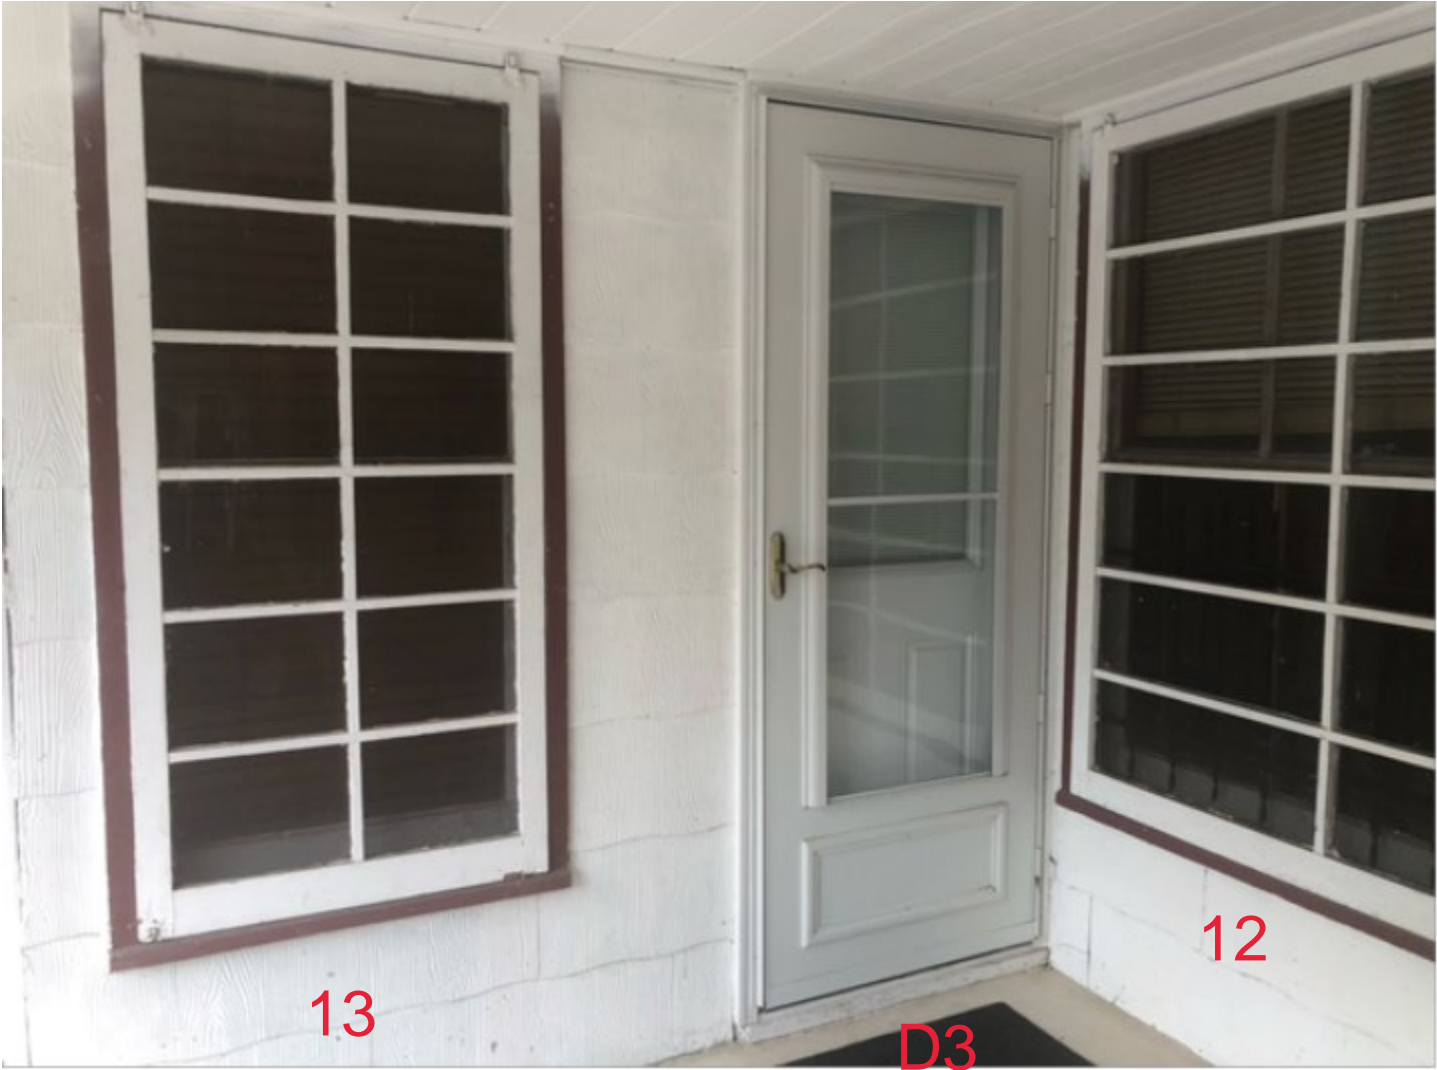
Window #12 and adjacent door to be replaced with French door.

- b. FENESTRATION MODIFICATION: SOUTH ELEVATION – The applicant has proposed to replace 1 wood window (window 12) and 1 wood porch door (Door 2) at the center of the south (rear) elevation. The applicant has proposed to replace the existing window and door with a set of steel French doors. Guideline 6.A.i for Exterior Maintenance and Alterations states that existing window and door openings should be preserved. Avoid creating new primary entrances or window openings on the primary façade or where visible from the public right-of-way. Guideline 6.A.ii for Exterior Maintenance and Alterations states that historic doors, including hardware, fanlights, sidelights, pilasters, and entablatures should be preserved. The metal window tracks may indicate that the window is not original to the structure. The rear porch features 3 doors, and the central and west-facing porch doors are located at the same corner of the rear porch. Staff finds that due to the unique fenestration pattern at the rear porch, the proposed fenestration modification is appropriate.

Would like to remove window #12 and the adjacent door and have it replaced with French doors.

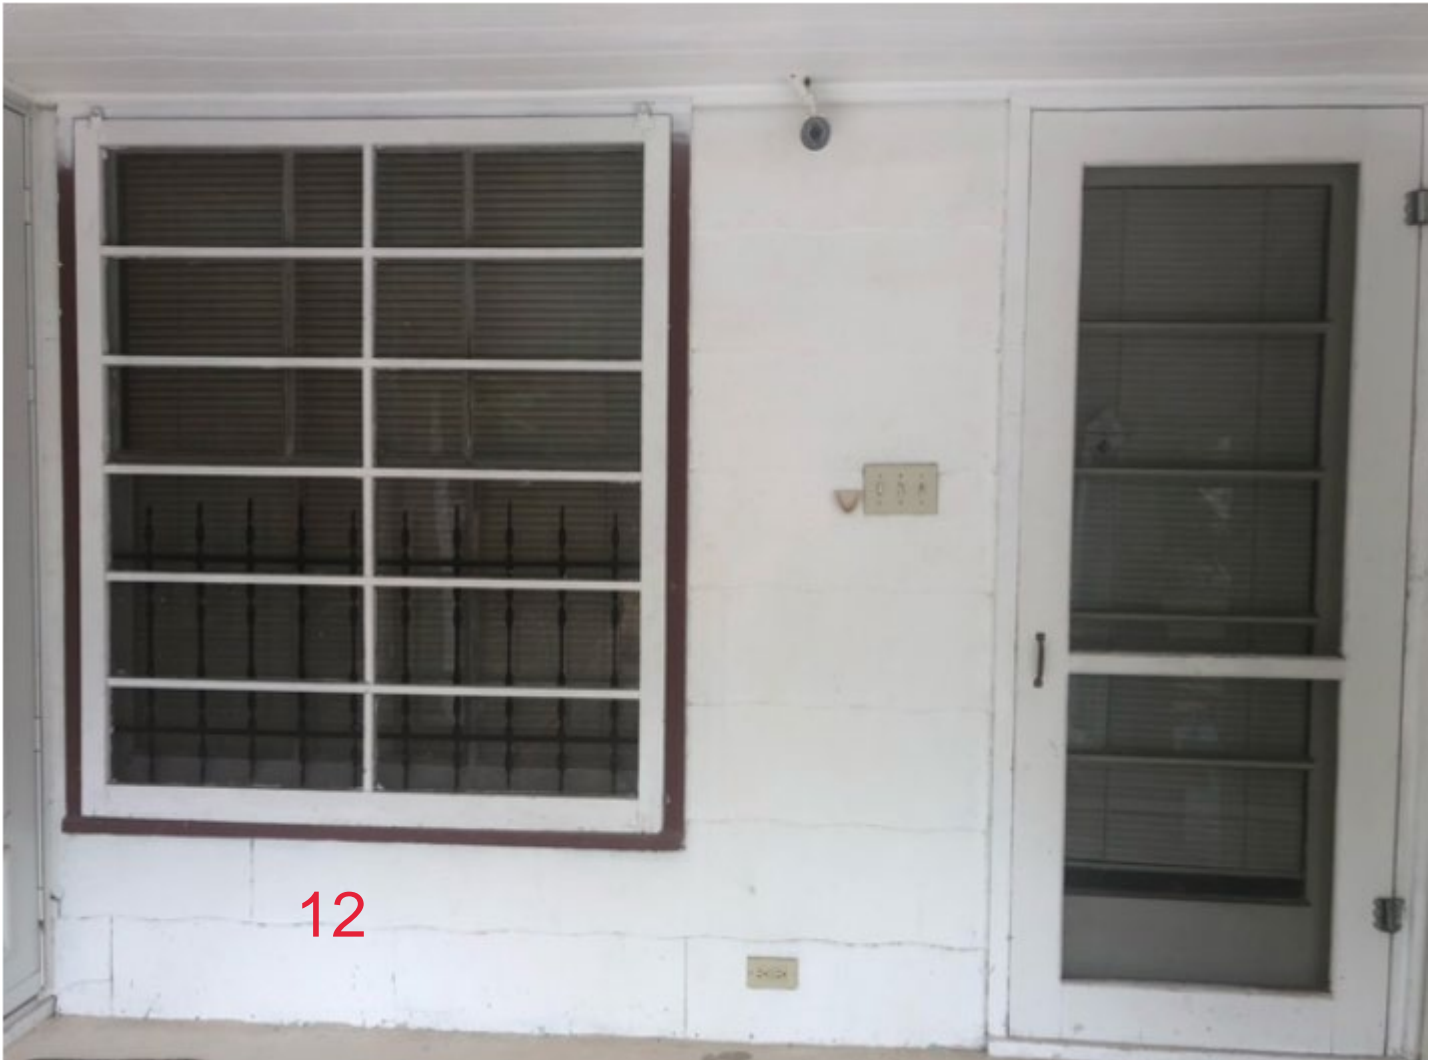
D2

For reference purposes, a third existing door on the porch which is next to the adjacent door of window #12. Comment, I have no idea why anyone would place two doors that close to each other or why three doors would be needed for one porch.

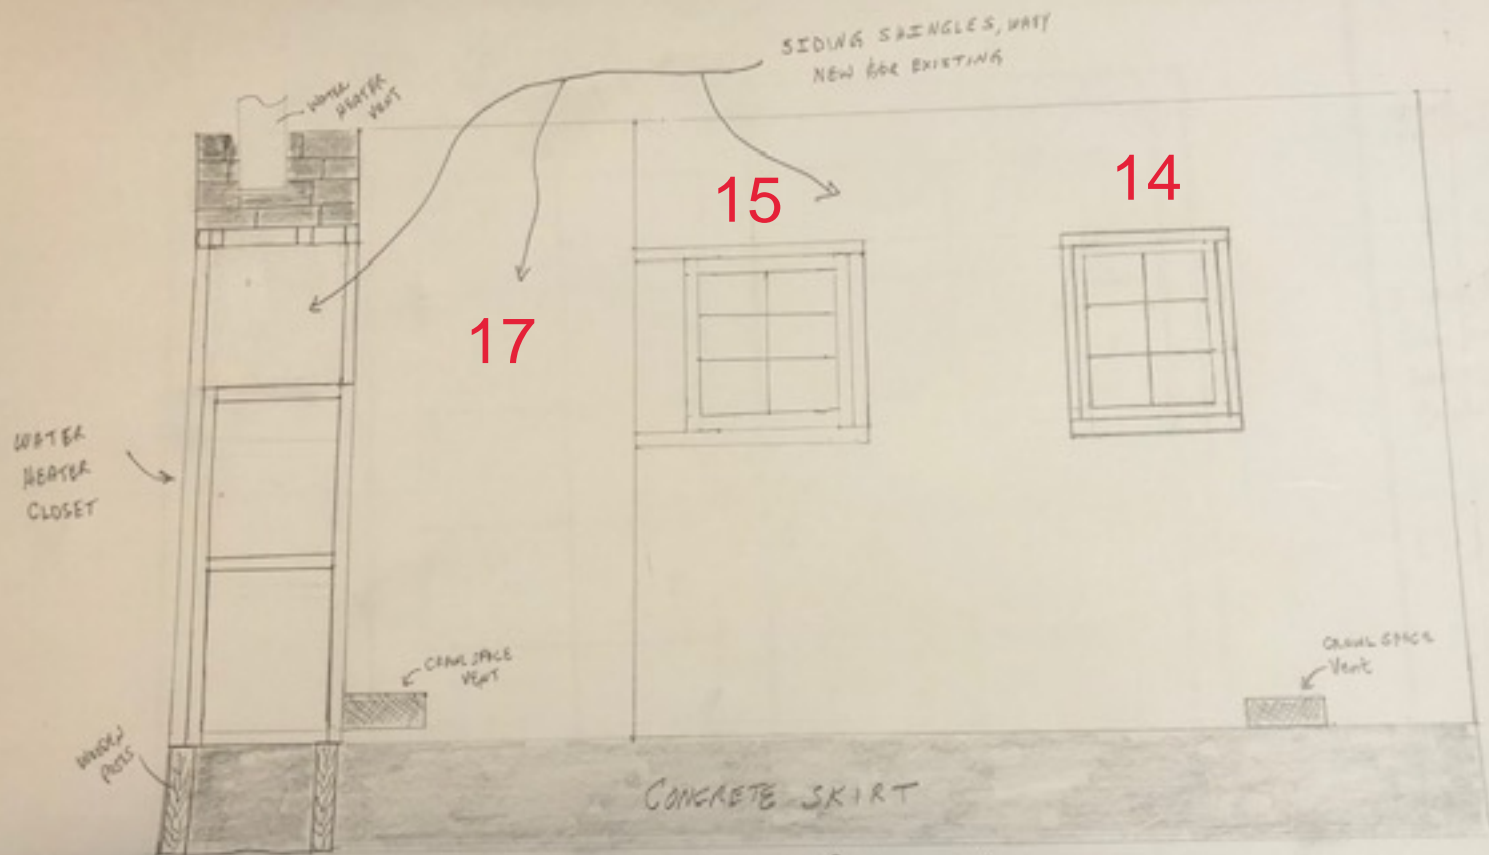
Looking to rear of house, left side of Porch  $\frac{1}{2}'' = 1 \text{ Foot}$

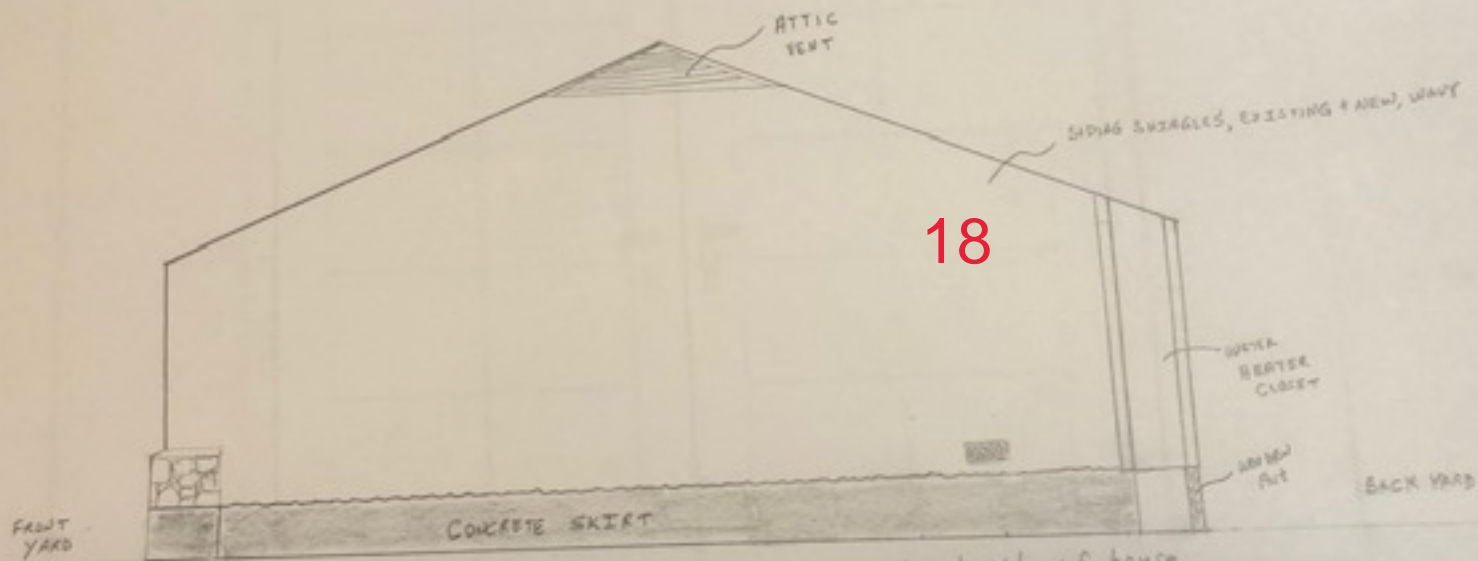
Street view - Right hand side of house
