HISTORIC AND DESIGN REVIEW COMMISSION

July 20, 2016 Agenda Item No: 19

HDRC CASE NO:	2016-273
ADDRESS:	442 E HUISACHE AVE
LEGAL DESCRIPTION:	NCB 3088 BLK 4 LOT 28 & W 1/2 OF 29
ZONING:	MF33 H
CITY COUNCIL DIST.:	1
DISTRICT:	Monte Vista Historic District
APPLICANT:	Ryan Reed/French & Michigan
OWNER:	Brad Parman, Tim Seeliger
TYPE OF WORK:	Screen in porch

Design Brief Huisache Apartments

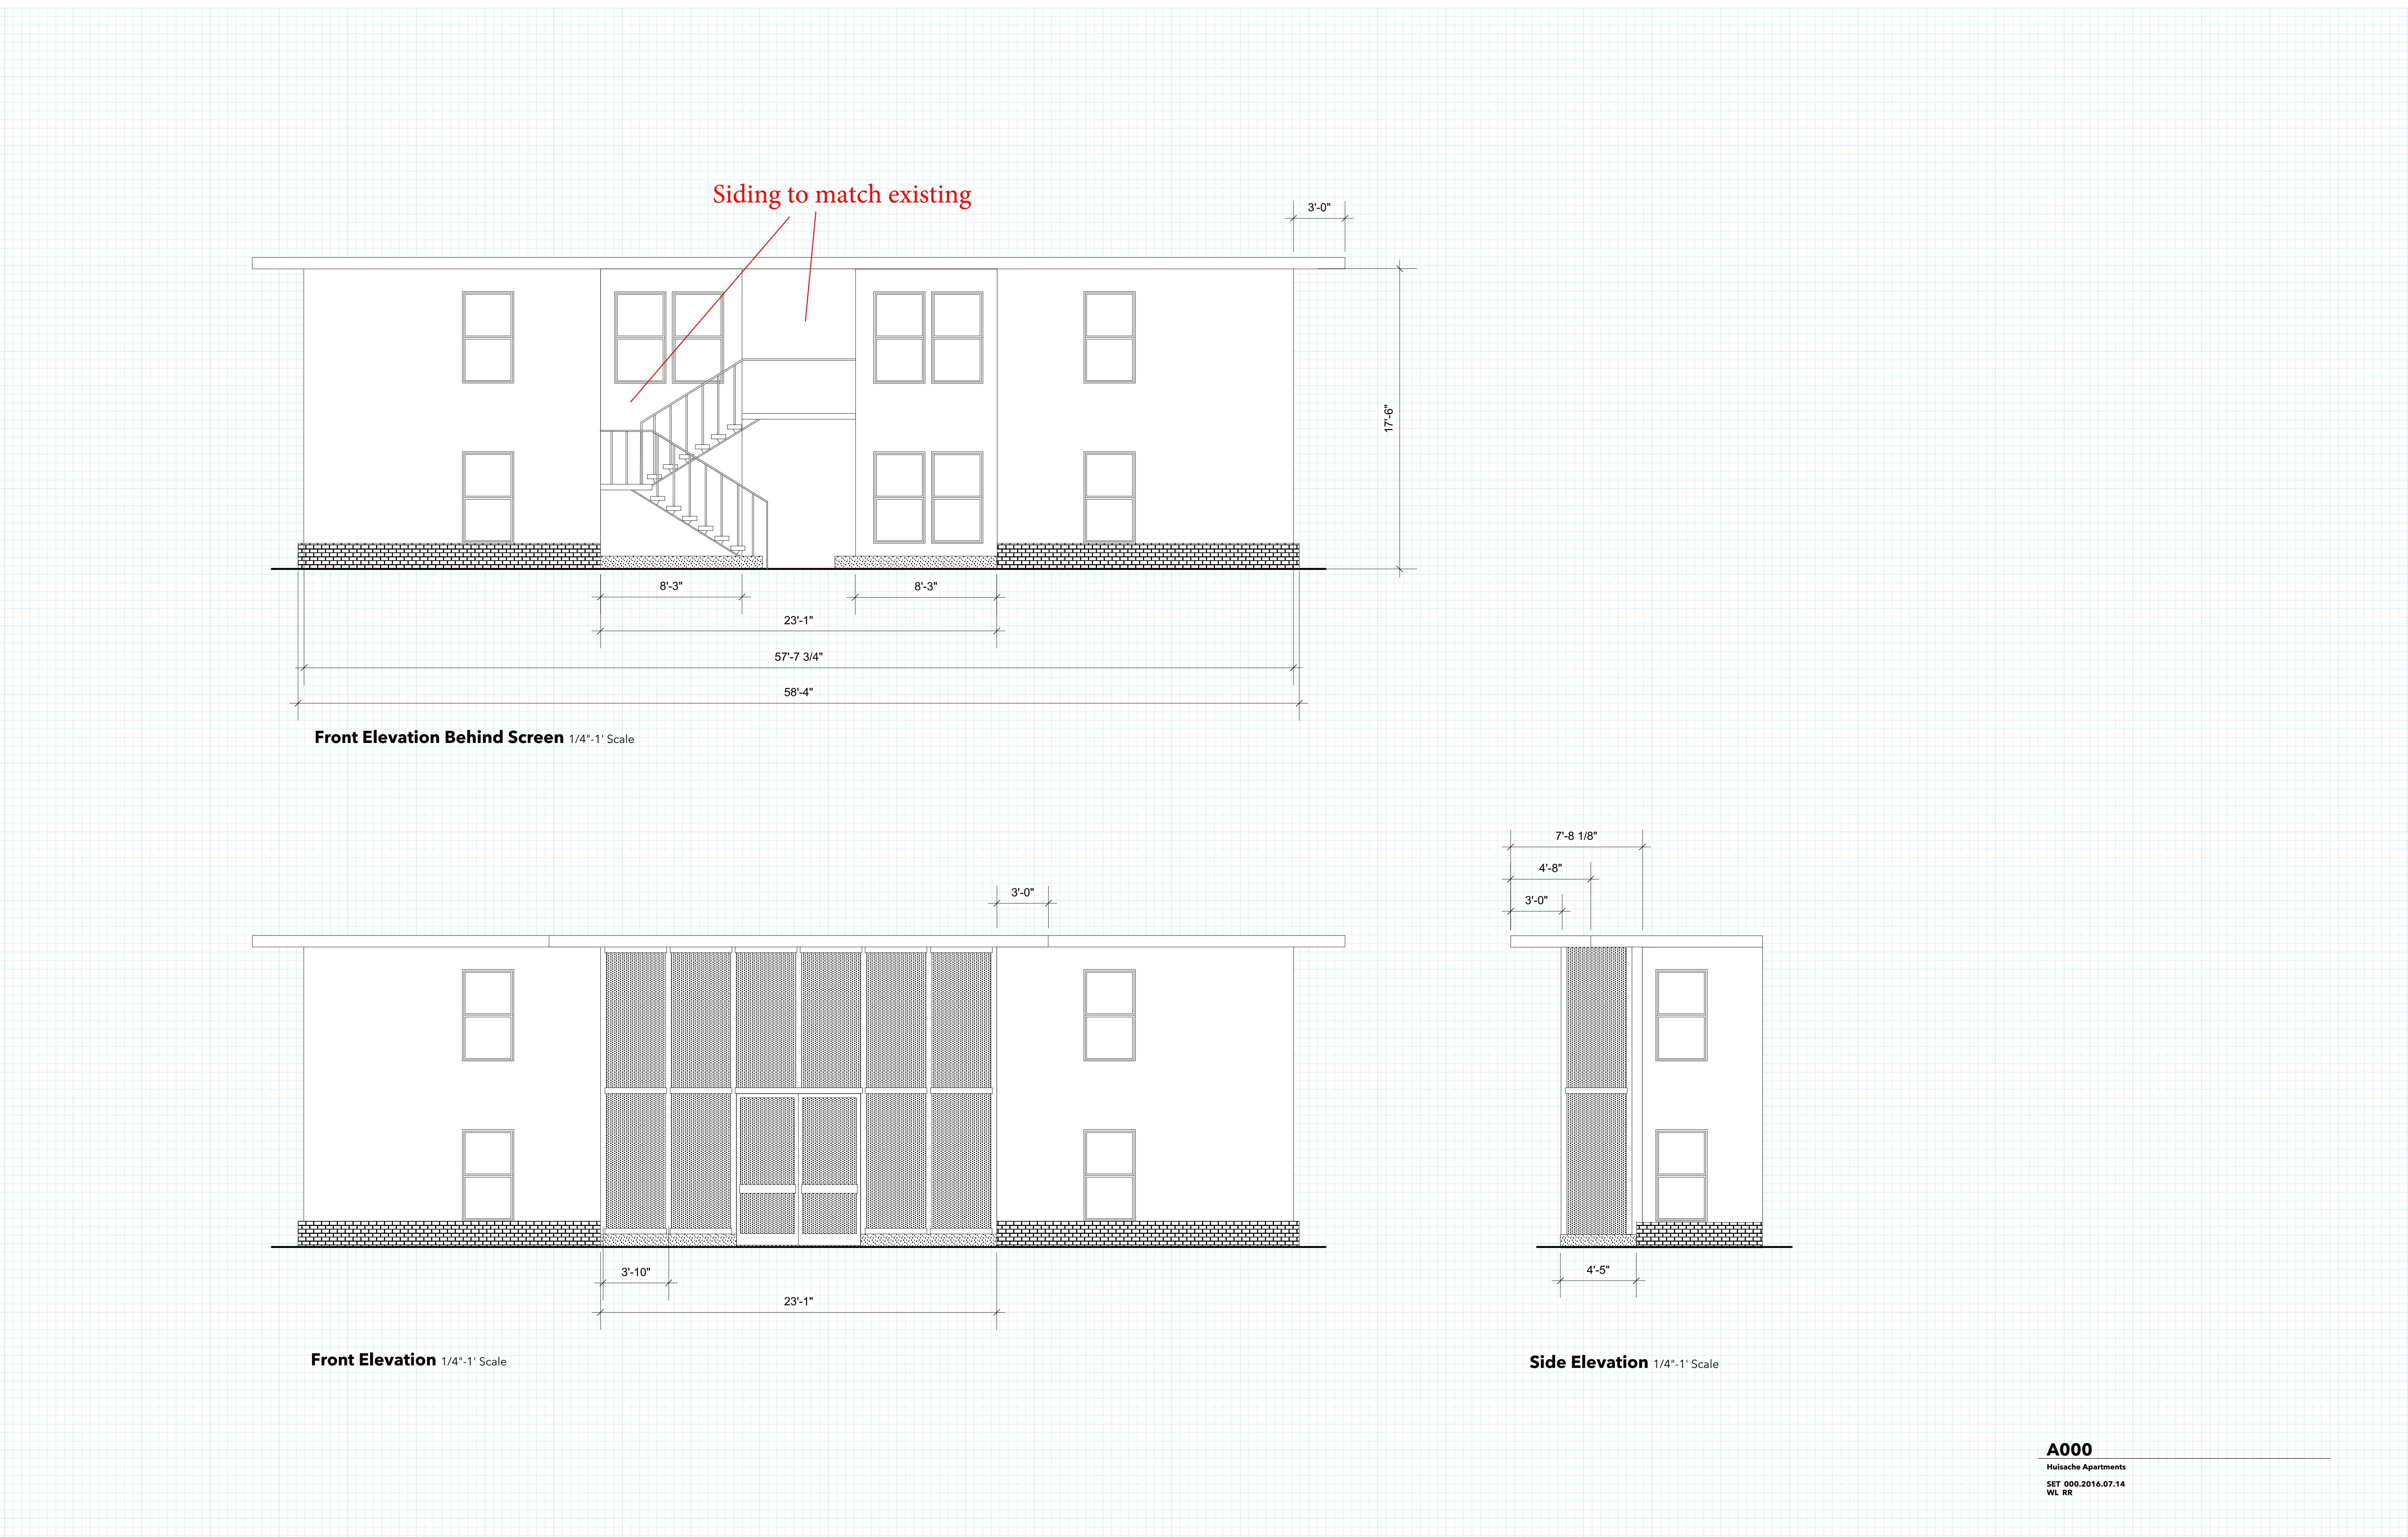
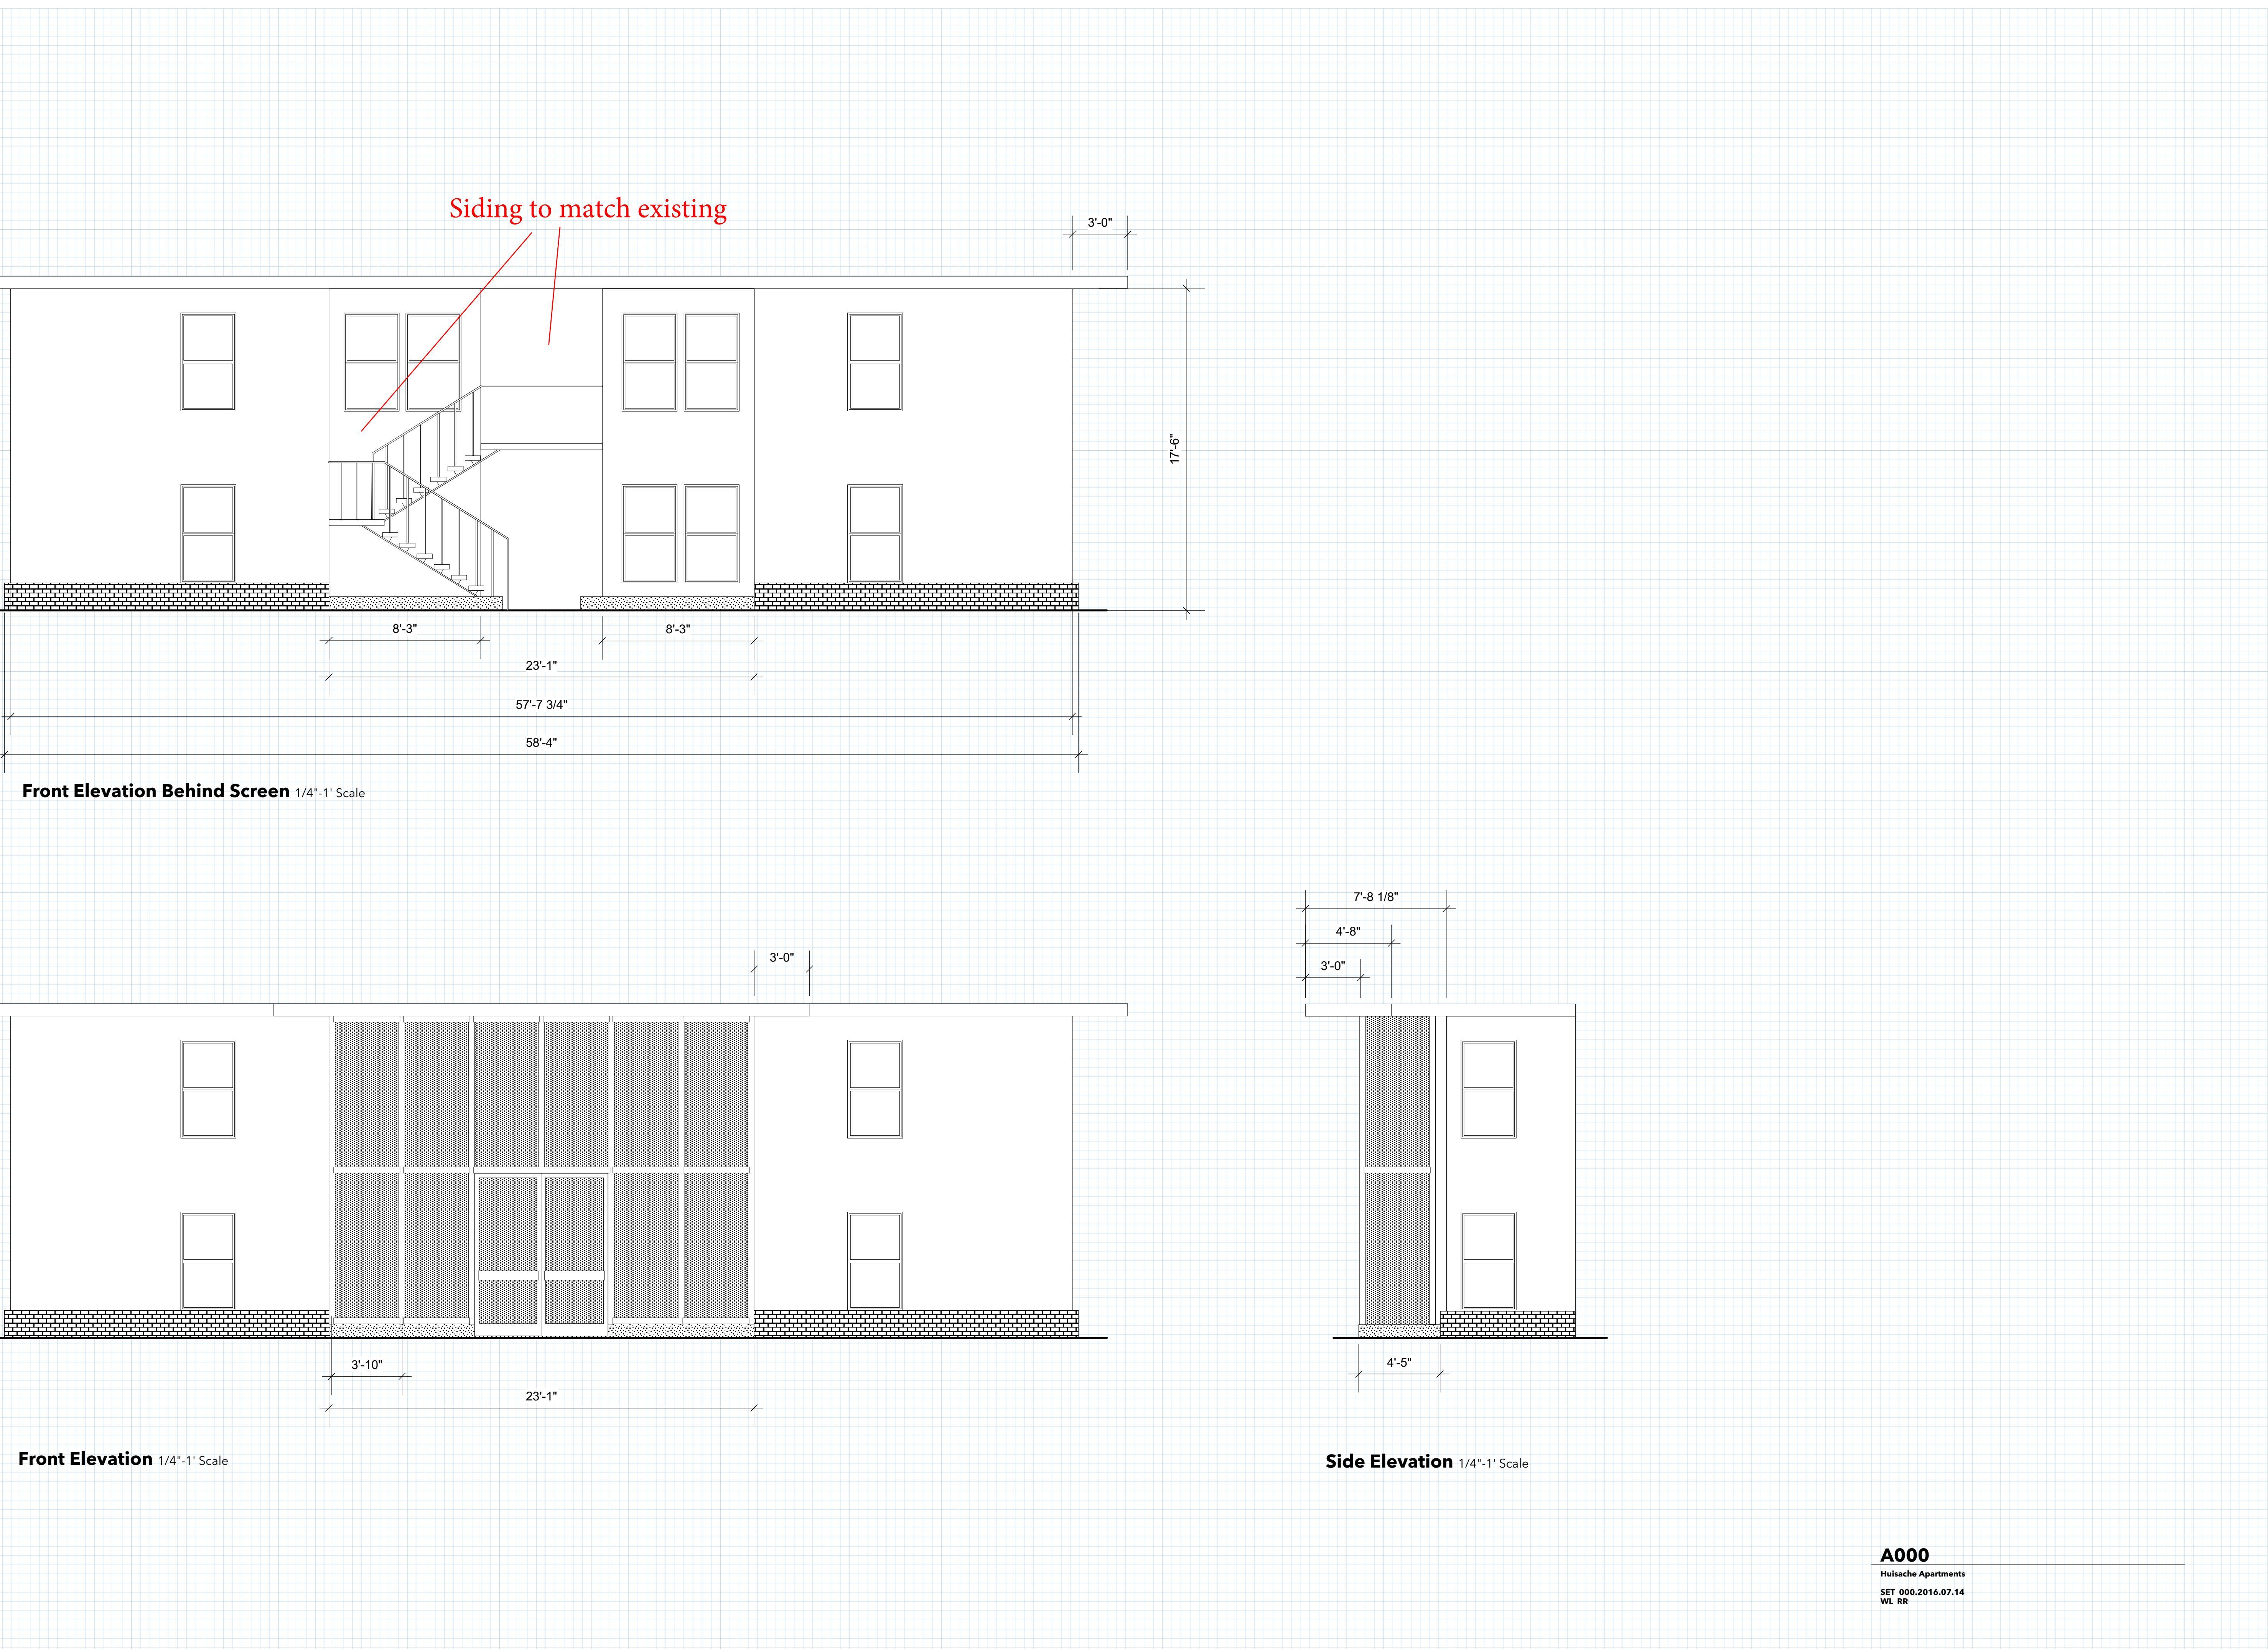
- e. The applicant is proposing to install a cedar framed screening, with brass or aluminum mesh, that would be the same height and roof line as the existing roof. The screening would extend 4'-5" from the façade and buil on existing concrete slab perimeter. The proposed frame has one over one panels on the sides, and 6 over 6 panels on each side mimicking the original 6 windows across. Staff finds the screening less impactful due to its transparent nature than what is existing. Staff finds the proposed screening panels appropriate proportions for the structure.

- Cedar wood post construction for screen enclosure, anchored to concrete perimeter.
- Wire mesh screen, brass or aluminum.
- Roof addition in front over enclosure, to follow 3' overhang around building
- Open staircase.
- Carry over patio tiles used elsewhere in building.

- f. The applicant is proposing to retain the existing interior stairs and open them up to the court yard. These elements would be screened by the proposed two story screening.
