### HISTORIC AND DESIGN REVIEW COMMISSION

#### March 06, 2019

HDRC CASE NO:	2019-043
ADDRESS:	224 E CAROLINA ST
LEGAL DESCRIPTION:	NCB 2956 BLK LOT B
ZONING:	RM-4, H
CITY COUNCIL DIST.:	1
DISTRICT:	Lavaca Historic District
APPLICANT:	Peter Matthew Price
OWNER:	Peter Matthew Price
TYPE OF WORK:	Amend previous approval for porch and addition; Tax Certification
APPLICATION RECEIVED:	January 10, 2019
APPLICATION RECEIVED: 60-DAY REVIEW:

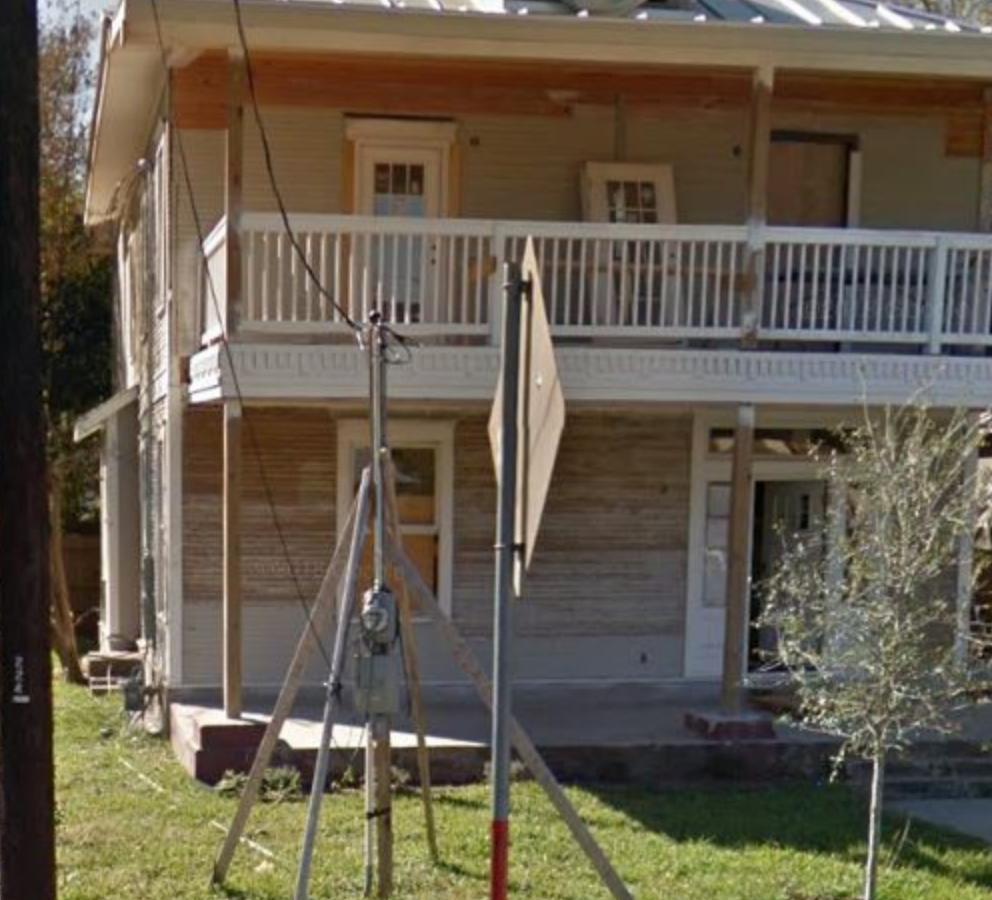
# Google Street View, December 2017

- a. The primary historic structure at 224 E Carolina was constructed circa 1900 in and first appears on the 1911 Sanborn map. The two-story single-family structure features a hipped standing seam metal roof with a centered front facing dormer, a symmetrical front façade configuration with the front door on the bottom right corner, and a brick chimney on the east elevation. The structure originally featured classical columns spanning both the first floor porch and second floor balcony; the front porch was removed leaving one freestanding column by 2007. The structure also featured an rear portion that first appeared on the 1911 Sanborn map.

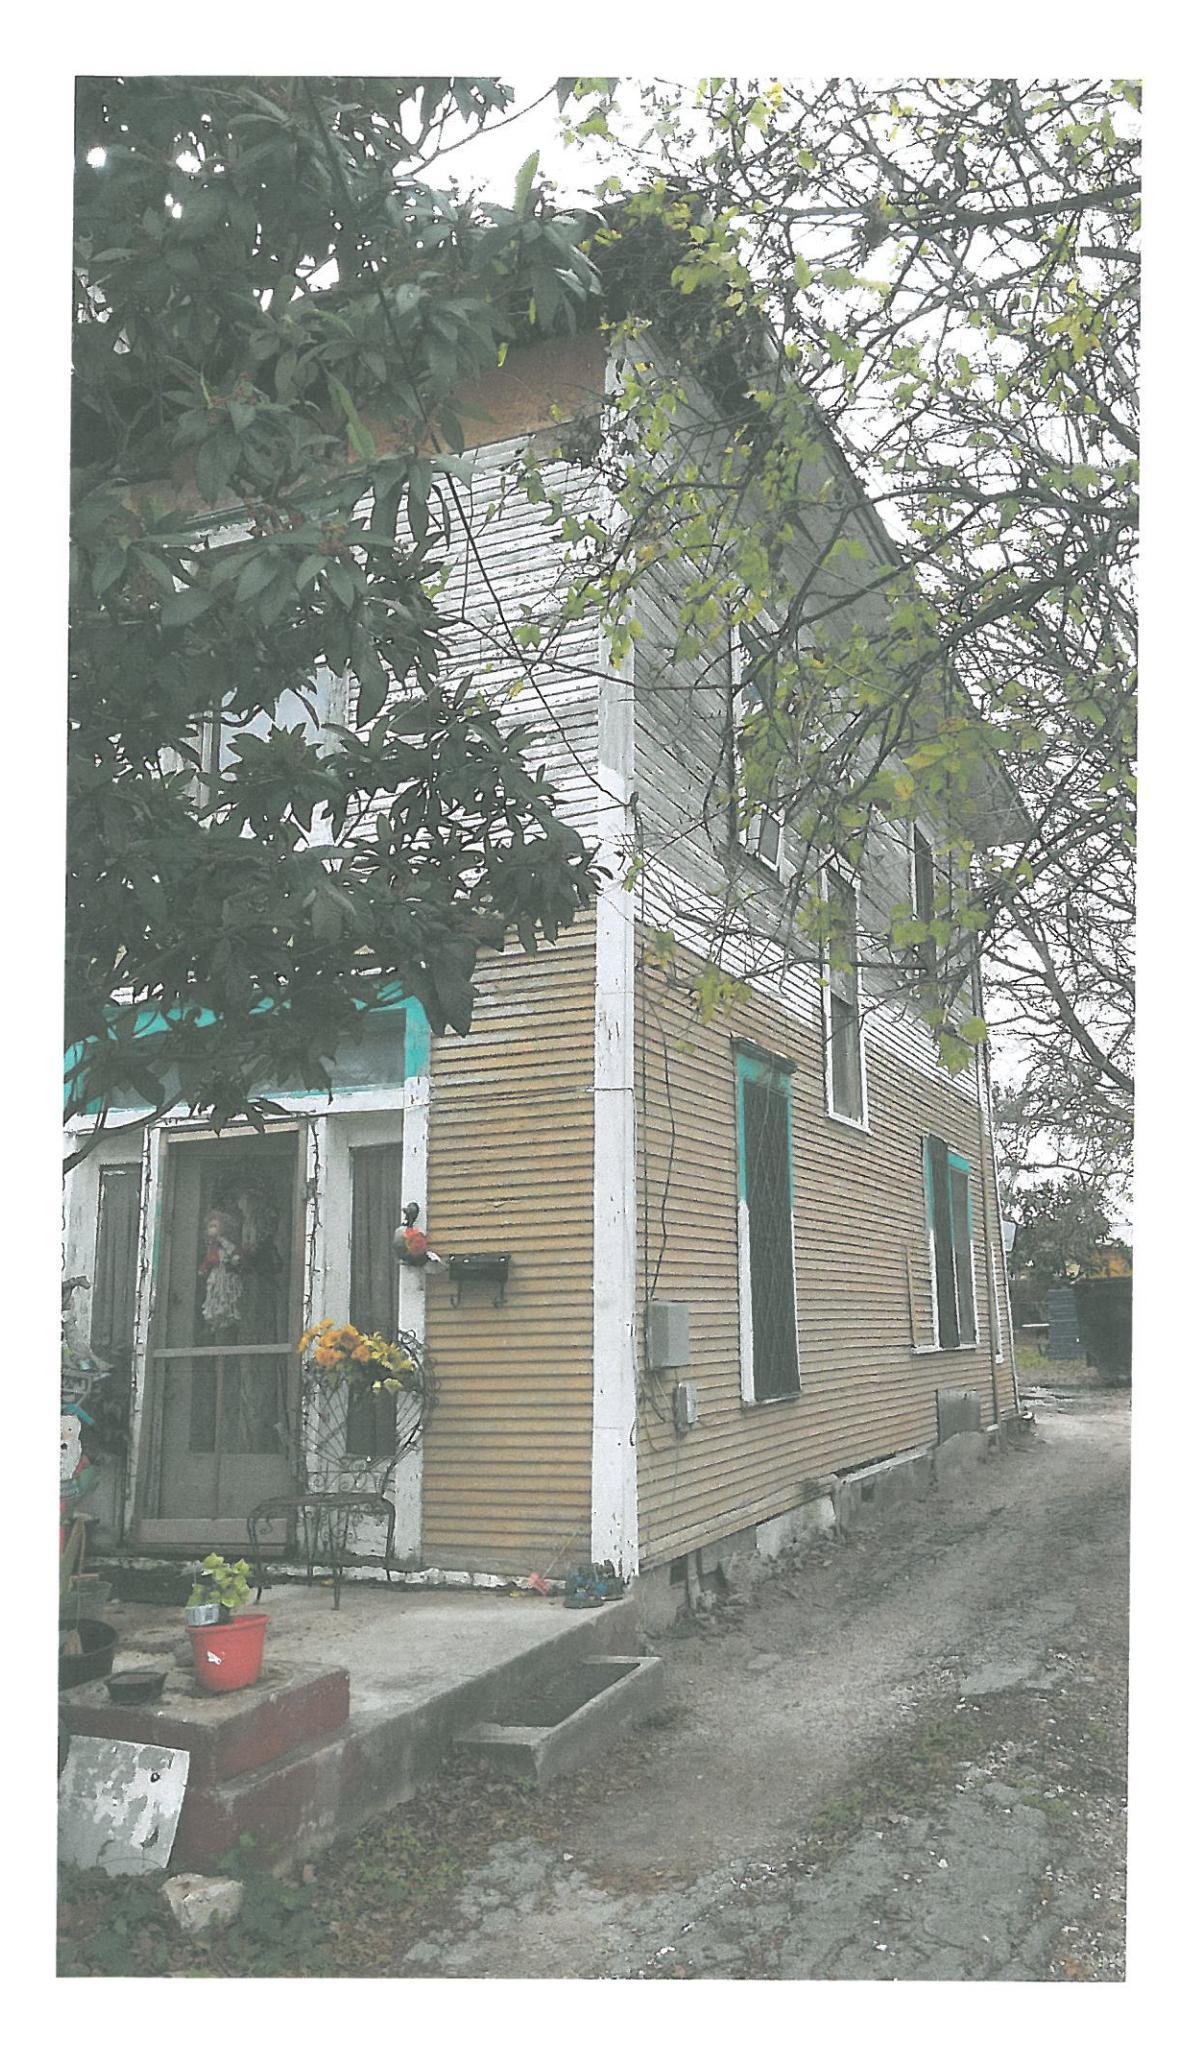
- d. ADDITION The applicant is requesting to the replace the existing rear portion of the house which featured an inset side elevation and 5 wood sashed windows and a rear door with a larger rear addition that is flush to the side elevations of the primary structure and includes a rear door, a set of double-doors, 1 sashed window, and 1 square picture window. Staff finds that the rear portion was constructed during the period of significance of the property as depicted in the 1911 Sanborn map and should be preserved in-place including its windows. Staff finds that the rear portion with the following Guidelines:

REMOVED REAR PORTION, FIRST APPEARS ON 1911 SANBORN MAP

- i. Complies with reconstruction design from the 2016 HDRC approval to feature full-height classical columns.
- ii. Restore the rear portion to its original configuration after submitting plans to staff or resubmit a plan for a rear addition that includes appropriate fenestration and inset side wall planes.
