# CITY OF SAN ANTONIO OFFICE OF HISTORIC PRESERVATION

## HISTORIC DESIGN GUIDELINES

### WINDOWS: REPAIR, REPLACEMENT, AND NEW CONSTRUCTION

December 16, 2015

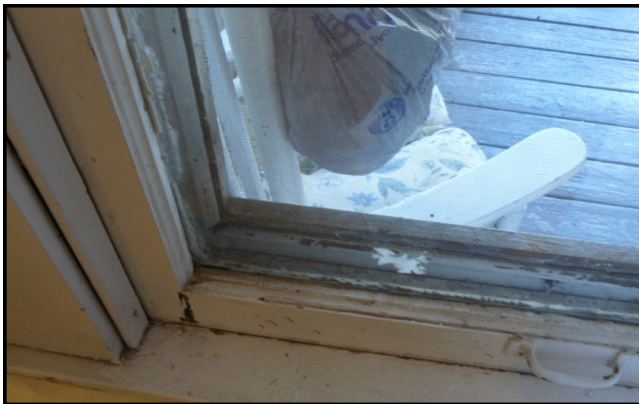
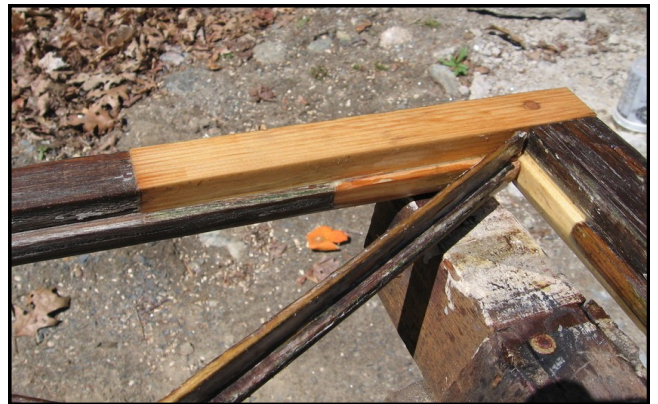
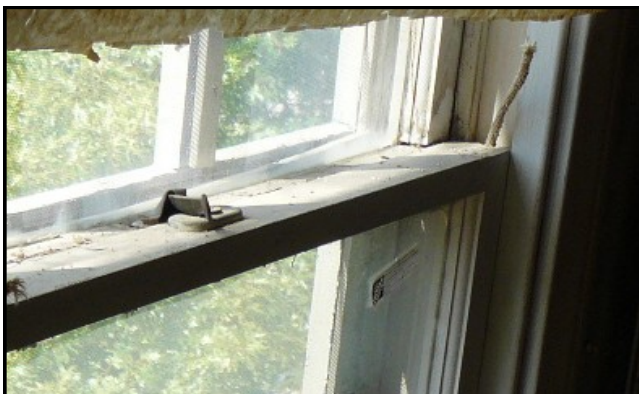
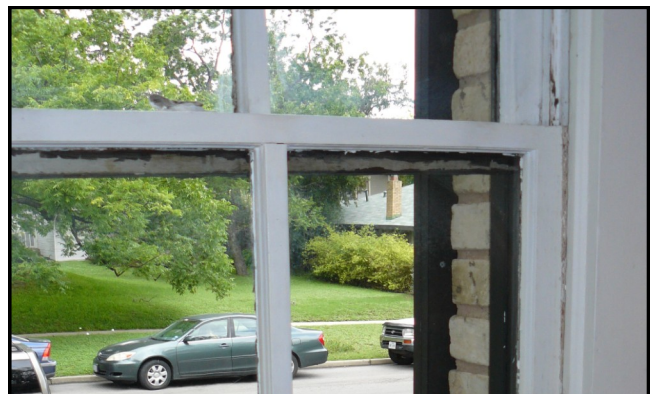
## Examples of Repairable Windows:

- Glass missing or broken;
- Meeting rails not aligning;
- Cords broken or hardware missing;
- Sill or frame rotted;
- Partially rotted rails and stiles which require patching.

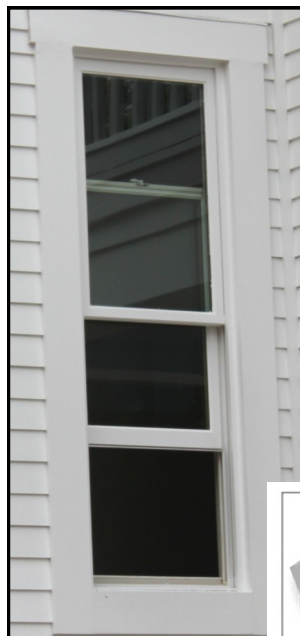
Block Frame

- Maintain traditional dimensions and profiles;
- Be recessed within the window frame. Windows with a nailing strip are not recommended;
- Feature traditional materials or appearance. Wood windows are most appropriate. Double-hung, block frame windows that feature alternative materials may be considered on a case-by-case basis;
- Feature traditional trim and sill details. Paired windows should be separated by a wood mullion.

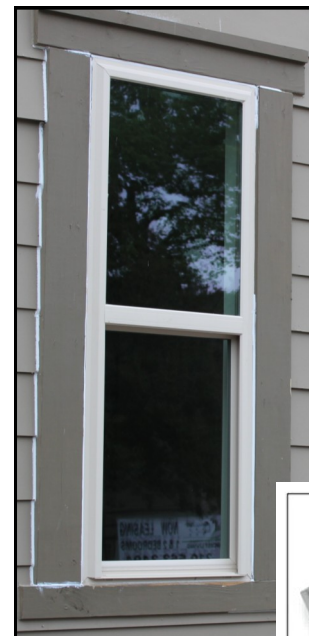
Flush Flange

(not recommended)
