# HISTORIC AND DESIGN REVIEW COMMISSION

**HDRC CASE NO:** 2016-317  
**ADDRESS:** 906 E CROCKETT ST  
**LEGAL DESCRIPTION:** NCB 583 BLK 8 LOT 8  
**ZONING:** RM4 H  
**CITY COUNCIL DIST.:** 2  
**DISTRICT:** Dignowity Hill Historic District  
**APPLICANT:** Joseph Garcia  
**OWNER:** Joseph Garcia  
**TYPE OF WORK:** Wood window replacement  
**REQUEST:**

1. Install a wrought iron front yard fence featuring a height of 4' – 6" with a gate height of 6' – 6".
2. Replace ten historic wood windows with one over one vinyl windows.
3. Replace the existing, original wood siding with cement board siding.

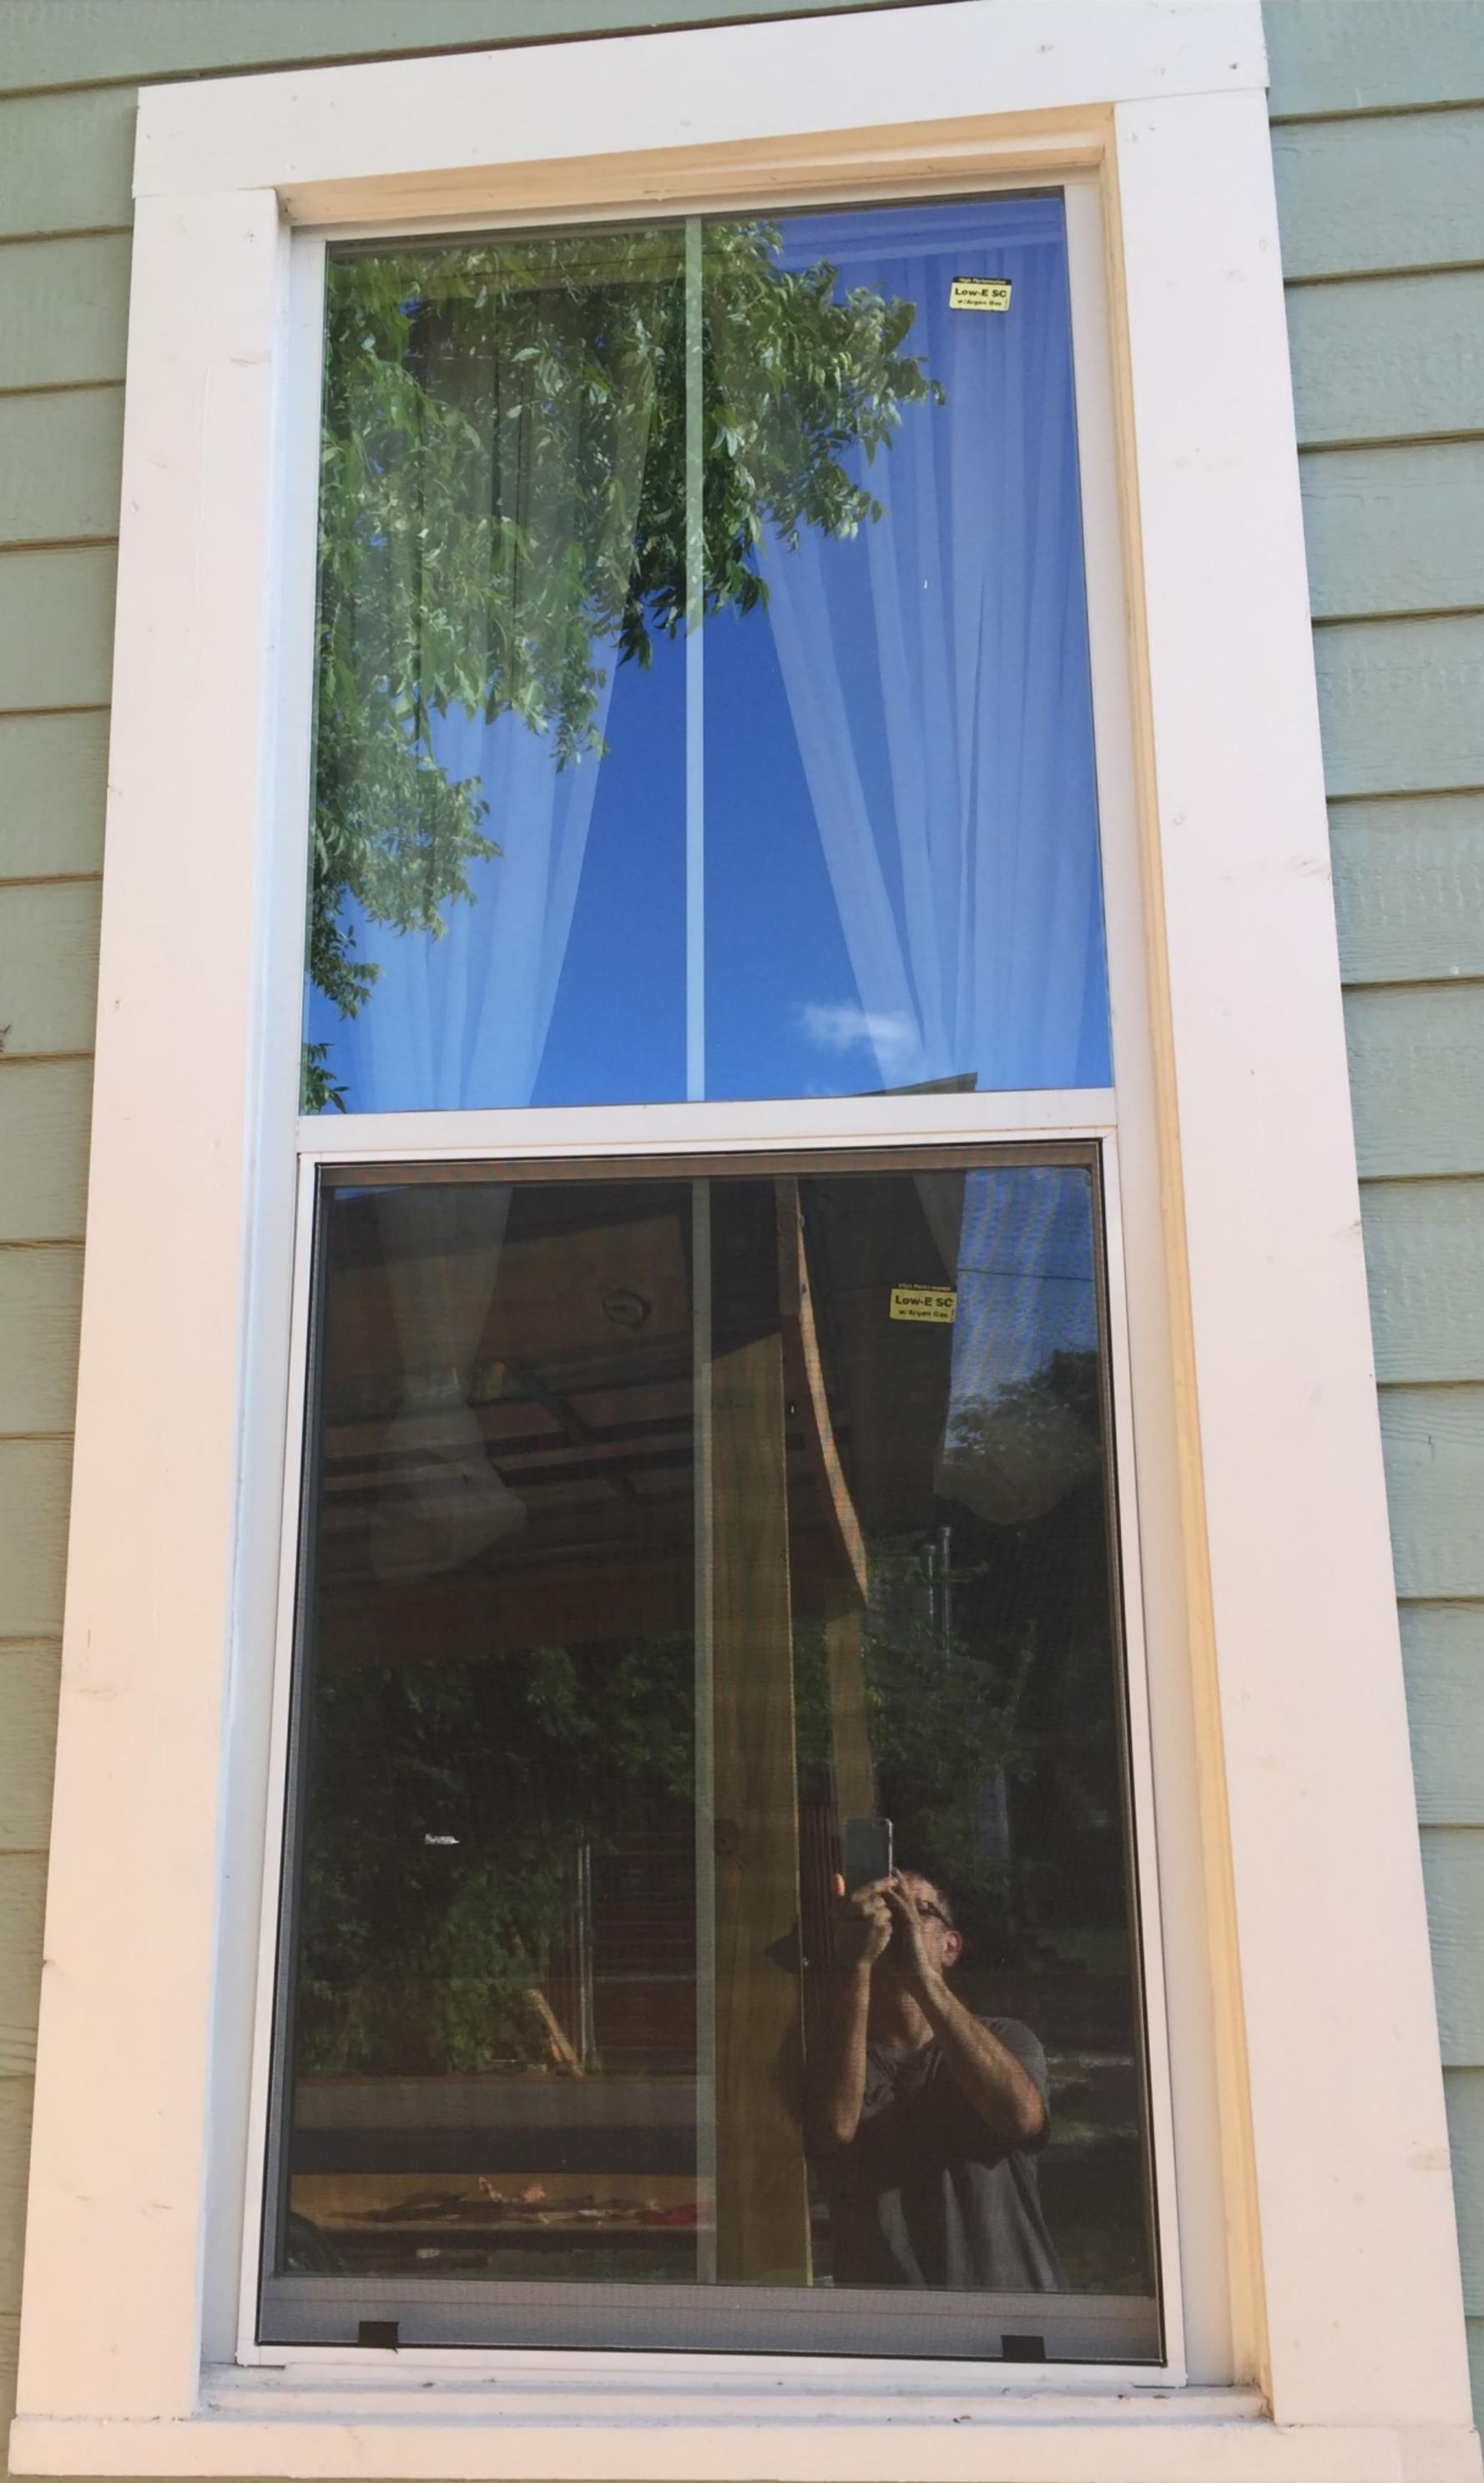
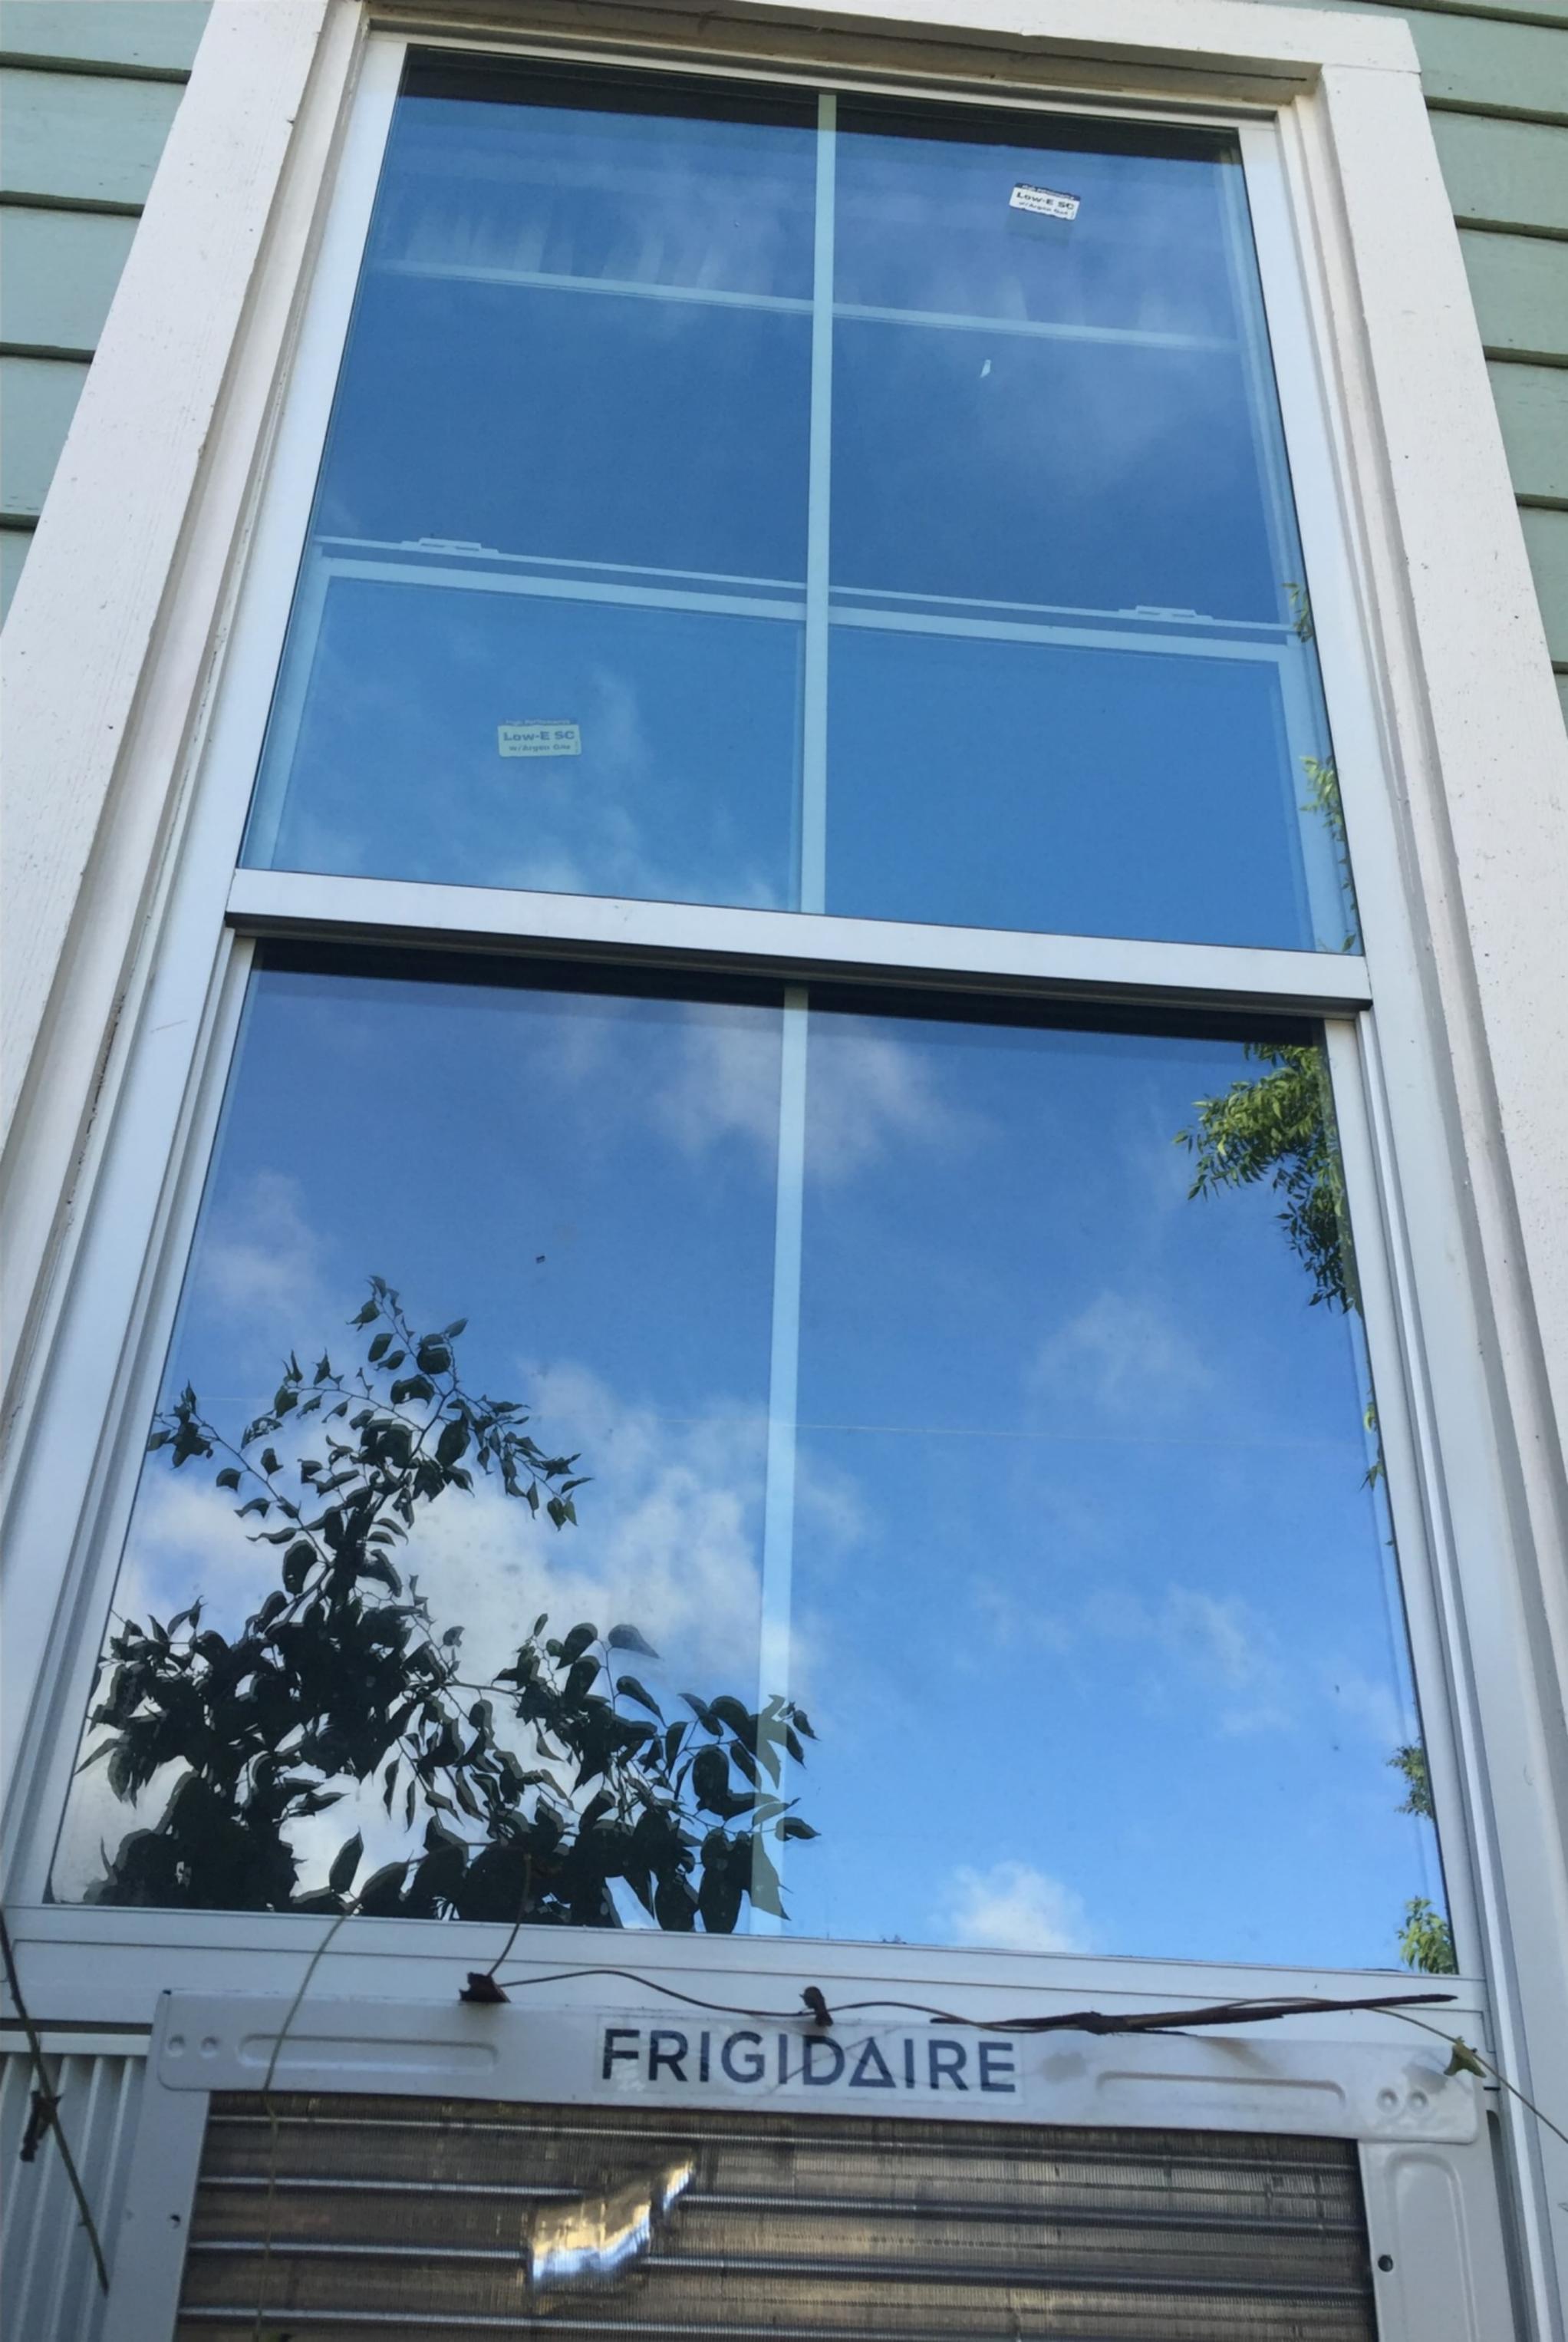
- d. WINDOWS – The applicant has replaced ten historic wood windows with one over one vinyl windows. According to the Guidelines for Exterior Maintenance and Alterations 6.A.iii. historic window should be preserved. Additionally, per 6.B.iv., new windows should be installed to match the existing windows in terms of size, type, configuration, material, form, appearance and detail. The current vinyl replacement windows are neither appropriate nor consistent with the Guidelines.

- 1. That the applicant reduce the height of the front yard fence to no more than four (4) feet in height.
- 2. That the applicant install wood windows comparable to the original wood windows.
- 3. That the applicant install wood siding comparable to the original wood siding.

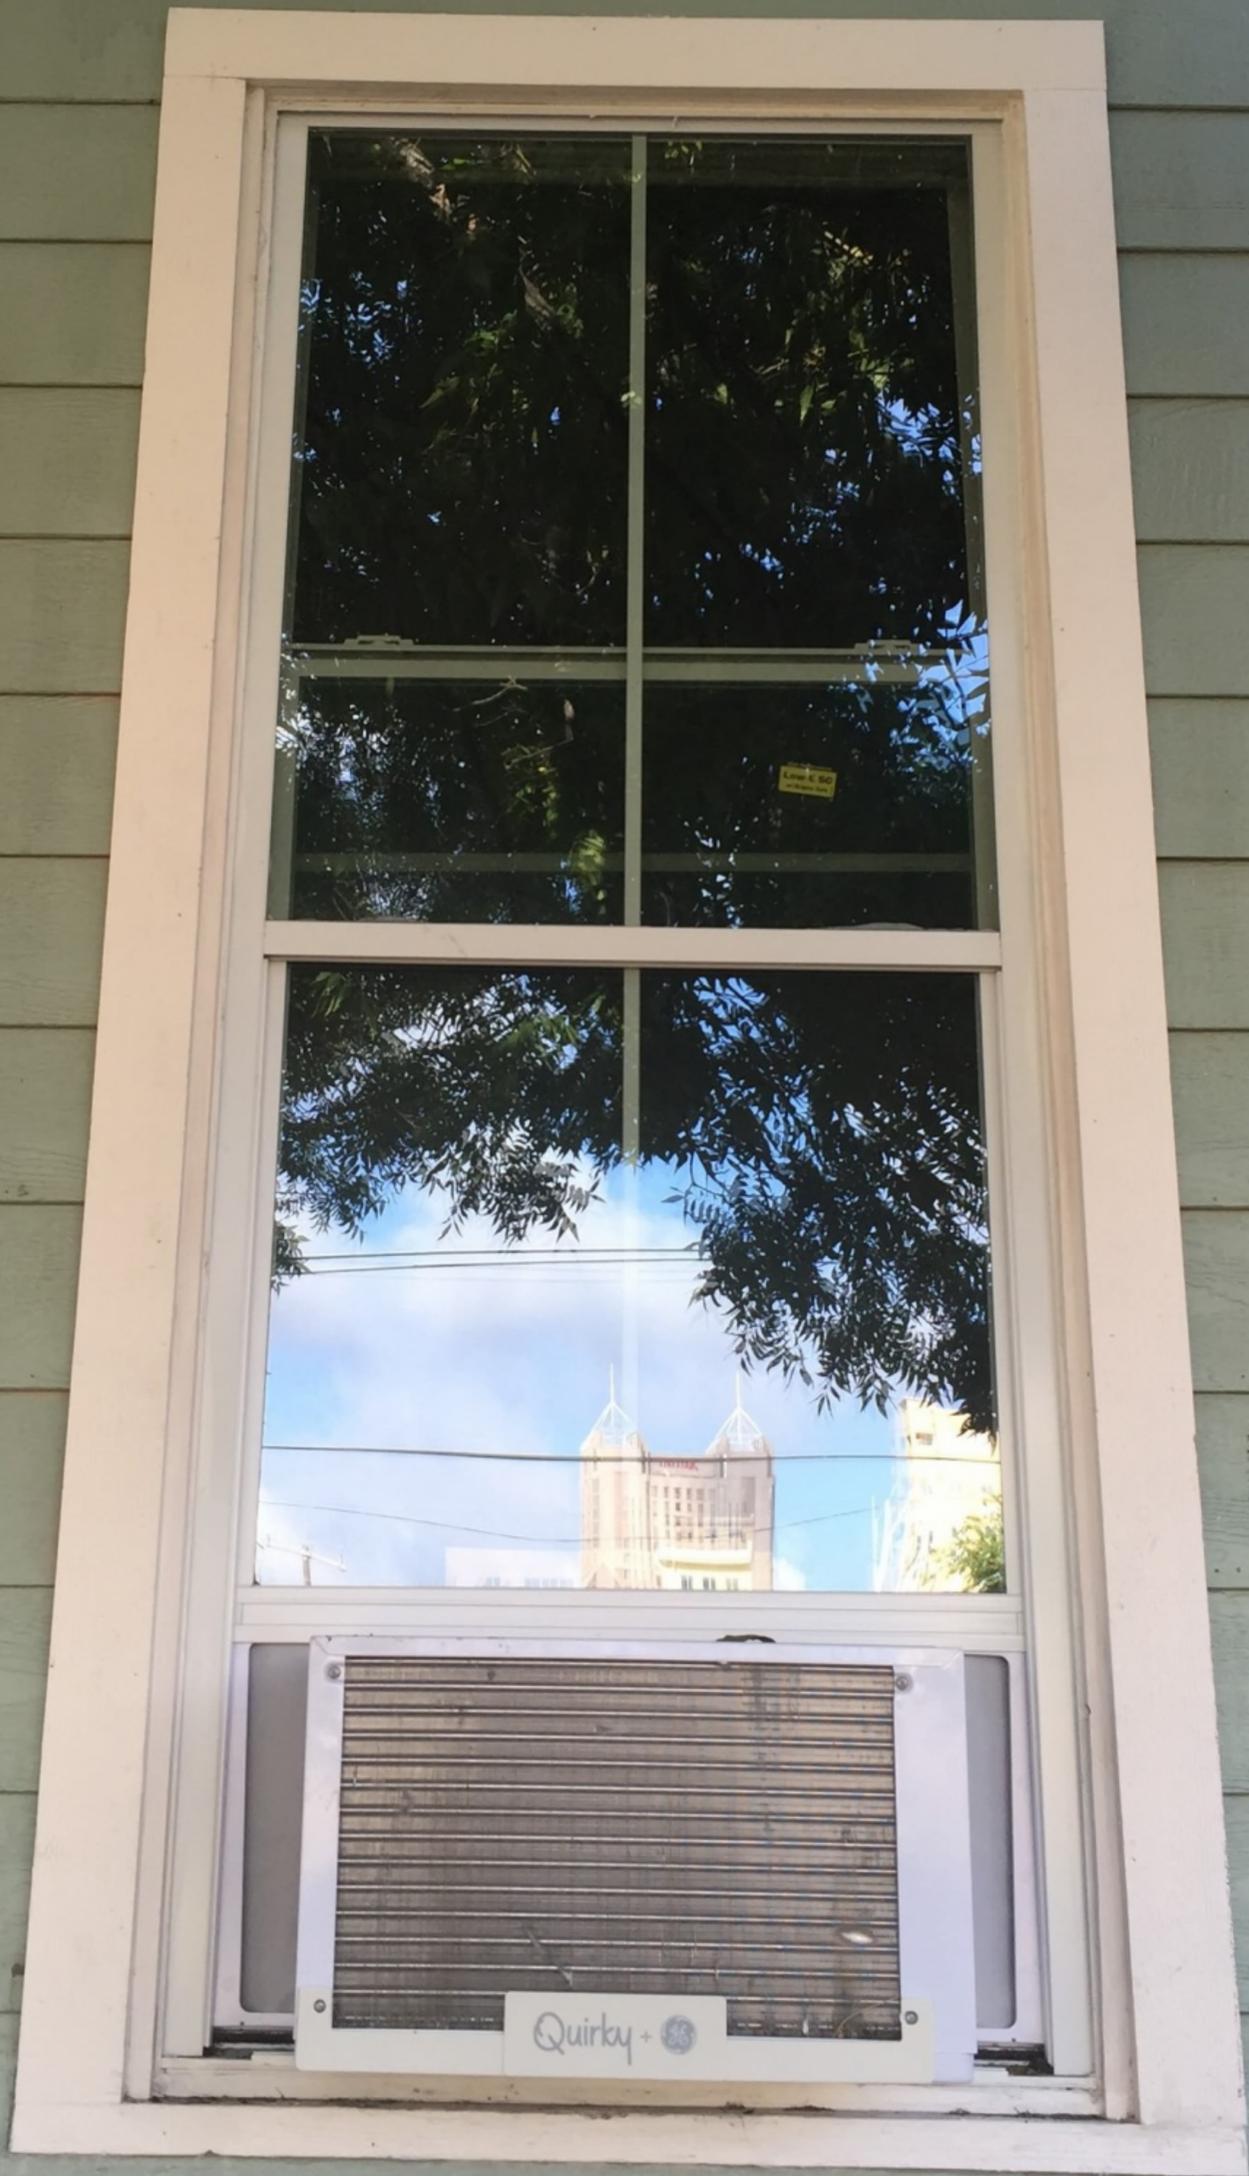
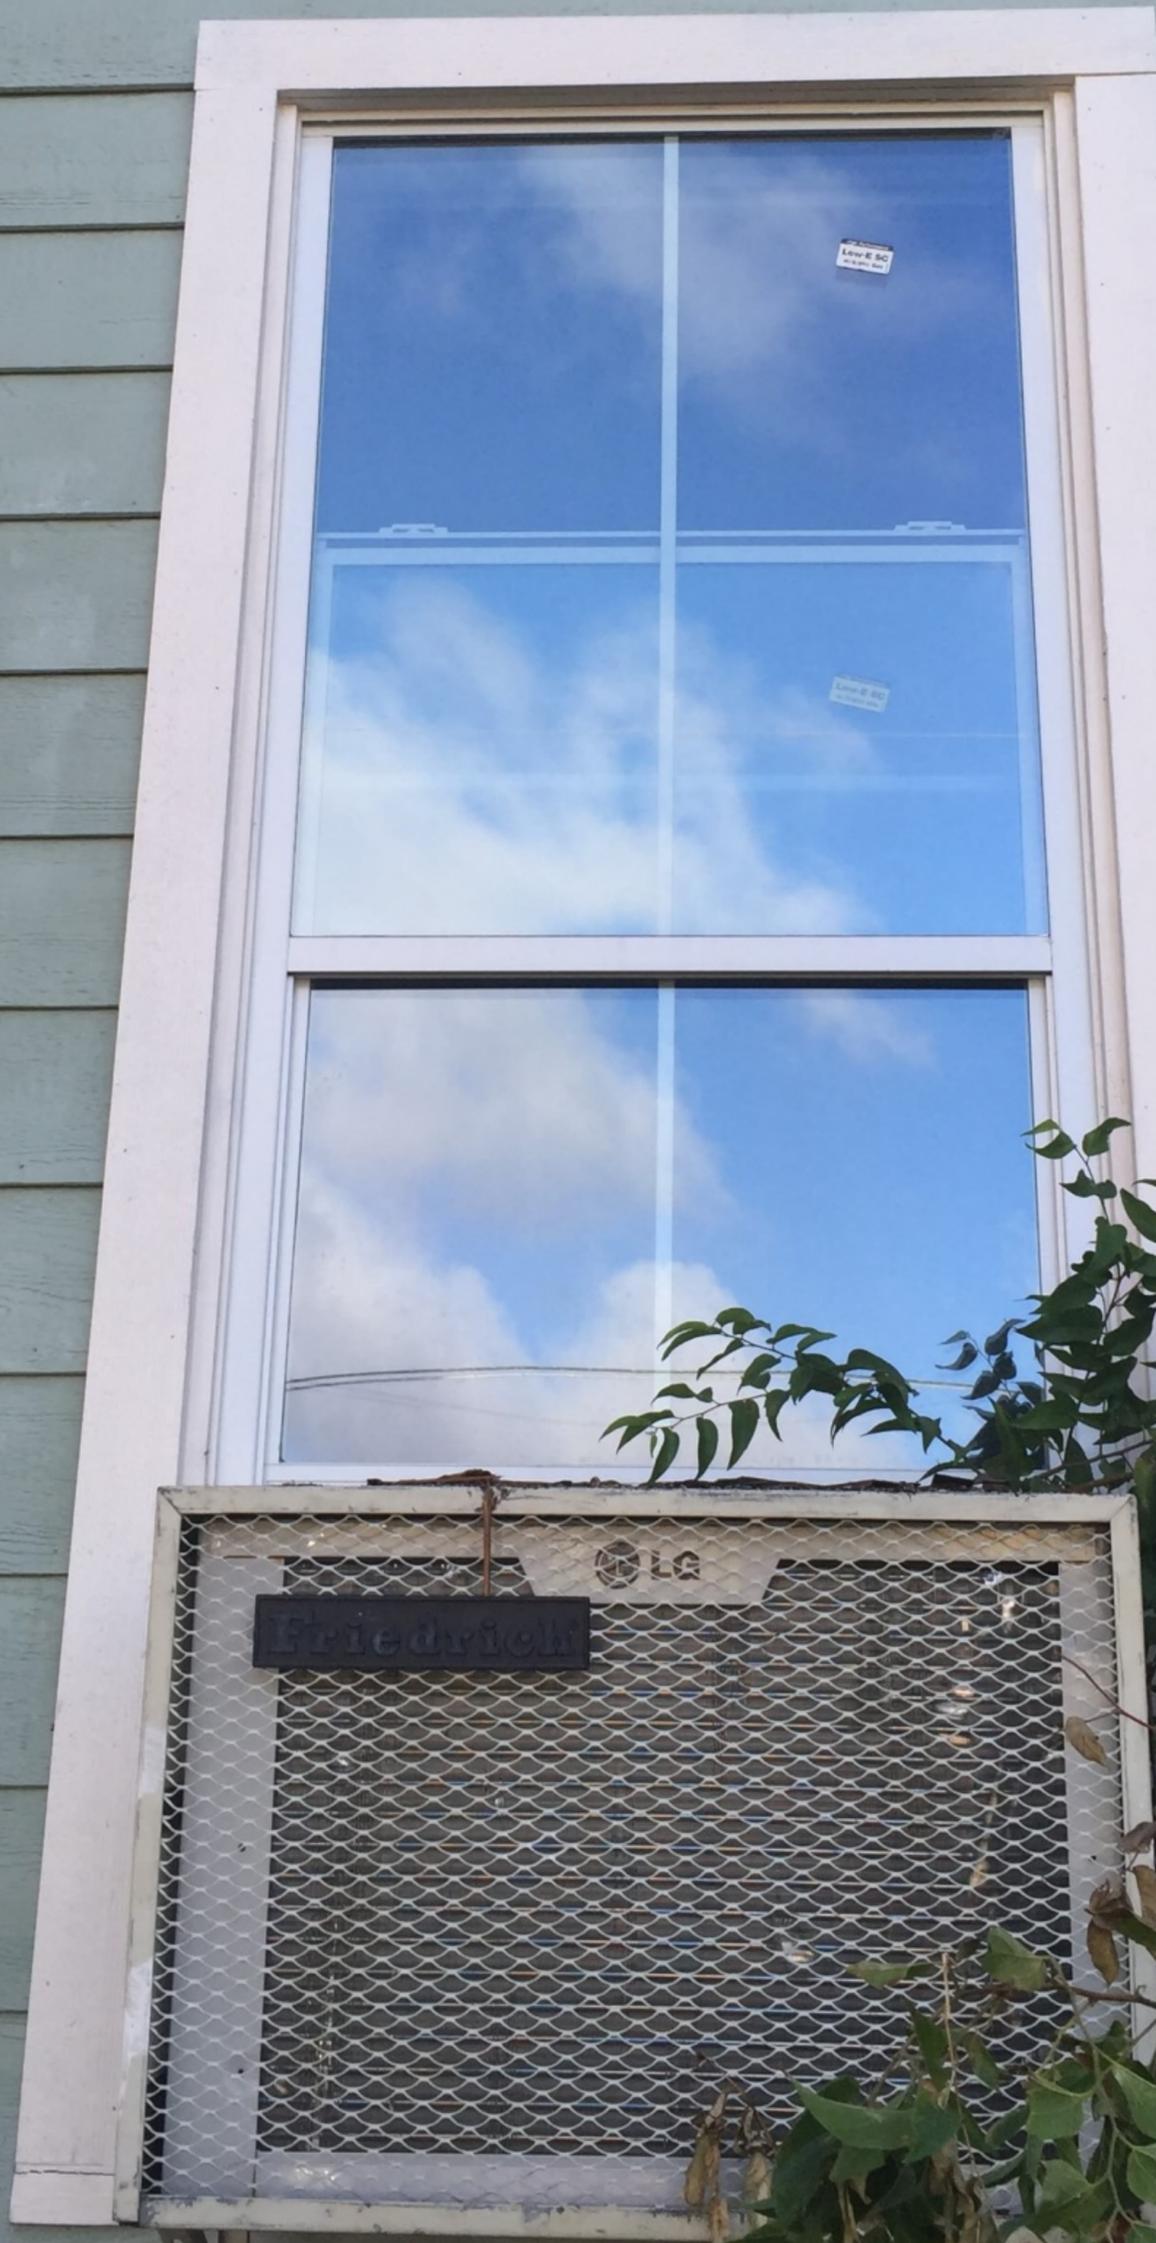
Low-E SC  
w/ Argon Gas

Low-E SC  
W/Argon Gas

If the HDRC approves the existing vinyl windows, staff recommends the applicant install wood screens that match the existing wood screens to screen the vinyl windows.

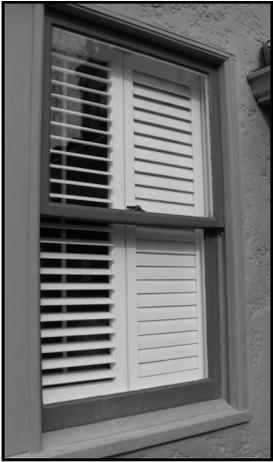
6.B.iv. *Install new windows to match the historic or existing windows in terms of size, type, configuration, material, form, appearance, and detail when original windows are deteriorated beyond repair.*

Individual sashes should be replaced where possible. Should a full window unit require replacement, inserts should

- Match the original materials;
- Maintain the original dimension and profile;
- Feature clear glass. Low-e or reflective coatings are not recommended for replacements;
- Maintain the original appearance of window trim or sill detail.

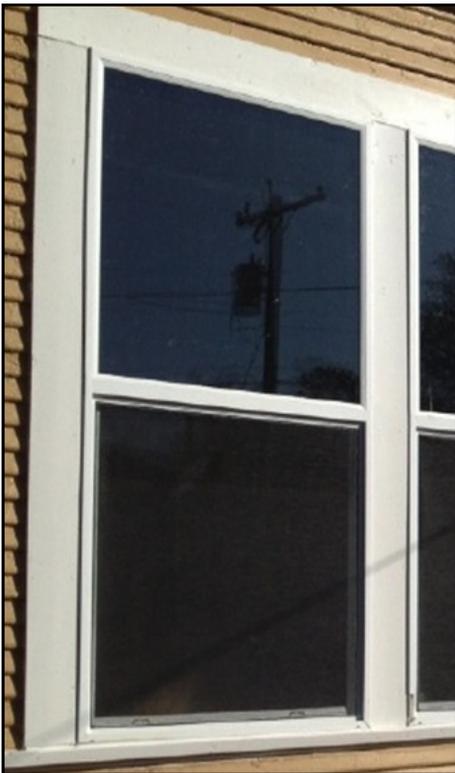
- Vinyl product changes the material
- Window is not recessed within frame
- Sash components do not feature traditional dimensions

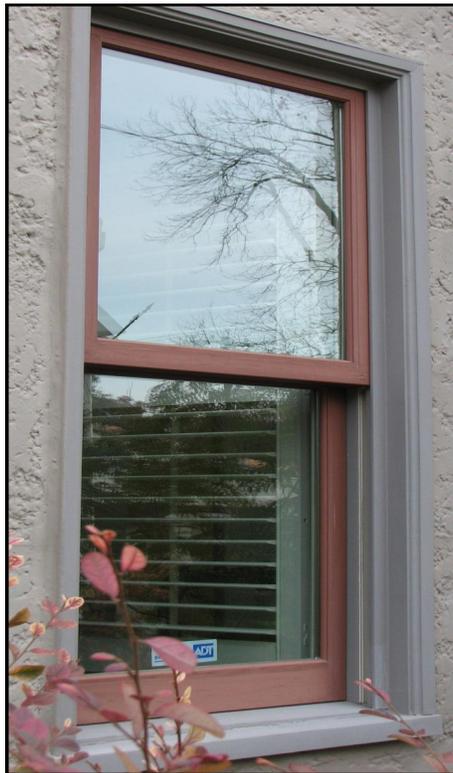
- Track insert alters profile
- Meeting rails thicker than original
- Low-e coating alters hue and reflectivity

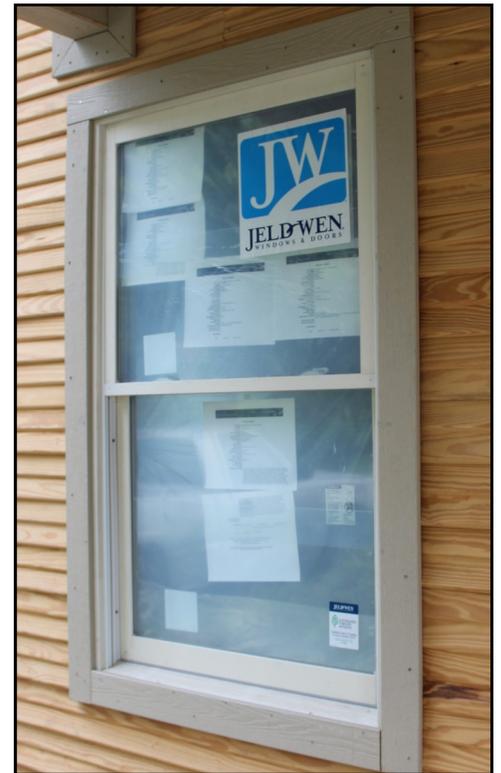
- Window trim and sill detail not consistent with original
